4 McCraes Walk  
Wargrave  
Berkshire  
RG10 8LN

## Preliminary Roost Assessment

Report ref.: R2861\_PRA\_a

**February 2025**

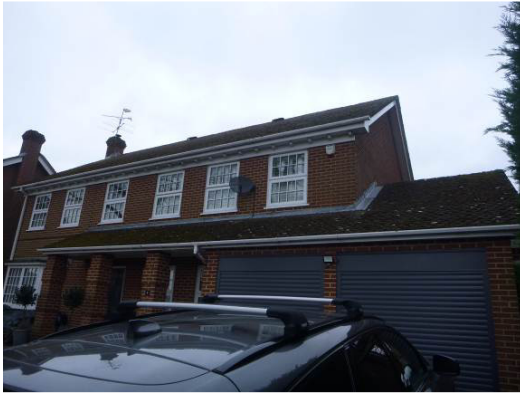
**5.2.2** The property was a detached brick built residential dwelling with an integrated double garage and flat roof rear extension (**Photographs 1 & 2**).

*Photograph 1. Front of property viewed from north.*

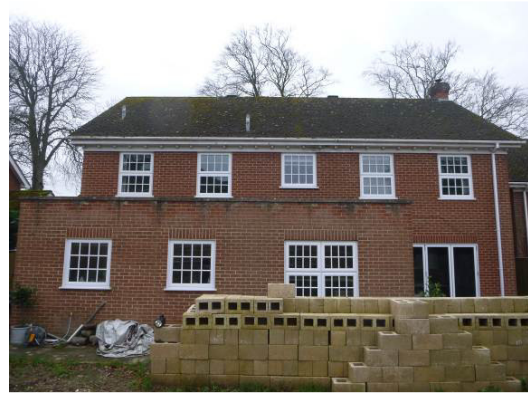
*Photograph 2. Rear of property viewed from south.*

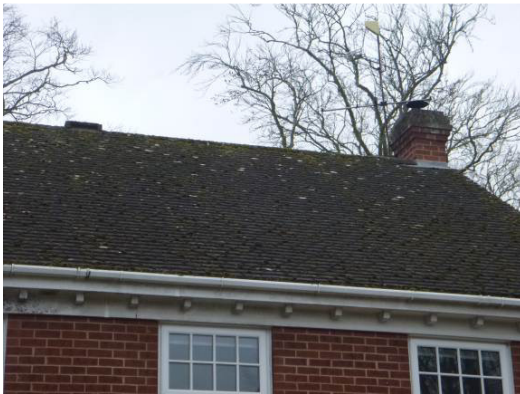
- 5.2.3** The plain roof tiles were flat and intact throughout (**Photograph 3**). The ridge tiles and mortar beneath were intact throughout. The lead flashing around the chimney and single-storey garage extension was flat. There were two air vents at the ridge (**Photograph 4**).

*Photograph 3. Flat roof tiles intact throughout.*

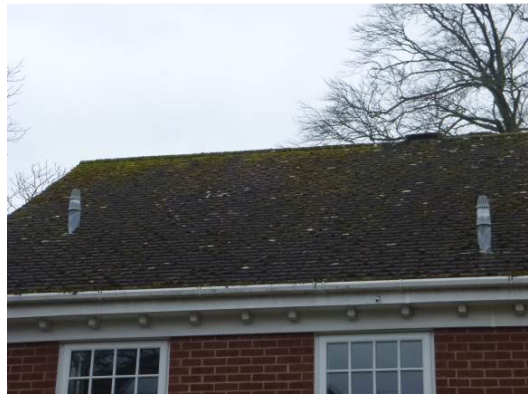
*Photograph 4. Ridge tiles and mortar intact throughout.*

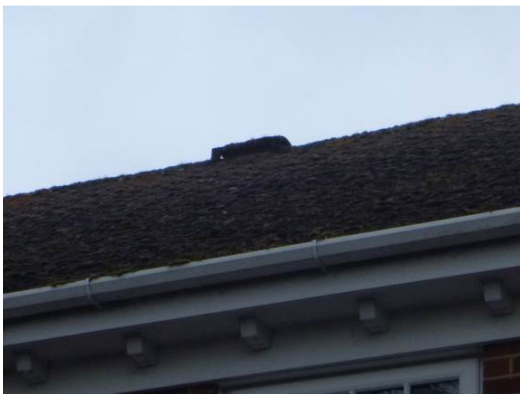
- 5.2.4** The soffits were tight to the brickwork throughout. The fascias and barge boards were tight throughout. There were two superficial cracks in the verge mortar and undercloaking at the western gable end (**Photographs 5 & 6**).

*Photograph 5. uPVC soffit tight to brickwork throughout.*

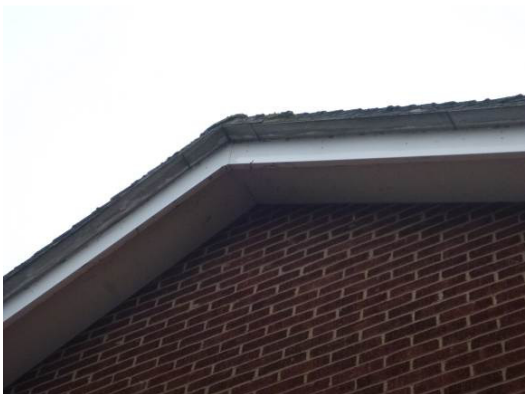
*Photograph 6. Superficial crack in gable verge mortar (western elevation).*

**6.1.3** Externally, the property had two superficial cracks at its western gable end which did not provide suitable access for crevice-dwelling bats, such as the locally recorded common pipistrelle (*Pipistrellus pipistrellus*) and soprano pipistrelle (*pipistrellus pygmaeus*) bats. Therefore, the property has been assigned negligible potential suitability for bats overall (see **Appendix 1** for potential suitability categories).

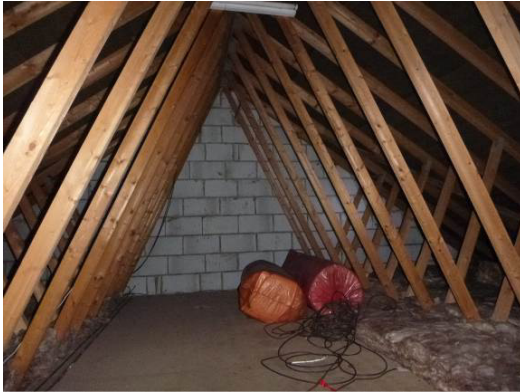
- 5.2.6** The building had a single void space accessible via a loft hatch from the first floor. The space had a maximum height of approximately 3m with timber trussed rafters; it was lined with hessian reinforced bitumen liner intact throughout, with two small slits for the air vents (**Photographs 7 & 8**).

*Photograph 7. Roof void with trussed rafters.*

**6.1.2** The roof void was cluttered by trussed rafters so was sub-optimal for the internal flight exhibited by void-dwelling bats, such as the locally recorded brown long-eared bat (*Plecotus auritus*). Furthermore no bat droppings were found internally, so the presence of void-dwelling species is considered highly unlikely.

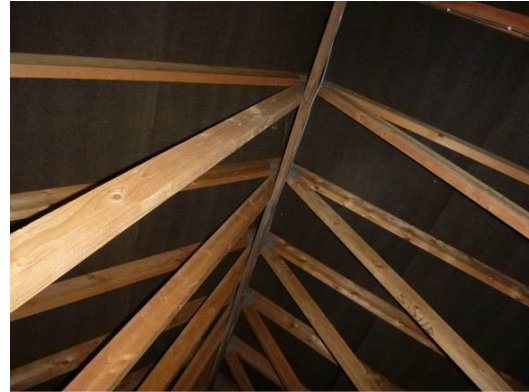
*Photograph 8. Bitumen reinforced liner, lightly cobwebbed at the ridge.*

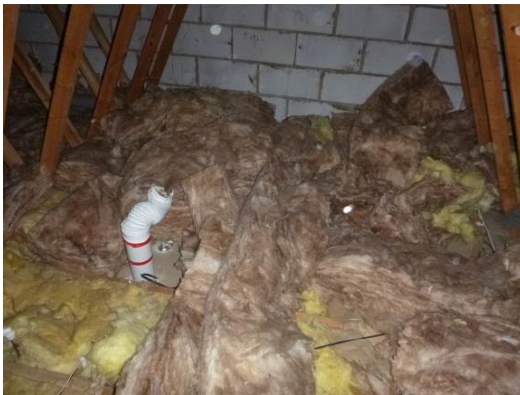
- 5.2.7** The floor was covered in fibreglass, double layered in places and was part boarded (**Photograph 9**). The eaves were empty down to the soffit box (**Photograph 10**).

*Photograph 9. Fibreglass insulation on floor.*

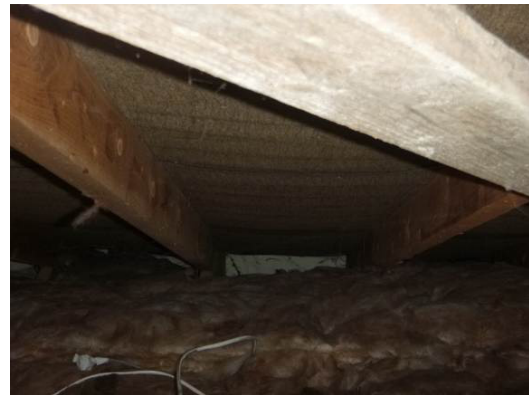
*Photograph 10. Eaves empty.*

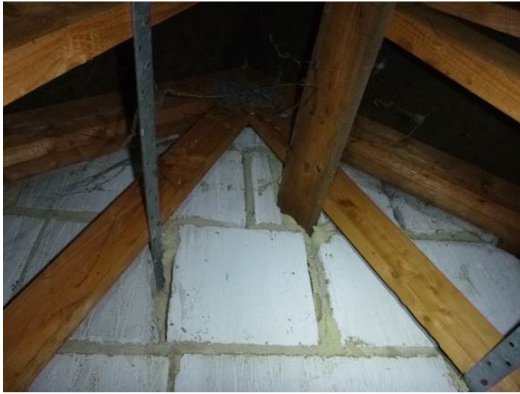
- 5.2.8** The blockwork on the gables was intact with fibreglass insulation stuffed into gaps behind the rafters (**Photographs 11 & 12**). There was no ridge beam and the apex was lightly cobwebbed. Overall the void was clear of items and clean.
- 5.2.9** No evidence of bats was found during the internal inspection.

*Photograph 11. Blockwork gables filled around rafter gaps.*

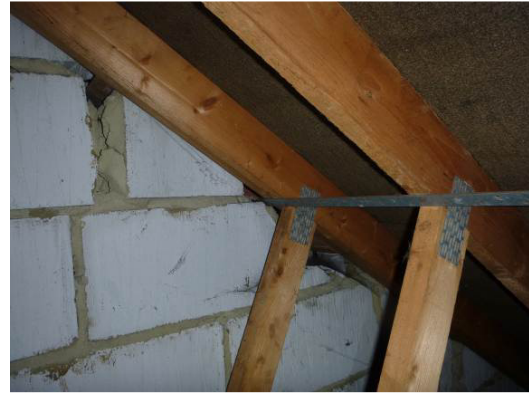
*Photograph 12. Blockwork gables filled around rafter gaps.*
