**12 Tamarisk Rise  
Wokingham  
Berkshire  
RG40 1WG**

## **Preliminary Roost Assessment**

Report ref.: R2971\_PRA\_a

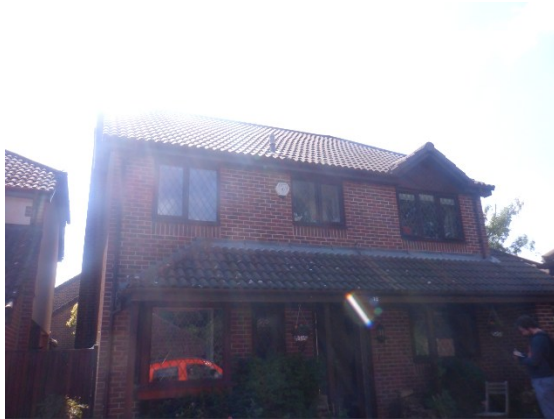
**5.2.2** The detached residential dwelling had a half-hipped pitched roof with an existing single-storey front and side extension (**Photographs 1 & 2**).

*Photograph 1. Front elevation viewed from the northwest.*

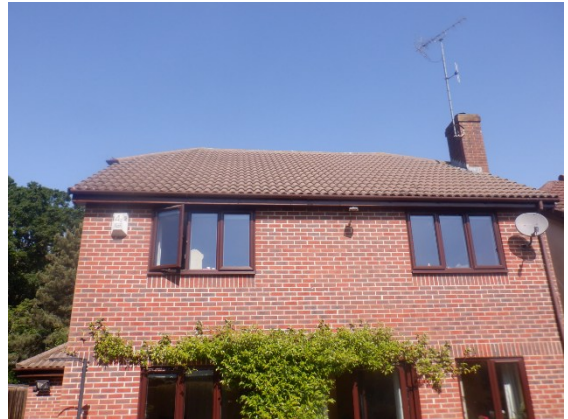
*Photograph 2. Rear elevation viewed from the southeast.*

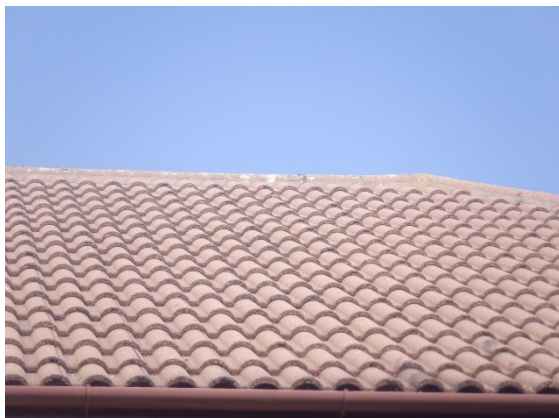
**5.2.3** The roof was covered by interlocking concrete tiles that were tightly fitted on both the front and rear elevations (**Photograph 3**). Whilst the mortar along the ridge and half-hips was fully intact across the second-storey, a section of hip mortar was partially crumbling on the low level, front extension, however, close inspection with a high-powered torch and the proximity of the feature to the guttering confirmed the feature to be of negligible suitability for roosting bats (**Photographs 4 & 5; Target note 1**).

*Photograph 3. Tightly fitted, interlocking concrete tiles (rear elevation).*

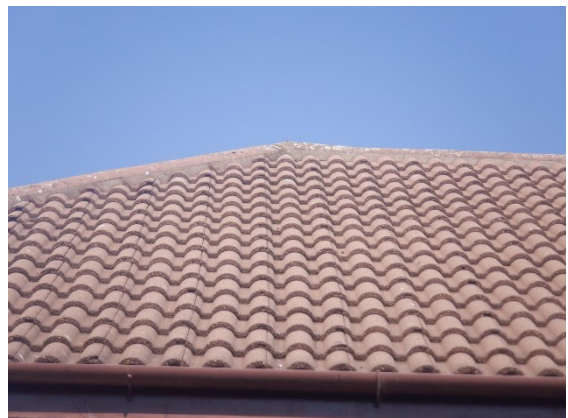
*Photograph 4. Fully intact ridge and half-hip mortar (rear elevation).*

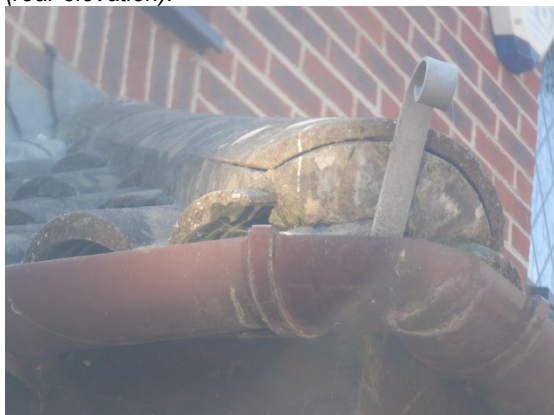
*Photograph 5. Crumbling hip mortar with negligible suitability for roosting bats (front elevation).*

6.1.3 Whilst the hip mortar was partially crumbling at the northern corner of the existing low level front extension, close inspection with a high-powered torch confirmed the feature to be of negligible potential due to its proximity to guttering and lack of crevice. Furthermore, the gap situated behind the lead flashing along the southern extension was filled with detritus, preventing use by roosting bats.

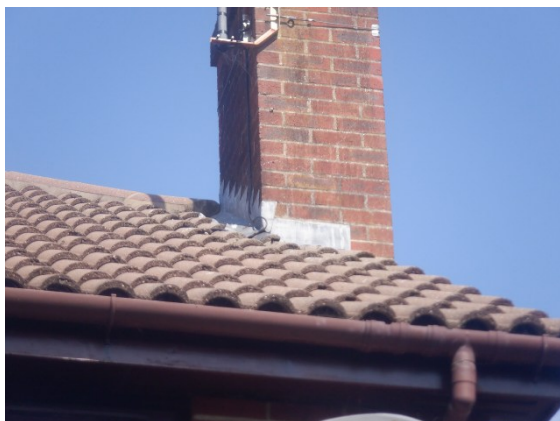
- 5.2.4** The lead flashing at the base of the chimney and flue pipe was flat to the brickwork and roof tiles (**Photographs 6 & 7**). Furthermore, whilst a slight gap was situated behind the lead flashing along the rear elevation of the existing side extension, close inspection confirmed the feature to be heavily cobwebbed and filled with detritus and of limited suitability for bats (**Photograph 8; Target note 2**).

*Photograph 6. Lead flashing flat around the base of the chimney (rear elevation).*

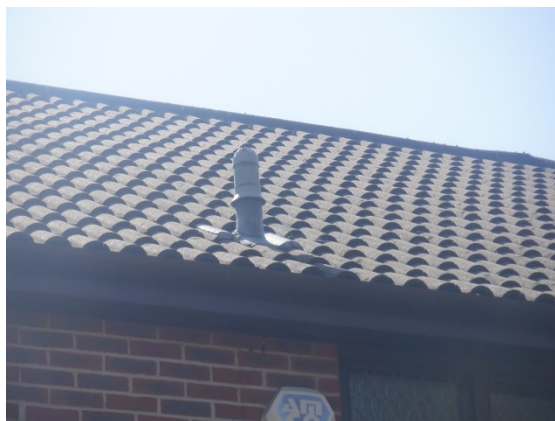
*Photograph 7. Lead flashing flat around the base of the flue pipe (front elevation).*

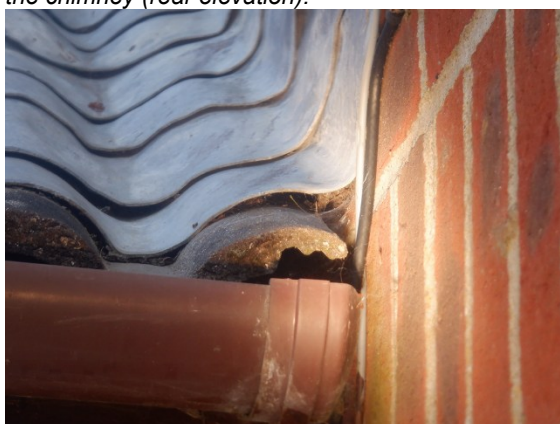
*Photograph 8. Gap behind lead flashing filled with detritus (southwestern elevation).*

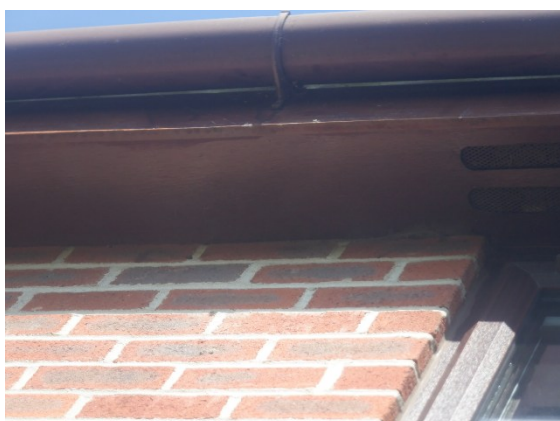
- 5.2.5** The painted timber soffits along the eaves of the house and extension were tight to the brickwork walls (**Photographs 9 & 10**).

*Photograph 9. Vented soffit sealed to brickwork (rear elevation).*

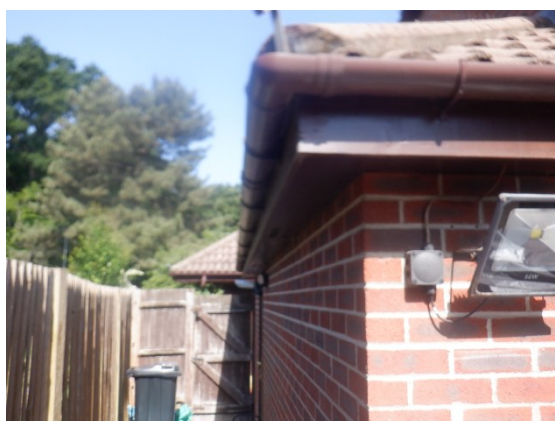
*Photograph 10. Vented soffit sealed to brickwork along the existing extension (southwestern elevation).*

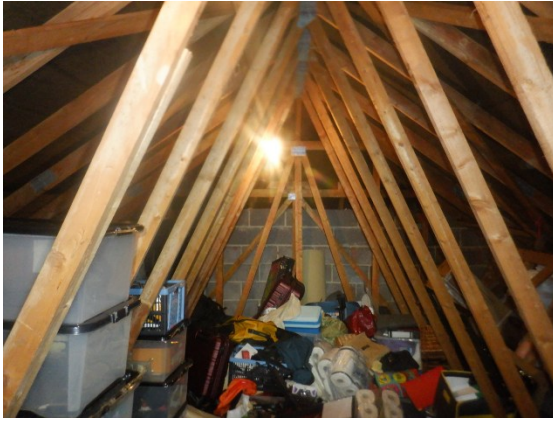
- 5.2.6** The building had one roof void that covered its two-storey footprint and was accessible via a loft hatch on the first-floor. The void had an approximate floor-to-ridge height of 2.5 metres and the roof was of 'trussed rafter' construction (**Photograph 11**).

*Photograph 11. Void of trussed construction.*

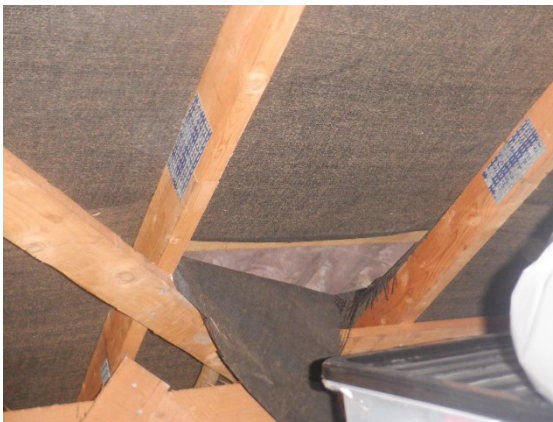
- 5.2.7** The roof was lined with Type 1F bitumen felt that was fully intact other than one large tear in which the underside of the roof tiles were visible (**Photograph 12; Target note 3**). The floor was centrally boarded over fibreglass insulation that did not fill the eaves, allowing access to the painted timber soffit (**Photograph 13; Target note 4**).

*Photograph 12. Large tear in bitumen felt with underside of tiles visible.*

- A single large tear in the bitumen felt roof lining with the underside of the roof tiles visible (**Photograph 12; Target note 3**);
- Open eaves with access to the vented soffit (**Photograph 13; Target note 4**); and
- Gaps behind and along the edges of the half-hipped blockwork gables (**Photographs 14 & 15; Target note 5**).

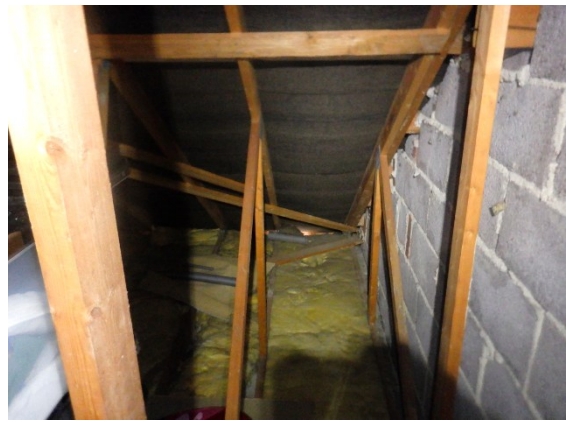
*Photograph 13. Open eaves with access to the painted timber soffit.*

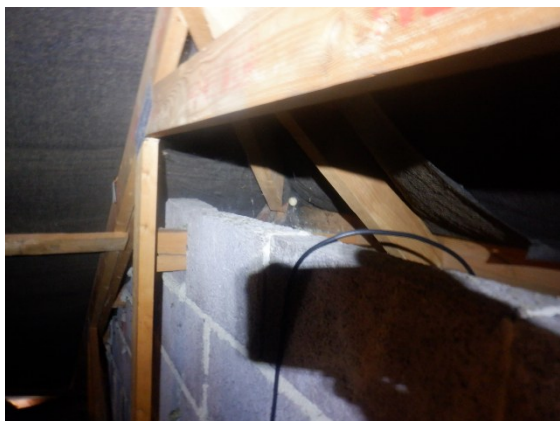
- 5.2.8** Open gaps were situated behind the half-hipped blockwork gables with further gaps along their edges that were partially filled with fibreglass insulation (**Photographs 14 & 15; Target note 5**).

*Photograph 14. Open gaps behind the half-hipped gables.*

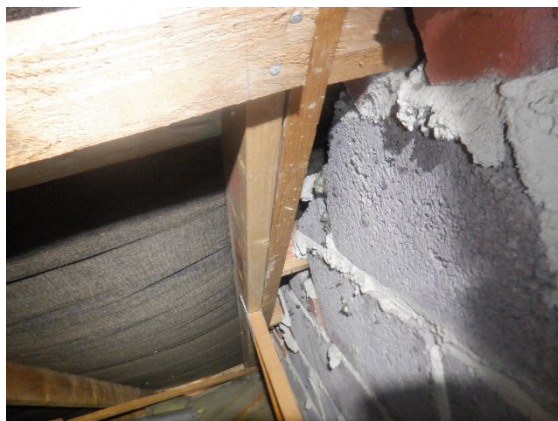
*Photograph 15. Gaps along edge of the half-hipped gables.*

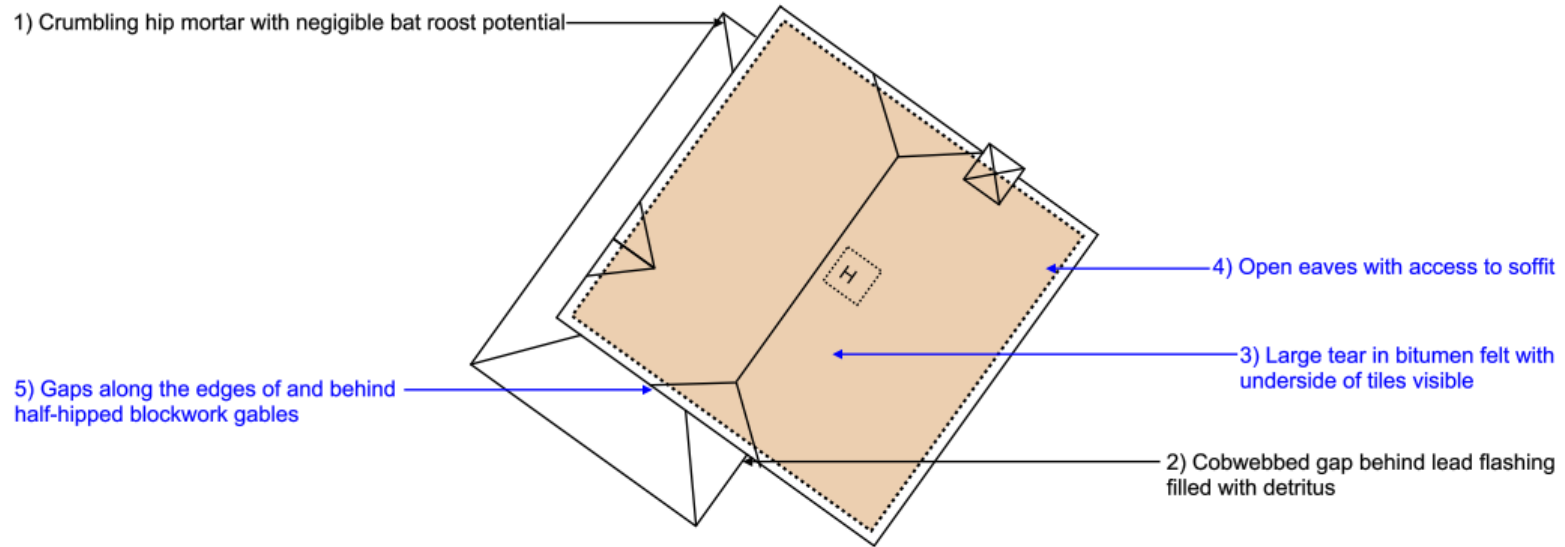
Figure 1 – Preliminary Roost Assessment Findings

**5.2.1** The findings from the external and internal inspections carried out for the property are described with photographs and are annotated in a plan (see **Figure 1**), as follows:
