## Preliminary bat roost assessment

| Site Location | 10 Arbor Lane, Winnersh, RG41 5JA |
| Document reference | CE4781 |

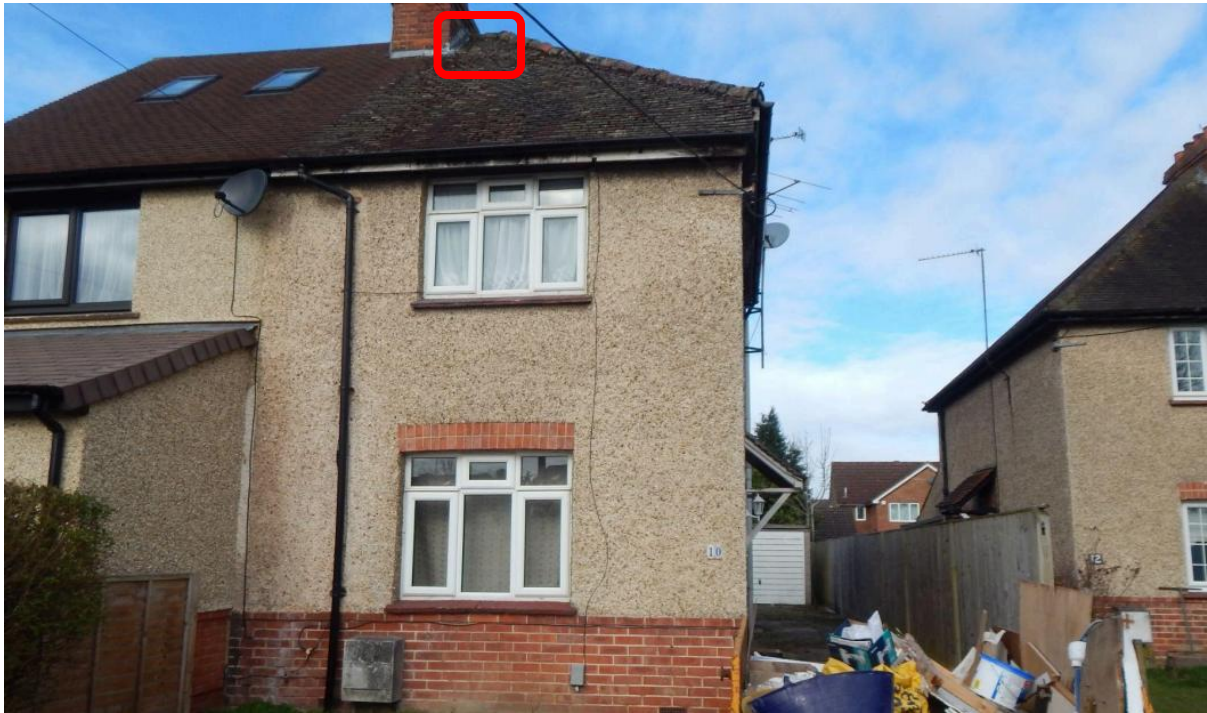
Image 1 – East facing elevation of the property where gaps below the ridge of adequate proportions to offer likely shelter/access opportunities for bats

- 6.7 In line with best practice survey guidelines, a structure that has demonstrated low value must have a further two emergence surveys to rule out or confirm activity from bats. This survey should be carried out within the recommended survey season from May to August.

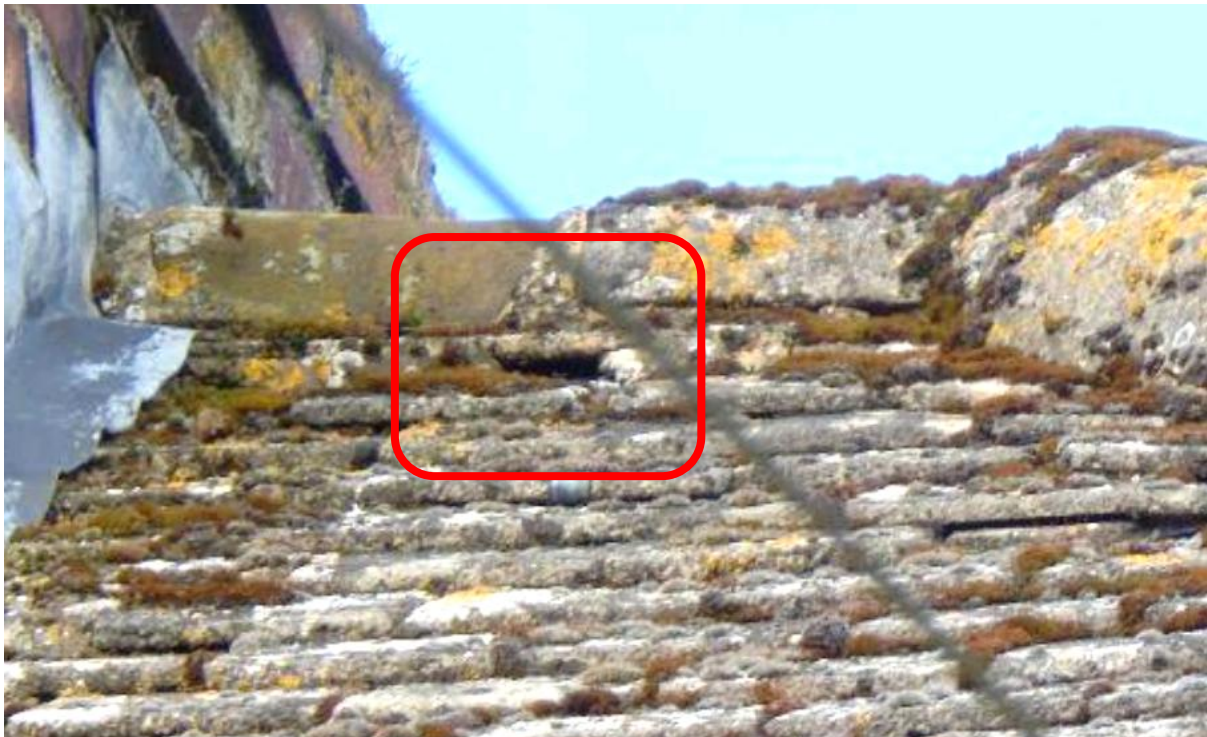
Image 2 – As per image one above

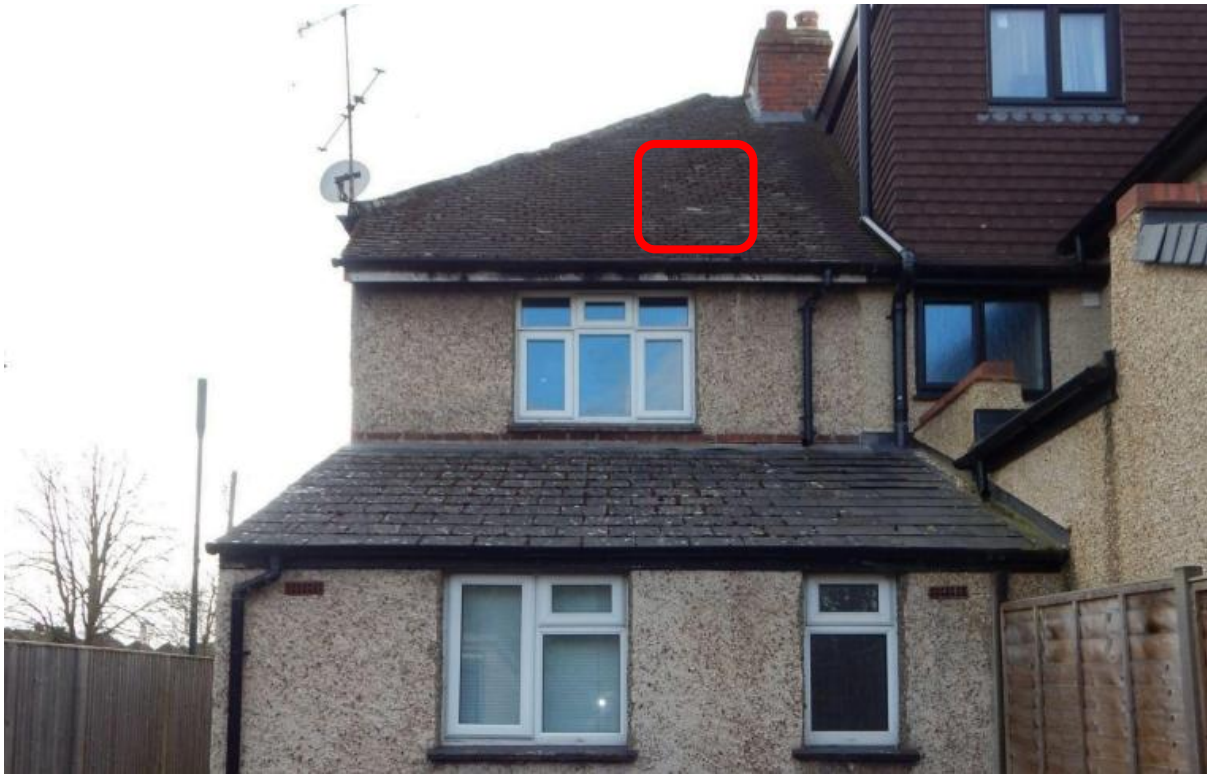
Image 3 – West facing elevation n of the property where gaps of adequate proportions to offer likely shelter/access opportunities for bats were observed within the tiled coverings

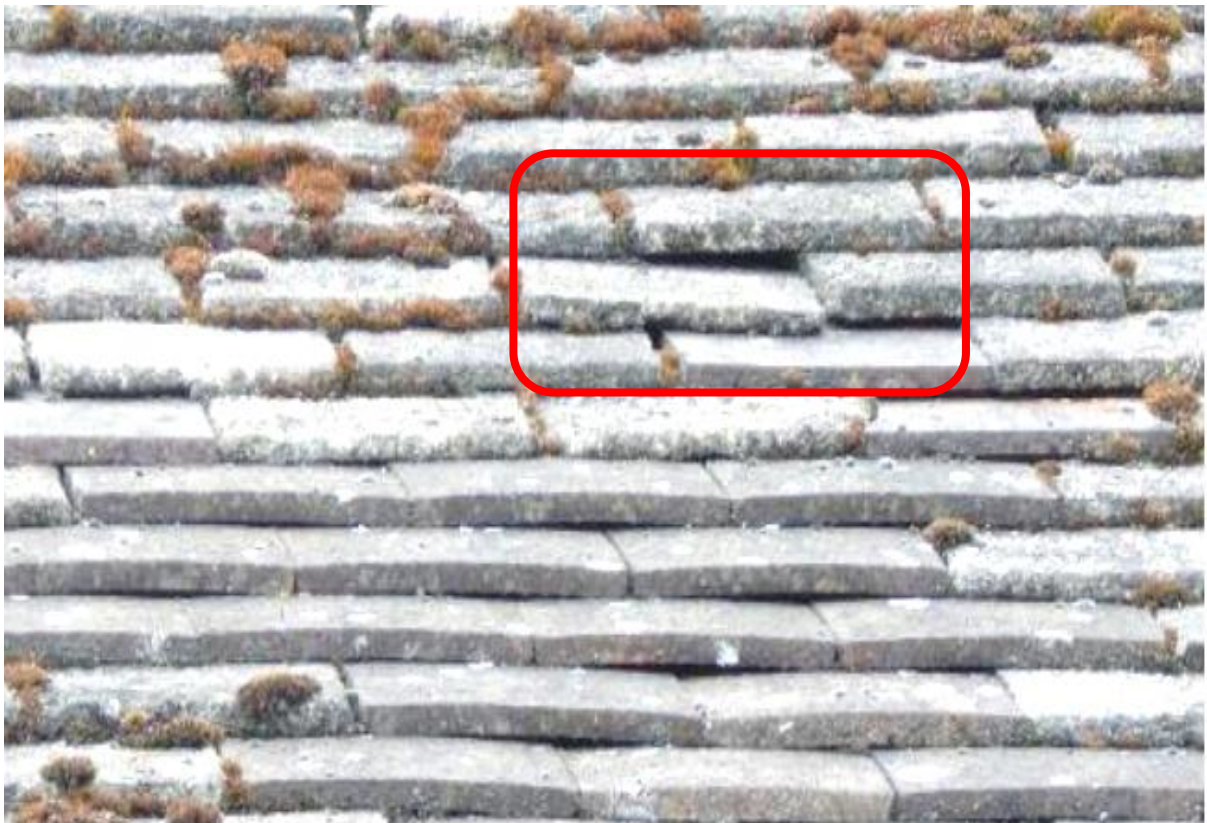
Image 4 – As per image three above

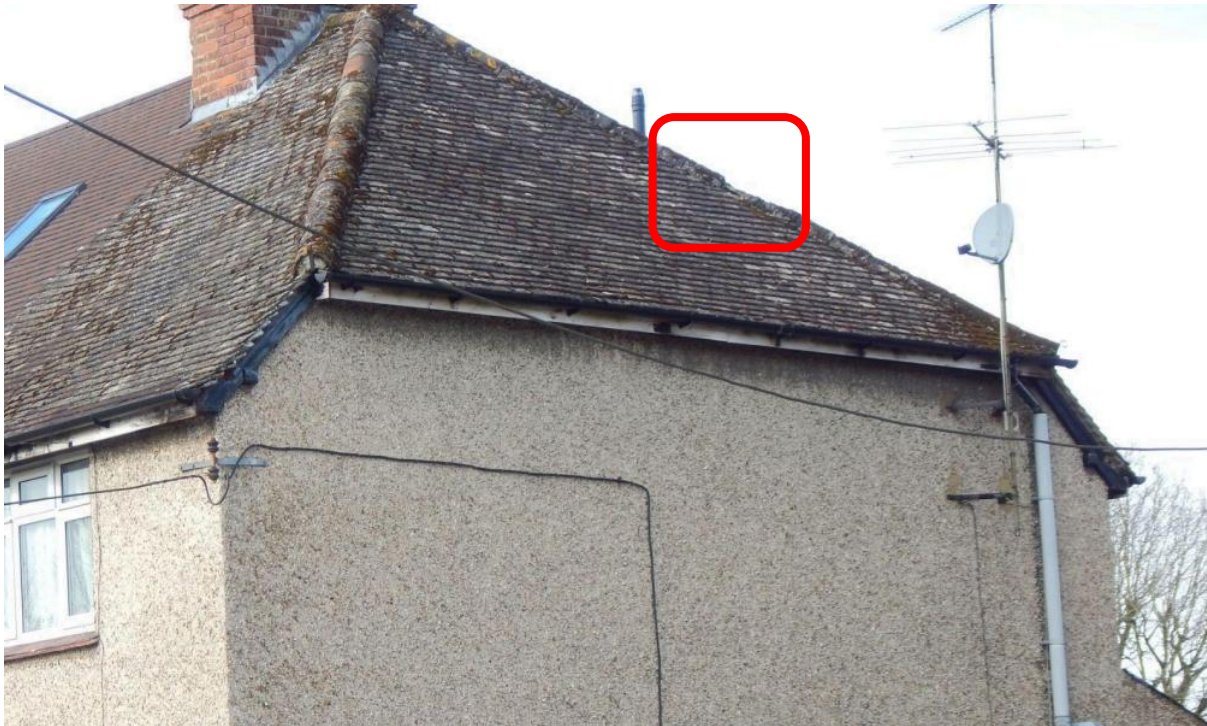
Image 5 – North facing elevation n of the property where gaps of adequate proportions to offer likely shelter/access opportunities for bats were observed within the hip coverings

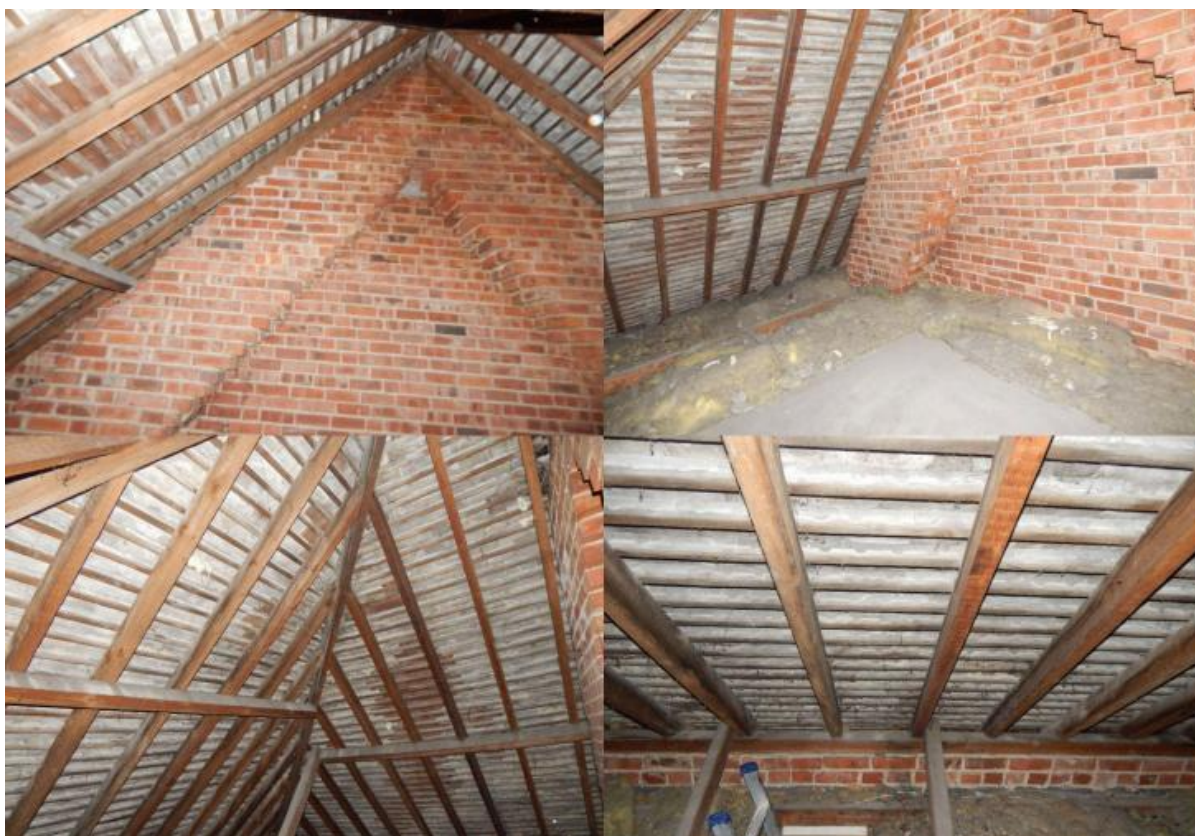
Image 7 – Internal view from within the main upper roof void spaces of the property

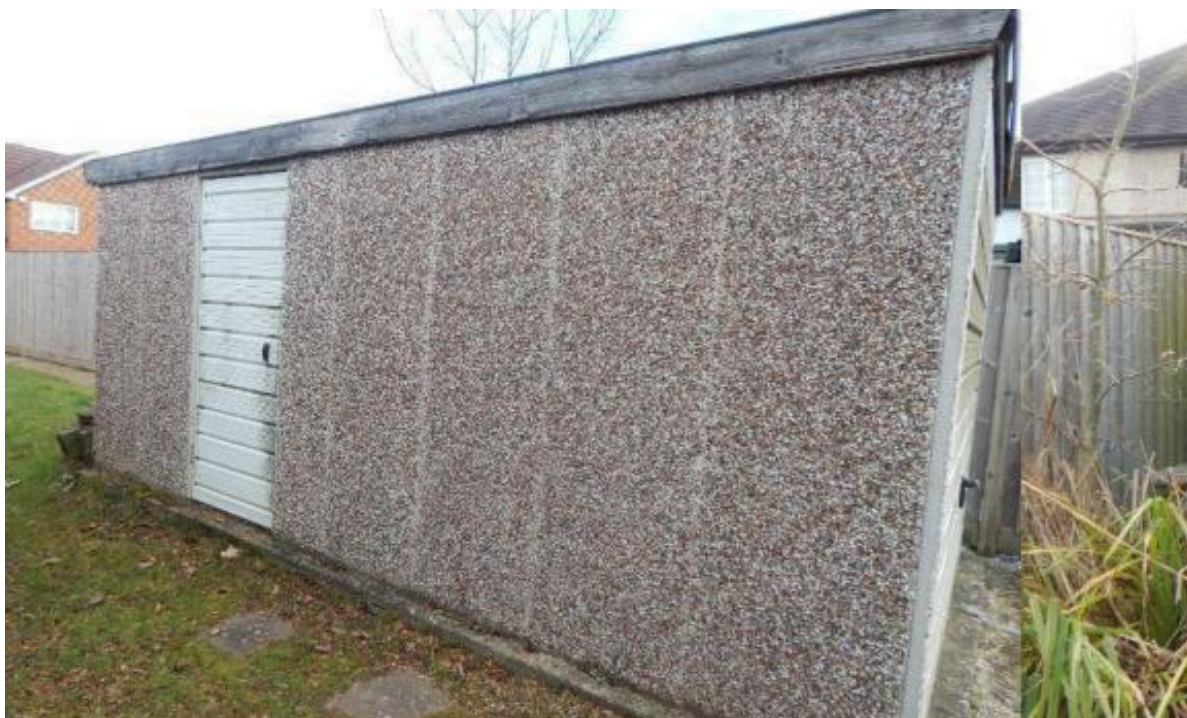
Image 8 – Detached garage located to the rear of the main dwelling

- 6.5 The detached garage structure has demonstrated no suitable features of value to bats throughout.
- 6.6 No evidence from bats was identified during the visit; however, we are unable to rule out or confirm any roosting evidence within the enclosed gaps between the roof coverings to the main property which look to offer suitable roosting opportunities used by crevice dwelling species of bats such as Pipistrelle which have been recorded locally. Evidence such as droppings would not always be visible from within these enclosed habitats.

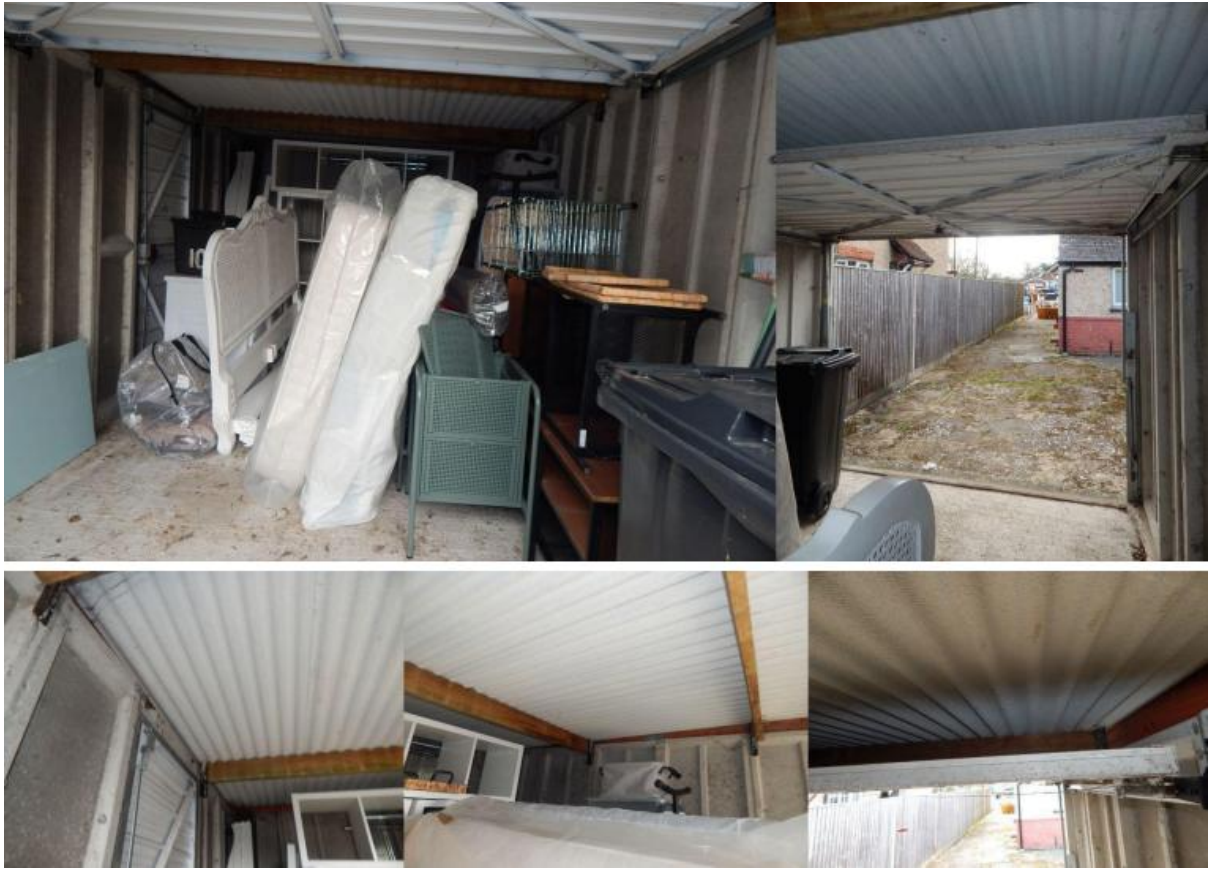
Image 9 – Internal view from within the detached garage structure

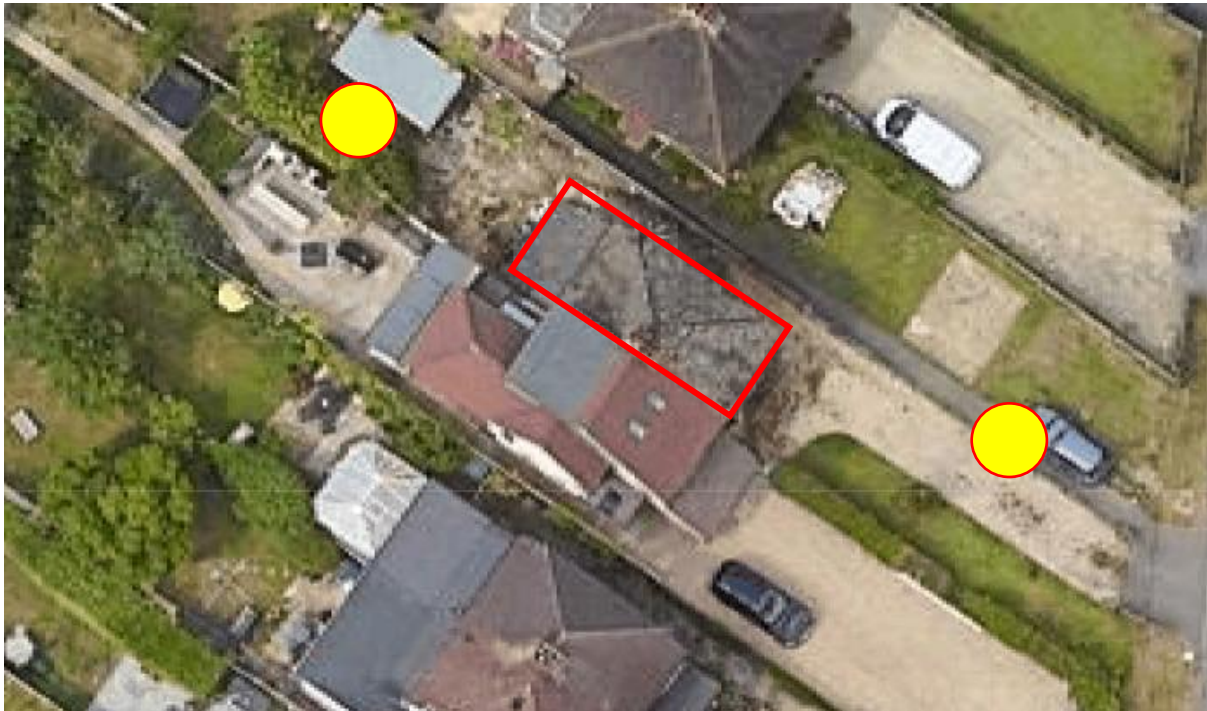
#### Appendix 4: Emergence Survey Location Points

Below site view to show suitable surveyor location points during each emergence survey to maintain visibility of the property.

In line with best practice survey guidelines, a total of two surveyors will be required to visually cover all elevations of the structure during each emergence survey.
