# Preliminary Ecological Appraisal and Roost Assessment

42 Pound Lane, Reading, RG4 6GG

This report is prepared to inform a planning application with the Wokingham Borough Council. The proposal is described as:  
The relocation of existing garage with amenity space, updating of existing portico, and adding soft planting.  
[Unsubmitted]

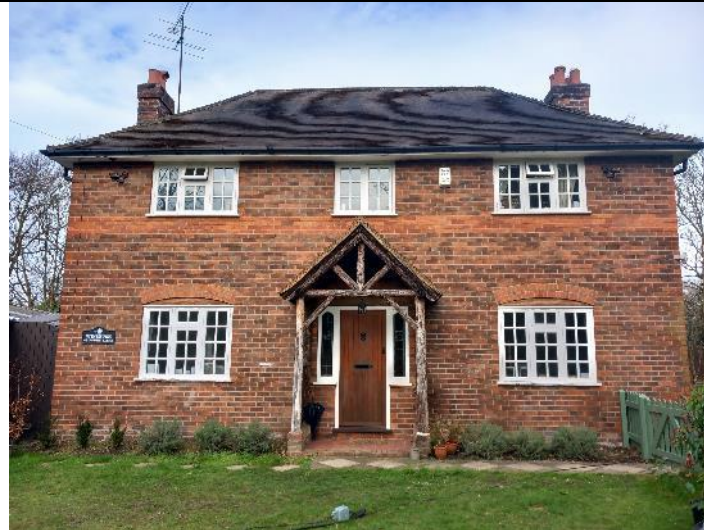
Photo 1: B1a – Southeast elevation.

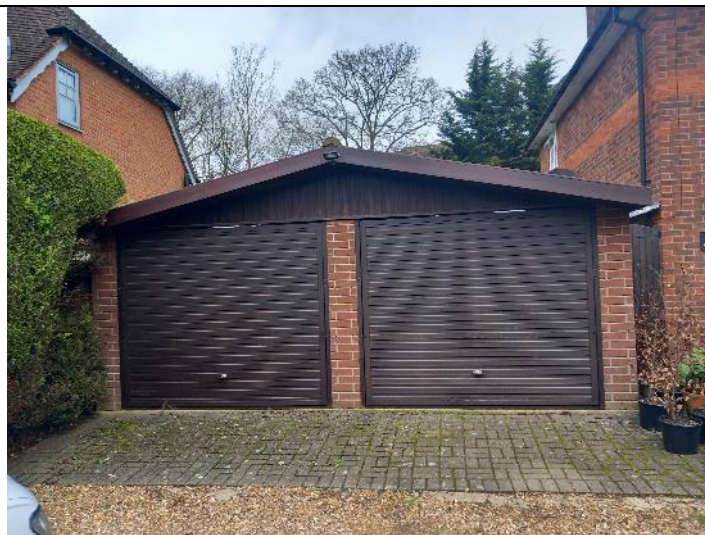
B1b is adjoined to the southwestern elevation of B1a. B1b is a single storey brick-built double garage, with a pitched and gabled corrugated roof.

Photo 2: B1b – Southeast elevation.

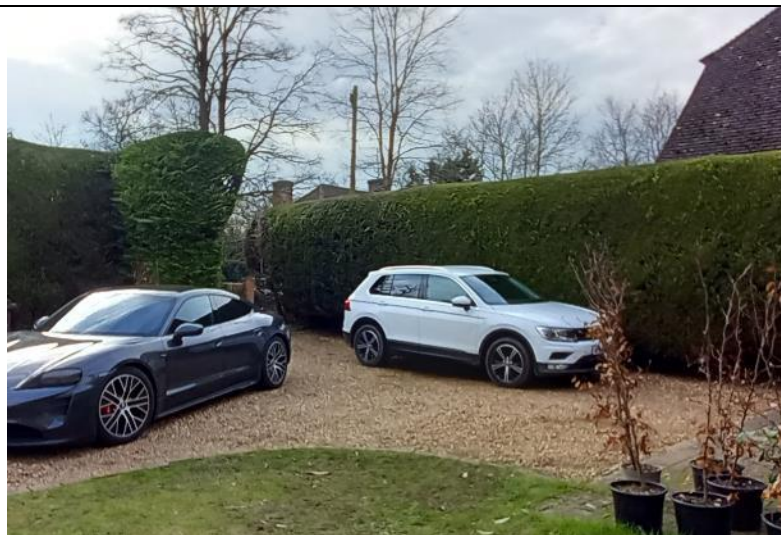
The entrance to the site is at the southern extent of the boundary and gravel is used to provide vehicular entrance and parking.

Photo 3: Looking at the entrance to the site from the southern elevation of B1a.

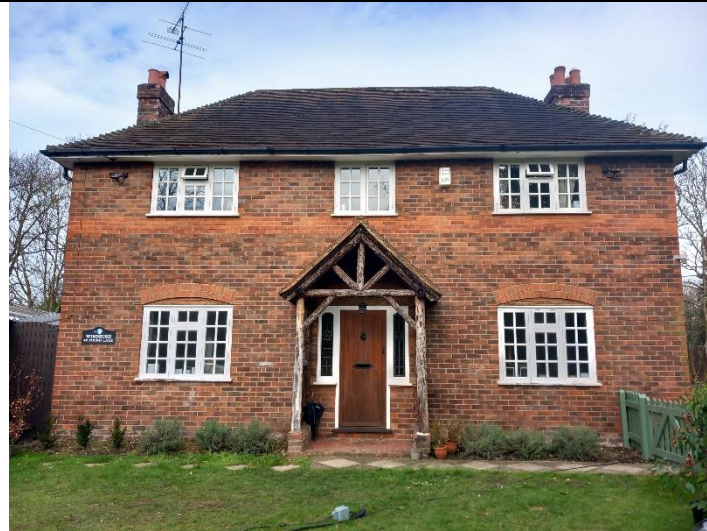
Photo 4: B1a – Southeast elevation.

The brickwork of B1 is well-mortared and in good condition throughout, with no gaps or cracks. There are no missing roof tiles.

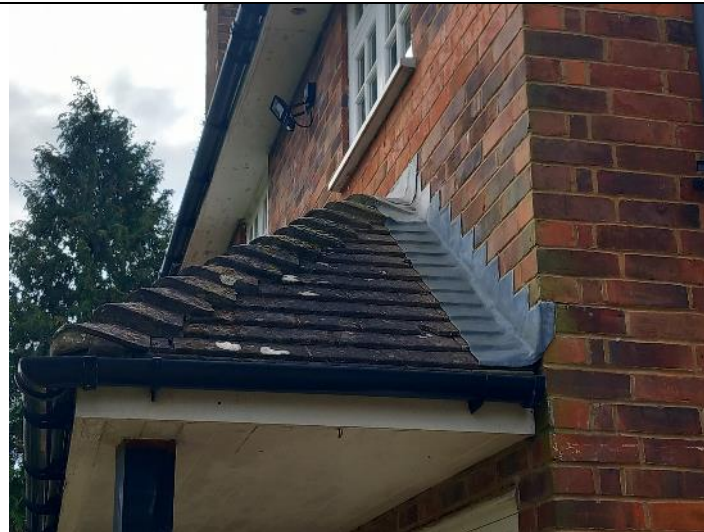
Photo 5: B1a – West elevation.

There is lead flashing on numerous areas of the roof. it is tight-fitting to the tiles and brickwork and well-sealed. There are no gaps or cracks, and there is no missing mortar in the hipped tiles.

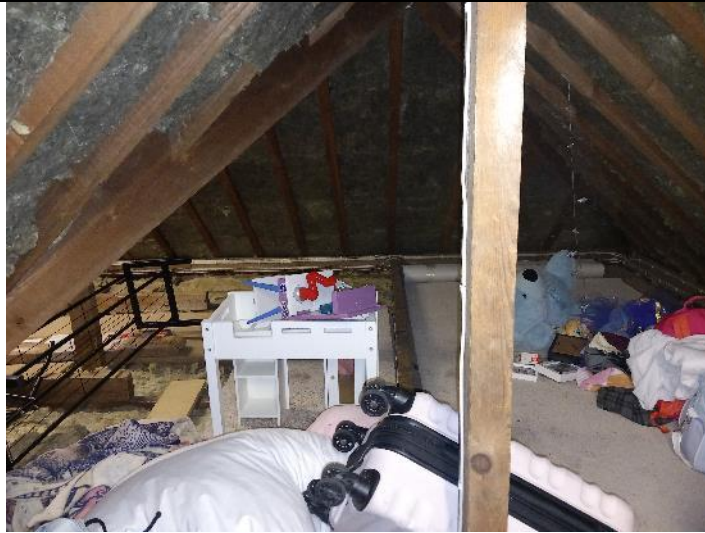
There is one loft space inside B1a. The loft space is fully boarded and therefore could be thoroughly assessed. No evidence of bats was found internally. The roof is lined with mineral wool and bitumen felt. No daylight could be seen entering from the exterior. The internal abiotic recordings of the loft space were recorded at 16°C and 72% humidity.

Photo 6: B1a – Interior

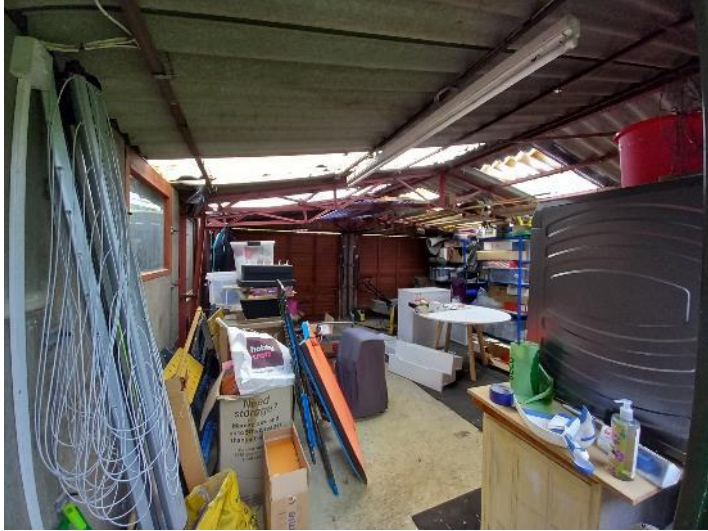
The interior of B1b is single skinned and there is no separate loft space. B1b is assessed as 'negligible' habitat value for roosting bats.

| | <p>Photo 7: B1b – Interior.</p> |

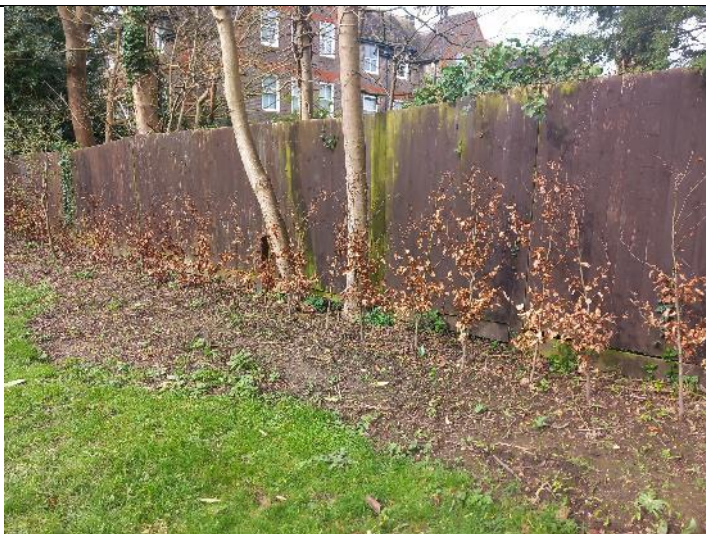
Bare ground at the north of the site.

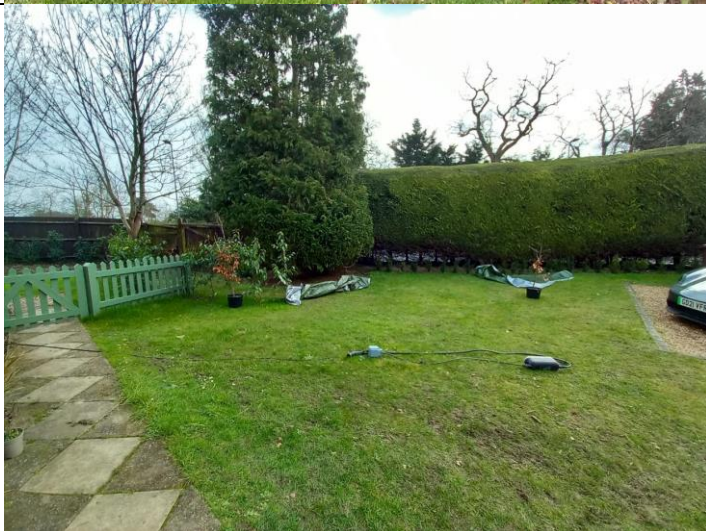
Amenity modified grassland at the south of the site, with artificial unvegetated, unsealed surface to the right of the photo.

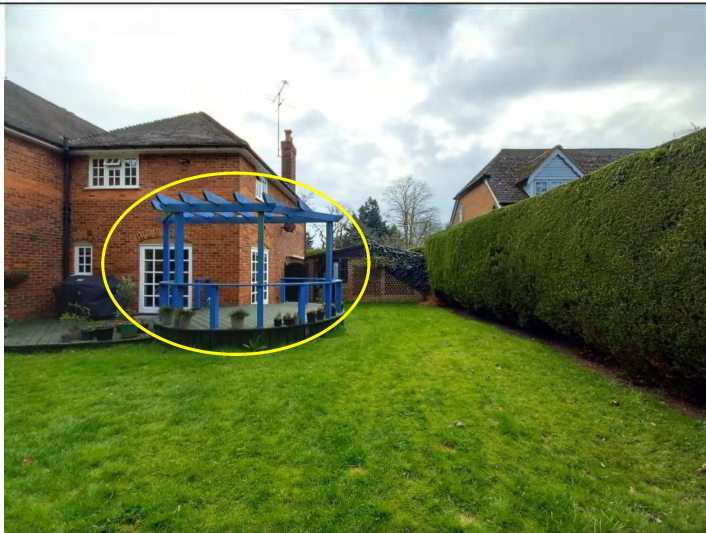
Northwest elevation of B1a, showing the structure that will become a flat patio.
