32 Sutcliffe Avenue  
Earley  
Wokingham  
Berkshire  
RG6 7JN

## Preliminary Roost Assessment

Report ref.: S2833\_PRA\_a

January 2025

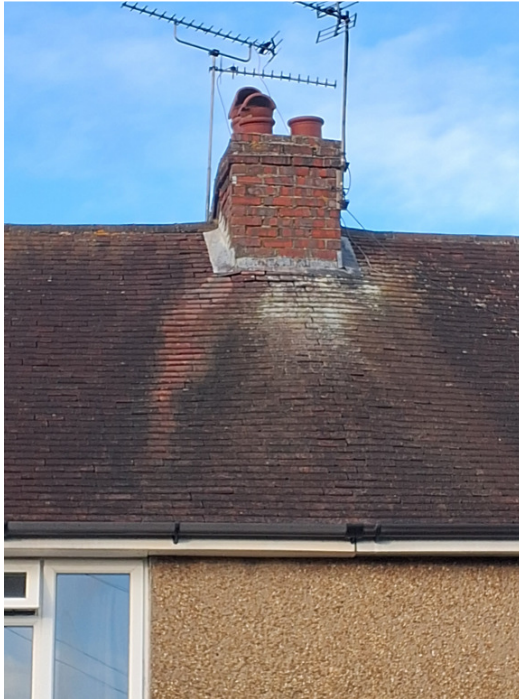
**5.2.2** The semi-detached house had a pitched roof with pebbledash walls and an existing single-storey rear extension. The roof was covered by clay tiles that were occasionally lifted, particularly at the base of the chimney, along the verge and across the front elevation of the house (**Photographs 1 & 2; Target notes 1 & 2**).

*Photograph 1. Uneven clay roof tiles at the base of the chimney (rear elevation).*

- Uneven and lifted clay roof tiles (**Photographs 1 & 2; Target notes 1 & 2**);
- A lifted ridge tile (**Photograph 5; Target note 3**);
- A gap behind the uPVC fascia along the pebbledash gable (**Photograph 7; Target note 4**);
- Unlined sections of the roof void with the ridge tiles visible (**Photograph 11; Target note 5**);
- Open eaves with access to the uPVC soffit (**Photograph 12; Target note 6**);
- Gaps within the internal party wall (**Photograph 13; Target note 7**); and
- Gaps at the apex of the brickwork gable (**Photograph 14; Target note 8**).

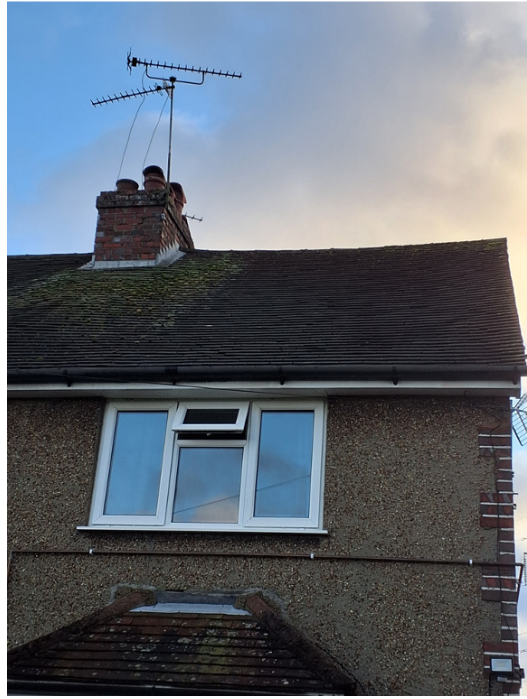
*Photograph 2. Uneven clay roof tiles (front elevation).*

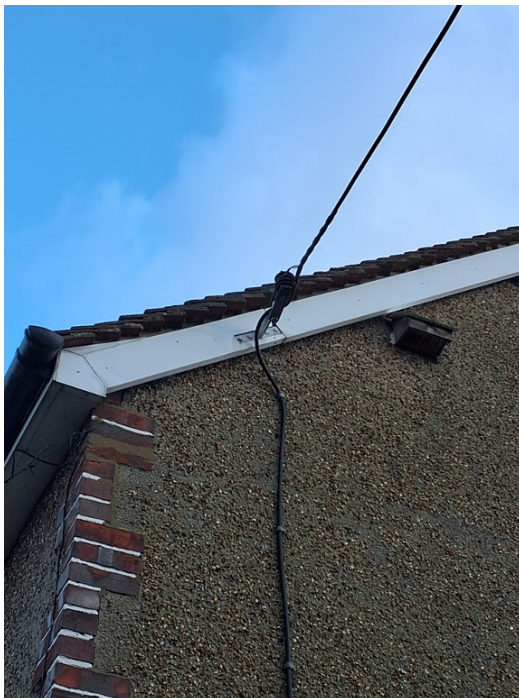
- 5.2.3** Whilst the verge mortar was fully intact along the gable end and the lead flashing was sealed to the roof tiles and brickwork chimney, a ridge tile was slightly lifted against the chimney (**Photographs 3, 4 & 5; Target note 3**).

*Photograph 3. Verge mortar fully intact along the gable (west elevation).*

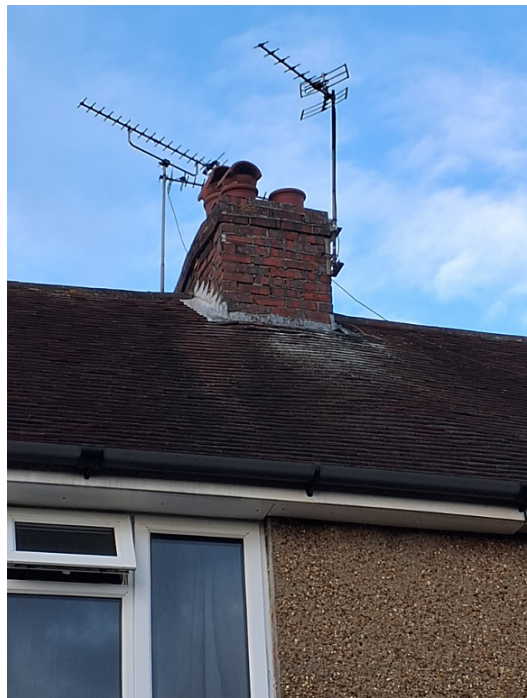
*Photograph 4. Lead flashing sealed to brickwork chimney and roof tiles (rear elevation).*

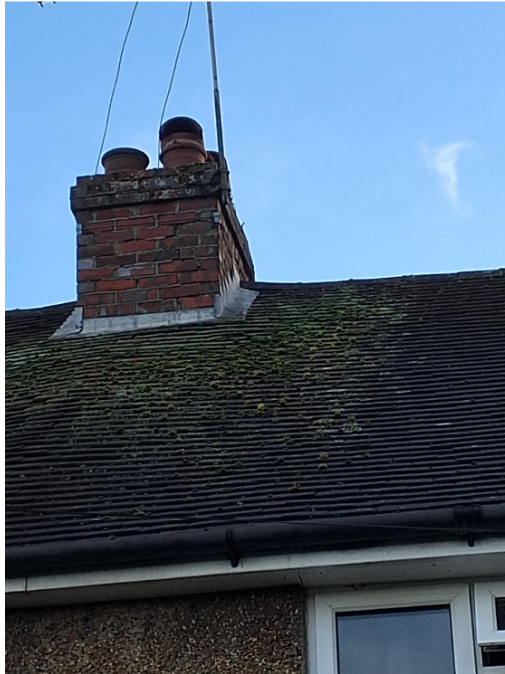
*Photograph 5. Raised ridge tile against the chimney (front elevation).*

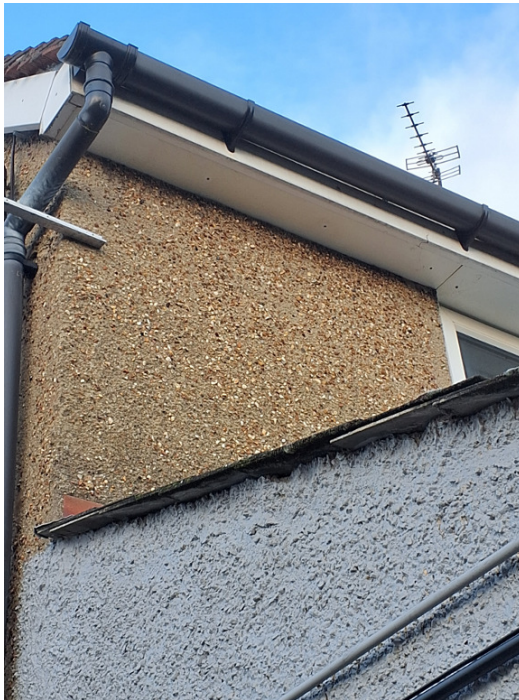
- 5.2.4** The uPVC soffit was fully sealed to the pebbledash walls of the property, however, a slight gap was situated behind the uPVC fascia along the gable (**Photographs 6 & 7; Target note 4**).

*Photograph 6. uPVC soffit sealed to pebbledash wall (rear elevation).*

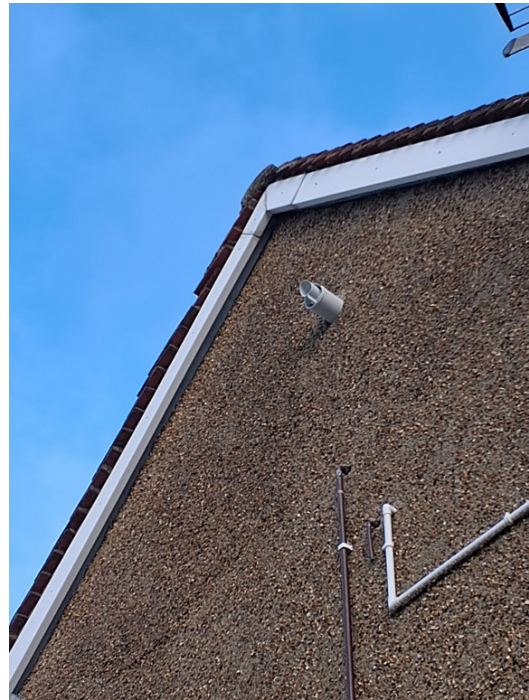
*Photograph 7. Gap between gable and uPVC fascia (west elevation).*

- 6.2.1** The observation of one small-sized dropping, resembling those typically deposited by pipistrelle bat species (*Pipistrellus* spp.), inside the roof void indicates that the property has likely been used by at least one individual pipistrelle bat, i.e. a confirmed bat roost. The location of the dropping and observed features indicates that the bat access point is likely to be associated with the gap behind the uPVC fascia along the gable end (**Photograph 7; Target note 4**).

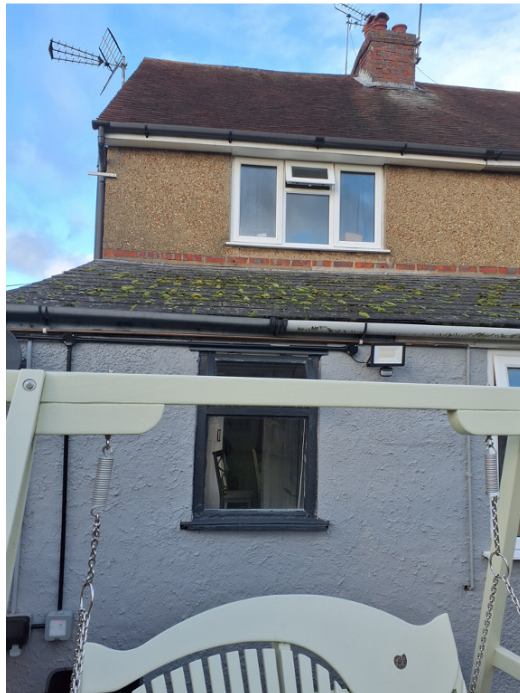
sealed across the roof and to the pebbledash wall (**Photograph 8**).

*Photograph 8. Slate tiles fully sealed (rear elevation).*

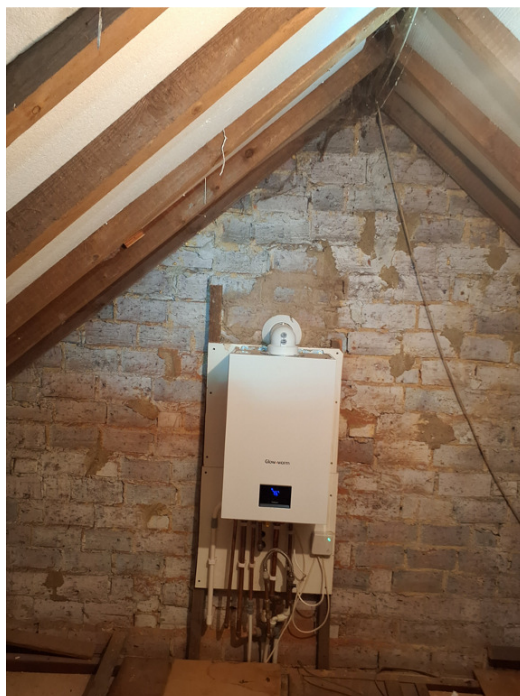
- 5.2.6** The roof void of the property, which was of cut & pitch construction and accessible via a loft hatch, covered the footprint of the semi-detached building and had an approximate floor-to-ridge height of 2 metres (**Photograph 9**).

*Photograph 9. Roof void.*

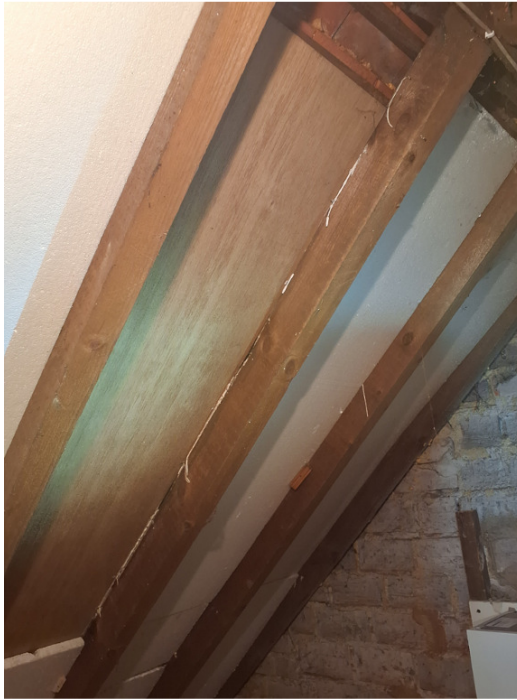
- 5.2.7** The roof was lined by timber boarding behind polystyrene which was fully intact other than along the ridge which was unlined, heavily cobwebbed and had sections of expanding foam visible (**Photographs 10 & 11; Target note 5**).

*Photograph 10. Timber boarding behind polystyrene.*

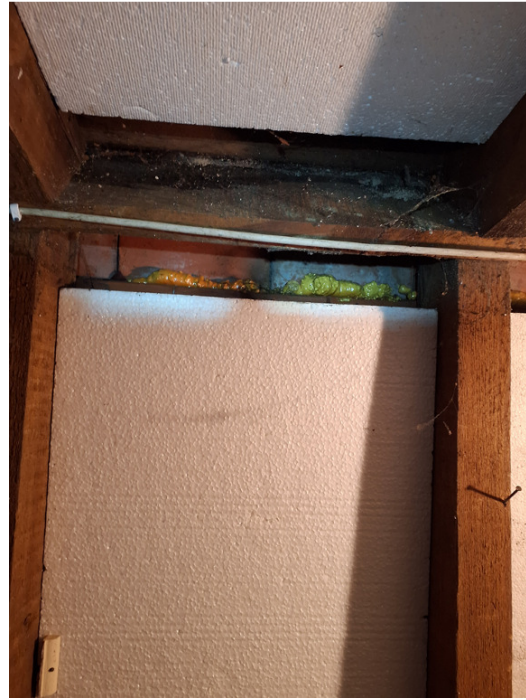
*Photograph 11. Unlined ridge with expanding foam visible.*

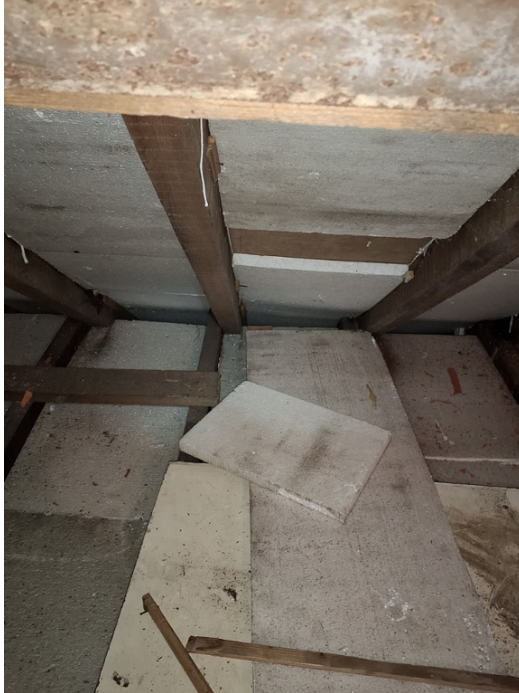
- 5.2.8** The floor was boarded over polystyrene that did not block the eaves, allowing access to the uPVC soffit (**Photograph 12; Target note 6**). The chimney was embedded within the brickwork party wall at the eastern gable end with the gaps on the rear elevation filled by expanding foam, but the gaps on the front elevation opening directly into the neighbouring void (**Photograph 13; Target note 7**).

Photograph 12. Open eaves with access to the uPVC soffit.

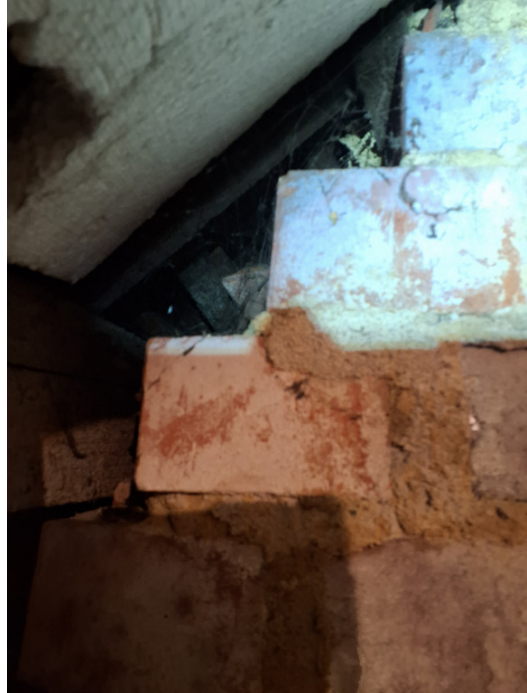
Photograph 13. Open gap within brickwork party wall, allowing access to neighbouring void.

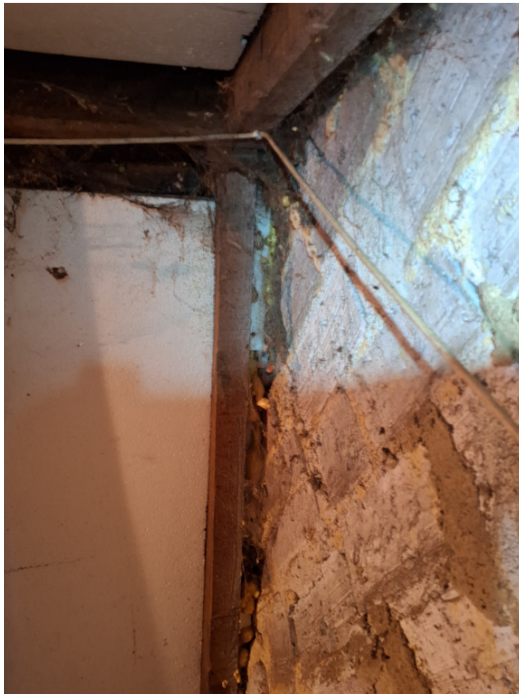
- 5.2.9** The edges of the brickwork (western facing) gable were mostly filled by expanding foam and polystyrene, however, a heavily cobwebbed gap was situated at the apex (Photograph 14; Target note 8). A single small-sized bat dropping was situated on the gable (Photograph 15).

Photograph 14. Heavily cobwebbed gap at the apex of the gable.

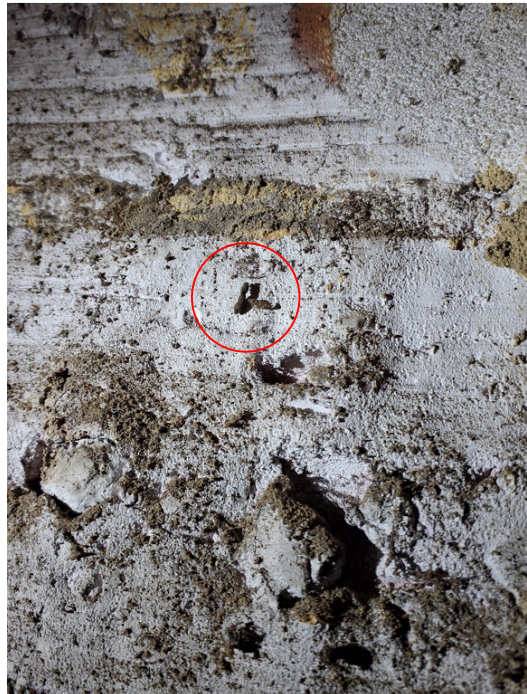
Photograph 15. Single small-sized bat dropping on the gable.
