**PHASE 2  
GEOTECHNICAL AND GEO-ENVIRONMENTAL  
SITE INVESTIGATION**

**LAND PARCEL 8  
HOGWOOD FARM  
(FINCHWOOD PARK DEVELOPMENT)**

**CALA HOMES THAMES AND  
LEGAL & GENERAL HOMES LIMITED**

17 January 2022

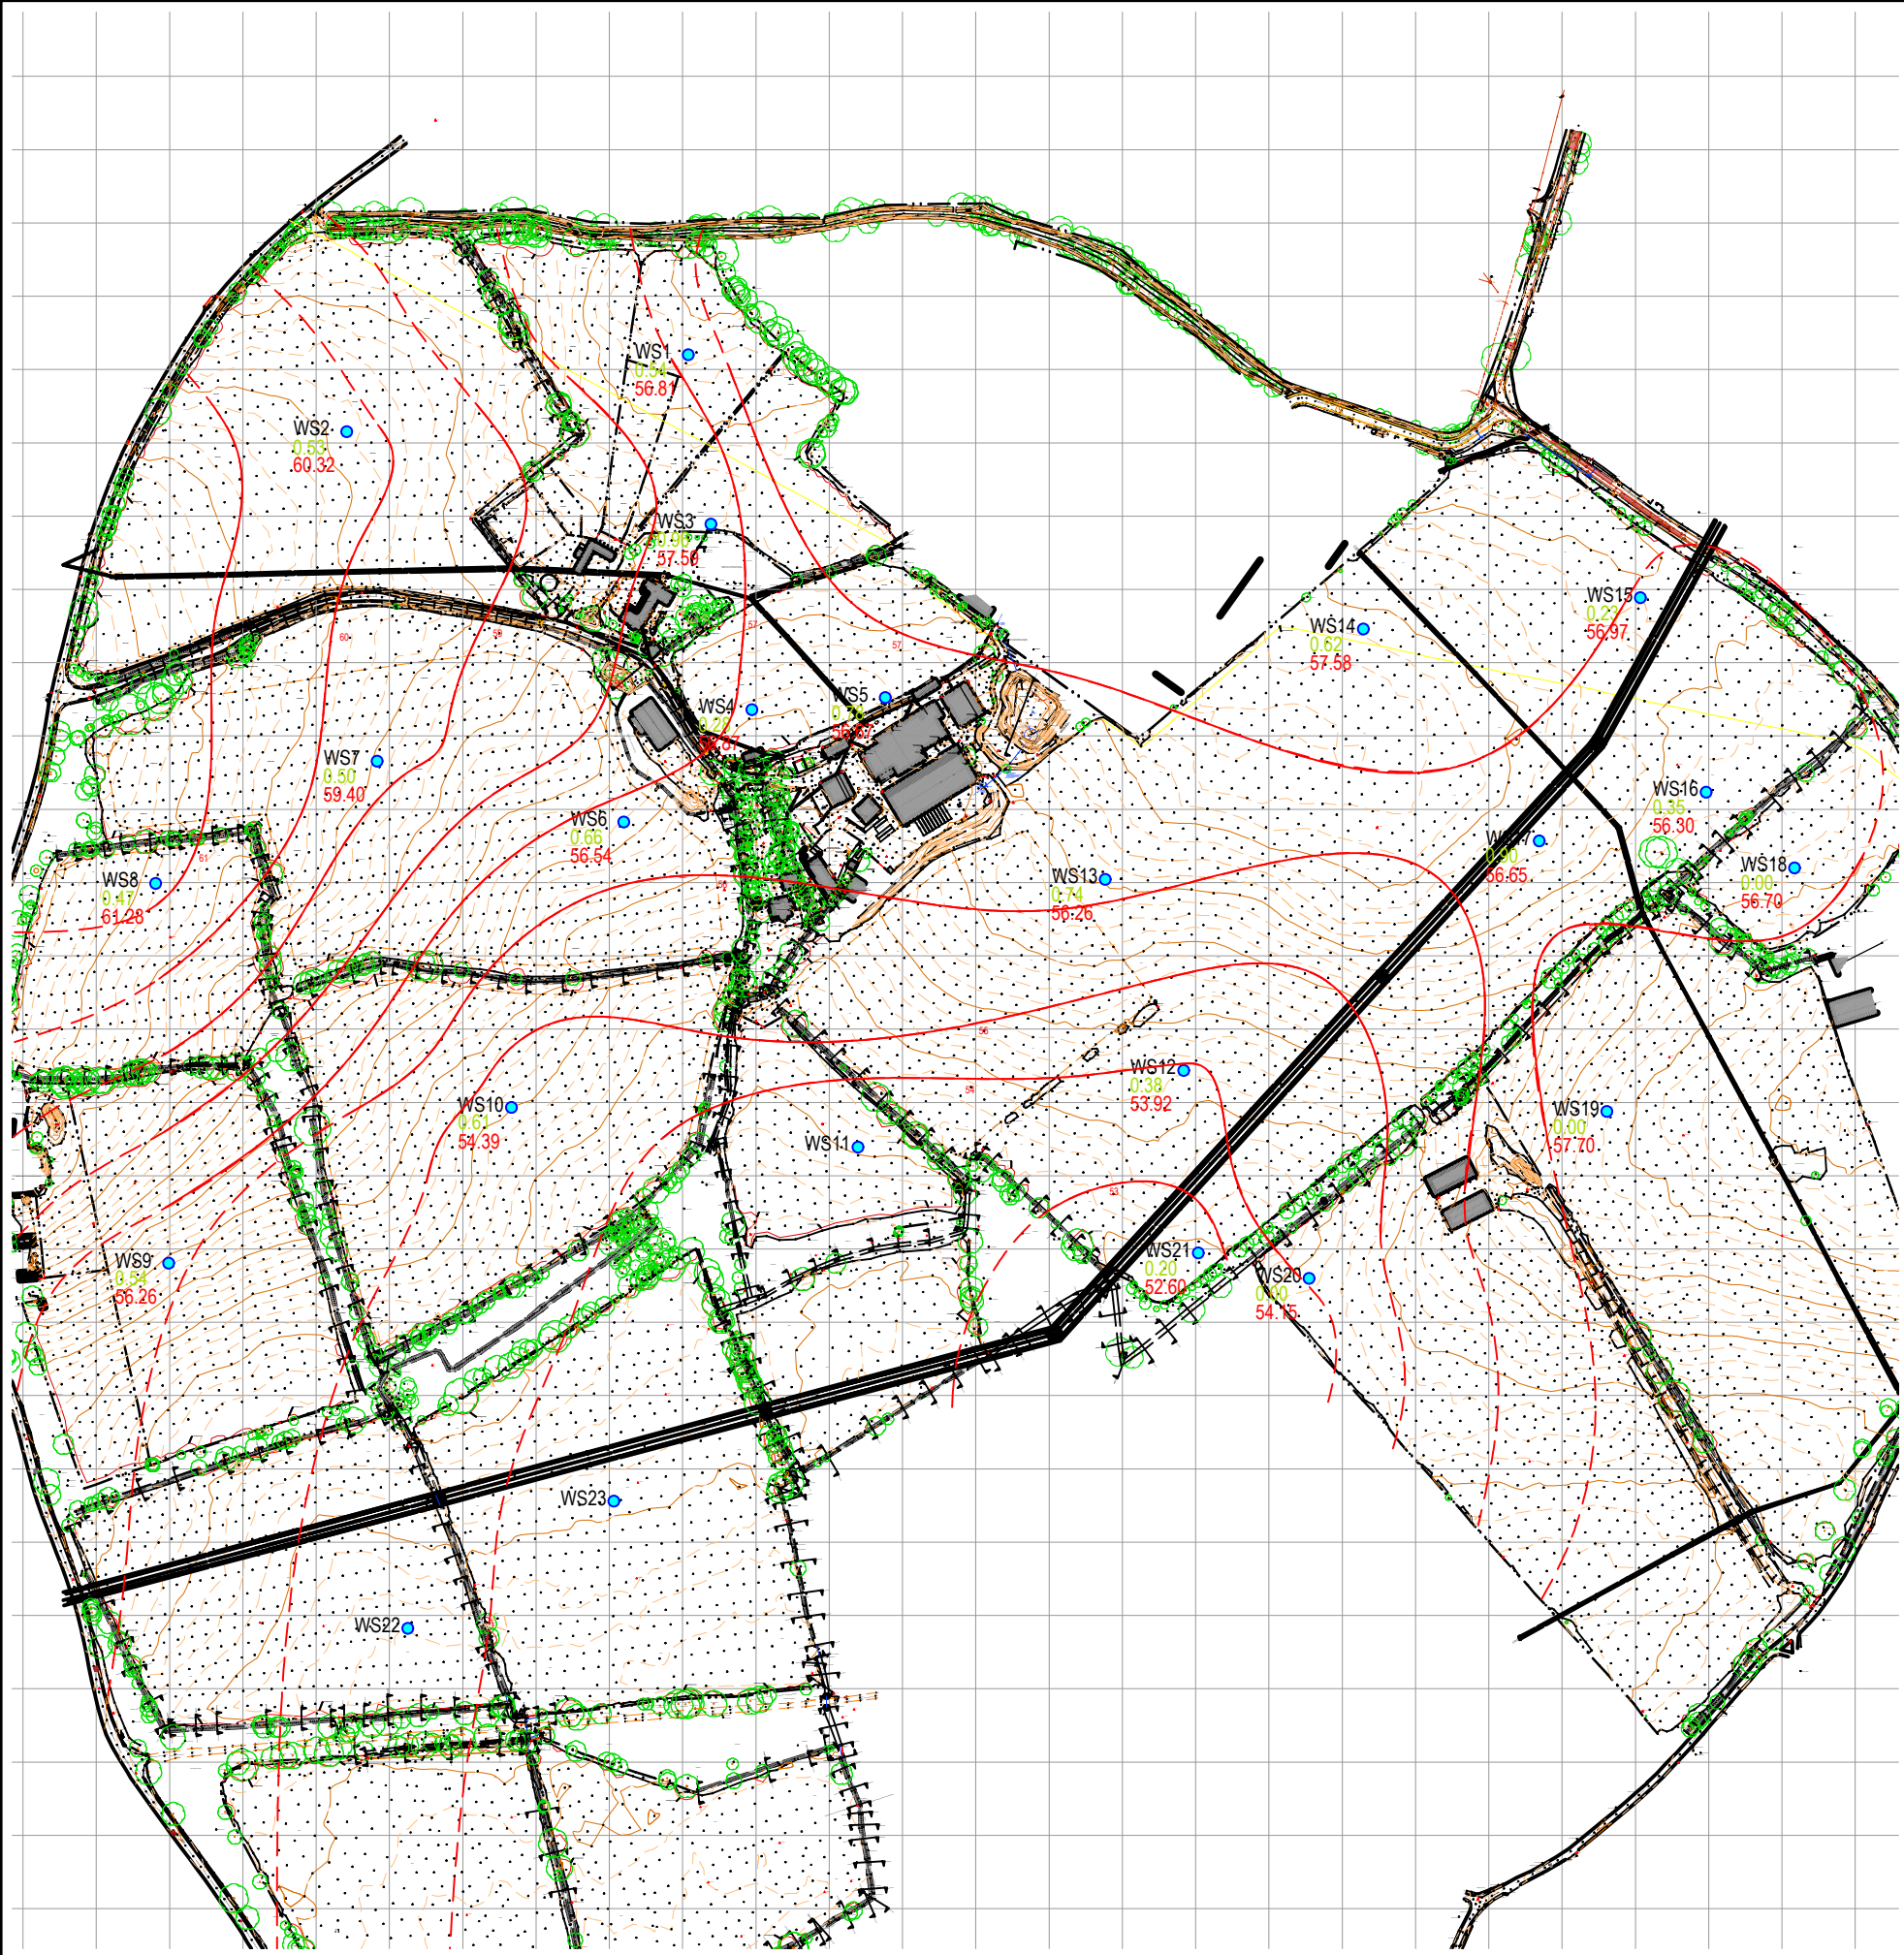
| DRAWN<br>TC | CHECKED<br>RAN | DATE<br>24.07.19 | DRAWING NUMBER<br>41623/005 | REV<br>A |

- 1.5 Highest water depth recorded throughout the monitoring period in metres below ground level.
- 50.50 Highest water depth recorded throughout the monitoring period in metres above Ordnance Datum.
- GWM Standpipe location
- Groundwater level contour line
- Groundwater level contour line - extrapolated

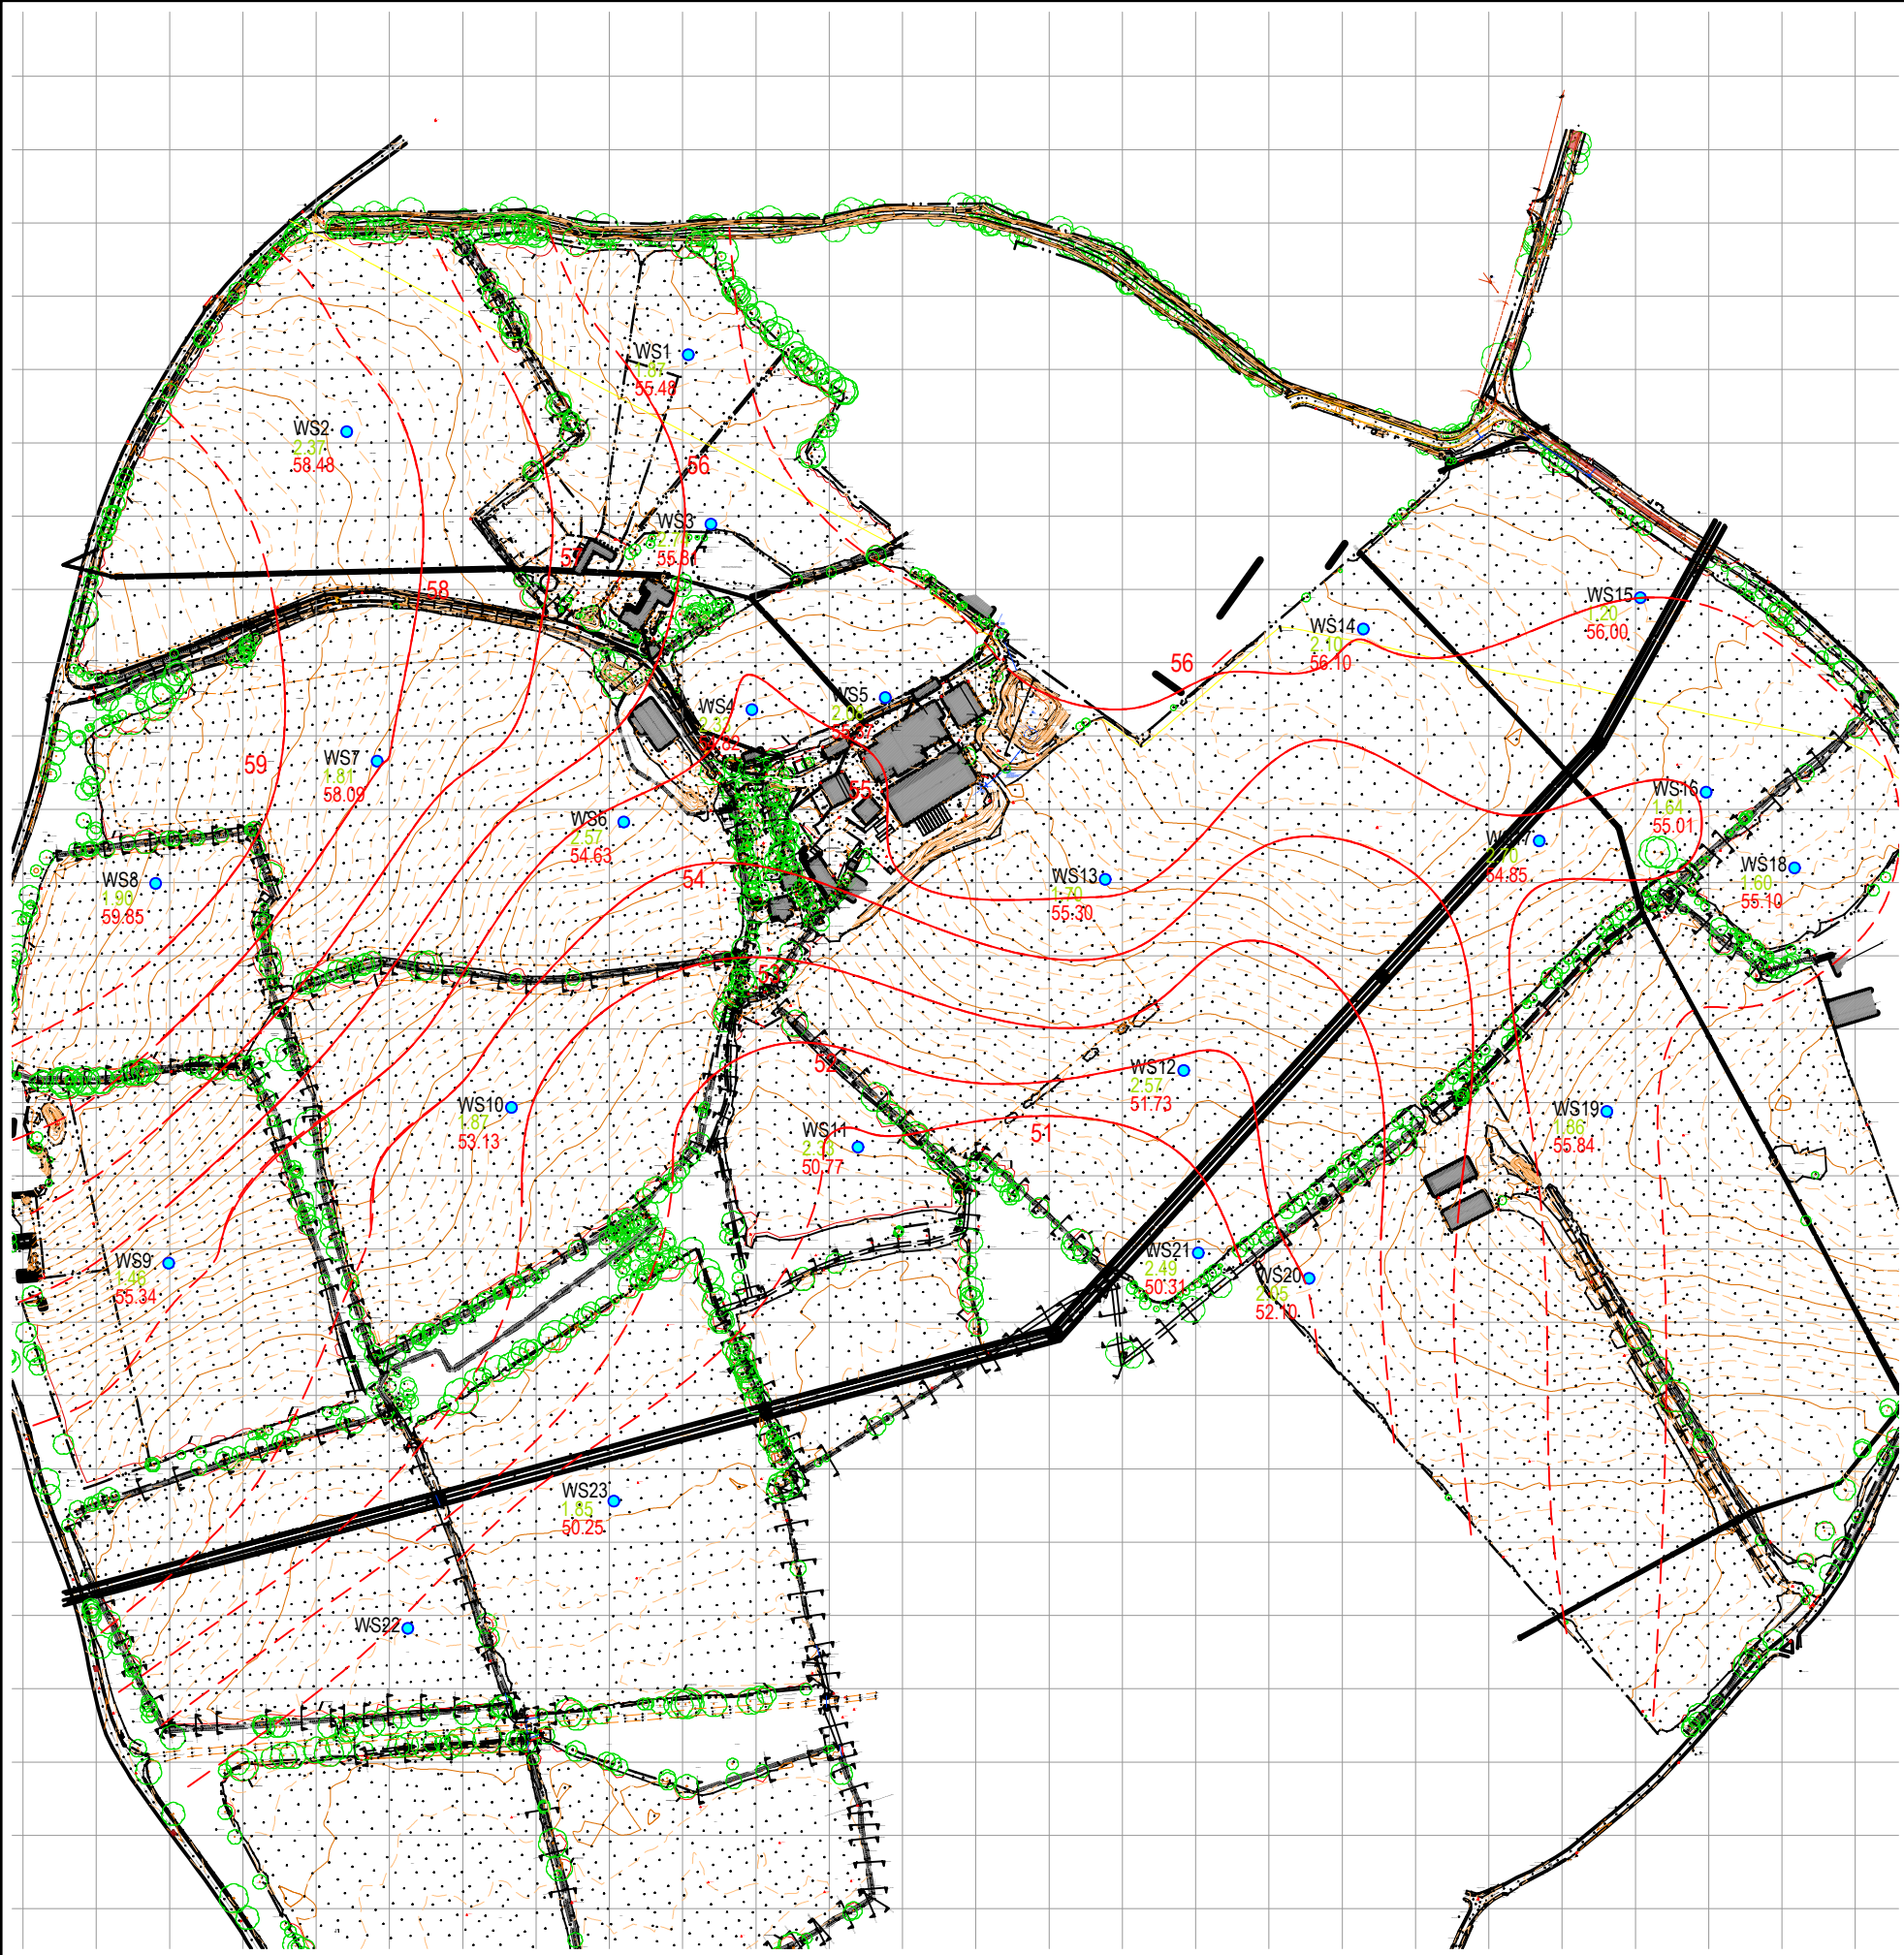
| DRAWN<br>TC | CHECKED<br>RAN | DATE<br>24.07.19 | DRAWING NUMBER<br>41623/006 | REV<br>A |

- 0.5 Lowest water depth recorded throughout the monitoring period in metres below ground level.
- 55.50 Lowest water depth recorded throughout the monitoring period in metres above Ordnance Datum.
- GWM Standpipe location
- Groundwater level contour line
- Groundwater level contour line - extrapolated
