## **BS 5837:2012 TREE SURVEY FOR MARRON REMISE WARGRAVE**

**Ref: PB/5837-25/06.11**

**24 June 2025**

A total of nine individual trees, two groups and two woodland groups were inspected on land at Marron Remise, Kentons Lane, Wargrave, RG10 8PD. The tree details are contained in the tree survey schedule included at Appendix 1. The trees were assessed in accordance with the cascade chart for tree quality (Table 1: Section 4) of British Standard (BS) 5837:2012. They are categorised as follows.

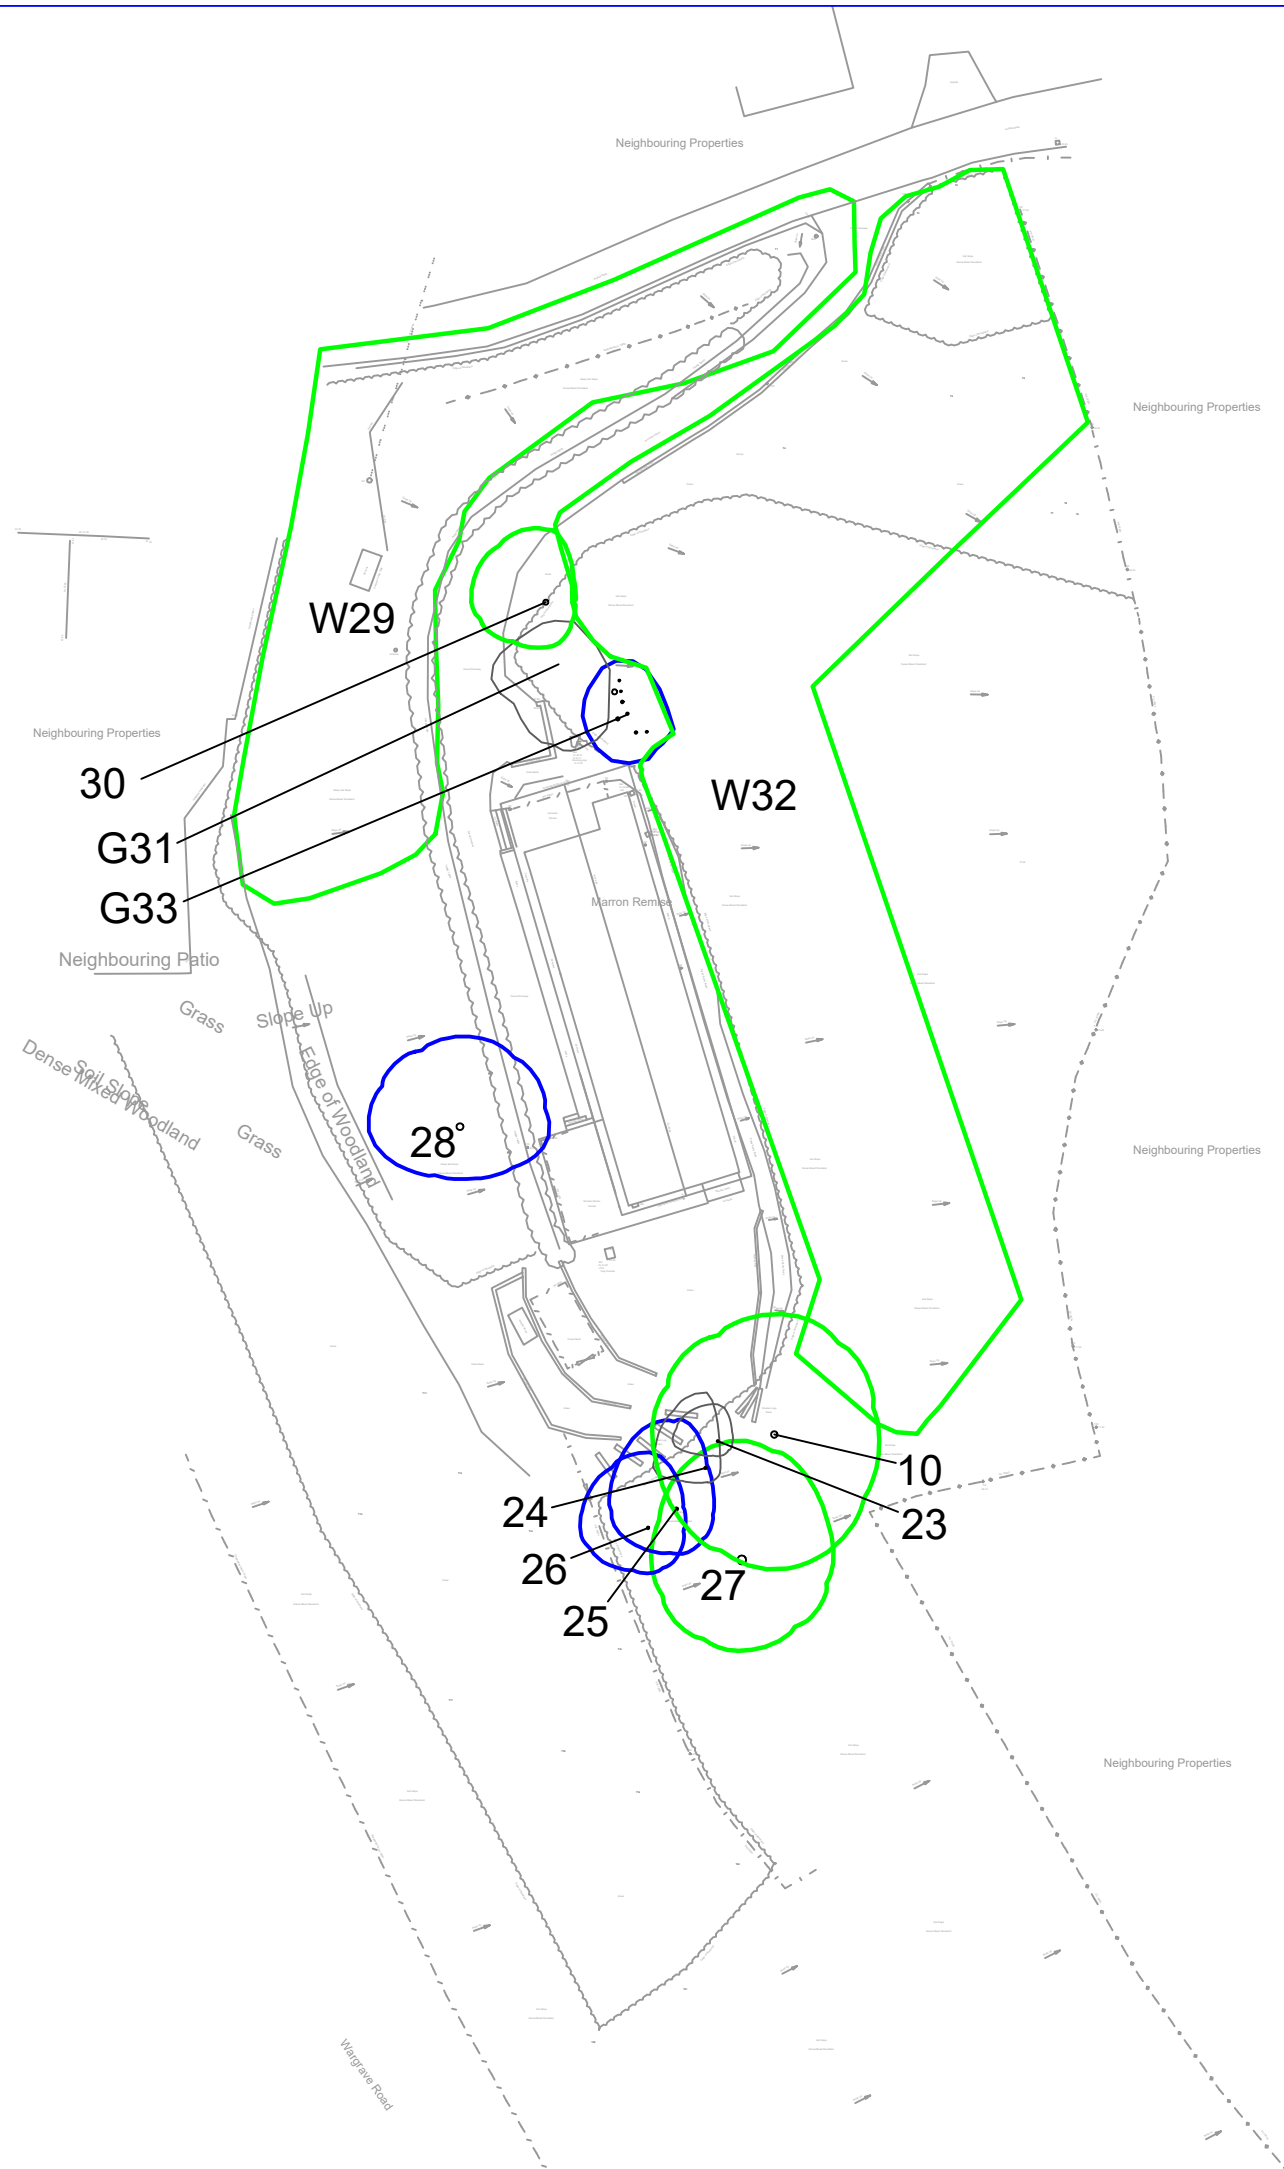
| Drawing Title | TREE LOCATION PLAN | | |

They are shown and located on the tree location plan ref PB/5837-25/06.11 included as Appendix 2.

- 3.2.1 We surveyed nine individual trees, two groups and two woodland groups with stem diameters of 75 millimetres and above. The tree details have been entered into a tree survey schedule included at Appendix 1.
- 3.2.2 For ease of identification the trees are shown on the tree location plan ref PB/5837-25/06.11 and have been allocated numbers. These numbers are cross-referenced within the BS 5837:2012 survey schedule.
- 3.2.3 In making the assessment, consideration has been given to:
  - The health, vigour and condition of the trees.
  - Any structural defects and safe life expectancy.
  - The size and form of the trees.
  - The rare, unusual or component part of a formal feature.
  - Groups or individual trees that provide definite screening or softening effect.
  - Trees forming distinct landscape features.

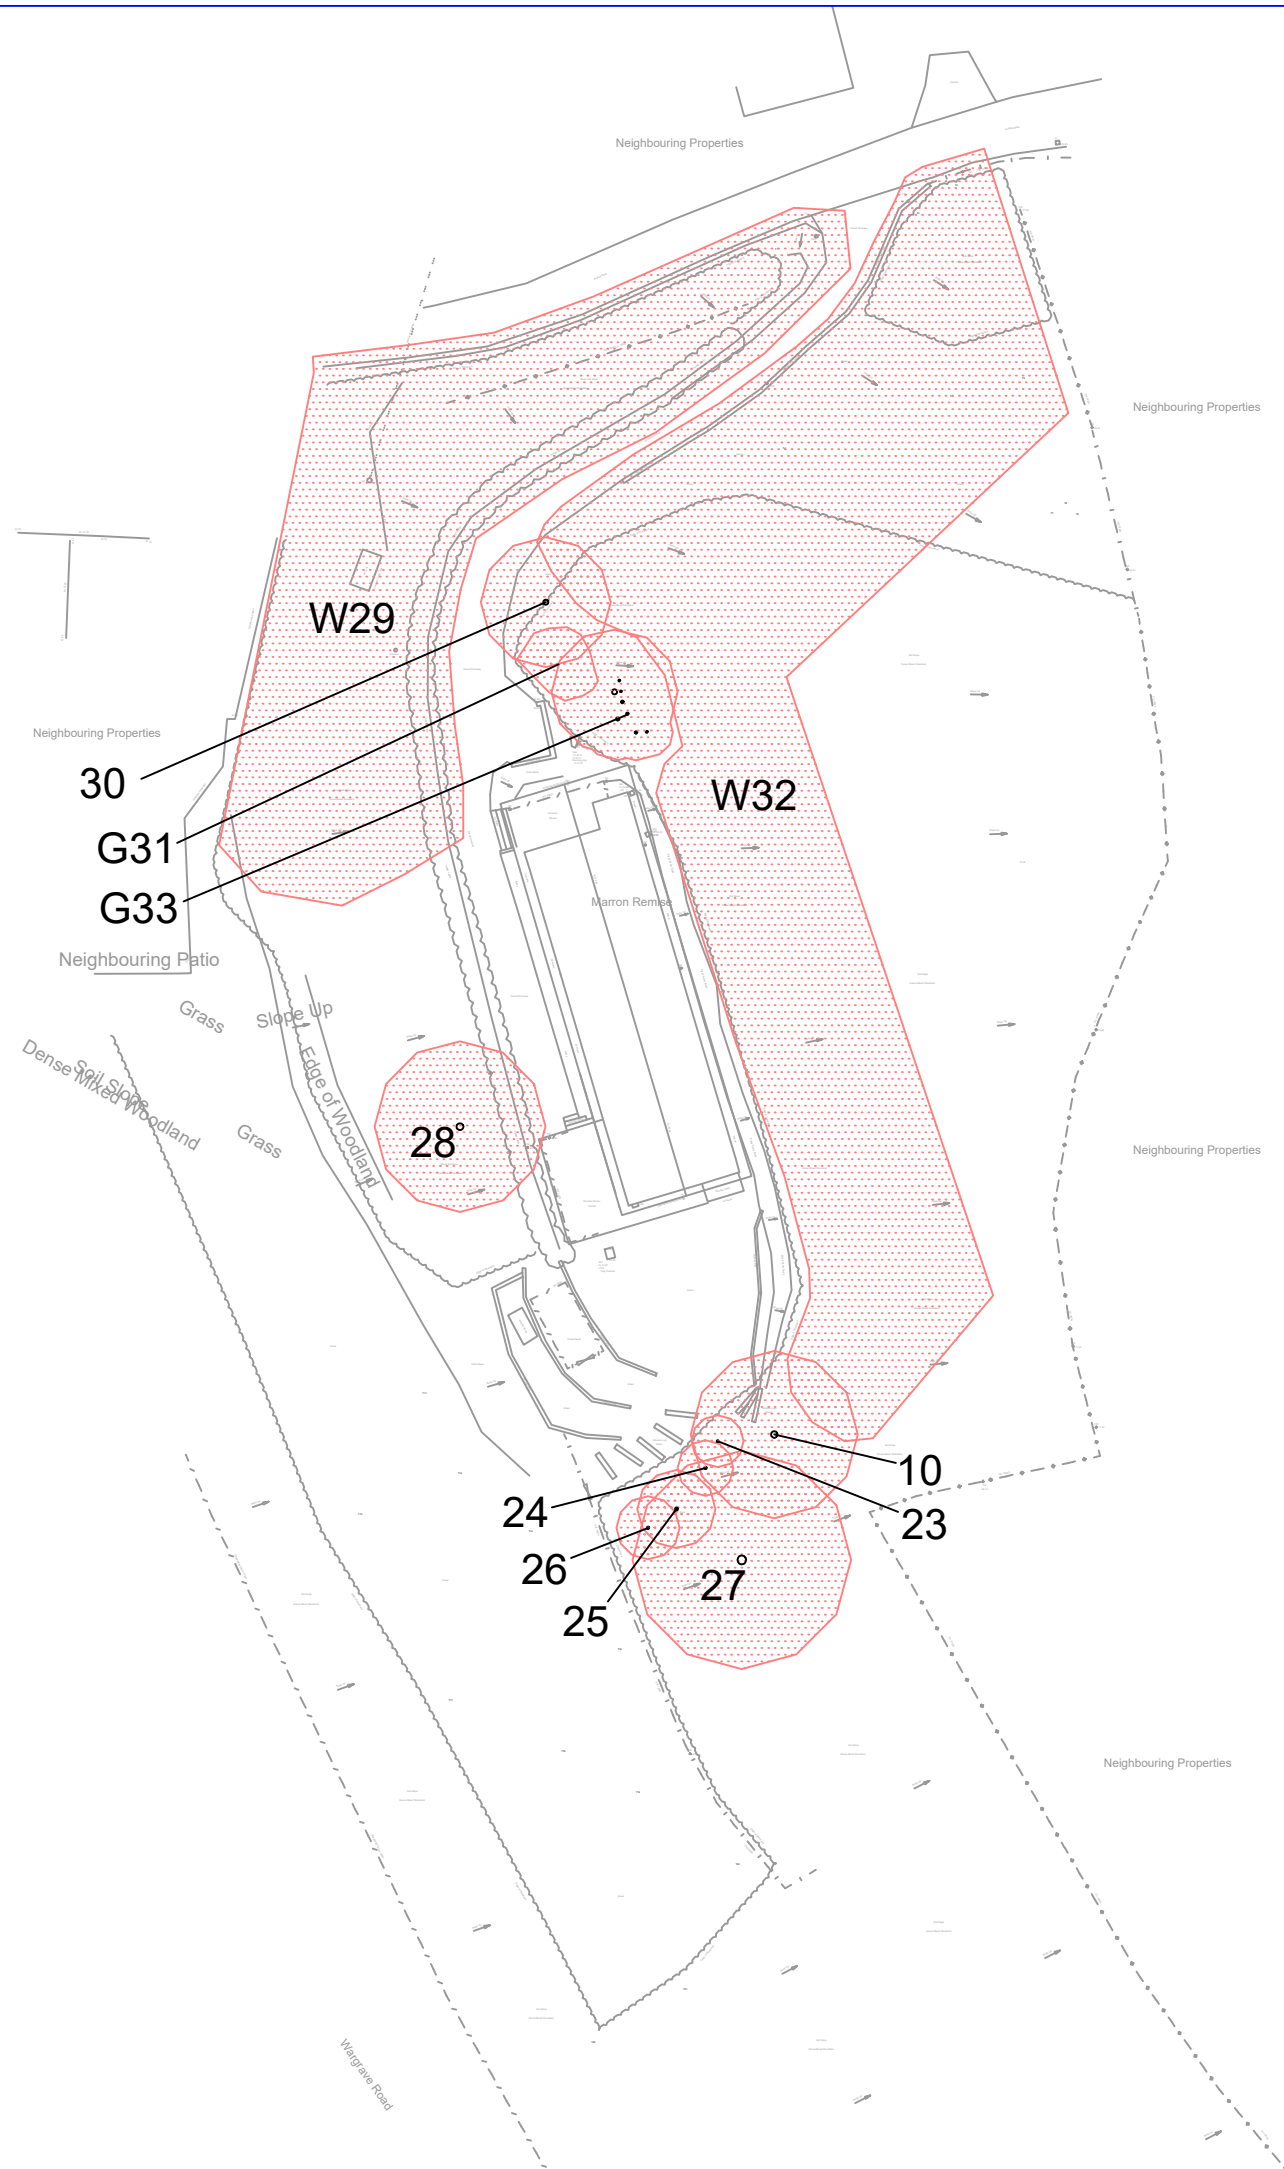
| Drawing Title | ROOT PROTECTION AREA PLAN | | |

Mitigation may be required to demonstrate how the retained trees' root protection areas (RPAs) will be protected during any development, including access to the proposed development area. The RPAs are shown on the plan included at Appendix 3.

- 4.2.2 Specified intrusions into the RPAs can take place only where the ground is adequately protected in accordance with the requirements of section 6 (6.2.3.3) of the BS or as may be agreed with the Local Planning Authority (LPA). The RPAs have been plotted as dodecagons or polygons taking account of the site constraints on plan ref PB/RPA-25/06.11.

- 4.2.3 The shape and position of the RPA may only be modified by an arboriculturist to meet the pre-existing site conditions or other factors that indicate that rooting has occurred asymmetrically. In all cases, we have considered the adjacent constraints including such things as the existing highway, site topography and existing buildings.

- 5.1 To protect retained trees from construction activities, notwithstanding the need for an Arboricultural Method Statement (AMS) in specific instances, the retained trees must be protected by suitable protection barriers and ground protection, the accompanying root protection area plan shows the RPAs and specific tree protection locations required prior to and during the construction activities.

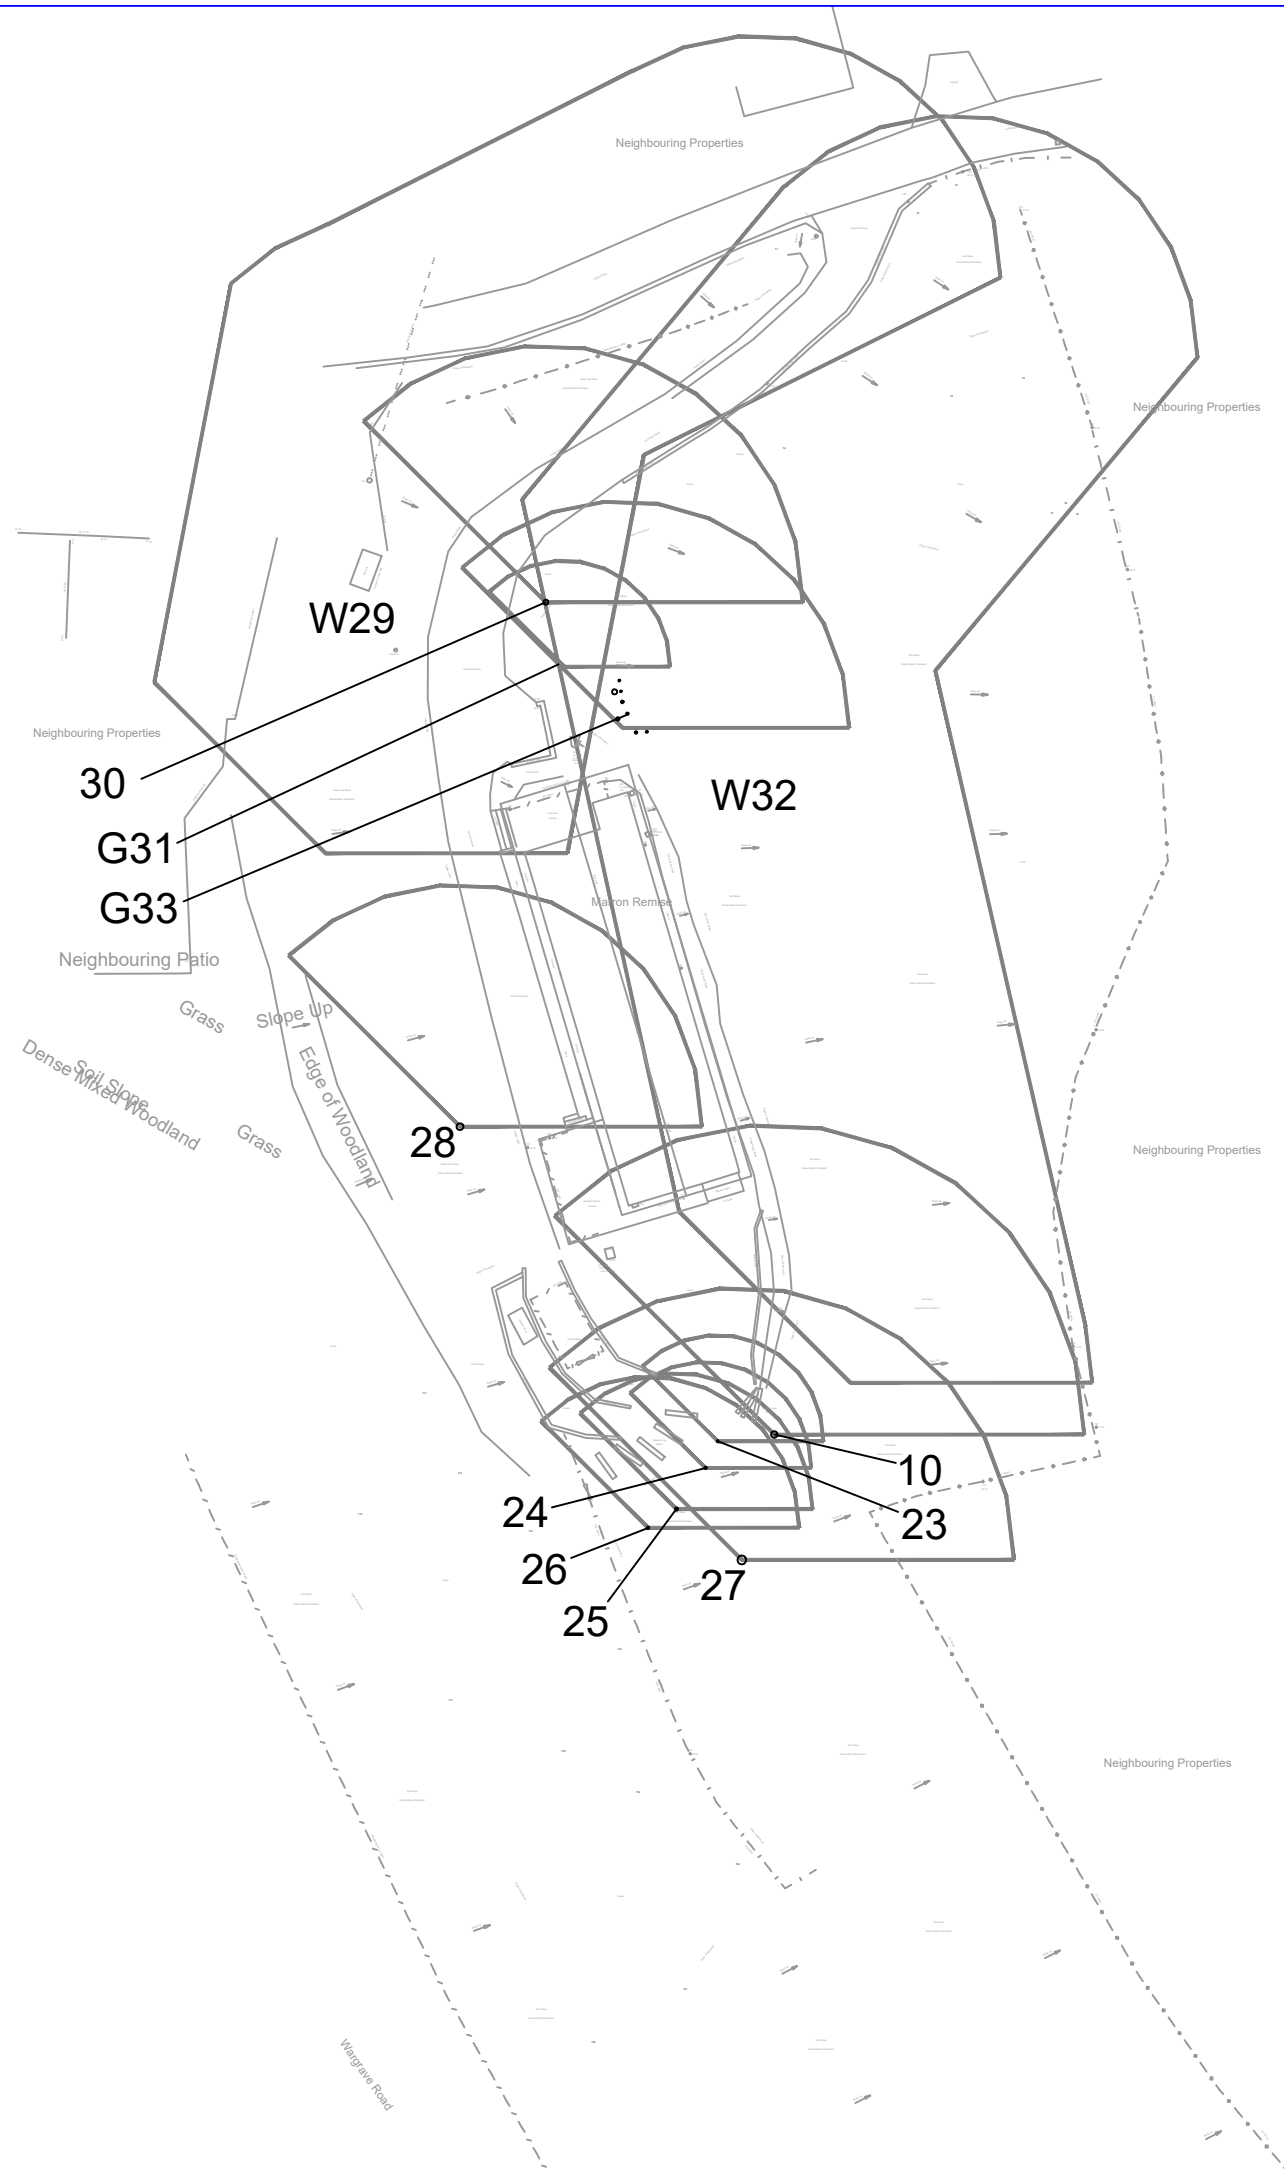
| Drawing Title | SHADE CONSTRAINTS PLAN | | |

- 4.3.1 Large trees that cast dense shade may result in pressure to prune or remove them. Whilst either shade or sunlight might be desirable depending on the potential use; the design should avoid unreasonable obstruction of light. The shade constraints posed by the trees are plotted onto plan ref PB/SC-25/06.11.

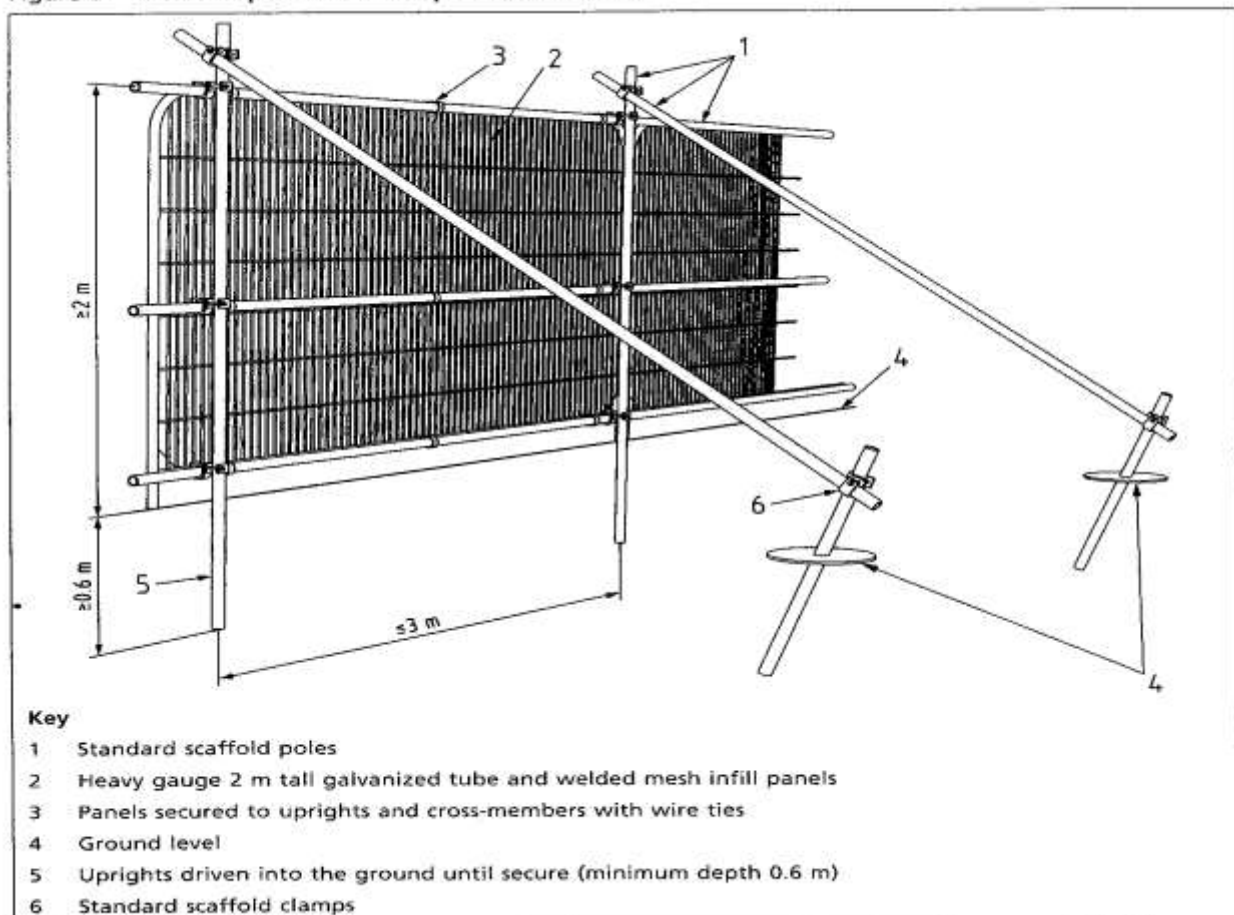
Figure 2 Default specification for protective barrier

**Root Protection Areas (RPAs), enclosed by Default Temporary Protective Fencing, as detailed below and to be agreed with the Local Planning Authority (LPA), shall:**

1. Be protected throughout the development process, as specified and detailed in BS 5837:2012 Section 6.2, Fig 2
2. Be erected prior to any construction, demolition or excavation works and remain in place for the duration of the project.
3. Preclude any delivery of site accommodation and or materials and or plant machinery.
4. Preclude all construction related activity, with the sole exception of specified arboricultural works and any other works carried out under supervision that has been agreed by all parties, and:
5. Preclude the storage of all development related materials and substances including fuel, oils, additives, cement and or any other deleterious substances.
6. Any incursions into RPAs must be by prior arrangement, following consultation with the LPA.
