**Kings Lake House  
Holly Bush Ride  
Finchampstead  
Berkshire  
RG40 3QR**

## **Preliminary Roost Assessment**

Report ref.: R2775\_PRA\_a

**February 2025**

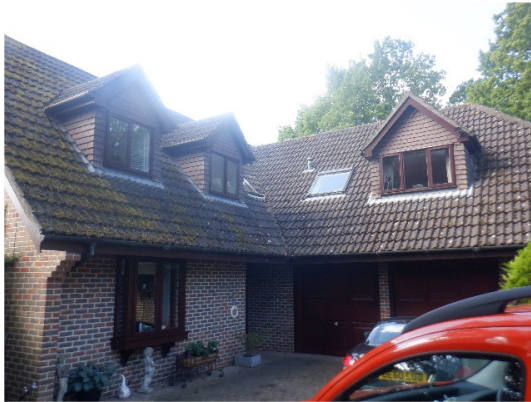
- 5.2.2 The house had a pitched roof with three half hipped ends and five dormer windows (**Photographs 1 & 2**).

Photograph 1. Front of house viewed from northeast.

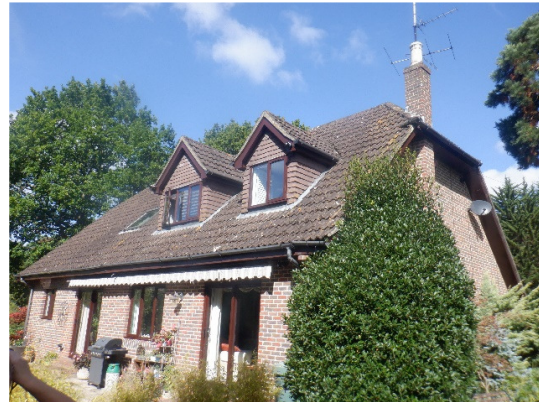
Photograph 2. Side and rear of house viewed from southwest.

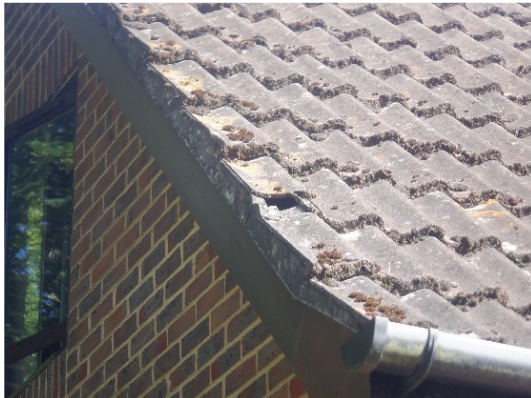
- 5.2.3 The half hipped roof was covered in interlocking tiles that were mostly tightly fitted, apart from a broken tile on the rear south western elevation (**Photograph 3; Target note 1**). The ridge, hip and verge mortar was fully intact (**Photograph 4**).

Photograph 3. Broken tile (rear elevation).

- broken tile on the rear south western elevation (**Photograph 3; Target note 1**).
- gaps were present behind the timber soffit boxes along the base of the hipped sections where they joined the brick wall (**Photograph 5; Target note 2**)
- a large gap behind the timber soffits on the northern facing half hipped end (**Photograph 6; Target note 3**)
- a few slits present between brickwork on the western elevation (**Photograph 8; Target note 4**)
- numerous gaps were present around the dormer windows, including lifted tiles around the corners, around the top corners of the window frames where tiles were uneven and a tile was missing at the apex on the front eastern most dormer windows (**Photographs 9, 10 & 11; Target notes 5, 6, & 7**).
- large gaps were also present at the junction of the dormer windows with the main roof (**Photograph 12; Target note 8**).

- 8.2.5** Replacement bat access points and roost sites may need to be created and/or reinstated into the house as part of an EPS mitigation licence or BMCL site registration. This compensation should aim for like-for-like roost sites with access points corresponding as closely as possible to the previous locations.

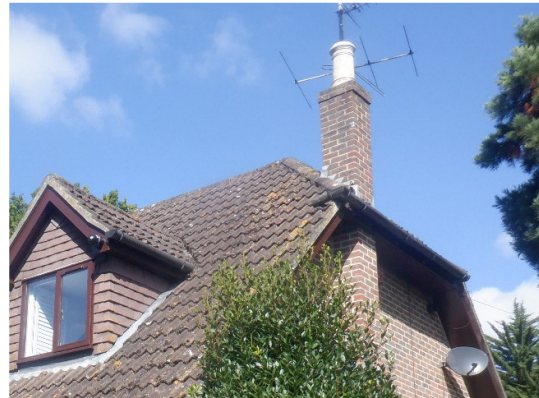
Photograph 4. Intact ridge, hip and verge mortar (rear elevation)

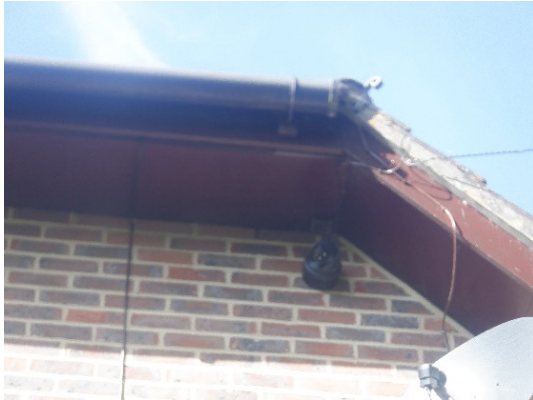
- 5.2.4 The lower edges of the half hipped ends were sealed with concrete, however gaps were present behind the timber soffit boxes along the base of the hipped sections where they joined the brick wall (**Photograph 5; Target note 2**). A larger gap was present behind

*Photograph 5. Gaps behind soffit boxes at hipped ends (eastern elevation).*

**6.1.3** The gaps behind the timber soffit boxes at the half-hipped ends and the junctions of the dormer windows could potentially lead within the roof void. The void had sufficient space for internal flight and suitable conditions for supporting void-dwelling bats, such as the locally recorded brown long-eared bat (*P. auritus*). Five medium sized bat

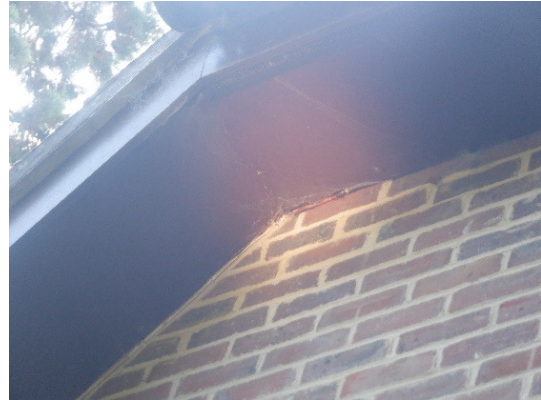
the timber soffits on the northern facing half hipped end, however it was cobwebbed and further timbers were visible behind (**Photograph 6; Target note 3**).

*Photograph 6. Large, cobwebbed gap at hipped end (northern elevation).*

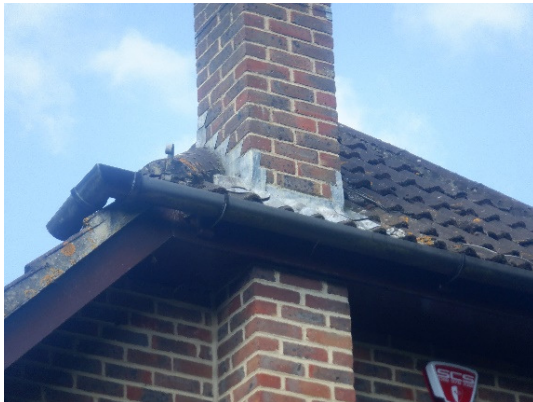
- 5.2.5** Lead flashing was tight around the chimney at the eastern side of the house (**Photograph 7**). A few slits were present between brickwork on the western elevation (**Photograph 8; Target note 4**).

*Photograph 7. Tight lead flashing against eastern chimney (eastern elevation).*

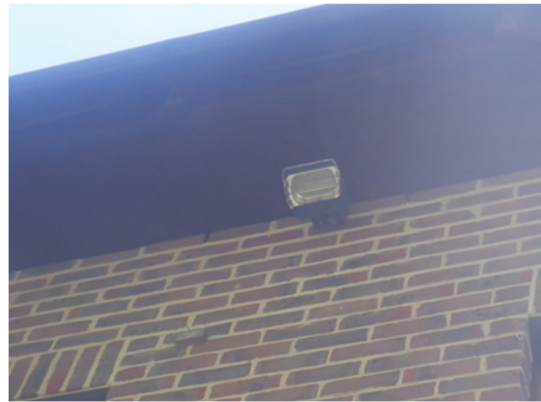
*Photograph 8. Slits in a few bricks on the western elevation.*

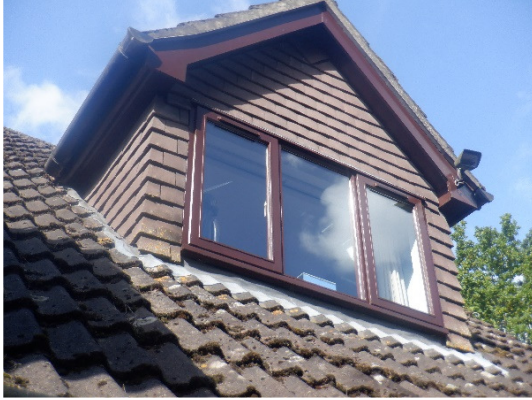
- 5.2.6** Numerous gaps were present around the dormer windows, including lifted hanging tiles around the corners, around the top corners of the window frames where hanging tiles were uneven and a tile was missing at the apex on the front eastern most dormer windows (**Photographs 9, 10 & 11; Target notes 5, 6, & 7**). Large gaps were also present at the junction of the dormer windows with the main roof (**Photograph 12; Target note 8**).

*Photograph 9. Lifted corner hanging tiles on dormer window (eastern elevation).*

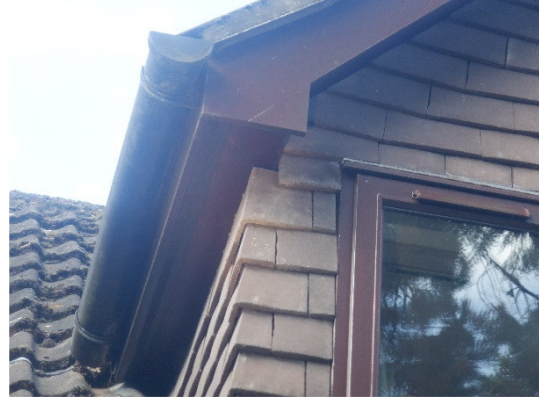
*Photograph 10. Gaps in the tiles around the top edges of the window frames (eastern elevation).*

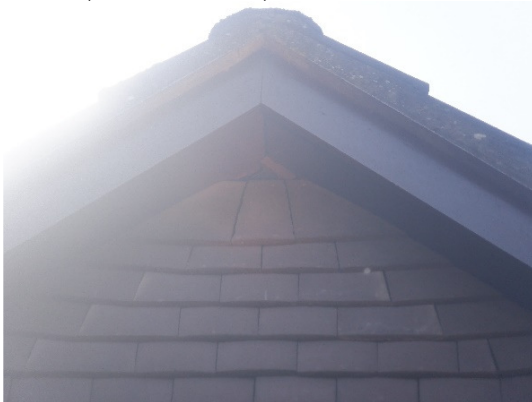
*Photograph 11. Missing tile at apex of front eastern-most dormer window (front elevation).*

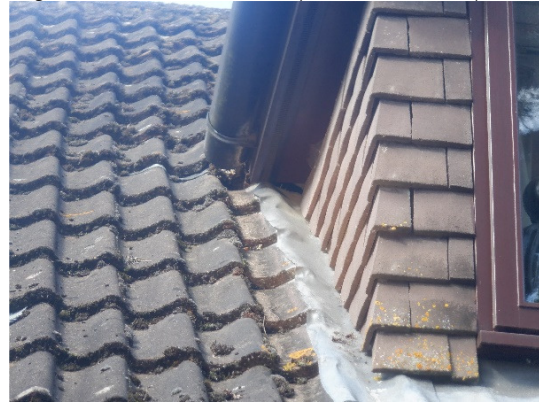
*Photograph 12. One of the large gaps present in the roof junction of a dormer window (eastern elevation).*

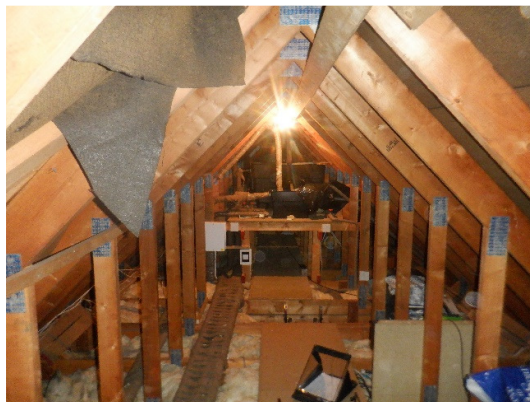
- 5.2.7** The property had one void with an approximate floor-to-ridge height of 2 metres that covered the footprint of the building, which was accessible via a first floor loft hatch (**Photograph 13**).

*Photograph 13. Roof void.*

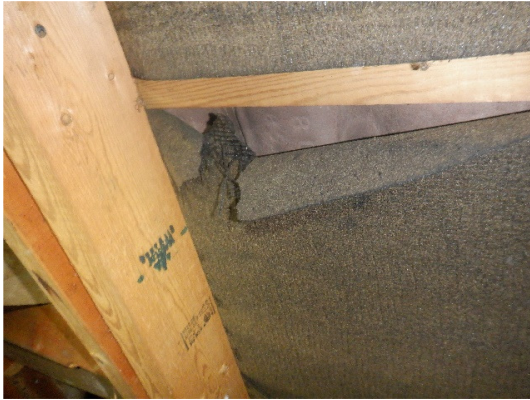
- 5.2.8** The roof was of trussed rafter construction and lined by hessian-reinforced bitumen felt that was fully intact throughout the roof apart from one section that was loose towards

*Photograph 14. Loose bitumen felt (roof void).*

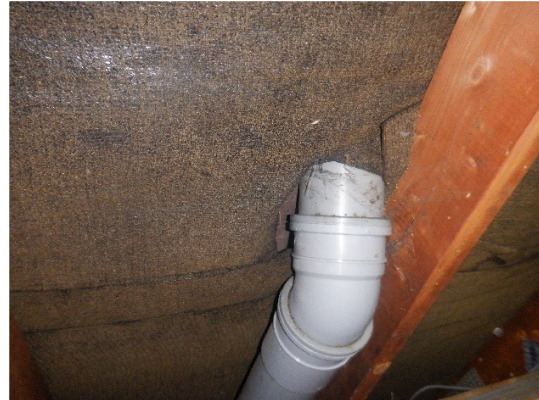
the northern end of the roof void (**Photograph 14; Target note 9**). The felt was also loose around a few pipes present in the roof void (**Photograph 15; Target note 10**).

*Photograph 15. Loose bitumen felt around the chimney at the internal brickwork wall (roof void).*

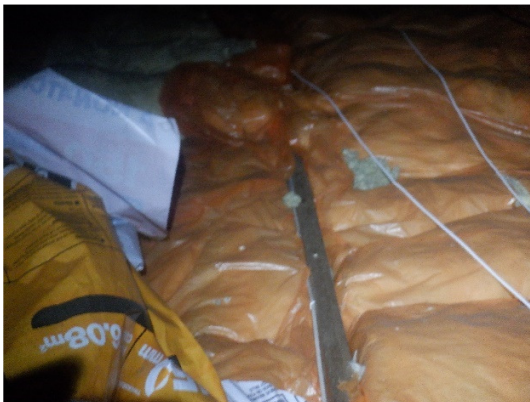
**5.2.9** The floor was insulated with fibreglass in the southern section and with plastic covered insulation in the northern section above the garage (**Photograph 16**). The eaves were partly open and partly filled with insulation boards (**Photograph 17**). The roof void was generally cobweb-free, however it was heavily cobwebbed around the chimney (**Photograph 18**).

*Photograph 16. Internal view of the roof void with fibreglass insulation in the northern section.*

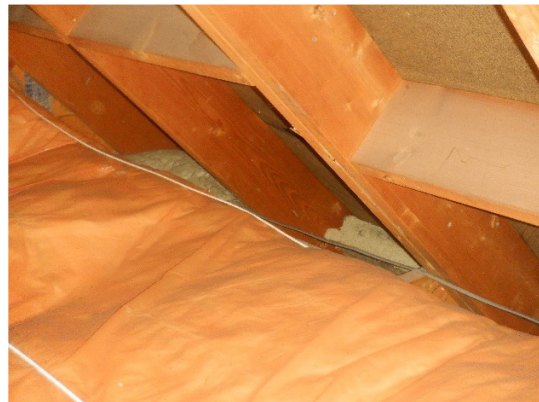
*Photograph 17. Eaves filled with insulation boards in places (roof void).*

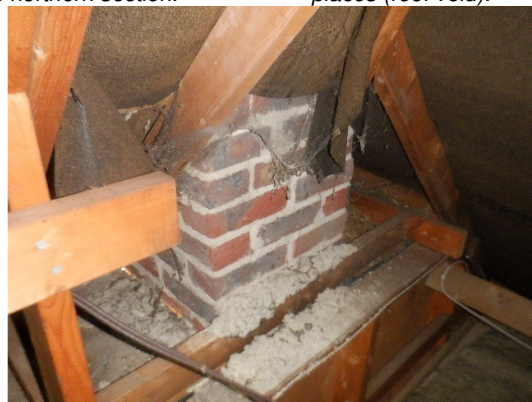
*Photograph 18. Heavily cobwebbed chimney (roof void).*

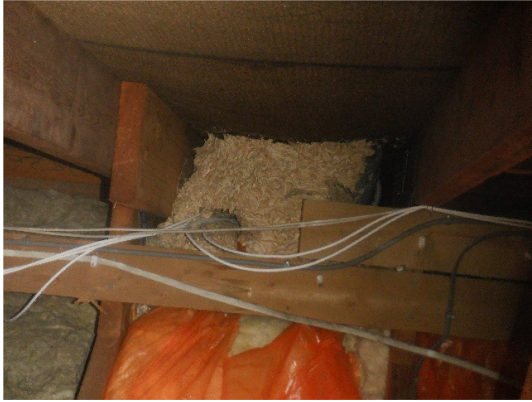
- 5.2.10** A wasp nest were present at the eaves in the eastern end of the roof and evidence of bird nesting material was present in the several corners of the roof (**Photographs 19 & 20; Target notes 11, 12, 13 & 14**). Three medium-sized bat droppings were scattered near the loft hatch and a further two droppings were scattered in the northern section of the roof (**Photographs 21 & 22**).

*Photograph 19. Wasp nest present in the eastern end of the roof space.*

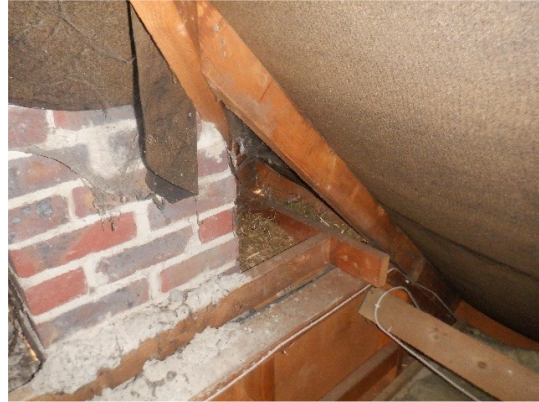
*Photograph 20. Bird nesting material at the eaves in the roof void.*

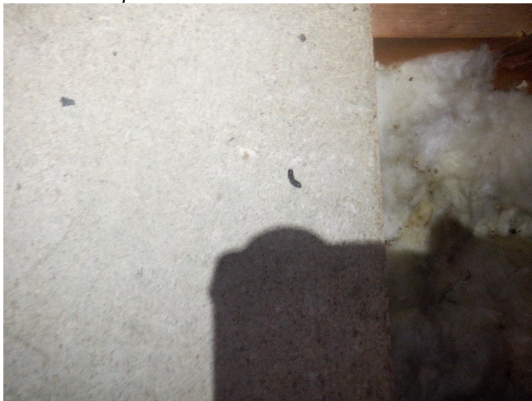
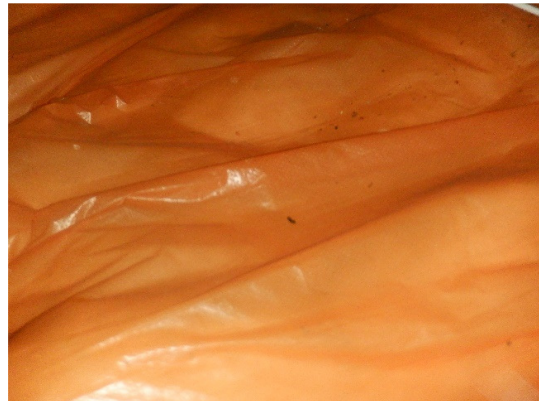
- 1.1.3** Five medium-sized bat droppings resembling those typically deposited by void-dwelling species such as the long-eared bats (*Plecotus* spp.) were observed within the roof void of the property. Access points are likely under gaps under the timber soffits or around the dormer window junctions with the main roof. Further external features that may offer potential crevice roost sites for regular use by large numbers of crevice-dwelling bat species included a broken roof tile, gaps under corner hanging tiles and around the window frames on the dormer windows. The property has been assigned high potential suitability for bats.

*Photograph 21. Medium-sized bat droppings within the void.*

*Photograph 22. Medium-sized bat droppings within the void.*

droppings typical of brown long-eared bat (*Plecotus auritus*) were found scattered within the roof void (**Photographs 21 & 22**).

- 7.2.1** Based on the current survey findings, the development proposals do not provide scope to be altered to avoid the potential adverse effects on bats. Therefore, further survey is recommended to characterise the confirmed bat roost and to determine the presence or likely absence of other bat roosts in the house, in order to be able to assess fully whether the development proposals will have an adverse effect on bats (see **Appendix 3** for further survey rationale). The recommended further survey approach and indicative mitigation proposals are detailed in **Section 8.1** below.

- 8.2.4** A soft demolition/roof strip approach to the works affecting the bat roosts would be adopted, i.e. careful removal of roof coverings by gloved hands and handheld tools under the direct supervision of a licensed ecologist or 'Registered Consultant'. In the event that a bat is found during the course of the works, the licensed ecologist or 'Registered Consultant' would capture the bat and transfer it directly to a woodcrete bat box installed in advance.
