# Preliminary Roost Assessment

4, Babbington Road, Reading, RG2 8HQ

This report is prepared to inform a planning application with Reading Borough Council. The proposed works are described as “the addition of two dormer windows, a Velux window, a vaulted hipped rain canopy porch and associated works”.

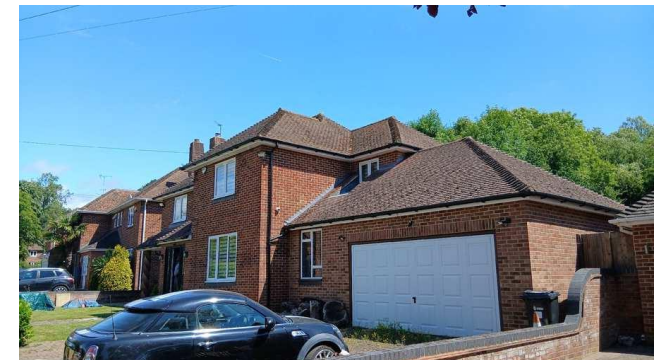
*Building B1*

The building is a residential dwelling. Its construction is modern and appears well-sealed, with no obvious cracks, crevices, or accessible voids that would typically offer suitable roosting opportunities for bats. Therefore, the building has negligible habitat value.

Bats are very unlikely to be roosting within B1 and as such, there are not anticipated to be any impacts on bats in these locations as a result of the proposed development.

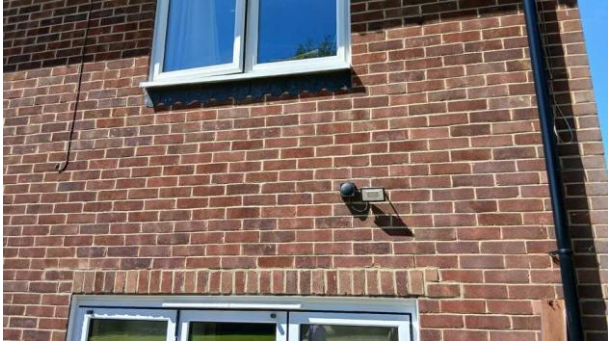
| Walls | Brick | <p><b>Condition/description</b><br/>The brickwork was observed to be in good condition with no damage.</p> <p><b>Suitability/access/evidence of bats</b><br/>No suitable habitat for bats.</p> | <p><i>B1 walls</i></p> |

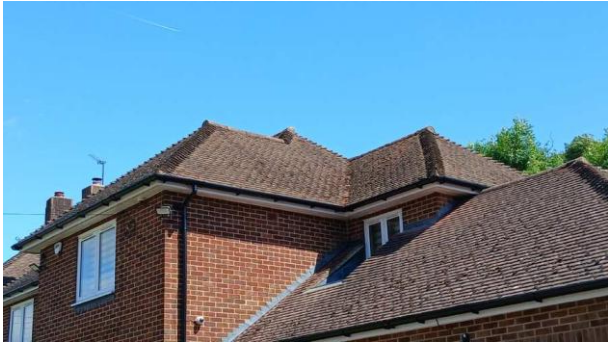
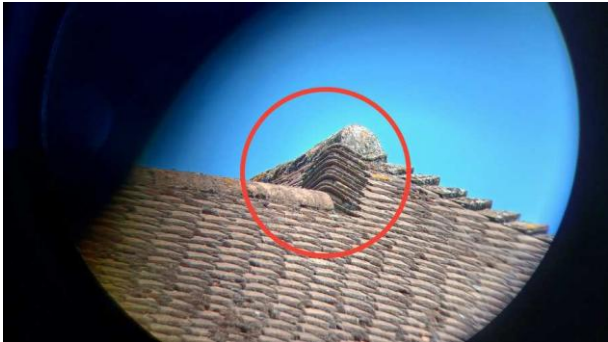
| Roof | Clay tiles | <p><b>Condition/description</b><br/>The roof tiles were observed to be in good condition with four missing some mortar beneath them. Upon inspecting these four tiles no gaps deeper than one inch were observed beneath them.</p> <p><b>Suitability/access/evidence of bats</b><br/>No suitable habitat was observed for bats.</p> | <p><i>B1 roof</i></p> <p><i>B1 roof - tiles with some missing mortar</i></p> |

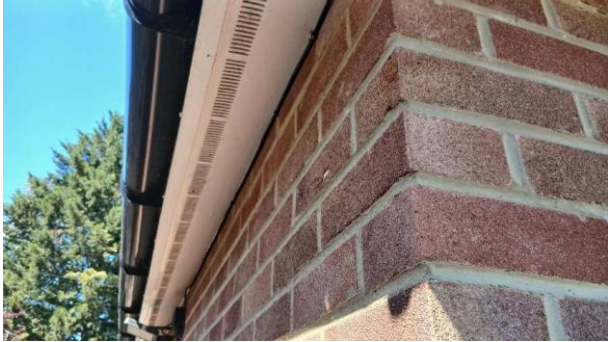
| Barge boards | uPVC | <p><b>Condition/description</b><br/>Good condition with no signs of damage.</p> <p><b>Suitability/access/evidence of bats</b><br/>No suitable habitat for bats.</p> | <p><i>B1 barge boards / fascia boards</i></p> |

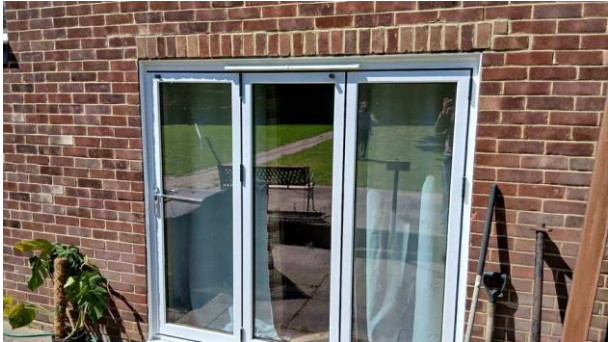
| Windows | uPVC | <p><b>Condition/description</b><br/>Good condition with no damage or gaps.</p> <p><b>Suitability/access/evidence of bats</b><br/>No suitable habitat for bats.</p> | <p><i>B1 window / doors frames</i></p> |

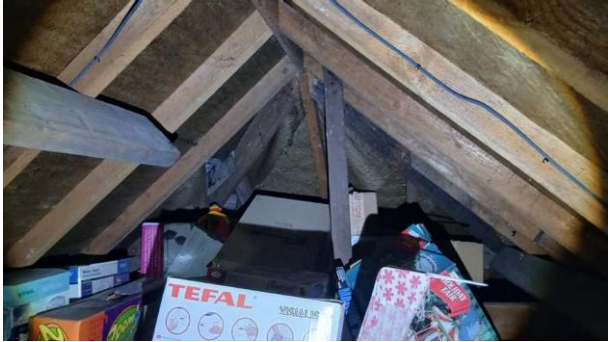
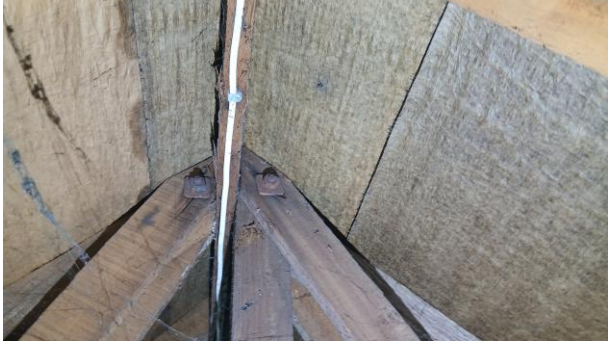
| Internal void 1 | Partially lined with bitumen felt | <p><b>Condition/description</b><br/>Loft 1 was observed to be in good condition. No light spill or damage to the roof was observed. Some areas of bitumen felt had come away from the roof.<br/>Dimensions (approx.): 15m long, 4m wide, and 2m high<br/>Temp: 25.4°C // Humidity: 57.3%</p> <p><b>Suitability/access/evidence of bats</b></p> | <p><i>B1 internal void 1</i></p> |

| | | Loft 1 provides suitable roosting habitat for void dwelling species assuming they could access it. | <p><i>B1 internal void 1</i></p> |

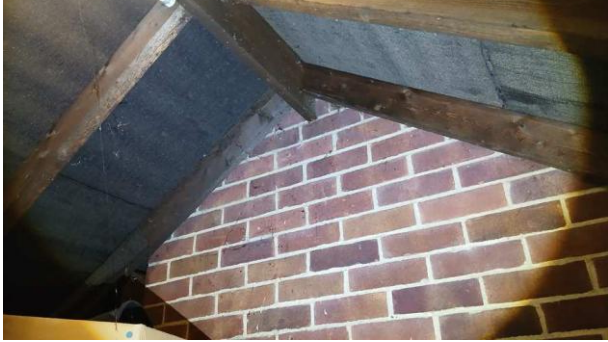
| Internal void 2 | Timber rafters.<br>Bitumen felt lining. | <p><b>Condition/description</b></p> <p>Loft 2 was observed to be in good condition with no light spill or damage to the roof seen.</p> <p>Dimensions (approx.): 5m long, 4m wide, 1.5, high</p> <p>Temp: 25.3°C // Humidity: 58.2%</p> <p><b>Suitability/access/evidence of bats</b></p> <p>The loft space would provide suitable habitat for roosting void dwelling bats assuming there were access.</p> | <p><i>B1 internal void 2</i></p> |

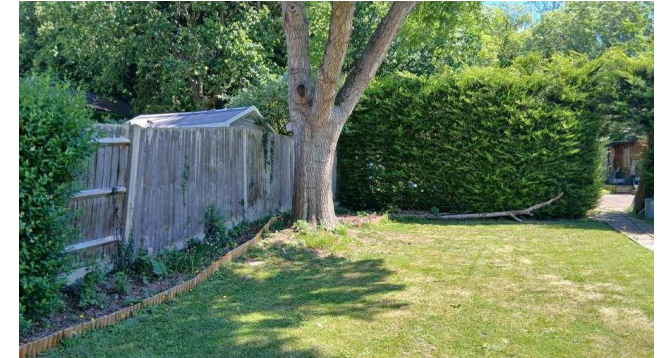
*Scattered trees; T1*

T1 is a common ash located in the rear garden. The tree has a DBH of 65cm.  
No roosting features were identified for this tree.

T1 will be retained and therefore no impacts to roosting bats are anticipated.
