# Wokingham Section 19 Flood Investigation

## Draft Report

March 2024

**WOKINGHAM  
BOROUGH COUNCIL**

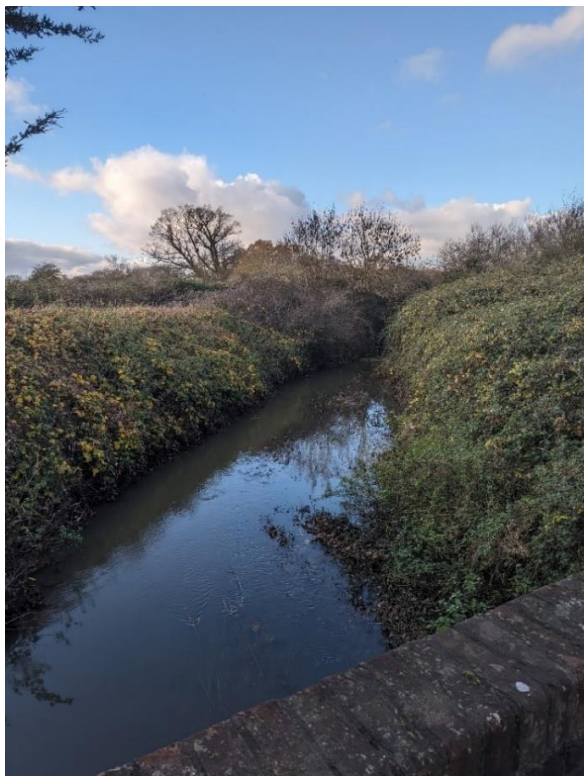
Figure 3- 3: Photographs of the Twyford Brook, a Main River in Hurst and Twyford

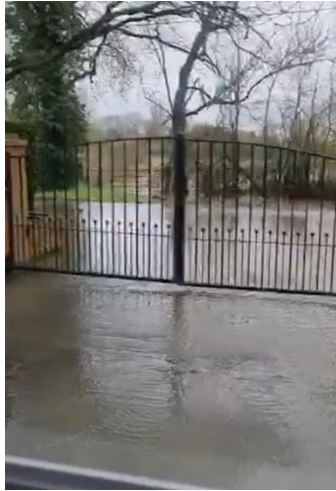
1. Flooding of Wokingham Road and Front drive of property on 31 March 2023

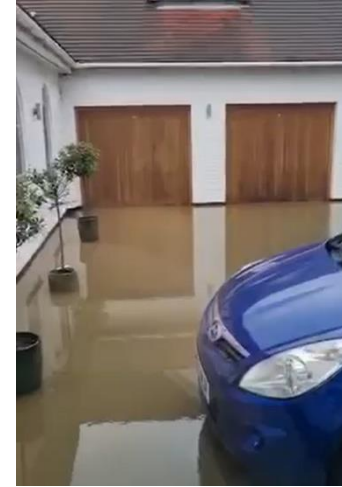
2. Flooding of driveway on 31 March 2023

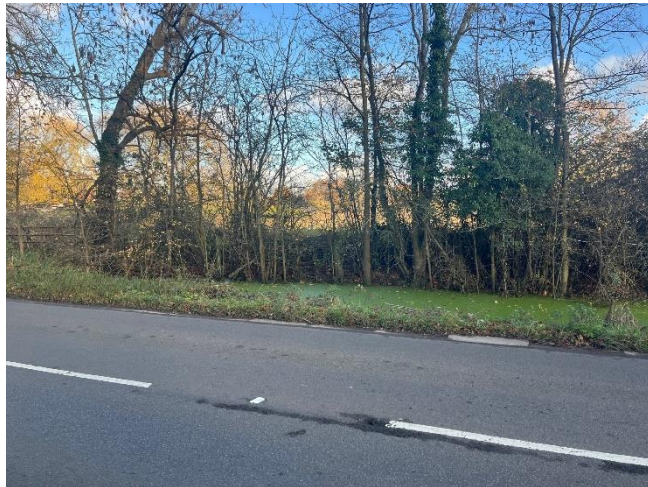
| <p>3. Site visit - high water levels in ditch on east side of the property (taken on 28 November 2023)</p> | <p>4a. Site visit - blocked culvert north of the property (taken on 28 November 2023)</p> |

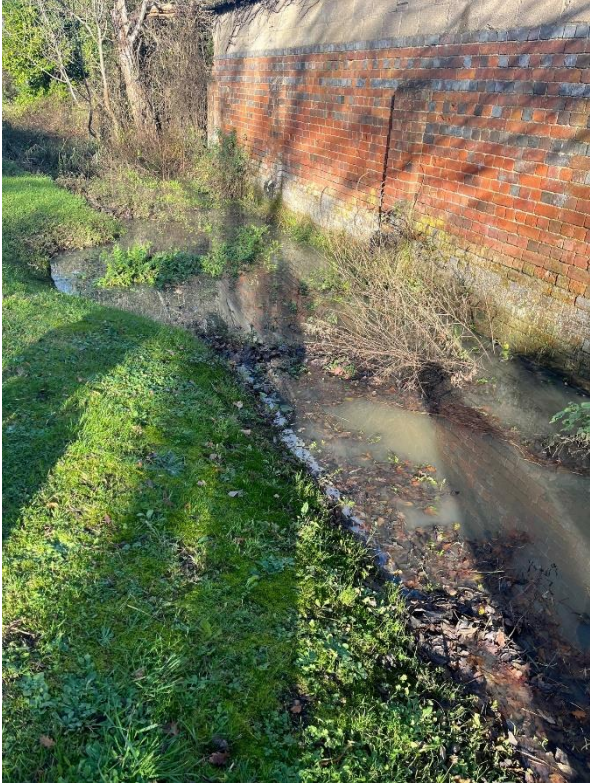
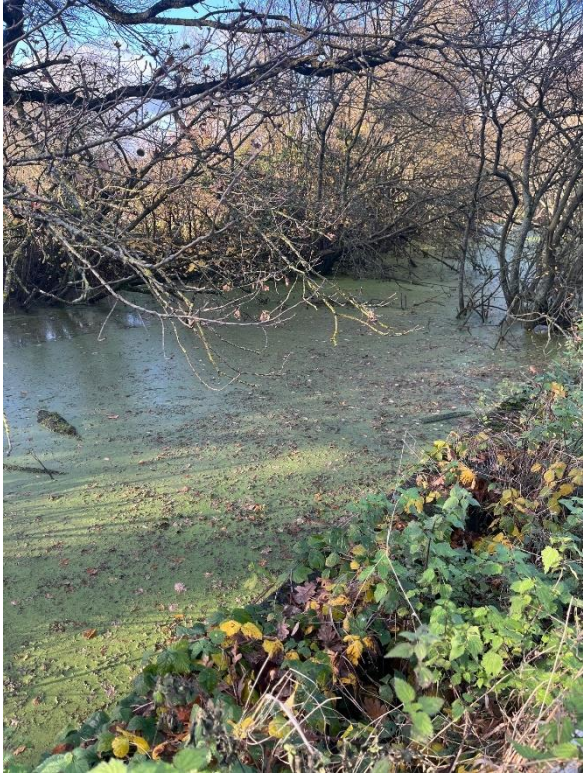
| <p>4b. Site visit - ditch downstream from culvert (taken on 28 November 2023)</p> | <p>5. Site visit – ditch on western side of Wokingham Road, north of the property (taken on 28 November 2023)</p> |

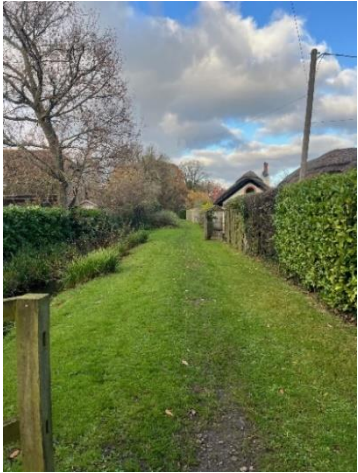
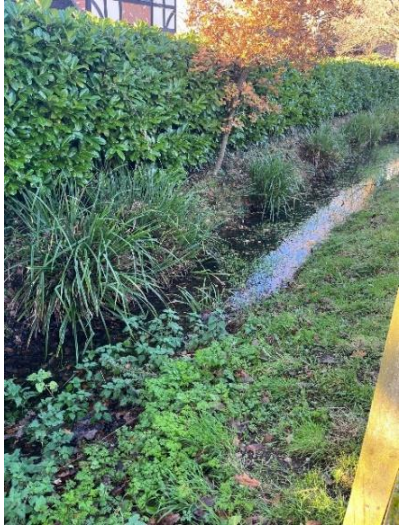
| <p>1. Footpath and ditch from the south of the property</p> | <p>2. Ditch on the western side of the property</p> |
| <p>3. Western side of property, adjacent to the footpath and ditch</p> | <p>4. Ditch on the western side of the property</p> |

Figure 8- 6: Photographs of the property and surrounding ditch taken on 28 November 2023

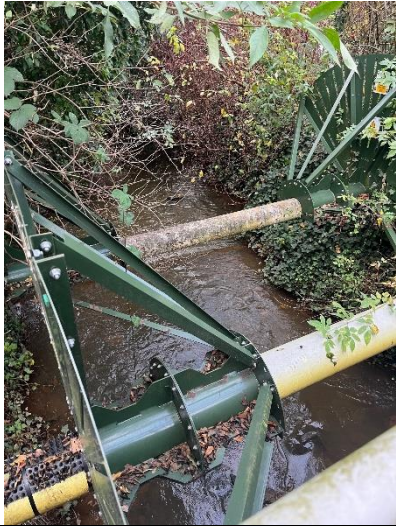
| <p>1. The Emm Brook River flowing eastward alongside the property</p> | <p>2. Footpath with a shallow ditch southwest of the property</p> |
| <p>3. River level gauge station located southeast of the property</p> | <p>4. The Emm Brook river from the bridge on Finchampstead Road</p> |

Figure 8- 8: Photographs of the property in Wokingham and surrounding area taken on 28 November 2023

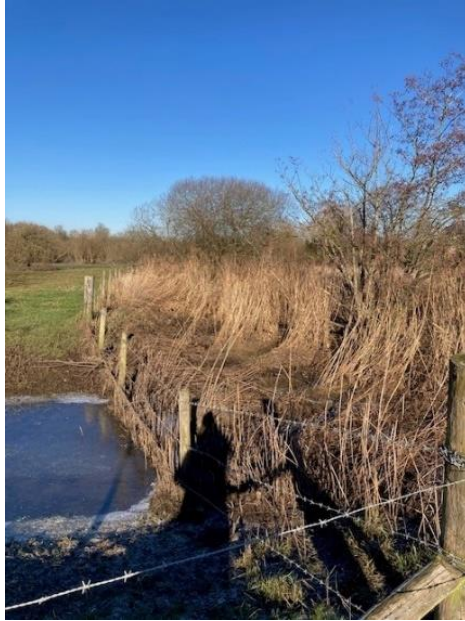
Twyford Brook severely restricted (January 2024)

One of the suggestions of the report prepared by landowners is the importance of maintaining flow in the Twyford Brook. The report recommends that all obstructions within the Twyford Brook, especially from the A321 (Hurst Road) bridge to Twyford station, to prevent water backing up towards Hurst should be cleared. This Section 19 reiterates the importance of this as the Twyford Brook will play a key role in allowing flows from watercourses upstream to be discharged.

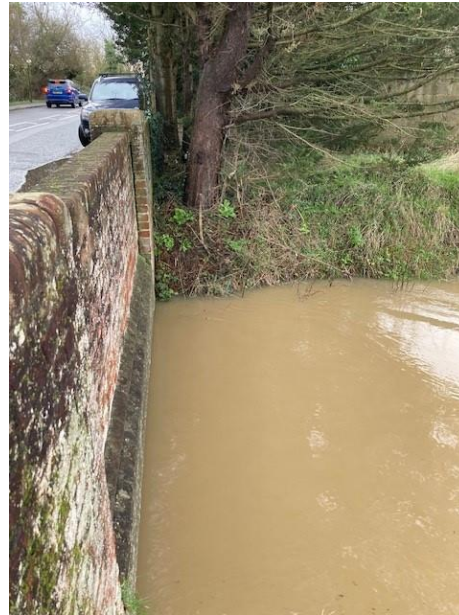
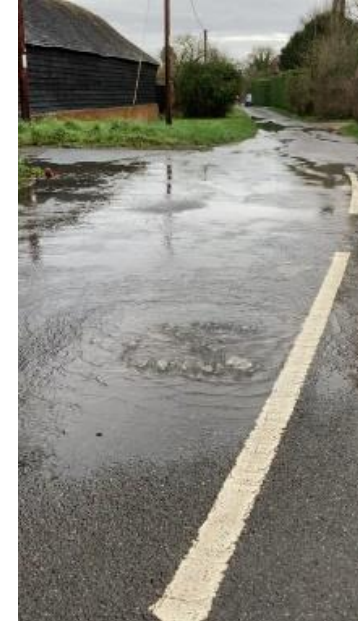
4. **Thames Water:** It is widely recognised that Thames Water's pumping station is woefully inadequate for the job, resulting in drains overflowing and adding to the flooding issues in Hurst. Therefore, WBC should deal with Thames Water to find a resolution for this problem.

Thames Water pumping station ineffective
