## **APPENDIX 14.1 - PRIOR'S FARM PHASE 1 REPORT**

**Phase I  
Geo-Environmental Site Assessment**

**Land at South Wokingham, Old Wokingham Road,  
Wokingham, RG40 3BQ**

***Omnia ref: A11866/1.1***

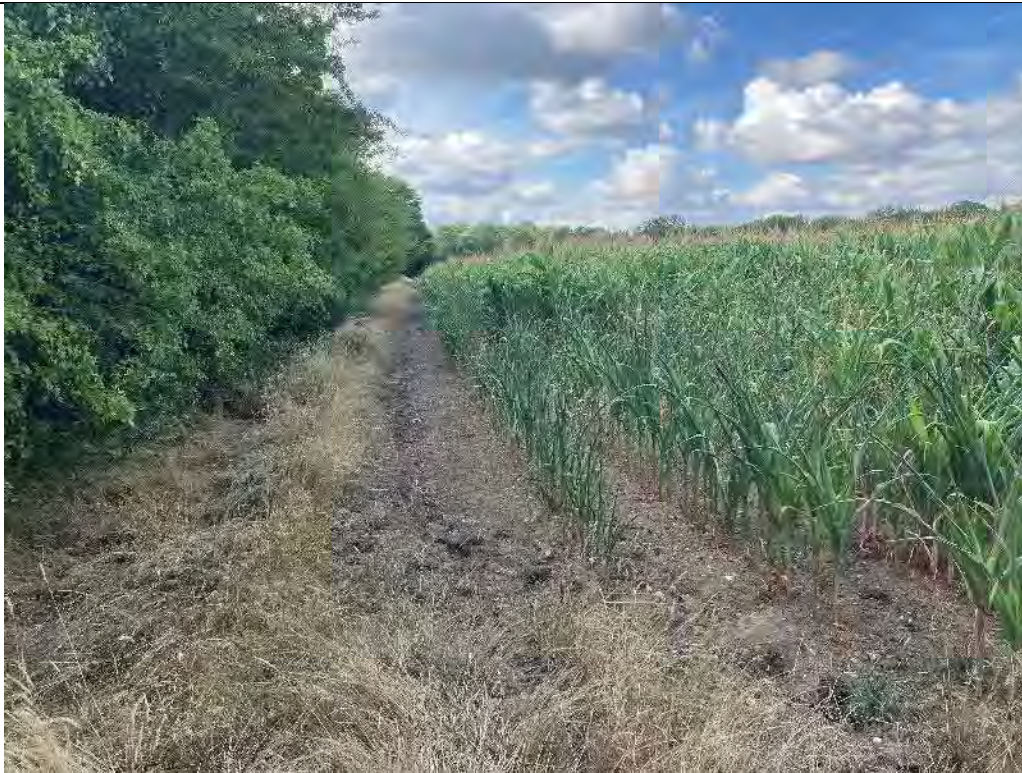
At the time of the site walkover, Area 1 largely comprised corn fields which contained crops approximately 1.0 to 1.5m in height (Photograph 1). Along the southern boundary was a stream, which flowed in an east to west direction at a medium speed. The stream was bordered by trees and dense bushes and was approximately 1.5m wide at its widest point (Photograph 2).

Photograph 1 – Corn fields within Area 1 (facing south)

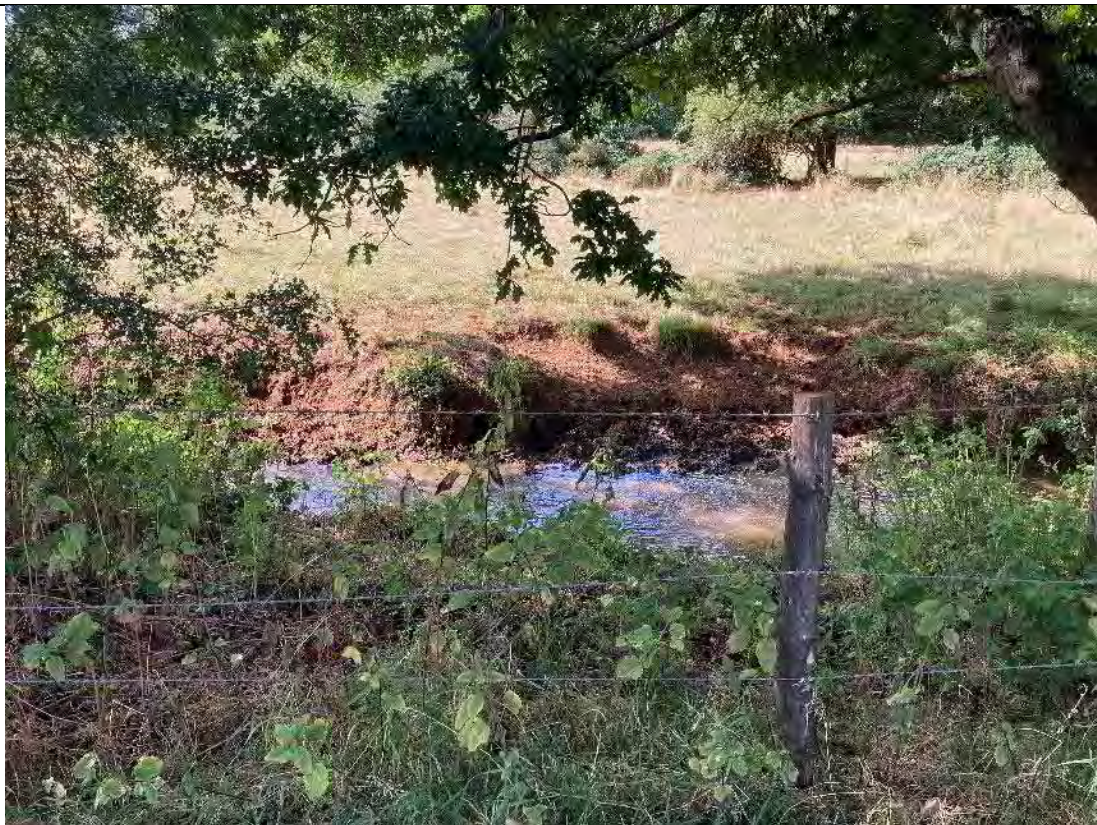
Photograph 2 – Watercourse located on the southern boundary of Area 1, flowing west to east (facing south)

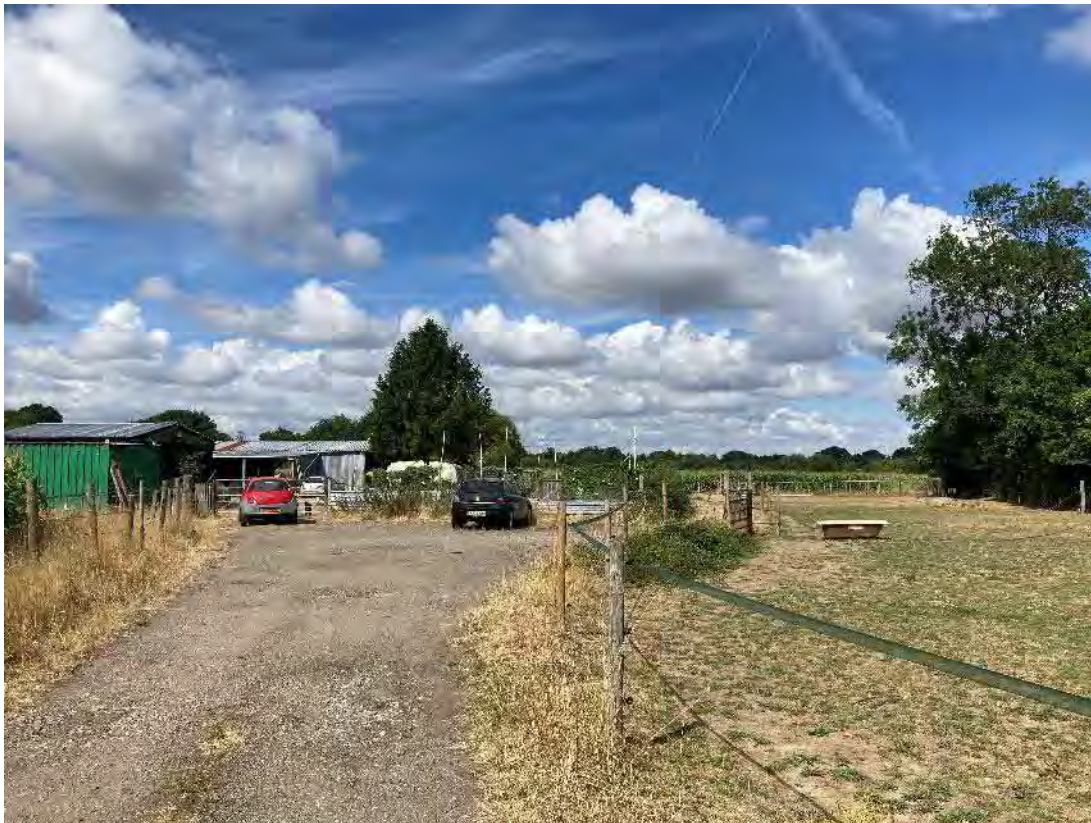
An access track ran west from the access gate towards a private yard and paddock area (Photograph 3). The area to the northeast of the access track comprised a small parcel of land, which contained a boat, trailer, sporadic pieces of farming machinery and a bathtub (Photograph 4).

Photograph 3 – Access track leading to private yard area within Area 1

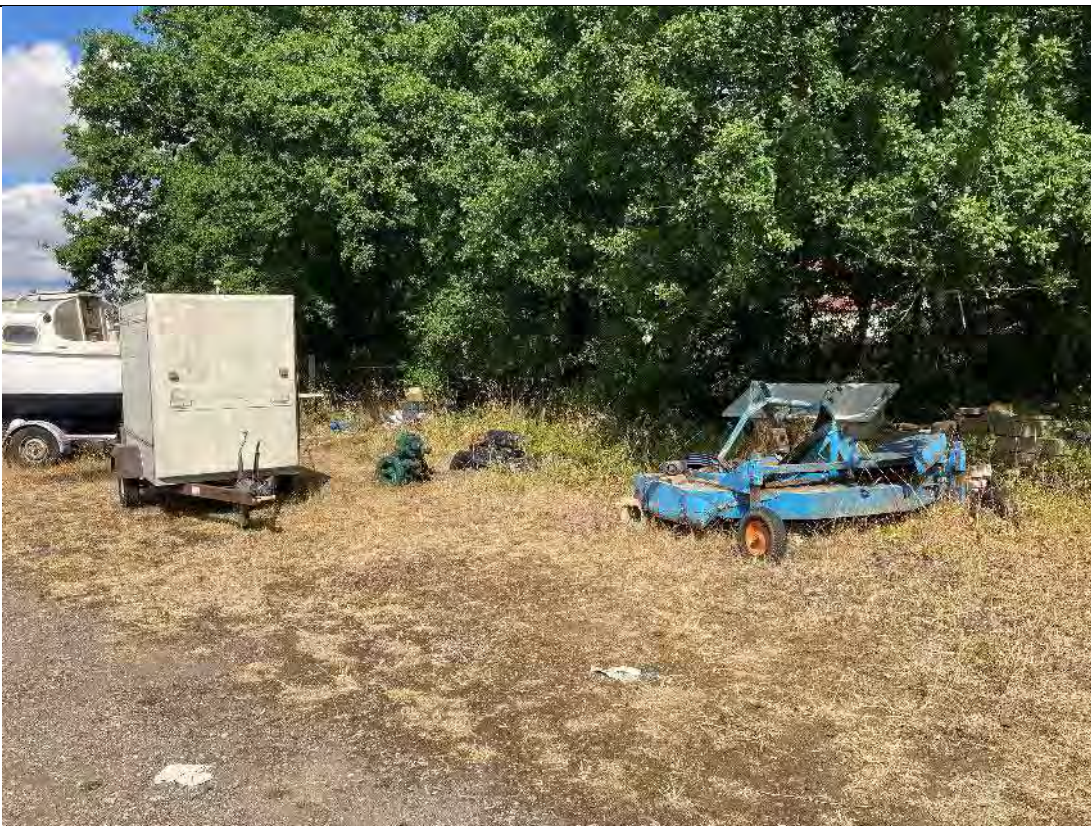
Photograph 4 – Area north of the access track within Area 1

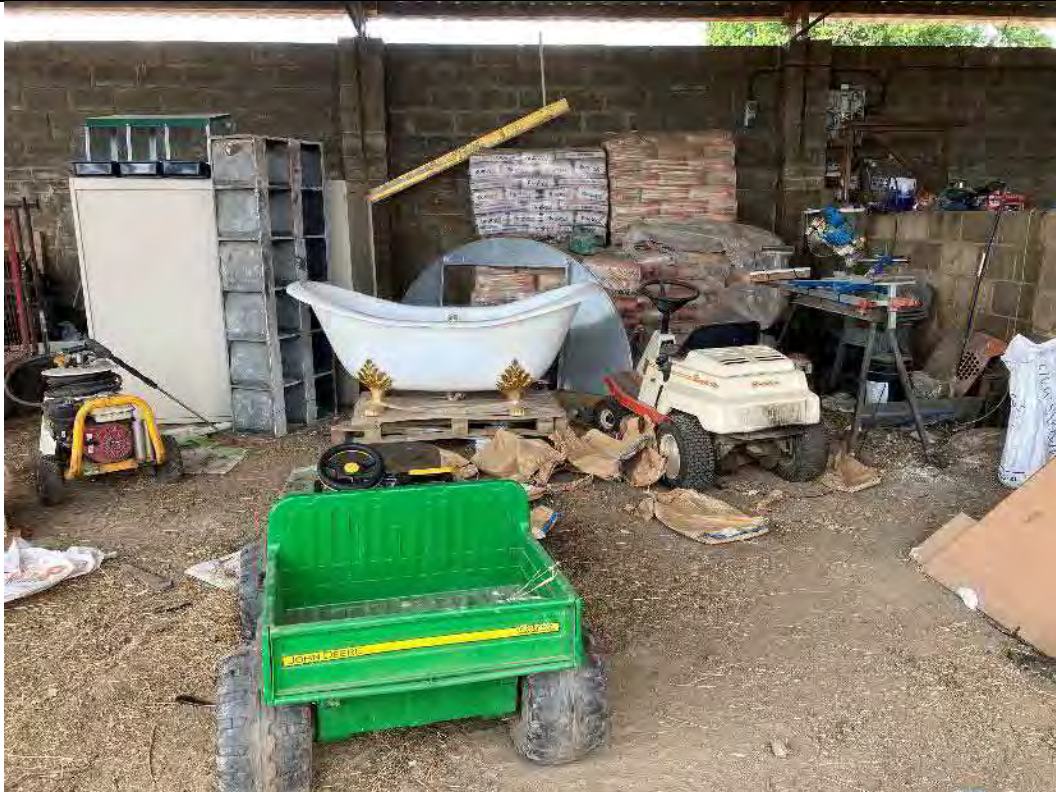
Barn 1 (Figure 3.3) was constructed out of a steel frame, with metal sheet roofing and a concrete floor. The barn appeared to be in good visual condition within no obvious Potential Asbestos Containing Materials (PACM) noted within its construction. Internally the barn was used for storage of building materials and various farm and household items (Photographs 7-8). Of note were two (2no.) 25L metal jerry cans (no labels but assumed to contain fuel), a plastic 25L container of 'Concentrate degreaser/parts washer fluid' and two (2no.) Calor Gas propane 19kg containers. A small area of this barn (approximately 1/3 of the barn size) was fenced off and contained hay, which was assumed to house animals.

Photograph 7 – Internal area of Barn 1

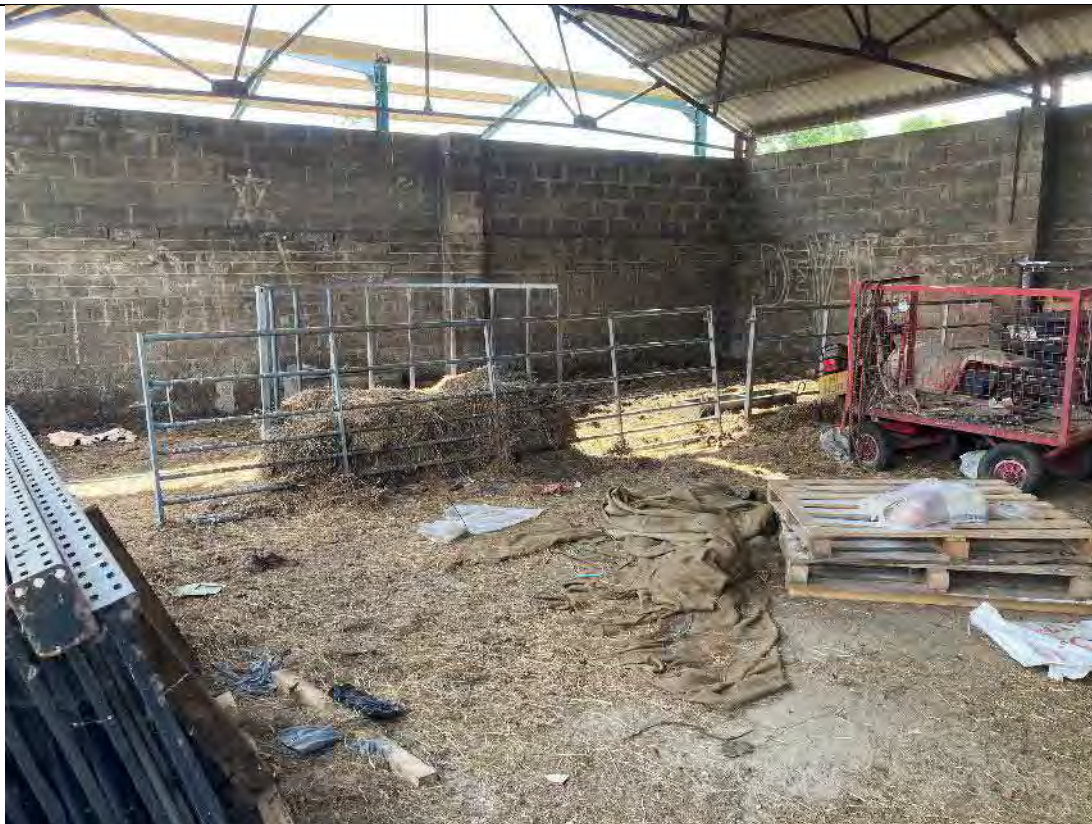
Photograph 8 – Internal access of Barn 1

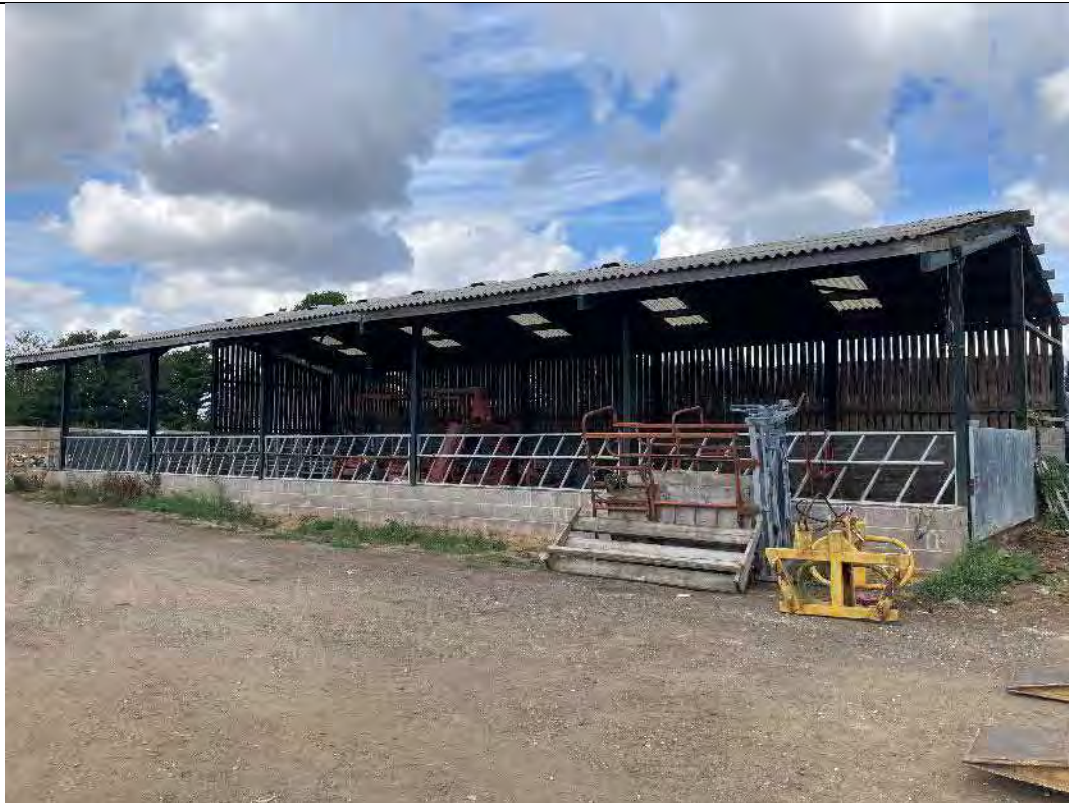
Barns 2 and 3 (Figure 3.3) were partially open barns, both constructed out of steel frames with wooden panelling, metal roofing and a concrete floor (Photograph 9-10). Both barns appeared to be in good visual condition within no obvious Potential Asbestos Containing Materials (PACM) noted within their construction. The barns were both used to store various machines, including mini-diggers, tractors and farming machinery. No spillages or visual signs of vehicle leakages were noted during the walkover from the machines and vehicles.

Photograph 9 – External view of Barn 2 (facing southwest)

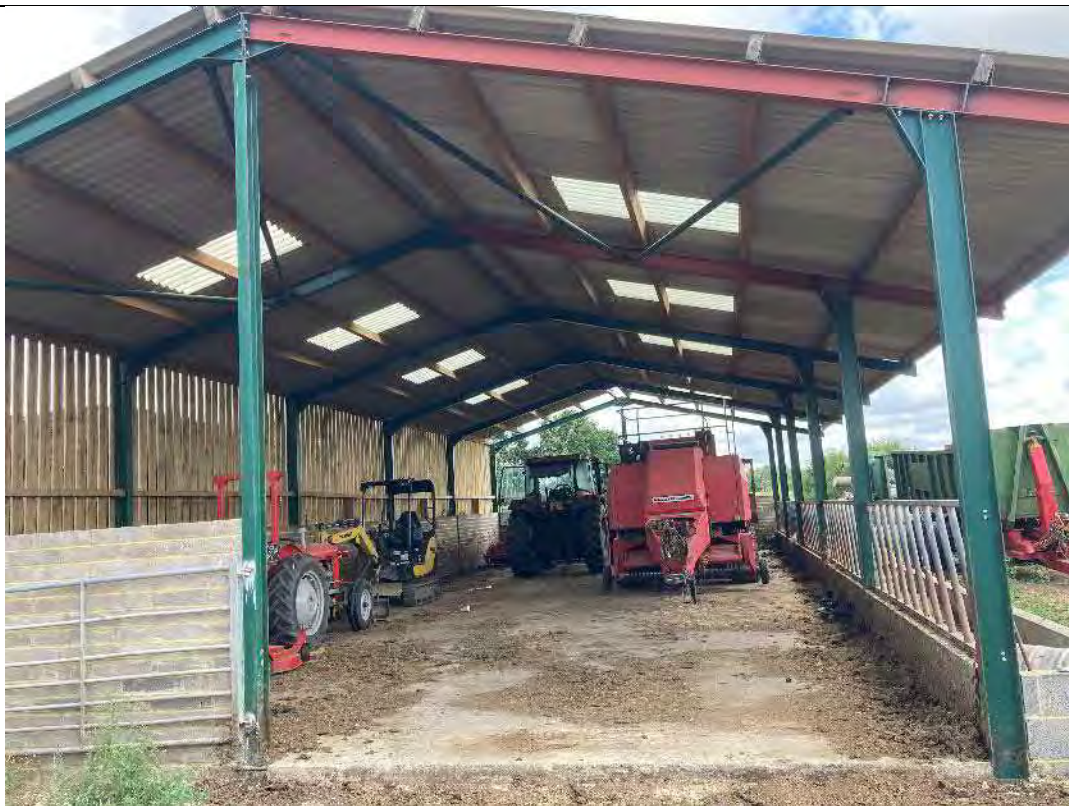
Photograph 10 – Barn 3 used for vehicle storage (facing south)

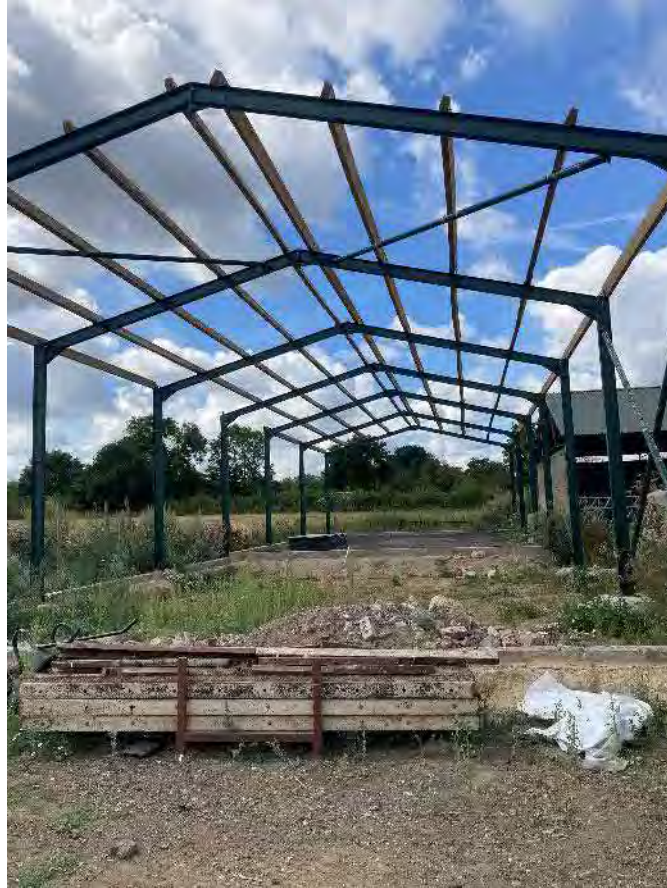
A fourth barn was in production at the time of the walkover, with the metal frame constructed (Photograph 11).

Photograph 11 – Construction of a fourth barn within Hambridge Farm (facing south)

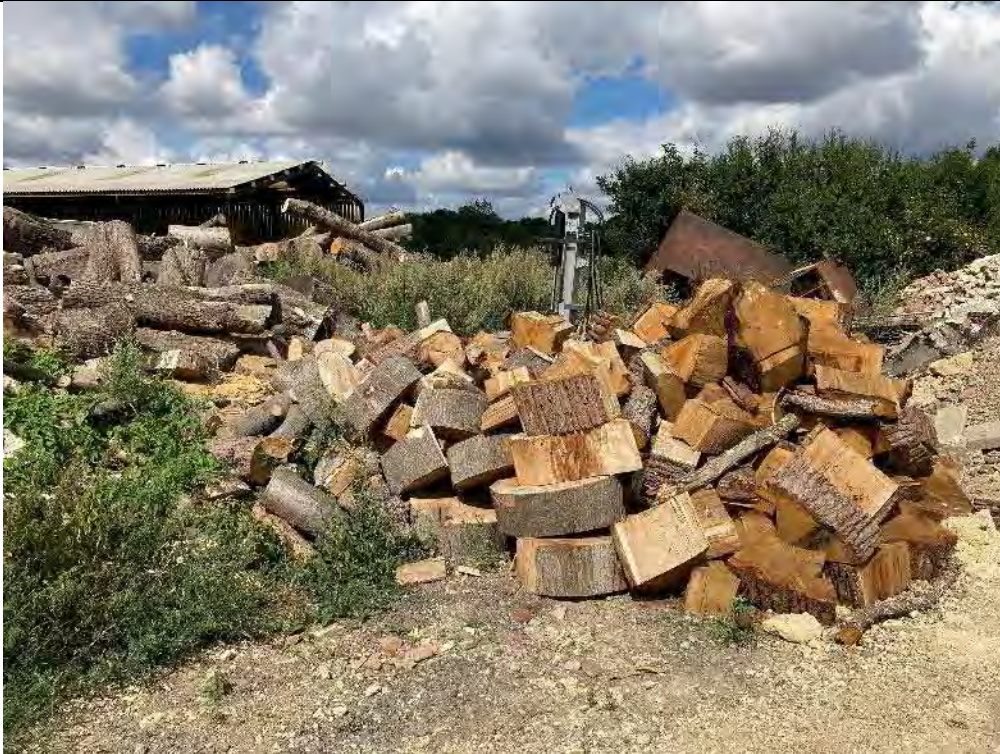
Stockpile 2 was approximately 3.0 x 10.0 x 8.0m (h x l x w) in size, which contained logs and tree stumps (Photograph 13).

Photograph 13 – Stockpile 2 within Area 2

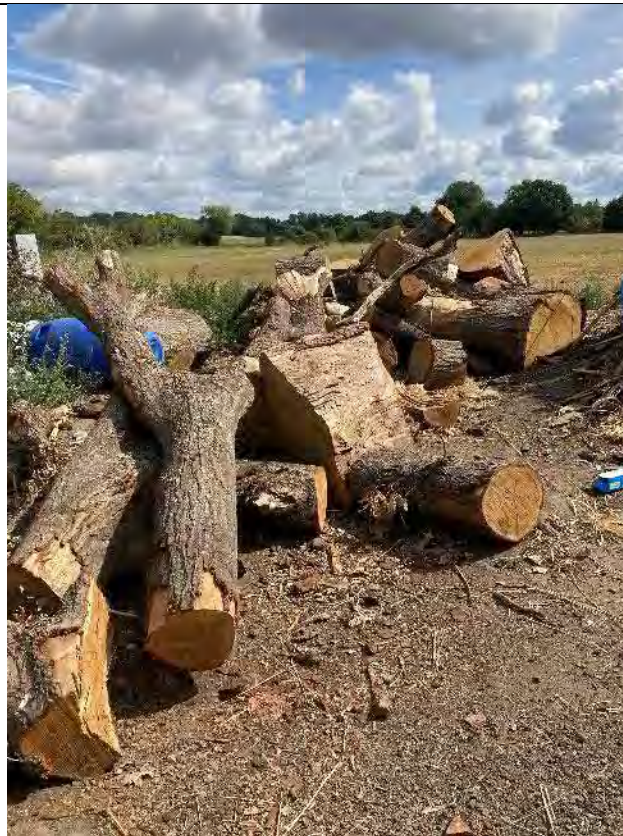
Stockpile 3 was approximately 3.0 x 5.0 x 4.0m (h x l x w) in size, which contained logs and tree stumps (Photograph 14).

Photograph 14 – Stockpile 3 within Area 2

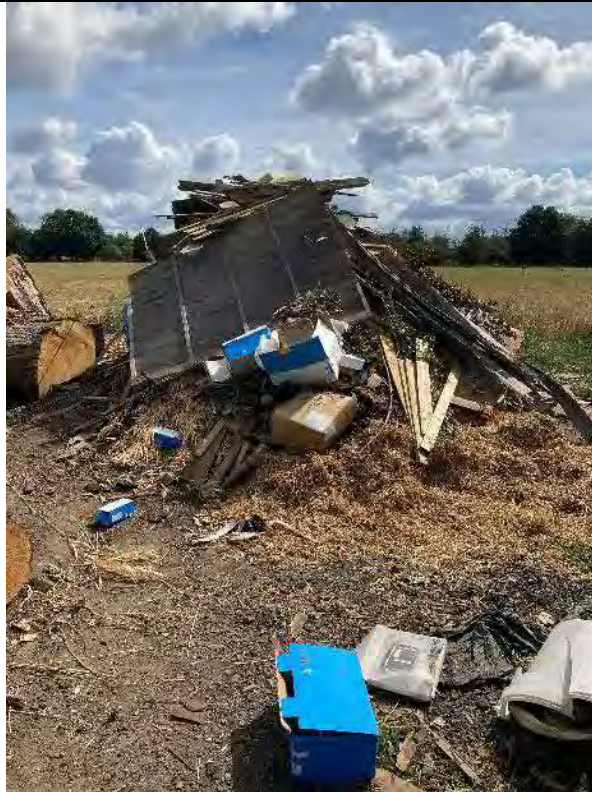
Stockpile 4 was approximately 4.0 x 6.0 x 6.0m (h x l x w) in size, which contained a mixture of materials and waste including hay, wood, wooden panelling, cardboard, plastic bags with unknown contents and vegetation (Photograph 15).

Photograph 15 – Stockpile 4 within Area 2

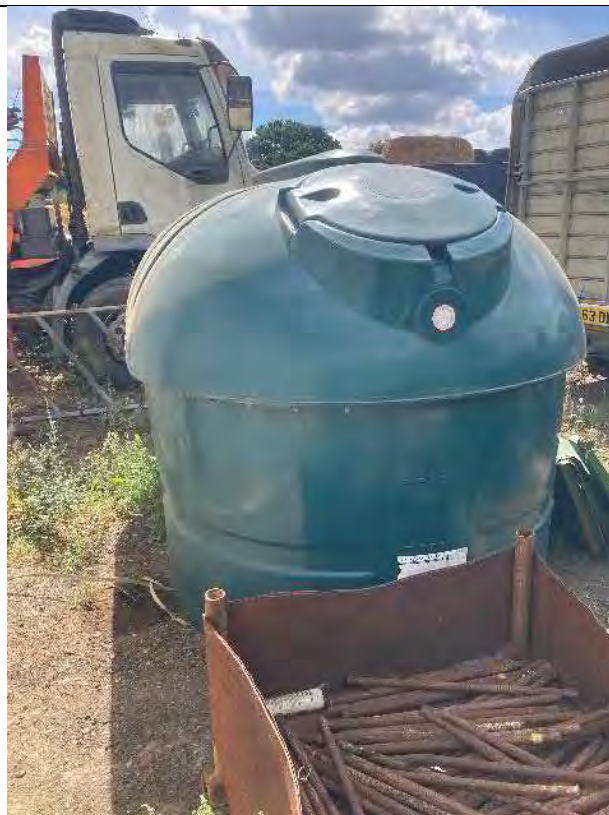
Two (2no.) tanks were situated within the farmyard area. Tank 1 was an approximately 2,000L capacity 'Balmoral Tanks' green plastic self-bunded fuel tank, situated east of Barn 3 (Photograph 16). A faint fuel-like odour was noted when in close proximity, and a small dark grey stain (approximately 0.30m diameter) was noted on the ground on the northern side of the tank. It was not confirmed whether this odour and stain were related to the tank.

Photograph 16 – Tank 1 (bunded fuel tank) adjacent to Barn 3 (facing south).

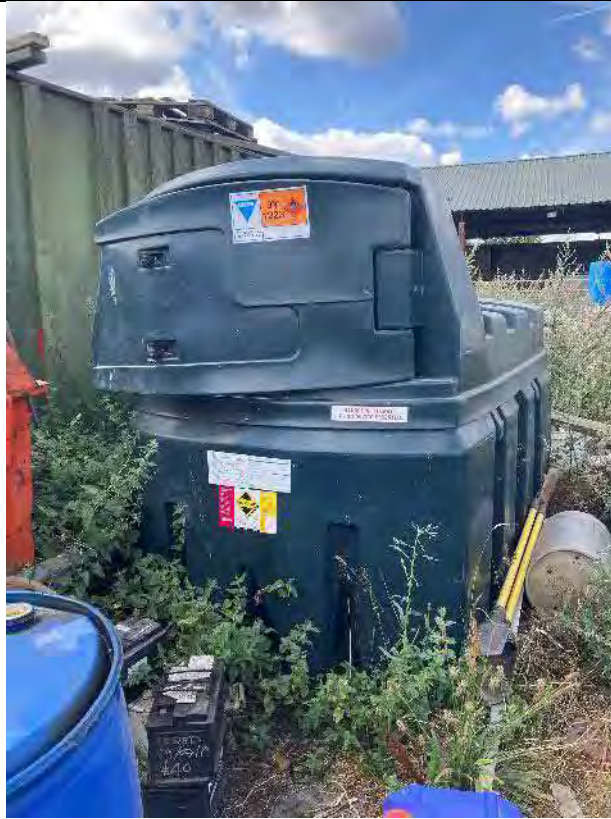
Photograph 17 – Tank 2 containing Kerosene located south of Barn 1 (facing north)

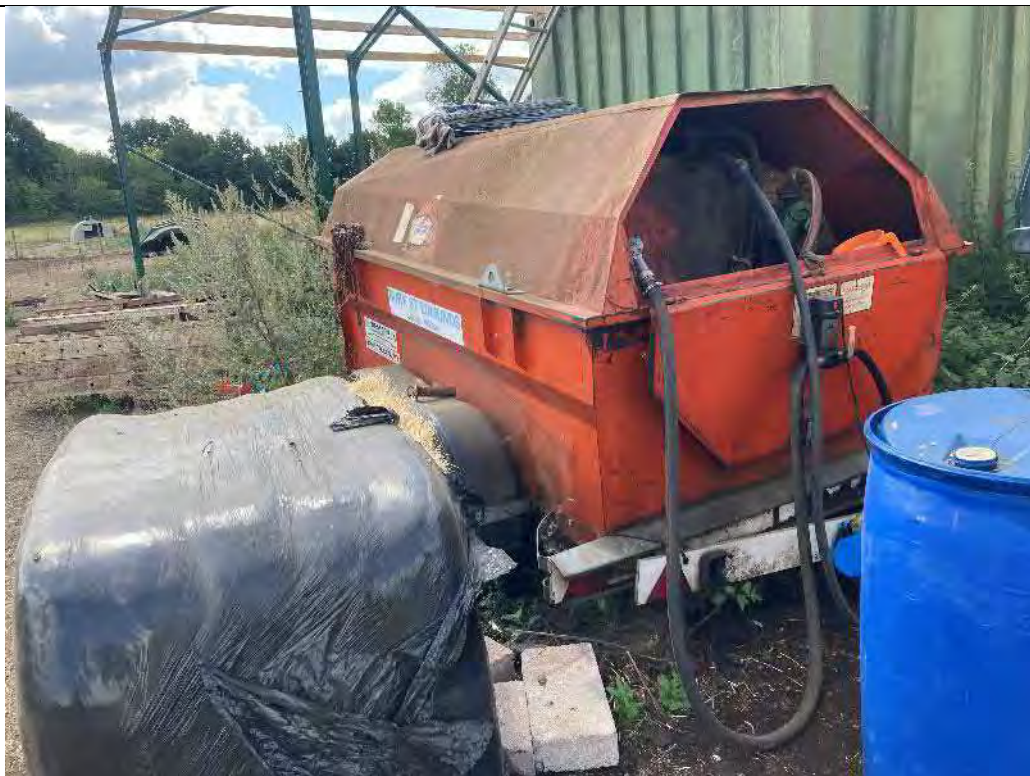
In addition, an orange, 2,000L portable fuel bowser (Western Bunded Refueller) was situated next to Tank 2 (Photograph 18). No visual or olfactory evidence of spillages or leaks surrounding Tank 2, or the portable fuel bowser were noted during the walkover.

Photograph 18 – Portable fuel bowser situated south of Tank 2 (facing east)

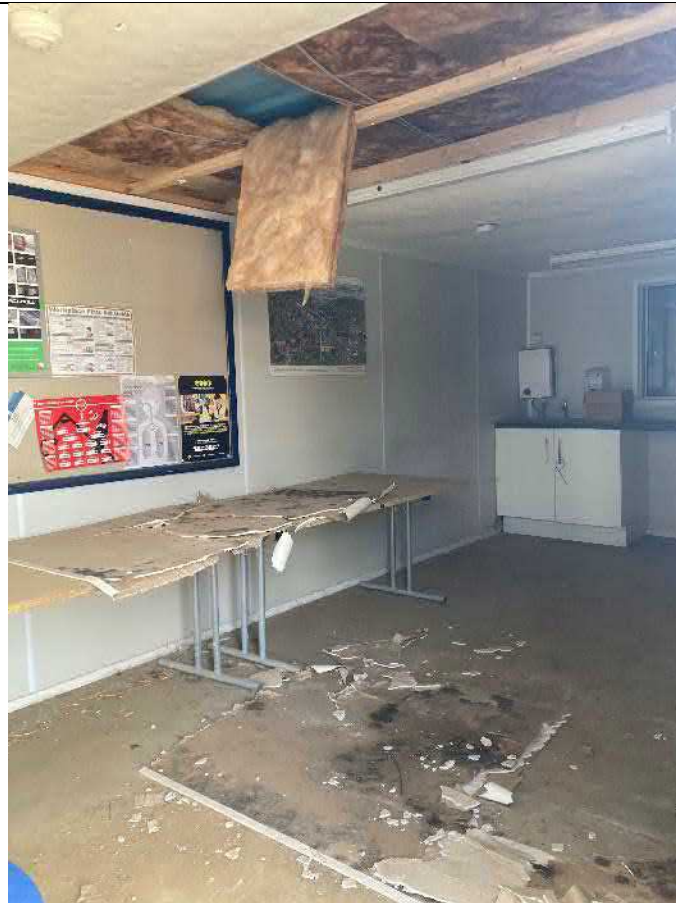
Three (3no.) metal shipping containers were situated within the farmyard area. Access into two of these was not possible, however the third (situated northeast of Tank 2) was comprised as a dis-used site office in a poor state of repair (Photograph 19). The internal wooden roofing and insulation had fallen into the main space of the container, and there was visual evidence of damp.

Photograph 19 – Internal area of the open metal container within Area 2

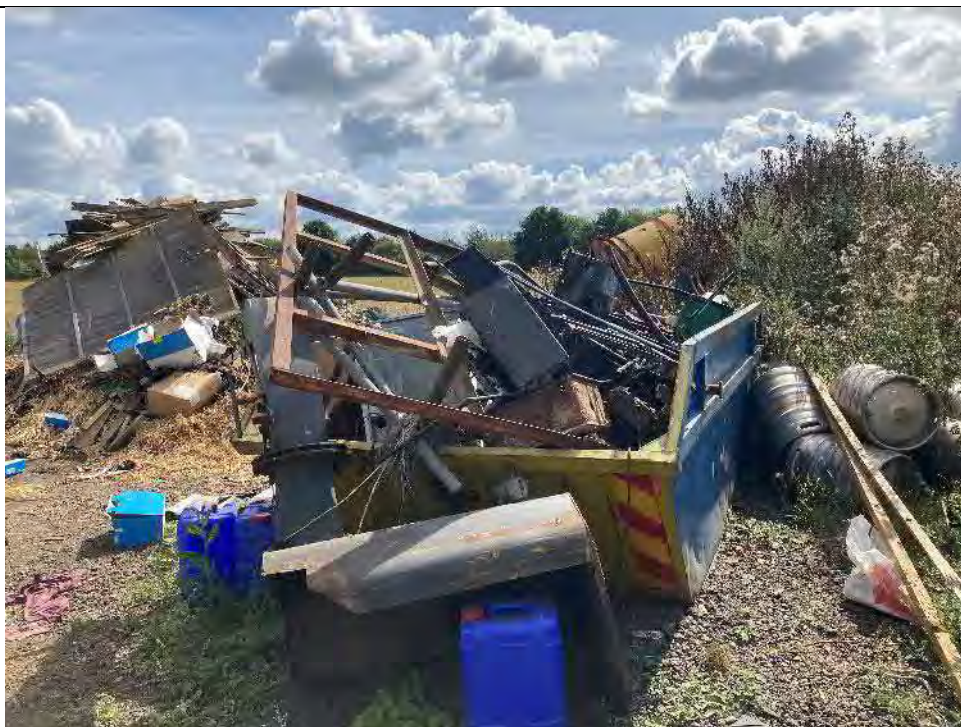
A 6-yard skip was located south of Stockpile 4, which appeared to be used for mixed waste. A visual inspection showed the skip contained wood, plastic, various pieces of metal and building materials (Photograph 20).

Photograph 20 – 6-yard skip within Area 2

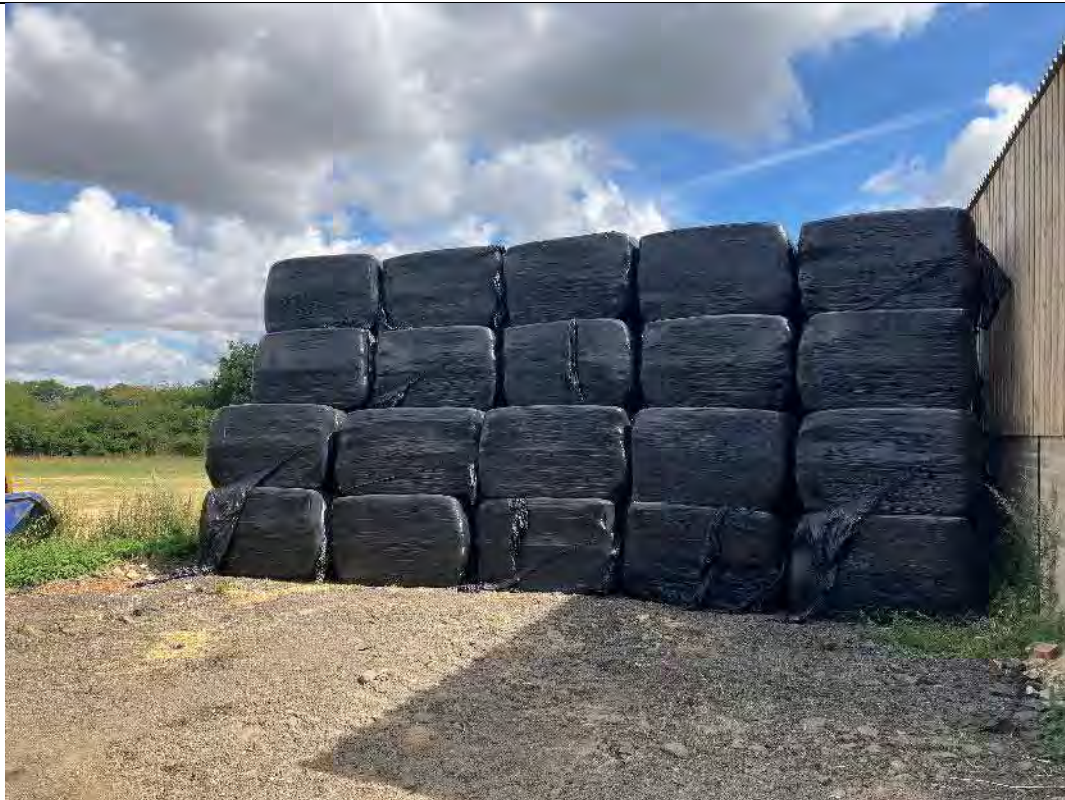
The farmyard area west of Barns 2 and 3 was used for wrapped, baled hay storage (Photograph 21).

Photograph 21 – Hay storage within the western extent of the farmyard in Area 2 (facing north)

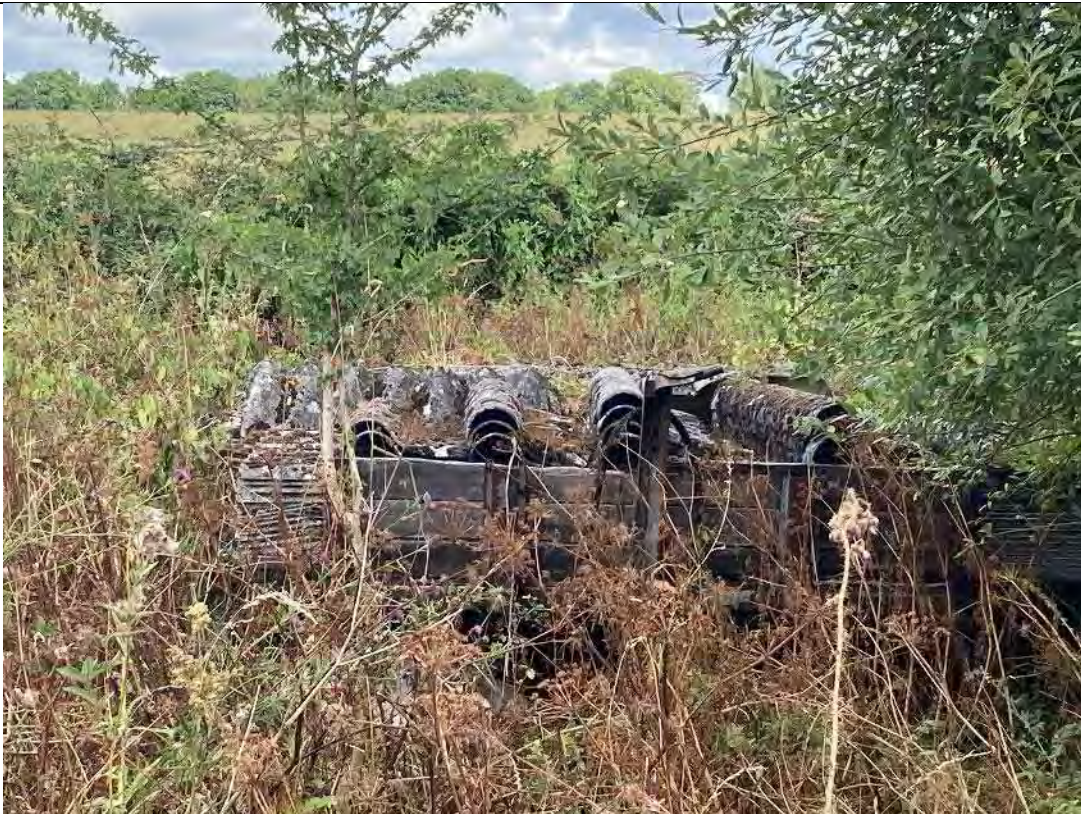
An inspection of the yard area within Area 1 was not undertaken, however corrugated cement roofing sheets were observed from a distance, which are considered to have the potential to contain Asbestos. PACM corrugated sheeting and tiles were also identified within the northeastern corner of Area 2.

Photograph 25 – PACM tiling within a trailer located in the northeast corner of Area 2

It is therefore recommended that an asbestos survey is undertaken in accordance with the Control of Asbestos Regulations (2012) prior to the commencement of any refurbishment or demolition works within Area 1. Before moving or disposing, the PACM sheeting and tiles within Area 2 should also be inspected.

It is recommended that an asbestos survey is undertaken in accordance with the Control of Asbestos Regulations (2012) prior to the commencement of any refurbishment or demolition works within Area 1. Before moving or disposing of the PACM sheeting and tiles within Area 2 these should also be inspected.

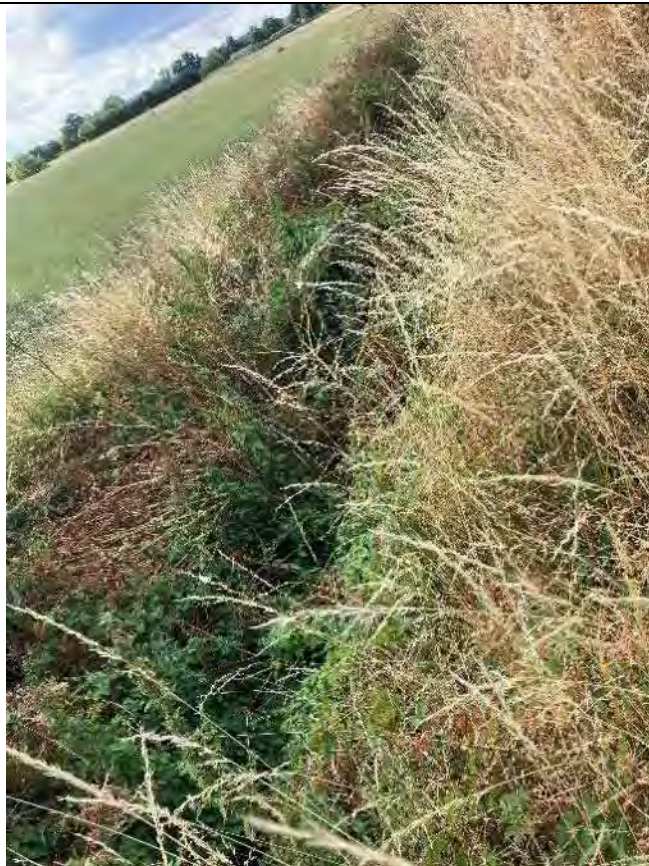
Photograph 30 – Inland watercourse trending north to south within Area 3 (facing south)

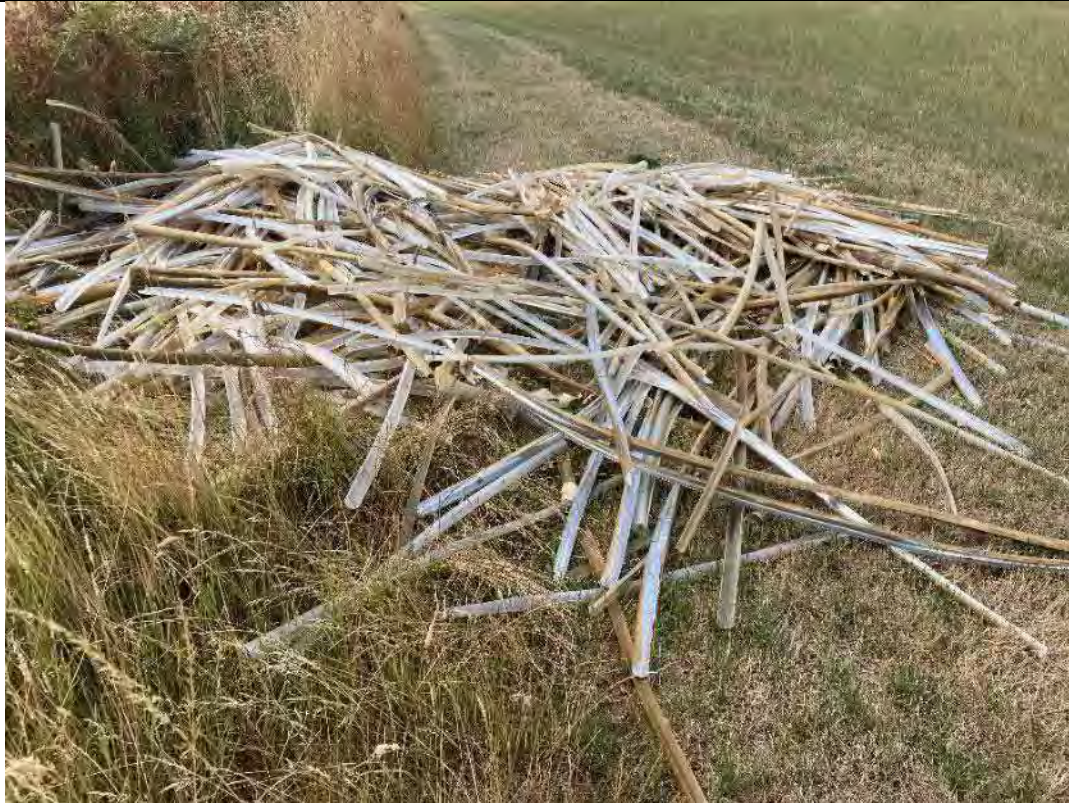
Within the northeast corner of the northern-most field of Area 3 was a pile of plastic tubing adjacent to the stream (Photograph 31). This was approximately 4.00 x 4.00 x 0.30m in size.

Photograph 31 – Pile of plastic tubing within agricultural field of Area 3.
