## **PRELIMINARY ECOLOGICAL APPRAISAL (DBW) AT 3 GARDE ROAD SONNING**

**Ref: SPH/NP/PEA-25/02.09**

Urban Tree Experts was commissioned by Mr E Hamed to conduct a preliminary ecological appraisal (daytime bat walkover [DBW]) of 3 Garde Road, Sonning, Reading, RG4 6XJ. This is to support a forthcoming planning application to Wokingham Borough Council.

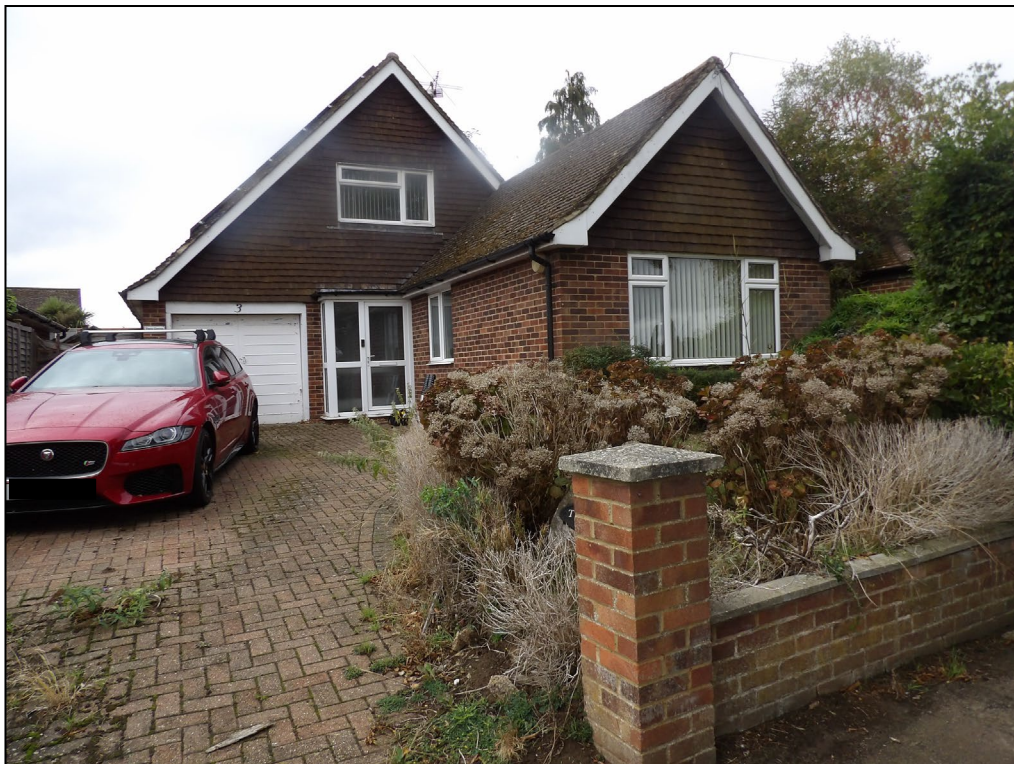
The application site comprises a detached, brick-built property with integral garage and paved driveway/parking area, lawn and shrubs at the front, see cover photograph. The rear garden mainly consists of perennial weeds with remnants of herbaceous plants, see Figure 3 below. The site itself offers limited foraging and commuting habitat for bats however there is direct ecological connectivity to the wider landscape that provides good habitat for foraging and roosting bats.

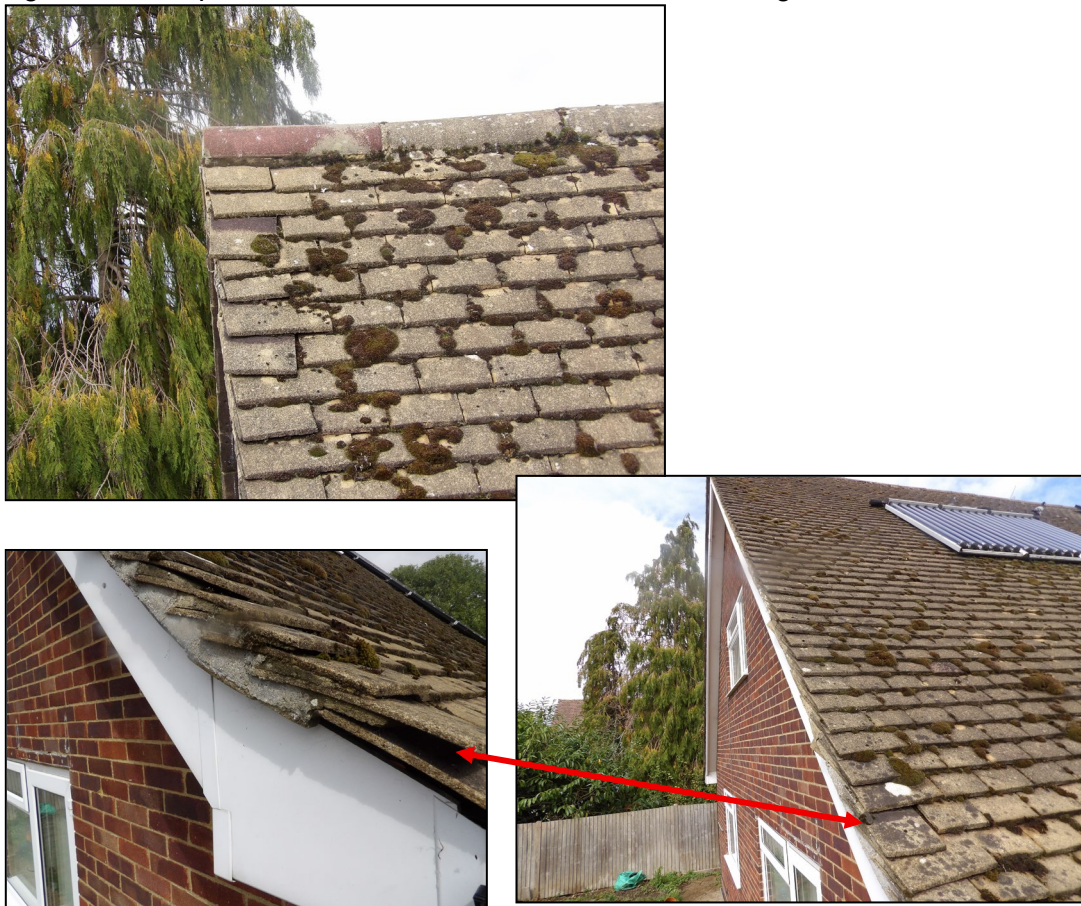
Figure 4. Examples moved roof tiles. 3 Garde Road, Sonning. 02.09.25

The property is a detached, chalet style, brick-built building with single storey front extension and integral garage. The pitched roofs are covered in tiles, the majority of which are close fitting however, on the rear, some tiles have moved leaving gaps that could be exploited by crevice dwelling bat species, see Figure 4 below. There is no missing mortar from the ridge tiles, (see Figure 5 on page 9) however there is missing mortar from the front and rear verges which could afford roosting opportunities for crevice dwelling bats, see Figure 6 on page 9. The front gable elevations are covered in hanging tiles, some of which have moved and a couple of which are missing and, the gaps could be used by roosting bats, see Figure 7 on page 10. The soffits and fascias are tight to the wall with no gaps that could be exploited by crevice dwelling bat species, see Figure 8 on page 10. There is a dormer window on the northern elevation, the flat roof of which is covered in well fitted bitumen felt (see Figure 9 on page 11) and the sides of which are covered in hanging tiles, all of which are well fitted with no gaps, see Figure 10 on page 11.

No bats or evidence of bats were recorded during the external inspection of the property although there are various features on the property that provide potential crevice roosting opportunities for bats and the presence or absence of bats could not be established.

The property is in a good to fair condition internally and externally. The moved/missing hanging tiles and moved/raised roof tiles and missing mortar in verges provide crevice-like features suitable for bats to roost and may also provide access into the loft space and we are unable to determine the presence or absence of bats in the building without further survey effort. When the findings from the site inspection are combined with the desk top study the property is classified as having a low potential to support roosting bats.

Based on the Bat Workers Manual and the Bat Surveys Good Practice Guidelines, one dusk emergence survey must be undertaken on the property, between May and August, to establish the presence or absence of roosting bats and in order to inform appropriate mitigation for the proposed works if necessary. The features identified will require three survey positions, all equipped with bat detectors and night vision cameras in order to cover the potential bat roosting features. If bats are recorded emerging from the building during the survey, two further activity surveys and an EPSL will be required in order for the development to proceed legally.

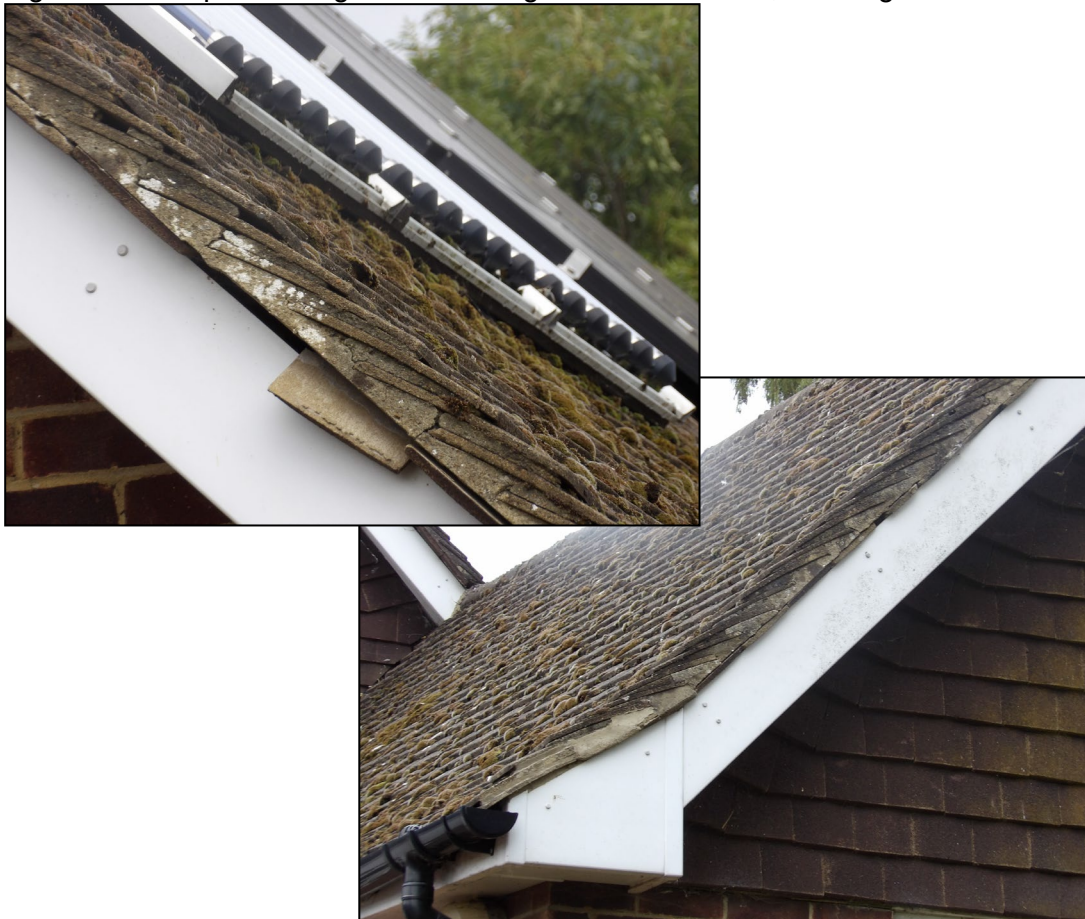
Figure 6. Example missing mortar in verges. 3 Garde Road, Sonning. 02.09.25

The properties suitability to support roosting bats was assessed and potential roost features identified during the preliminary inspection. The property is in a good to fair condition internally and externally however, there are moved/missing hanging tiles and moved/raised roof tiles and missing mortar in verges which could provide potential roosting opportunities for bats or provide access into the building for bats, and the presence or absence of bats could not be determined without further survey effort. In line with best practice guidelines, the building was assessed as having low potential<sup>1</sup> to support roosting bats.

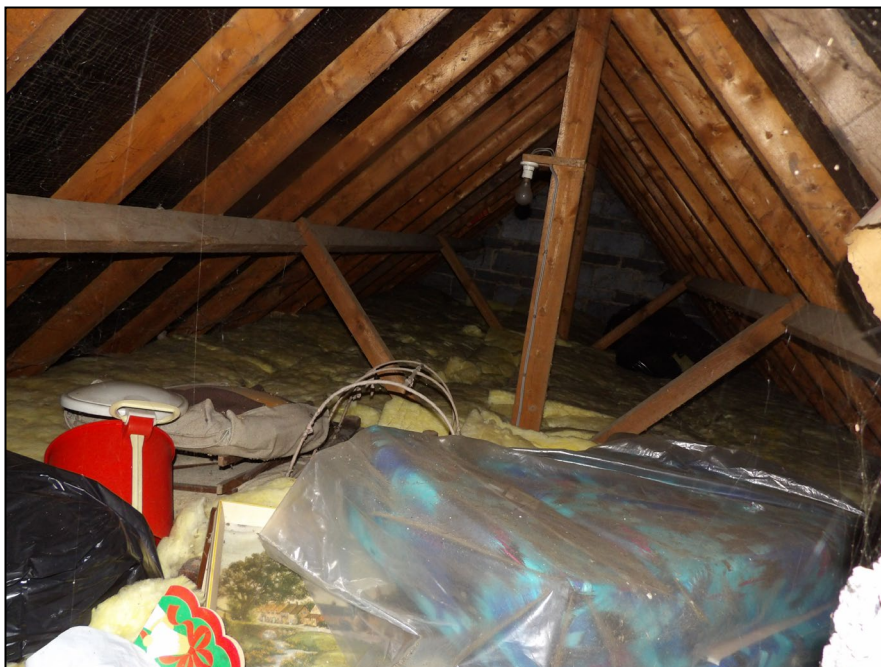
Figure 11.  
Example loft  
space above  
extension. 3  
Garde Road,  
Sonning.  
02.09.25

There are two loft spaces within the property. The space above the front extension was access via an eaves cupboard. The loft space was not lit, not boarded and is insulated, see Figure 11 below. The space in the main property was access via a loft hatch, this space was also not lit, not boarded and insulated, see Figure 12 below. The roof tiles in both lofts are lined with bitumen felt, all of which that could be seen appeared to be in a good condition.

Due to the lack of boarding and deep insulation a thorough inspection of both loft spaces could not be conducted.
