PRELIMINARY ECOLOGICAL APPRAISAL (DBW) AT ARLINGTON BASINGSTOKE ROAD, SPENCERS WOOD

Prepared for:
Rammurti Design Limited
268 Tilehurst Road
Reading
RG30 2NE

3 January 2025

Ref: SPH/NP/PEA-24/10.12

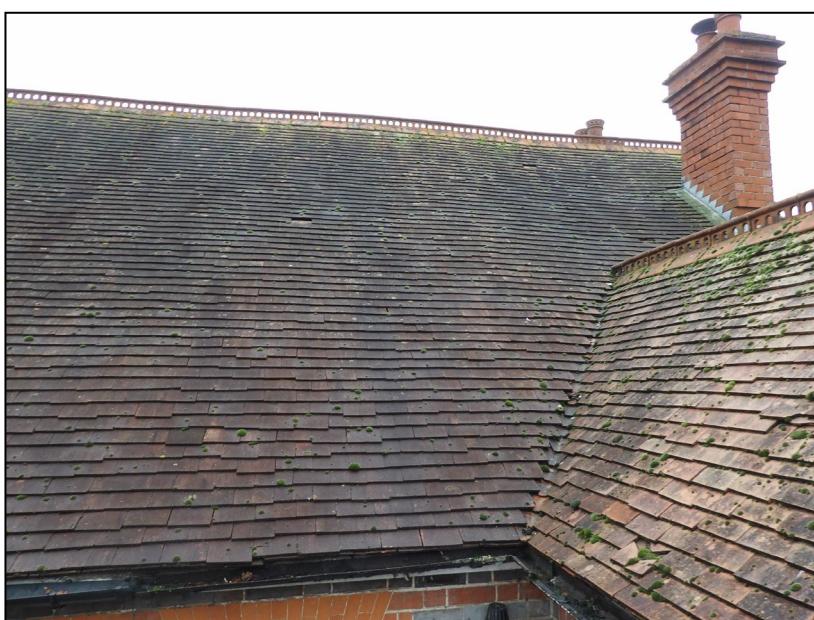
Figure 4. Example of roof tiles. Arlington, Basingstoke Road, Spencers Wood.
10.12.24

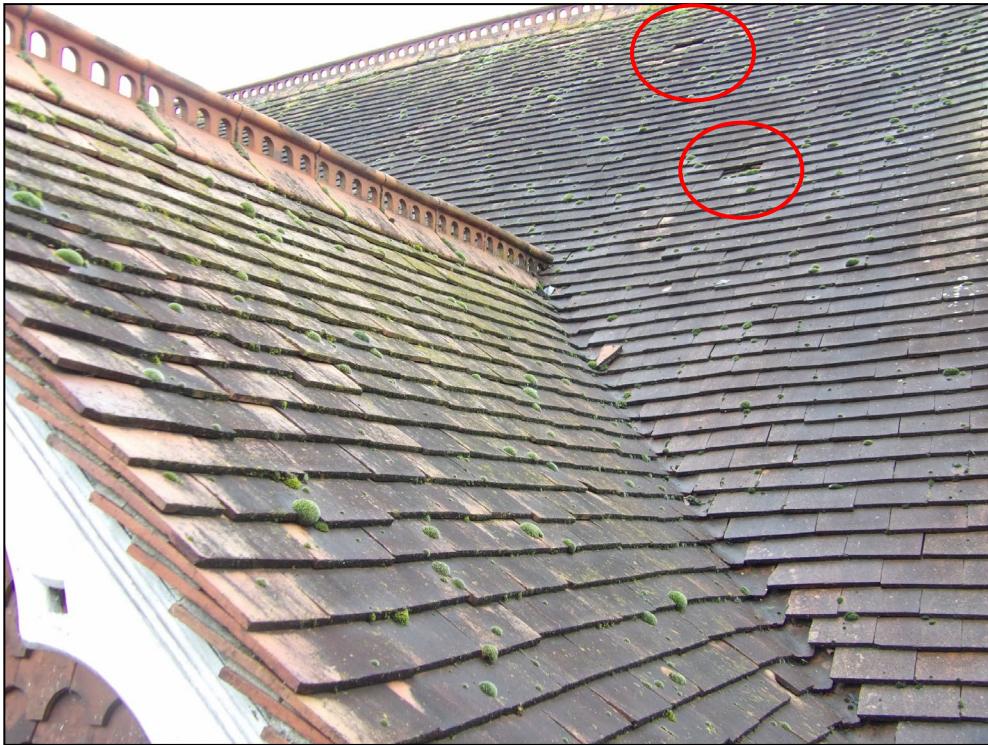
Figure 5. Missing roof/broken tiles. Arlington, Basingstoke Road, Spencers Wood. 10.12.24

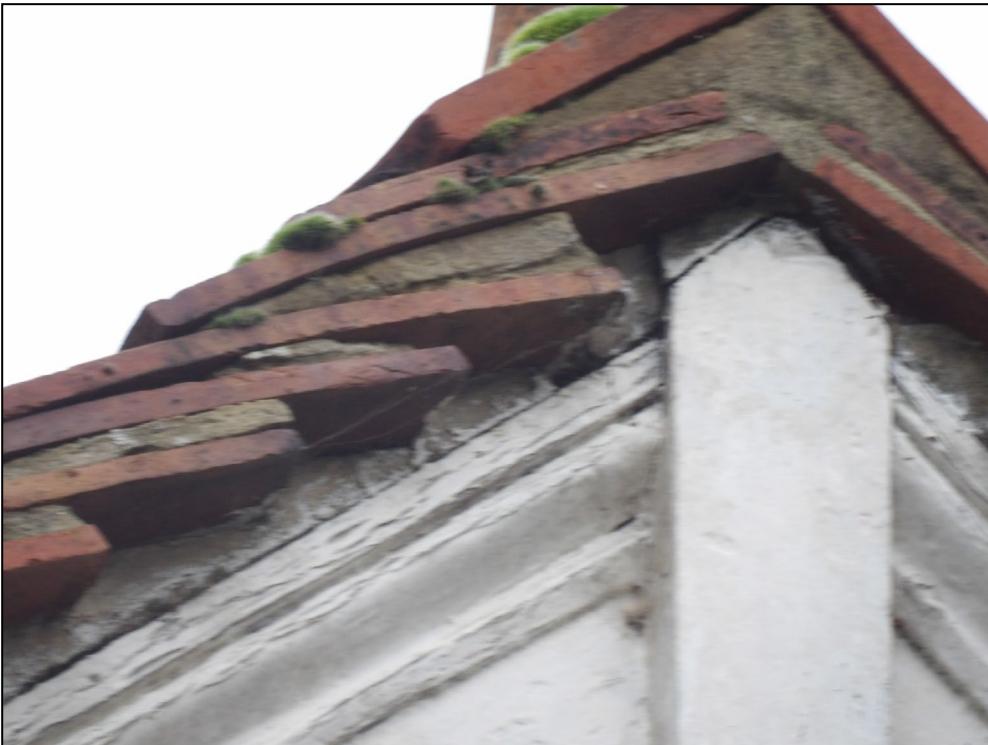
Figure 6. Well cemented verge on main property. Arlington, Basingstoke Road, Spencers Wood. 10.12.24

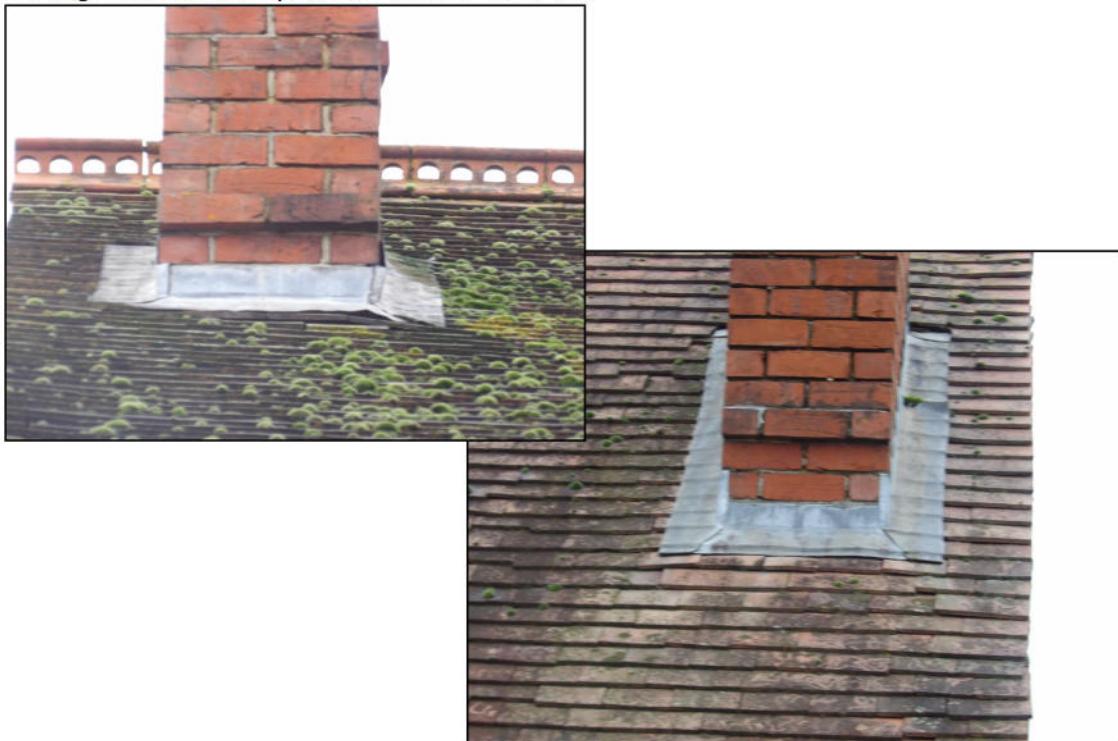
Figure 7. Example gaps in tiles/lead flashing around chimney stacks. Arlington, Basingstoke Road, Spencers Wood. 10.12.24

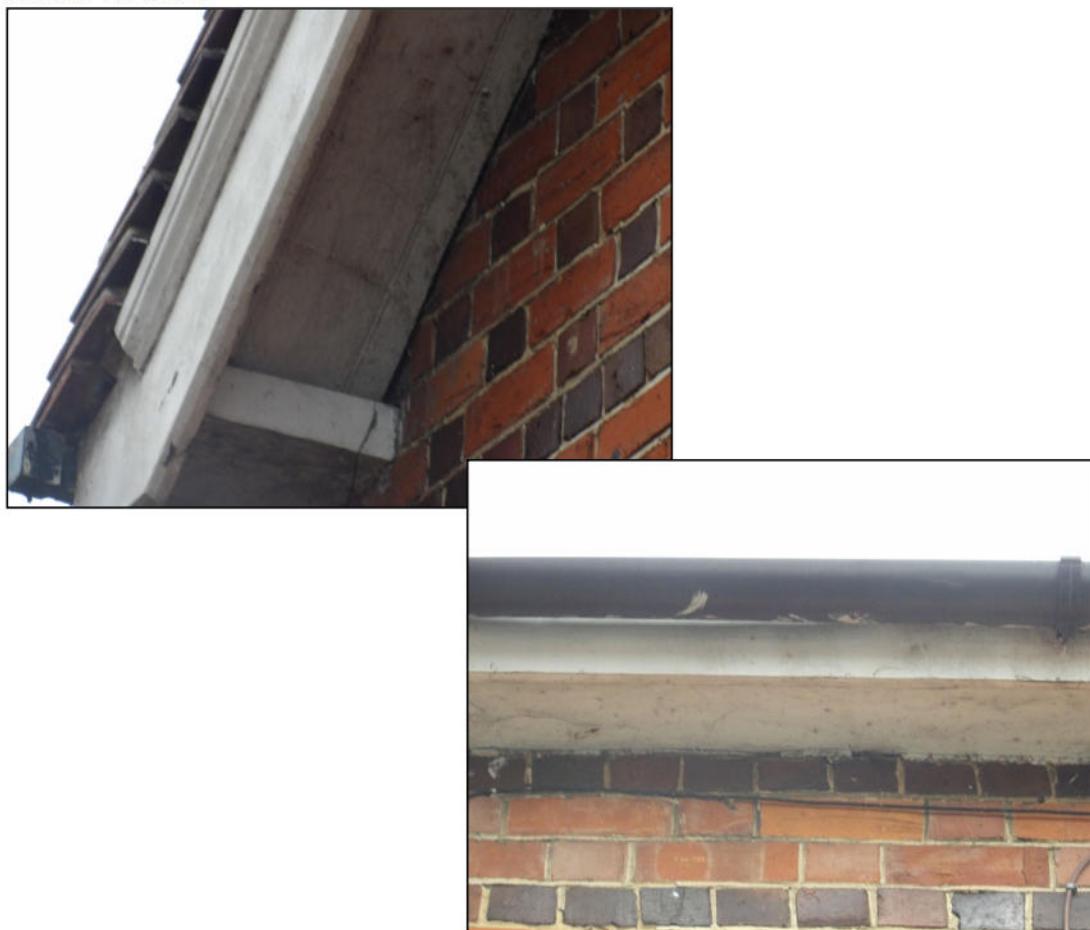
Figure 8. Example sealed soffits/fascias. Arlington, Basingstoke Road, Spencers Wood. 10.12.24

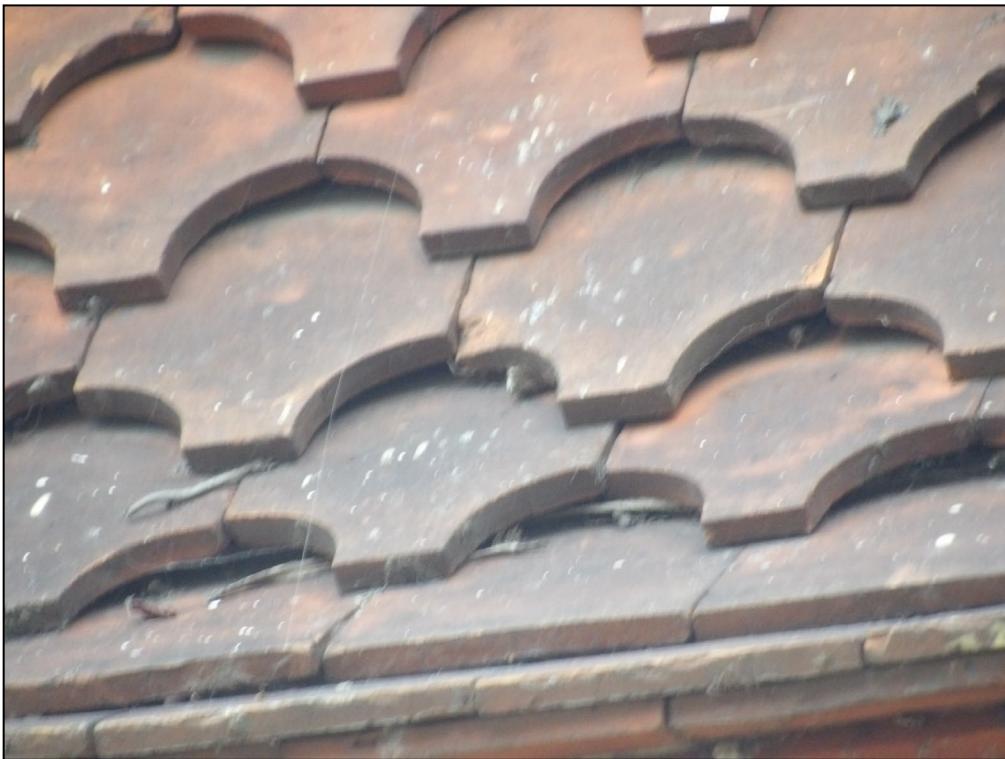
No bats or evidence of bats was recorded during the external inspection of the property or garage/utility although there were several gaps in the roof and hanging tiles and verges that could provide potential roosting opportunities or access into the building for roosting bats.

Figure 9. Example of gaps in hanging tiles. Arlington, Basingstoke Road, Spencers Wood. 10.12.24

Based on the Bat Workers Manual and the Bat Surveys Good Practice Guidelines, two dusk emergence surveys must be undertaken on the property, between May and August, to establish the presence or absence of roosting bats and in order to inform appropriate mitigation for the proposed works if necessary. The features identified will require three survey positions equipped with bat detectors and night vision cameras in order to cover all the potential bat roosting features. If bats are recorded emerging from the building during the surveys, one further activity survey and an EPSL will be required in order for the development to proceed legally.

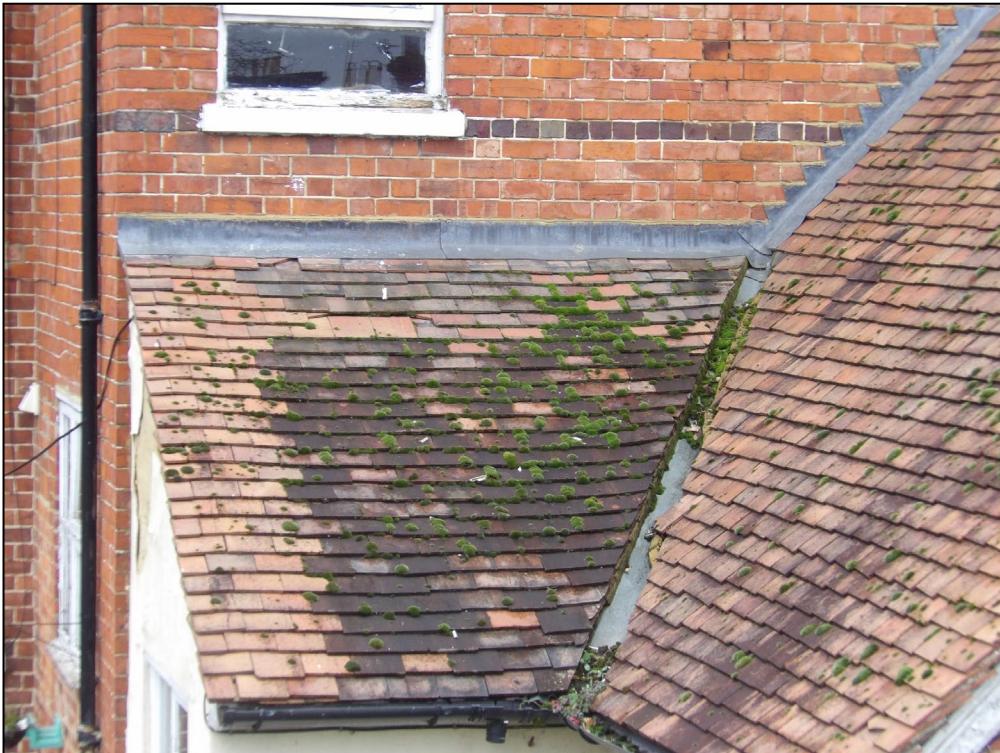
Figure 11. Broken roof tiles rear extension. Arlington, Basingstoke Road, Spencers Wood. 10.12.24

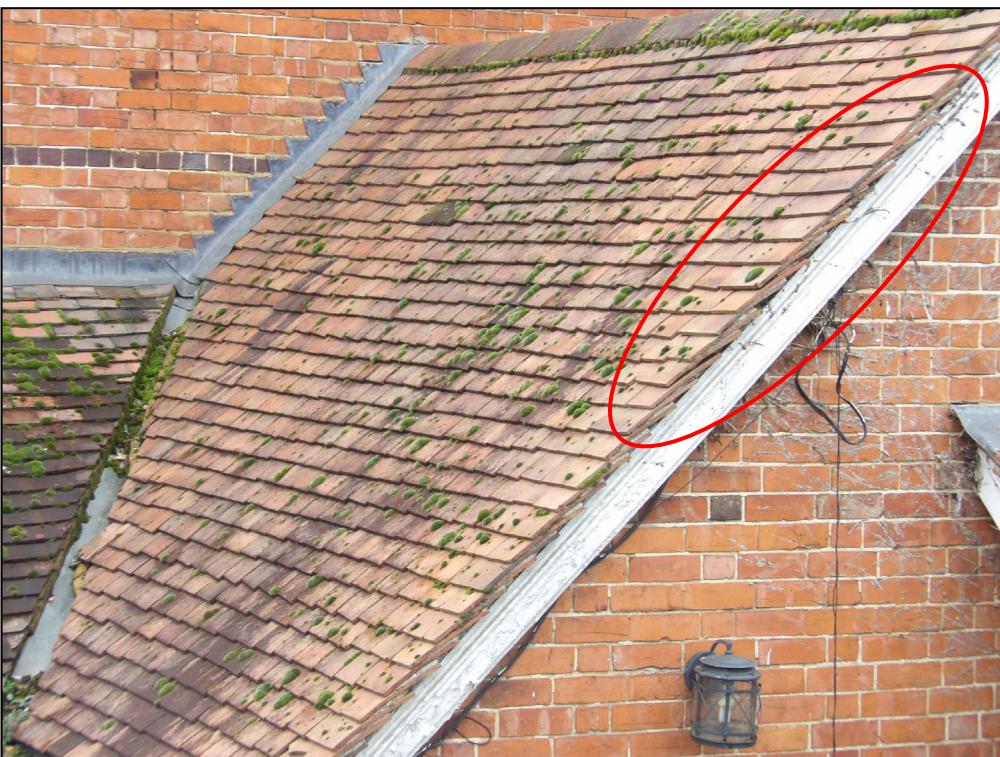
Figure 12. Gaps in verge of rear extension. Arlington, Basingstoke Road, Spencers Wood. 10.12.24

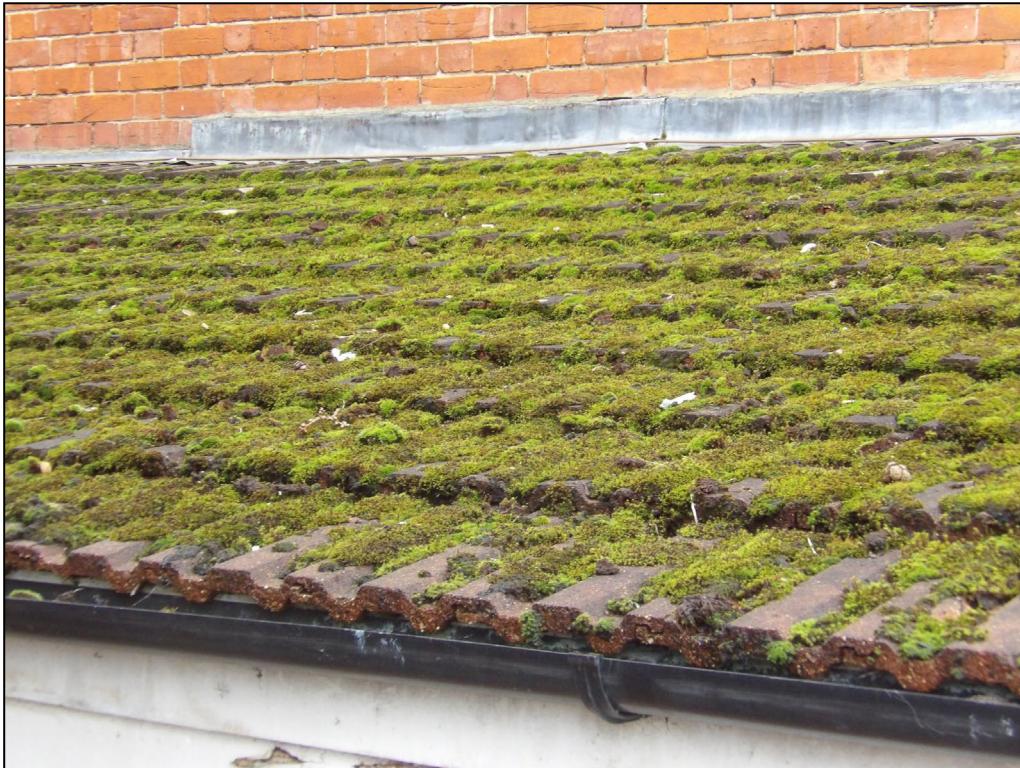
Figure 13. Example roof tiles on garage/utility and sealed flashing. Arlington, Basingstoke Road, Spencers Wood. 10.12.24

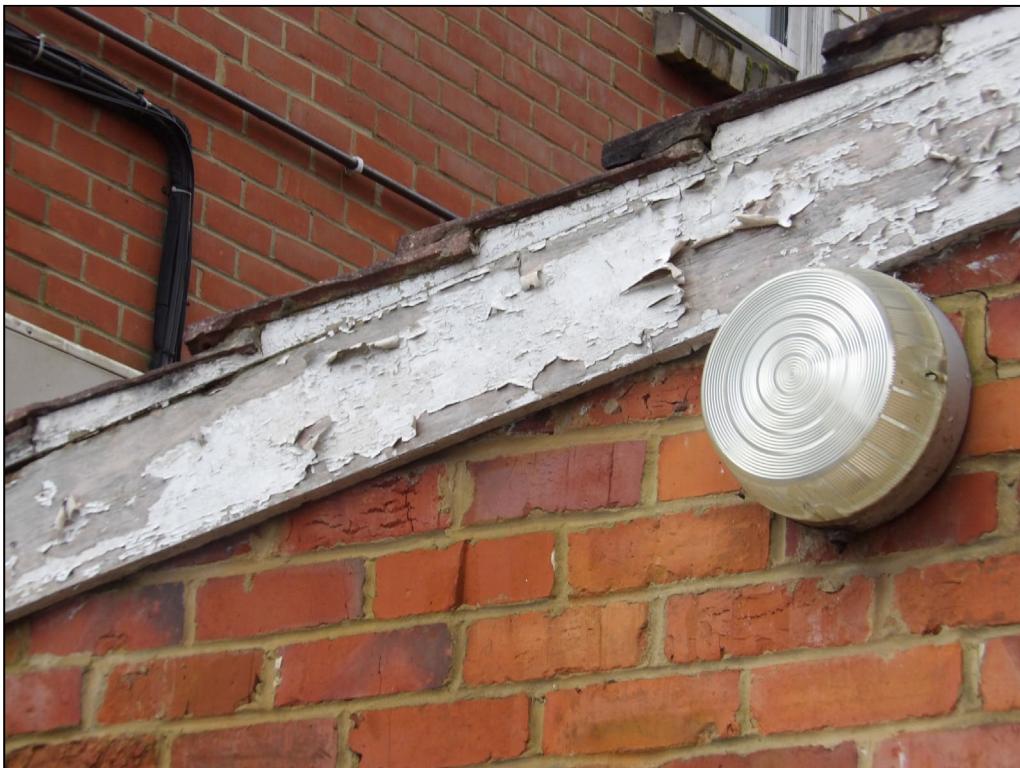
Figure 14. Example flush fascias and sealed verges on garage/utility. Arlington, Basingstoke Road, Spencers Wood. 10.12.24

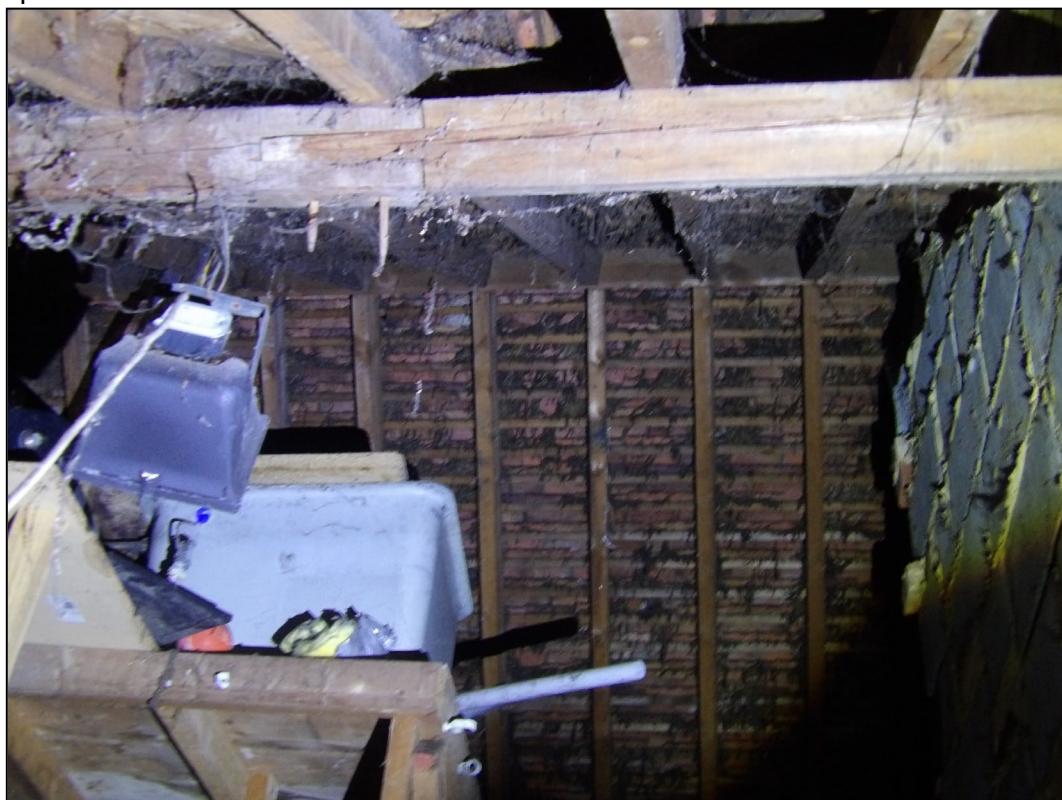
The loft space in the property was accessed through a hatch via steps and is in a poor condition internally. The loft is uncluttered, not lit, partially boarded and partially insulated and the roof tiles are unlined, see Figure 15 below. Due to the lack of boarding a thorough inspection of the loft space could not be undertaken.

No bats or evidence of bats was recorded during the internal inspection of the property or garage/utility however, due to the condition of the roof of the property and lack of lining beneath the roof tiles, bats could potentially access the building to roost.

Figure 15. Example of loft space and unlined roof tiles. Arlington, Basingstoke Road, Spencers Wood. 10.12.24

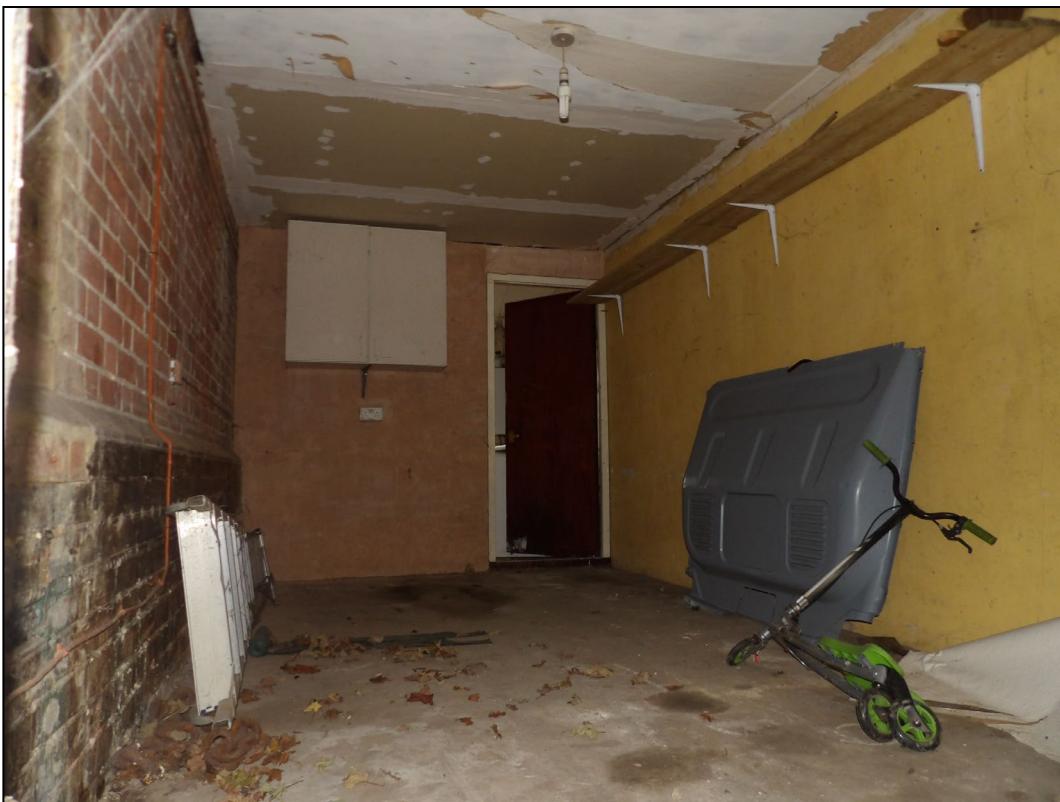
The garage/utility was also inspected internally. The roof in both these spaces is plaster boarded, see Figure 16 on page 15. There is no access to the void space above but given the good state of the garage/utility roof externally this was not thought to be a significant constraint to the survey.

Figure 16. Internal view of garage. Arlington, Basingstoke Road, Spencers Wood. 10.12.24
