## **6 DENMARK AVENUE, WOODLEY**

In accordance with your instructions, AA Environmental Limited (AAe) carried out a Preliminary Roost Assessment (PRA) of the above property on Thursday 29 August 2024. The purpose of the survey was to assess the presence or likely absence of bats utilising the building and provide appropriate mitigation measures, as necessary. A series of photographs has been attached for reference.

| Rev. | Details | Drawn<br>Chkd. | Date |
|---|---|---|---|
| TITLE<br>Photograph Record Sheet | | | |

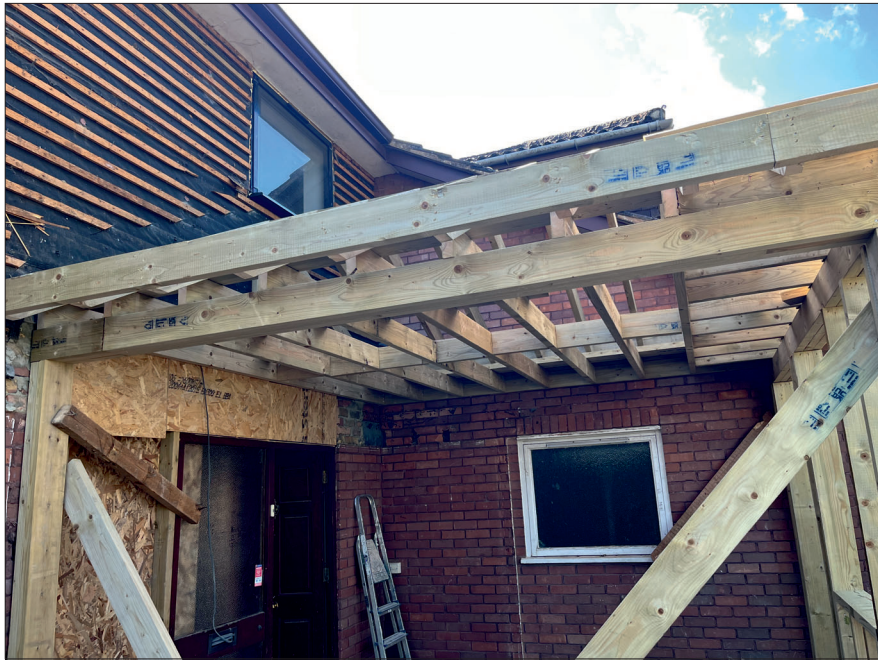
The property was a two-storey masonry constructed house, with a pitched engineered pantiled roof. Timber soffits/fascias were present, which were well-sealed. Internally, the roof space of the property was lined with bitumen-based felt and insulated with mineral wool. Some works had already been completed, including the removal of the chimney stack and replacement front porch currently under construction.

Photograph 1: Showing the timber frame of the new front porch.

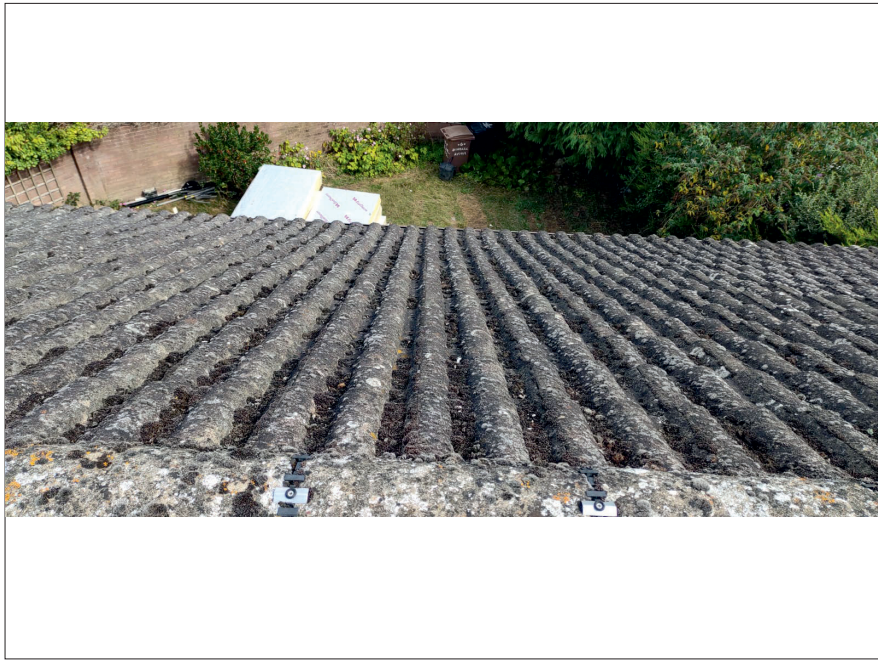
No evidence of bats was recorded during a careful internal and external inspection of the property. The roof tiles were engineered pantiles and were well aligned and tightly sealed, with no obvious access points recorded. Internally, the roof space was fully accessed and lined with bitumen based felt and insulated with mineral wool and appeared well-sealed. It was found to be dusty and cobwebbed throughout with some old wasp nests and rodent droppings (mouse) recorded. The area around the removed chimney stack was carefully inspected with no evidence of bats recorded.

Photograph 2: Showing the well aligned and sealed roof tiles.

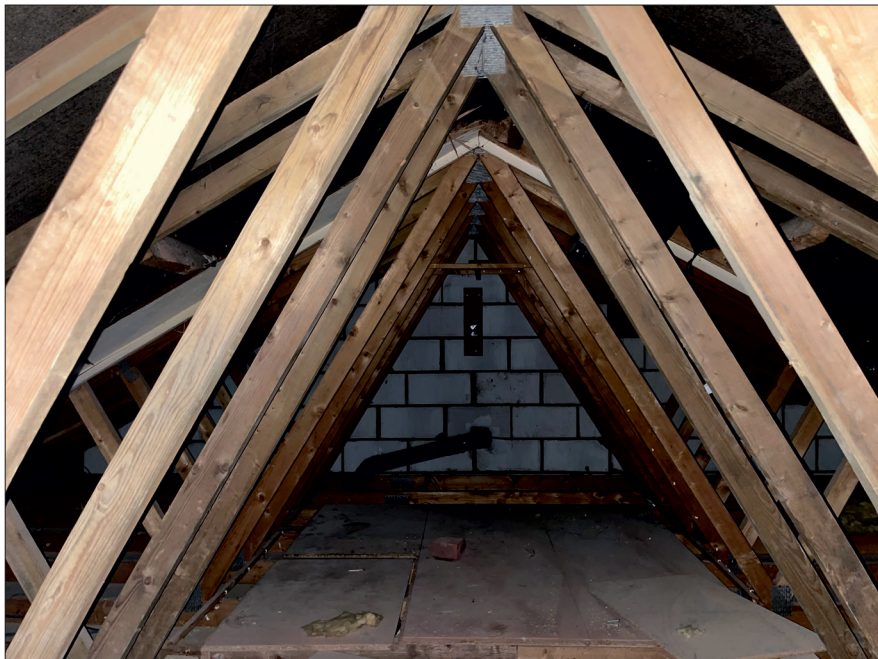
Photograph 3: Showing the attic space.

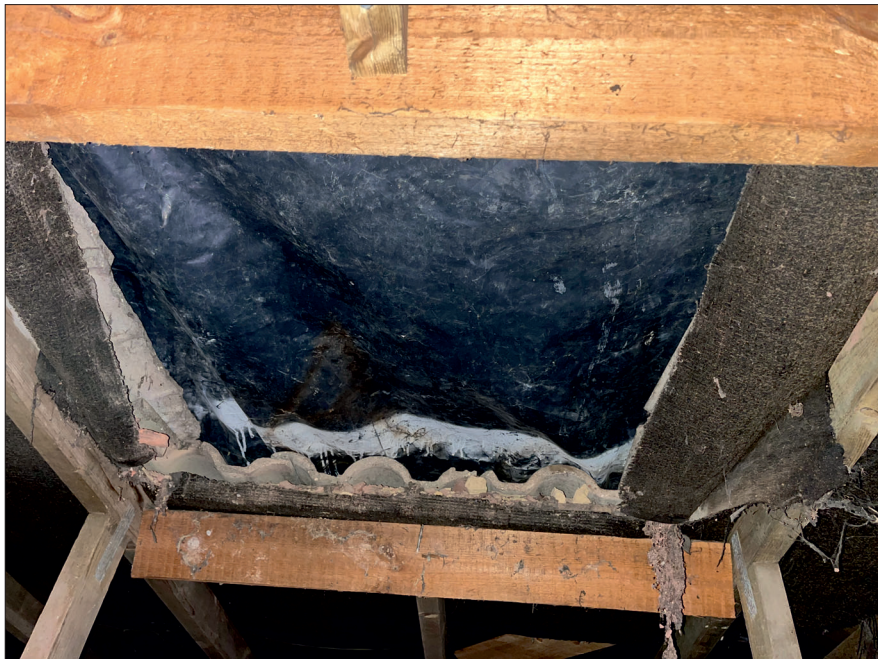
Photograph 4: Showing the area of the removed chimney stack.

A thorough examination of the existing building was completed, with all potential access points and/or roosting opportunities fully inspected for evidence of bats. The roof space was fully accessed and not complex allowing a thorough inspection and, therefore, there are considered to be no constraints to the survey findings. Although no evidence of bats was recorded and no further surveys are considered necessary, all site operatives should be made aware of current legislation protecting bats and their roosts. In the unlikely event of any bats being encountered on the site, then works should stop immediately and Natural England or AAe contacted so that appropriate advice can be provided.
