## Preliminary Roost Assessment

## Preliminary Roost Assessment of 26 Old Bath Rd, Sonning, Reading, RG4 6TA

**Site Name:** 26 Old Bath Road  
**Site Location:** 26 Old Bath Rd, Sonning, Reading, RG4 6TA  
**Reference Number:** Eco26-16  
**Report Version:** 002  
**Status:** Final

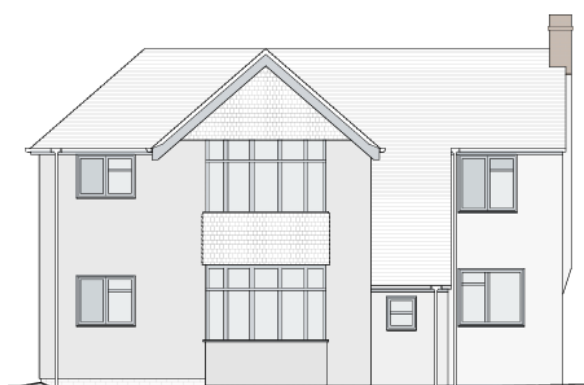
EXISTING REAR (NW) ELEVATION

The proposed works comprise a two-storey rear (northwest) gable extension, which will necessitate the removal of the existing catslide roof, together with a single-storey wraparound extension to the northwest and southwest elevations.

The works will also involve the removal of the existing gable-end chimney and rear (ground level) hanging tiles to facilitate the development (collectively hereafter referred to as “the proposed works”).

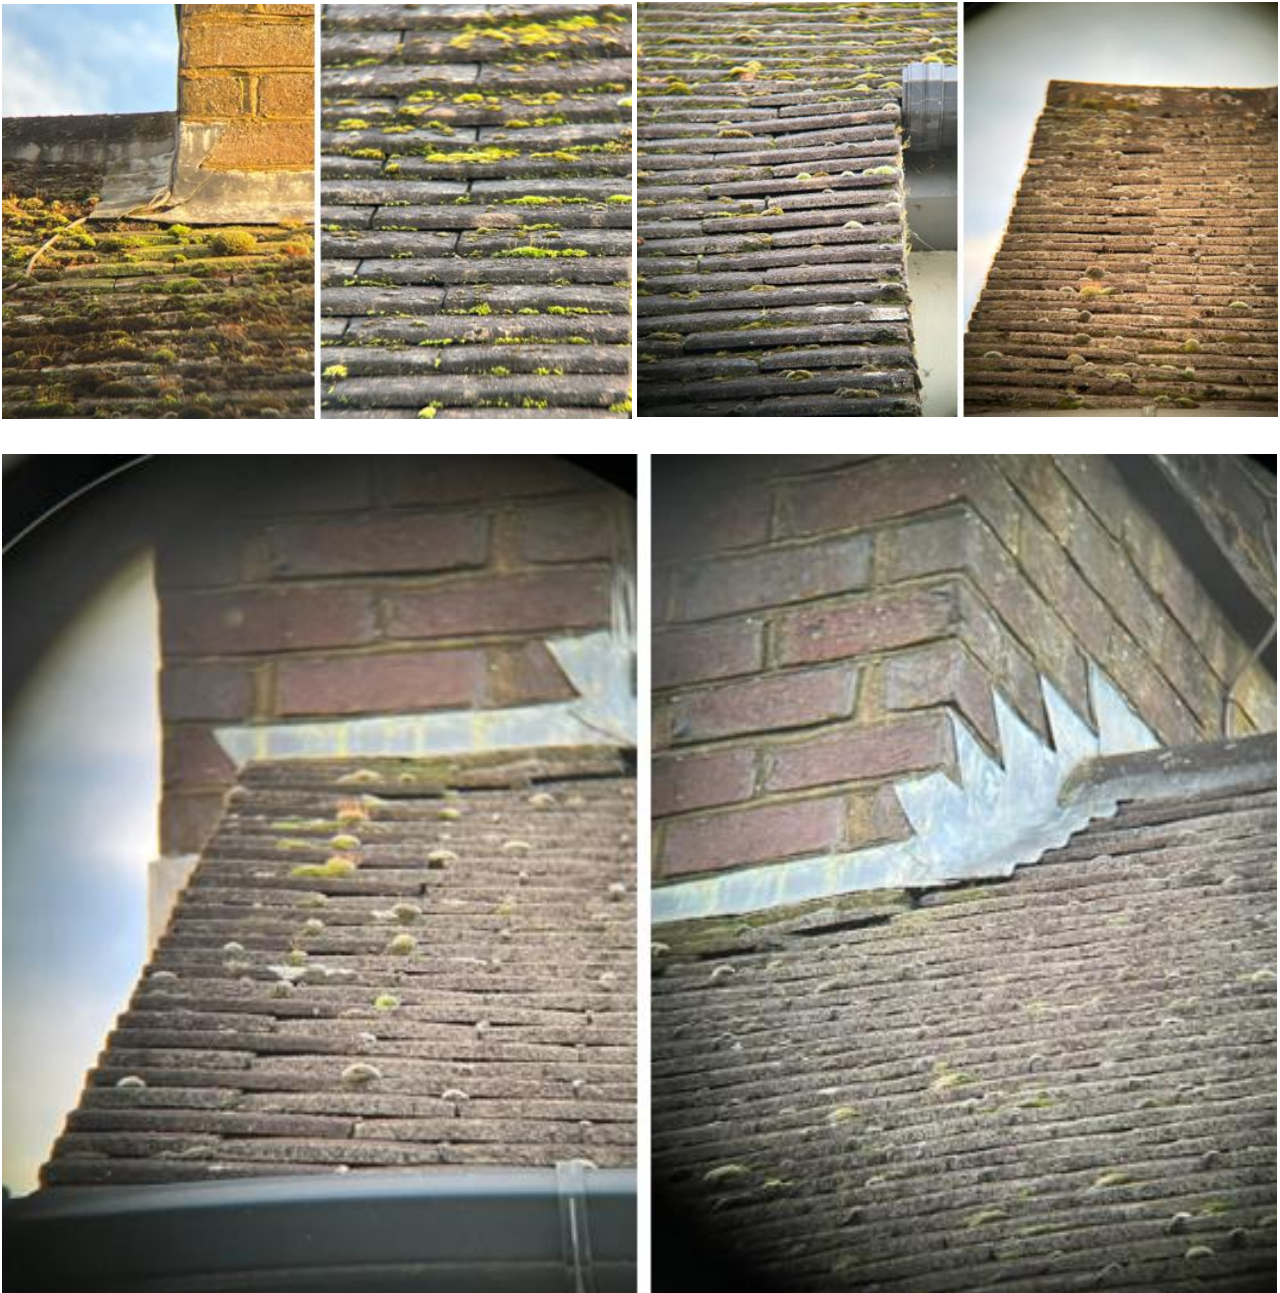
**Figure 3: Example of PRFs identified on B1**

Along the northwest elevation (the area of the proposed extension), multiple potential roost features (PRFs) are present. Notably, roof tiles are lifted along the northern ridge close to the gable end, and gaps are present where the lead flashing has lifted around the north side of the chimney. On the catslide roof, several tiles are lifted, creating gaps beneath which bats could gain access. Tiles running vertically down the verge also show significant lifting.

Hanging tiles at both ground- and first-floor levels provide openings into an internal void which may facilitate bat roosting in larger numbers. The upper hanging tiles present gaps where they meet the roof overhang, potentially providing access into further unseen voids, including the loft space.

On the south and southeast elevations, several PRFs were observed, most notably beneath roof tiles along the ridge near the gable end and beneath lifted tiles and lead flashing around the chimney. A small gap is present beneath a single lifted tile on the left-hand side of the porch roof, while a larger gap was noted beneath the ridge tile on the far right-hand side of the main roof section.

In accordance with Collins (2023), **three dusk emergence surveys are required**, to identify the presence or likely absence of roosting bats on site. The emergence surveys should be carried out between late-May and August inclusive. The surveys must take place in optimum weather conditions, to maximise the likelihood of recording bats, with dusk air temperatures exceeding 10°C and avoiding heavy rain or strong wind. The surveys should commence at least 15 minutes before sunset and continue for at least 1.5 hours after sunset. However, to account for late-emerging species, it is recommended that the survey continue for at least two hours after sunset.
