**44 Ilfracombe Way  
Lower Earley  
Earley  
Reading  
RG6 3AQ**

**ECOLOGICAL SURVEY REPORT (BATS)**  
**(Preliminary Roost Assessment/DBW)**

**Prepared for:  
Mr M. Sakamoto  
Date: 24/7/25.  
Ref: NWP/ESR-24/7/25.**

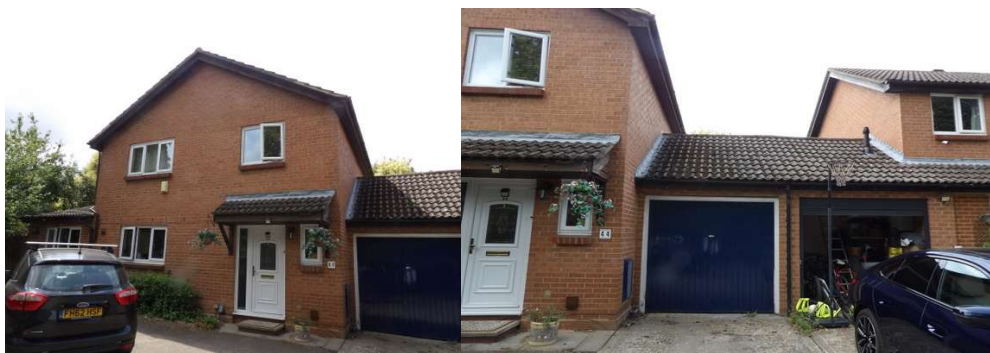
Figure 3. Driveway/Access road.

Immediately to the front of the main dwelling is a tarmac driveway/access road. Figure 3. Adjoining the rear of the house is an area of timber decking. Figure 4.

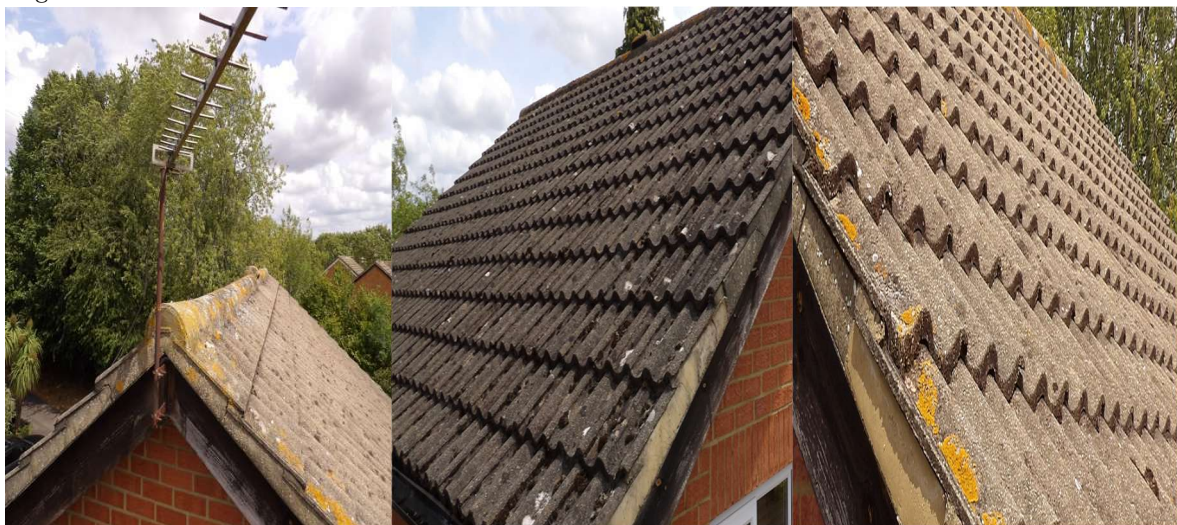
The ridge tiles on the dwelling were in good condition with no significant missing mortar that bats could exploit. Figure 1.

The tiles covering the roof were in good condition. Figure 2/3.

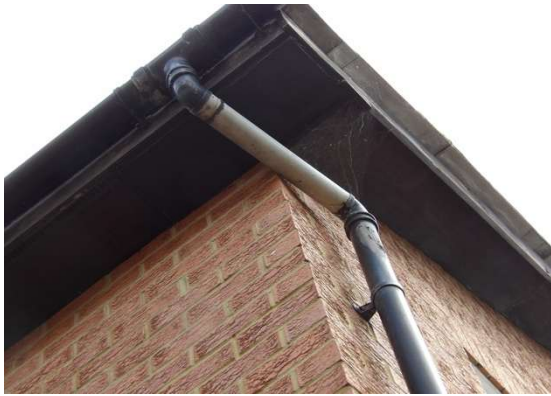
The wooden soffits and fascia were all in good condition, close fitting to the walls with no splits or significant openings. Figure 4.

**The eaves tiles** were in good condition with no significant missing mortar that bats could exploit. Figure 5.

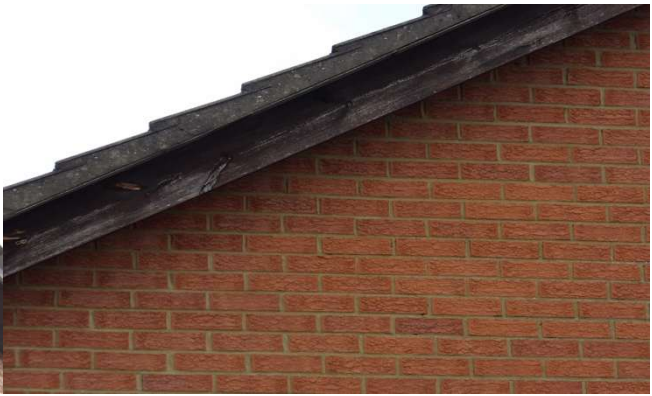
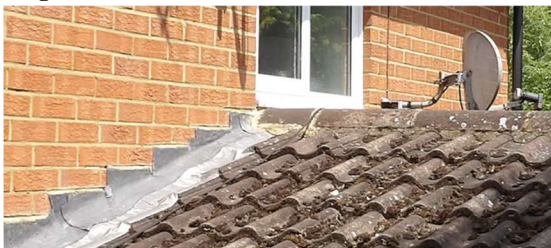
The ridge tiles on the extension were in good condition with no significant missing mortar that bats could exploit. Figure 6.

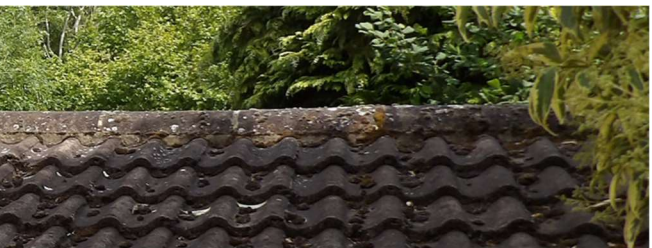
The tiles covering the roof were in good condition. Figure 7.

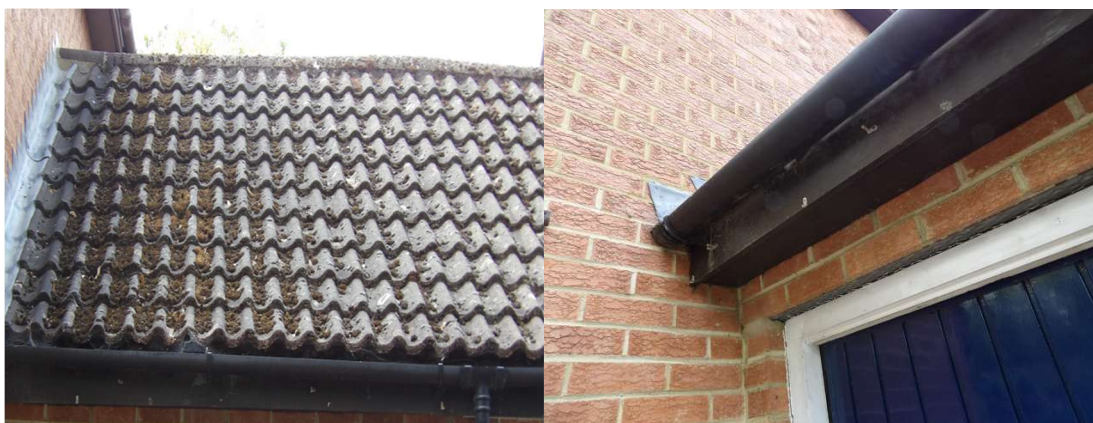
The tiles covering the roof were in good condition. Figure 12.

The wooden soffits and fascia were all in good condition, close fitting to the walls with no splits or significant openings. Figure 13.

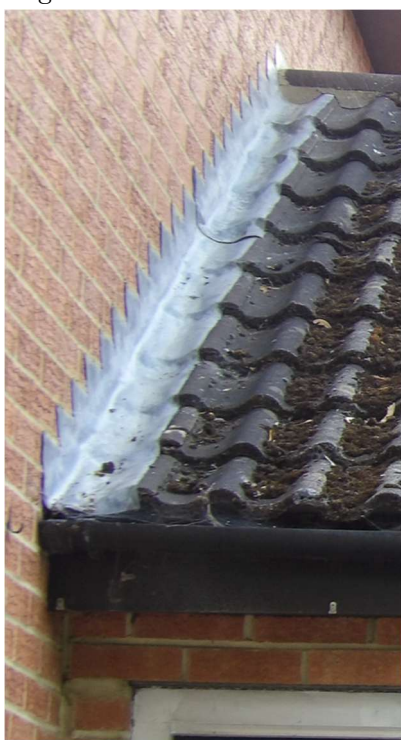
The leadwork was in good condition, close fitting with no significant gap' s bats could exploit. Figure 14.

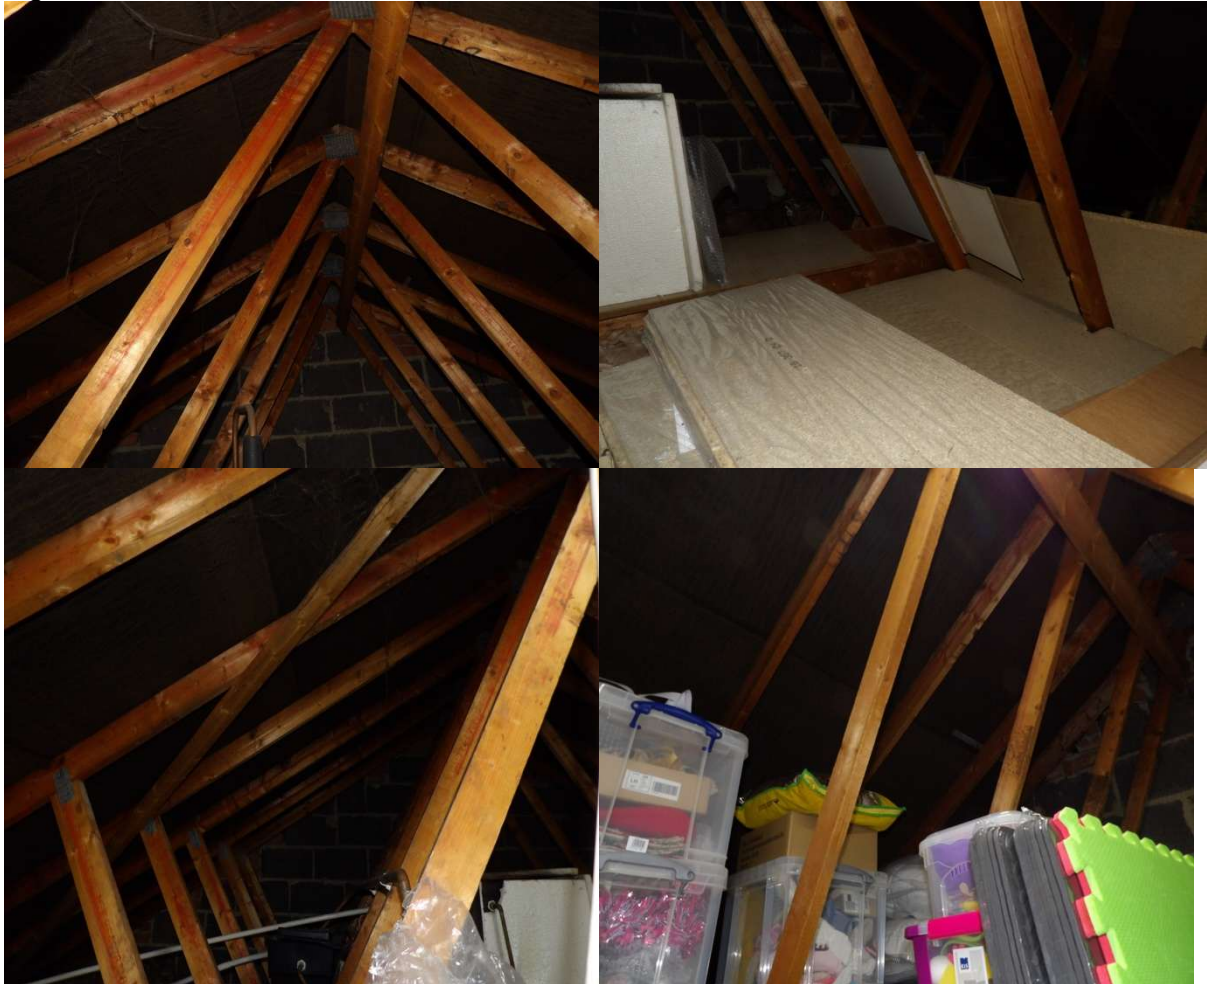
Figure 1/2/3/4.

**Main dwelling**-The roof void in the main dwelling was accessed via steps, it was being used to store some personal possessions.

There was no light ingress.

The loft area was lit, it was boarded and insulated.

The tiles were lined with bitumen felt, there was no visible rips or tears.

Figure 1/2/3/4 show general structure and condition of the loft over the main dwelling.

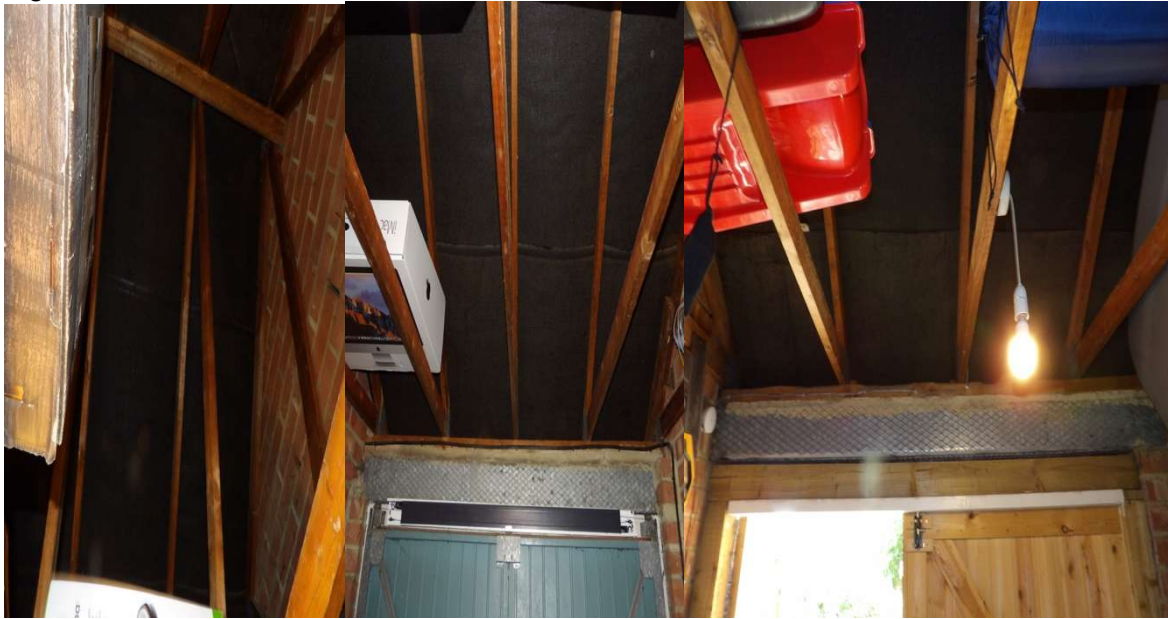
Figure 5/6/7.

**Garage**- The garage had no ceiling, the tiles were lined with bitumen felt, it was in good condition with no visible rips or tears.

Figure 5/6/7 show general structure and condition of the loft over the garage.
