## Preliminary Roost Assessment

Manor Cottage, Barkham Street, Barkham, Wokingham, Berkshire, RG40 4PJ

This report is prepared to inform a planning application with the Wokingham Borough Council. The proposal is described as:

Single and two-storey extensions on the existing dwelling.

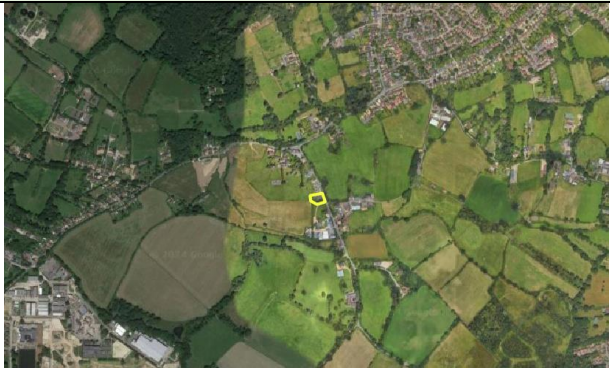
| Summary of site and desk Study | <p><b><u>Site description</u></b></p> <p>The site is centred on [SU 78067 66734] and has an area of [0.2ha]. The site is characterised by a residential dwelling, driveway and large garden. It contains scattered trees, shrubs and hedgerows which provide foraging and commuting opportunities for bats.</p> <p>There are further large trees in the gardens of neighbouring properties and patches of woodland in close proximity to the site, all of which likely provide foraging and commuting opportunities for bats. The woodlands may also provide roosting opportunities.</p> <p>There are interconnected tree lines and hedgerows along field boundaries. These create a network of commuting routes for bats, connecting woodlands and other suitable bat habitats in the surrounding area. A site location plan is provided in Appendix 2.</p> <p>To the author’s knowledge, no previous ecology reports have been produced for this site.</p> <p><b><u>Historical records</u></b></p> | | | <p>Figure 1: An ariel view of the site marked in yellow.</p> | |

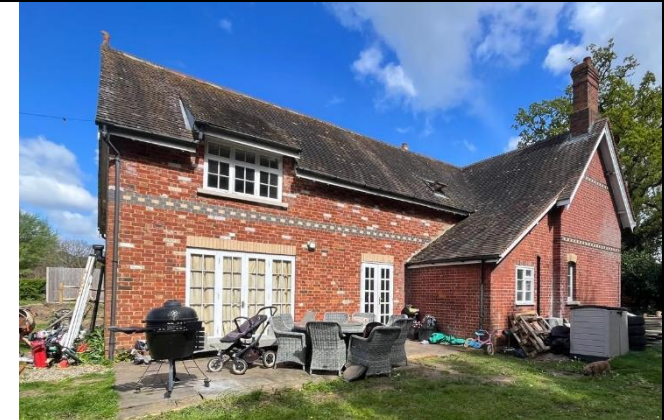
| <p><i>Summary of Survey Findings</i></p> | <p>B1 is a <b>confirmed roost</b> with high habitat value as identified by approximately &gt;150 bat droppings located below the ridge beam throughout the loft.</p> <p>B1 is a detached two-storey brick built house (figure 1) with a gable and sloped pitch roof clad in concrete roof tiles which appear to be lifted in areas on all elevations (figure 2) aswell as gaps between the ridge tiles (figure 2 and 3) which can provide roosting opportunities and access into the roof structure for both void and crevice dwelling bats.</p> <p>There are UPVC soffits, fascia and bargeboards around the property, the soffits appear to be in excellent condition with no rot gaps, or linear soffit gaps between the soffit and the brick walls.</p> <p>There are UPVC windows and doors around the property which are all well-sealed and tight-fitting to the surrounding structure, providing no roosting sites for bats.</p> <p>There is one chimney located on the roof of the building. The brickwork on the chimneys is in good condition. There is lead flashing around the base of the chimney, which is flat and without gaps.</p> |

Figure 2: The southern elevation of B1.

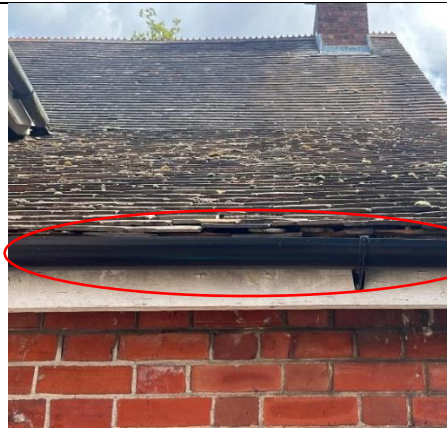
Figure 3: Lifted roof tiles on the western sloped roof.

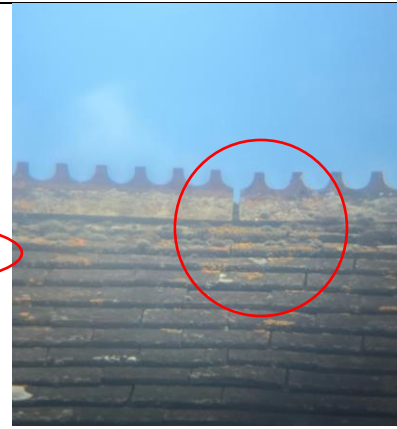
Figure 4: Missing mortar between the ridge tiles.

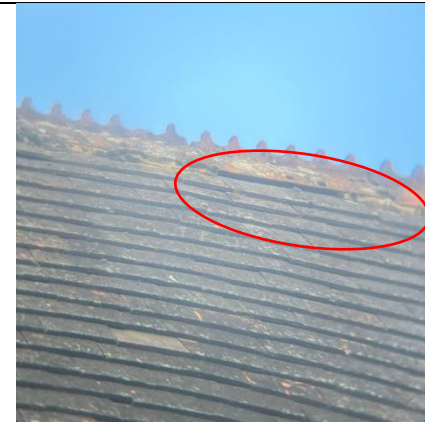
Figure 5: Gaps between the ridge tile and roof tiles.

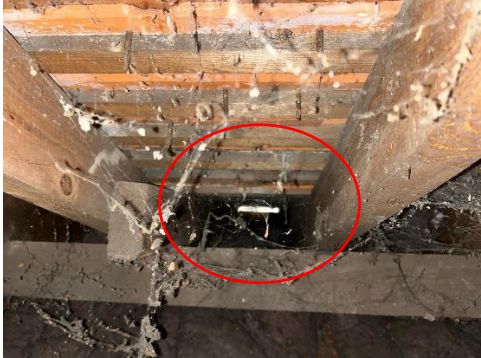
Light could be seen entering the loft at the base of the roof which could be used as an access point into the loft (figure 6).

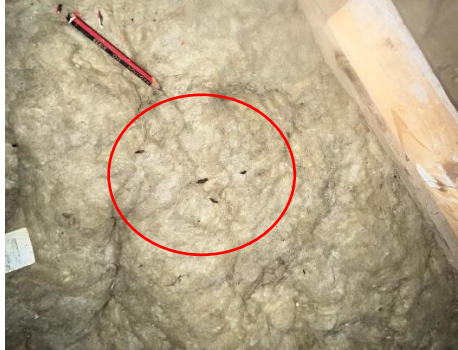
Evidence of bats in the form of approximately >150 droppings were identified scattered below the ridge beam (figure 7) throughout both sections of the loft (figure 8). They appeared to be a mixture of ages indicating repetitive use of the roost.

| <b>Recommendations</b> | <p><b><u>Bat Emergence and Re-entry Surveys</u></b></p> <p>Three bat emergence surveys are required during the active bat season (optimal May to August, suboptimal September) to characterise the roosts present. At least two of the surveys should be completed during the optimal survey period May to August inclusive.</p> <p>Infra-red cameras should be used as an aid.</p> <p>Surveys should be a minimum of three weeks apart.</p> <p>Four surveyors are required to provide full coverage of the building.</p> <p>Bat droppings will need to be sent for DNA analysis.</p> <p>An EPSL application to Natural England will be required. The EPSL application requires that surveys have been undertaken within the most recent active bat season and planning permission must have been granted and all relevant wildlife-related conditions have been discharged prior to submission.</p> |

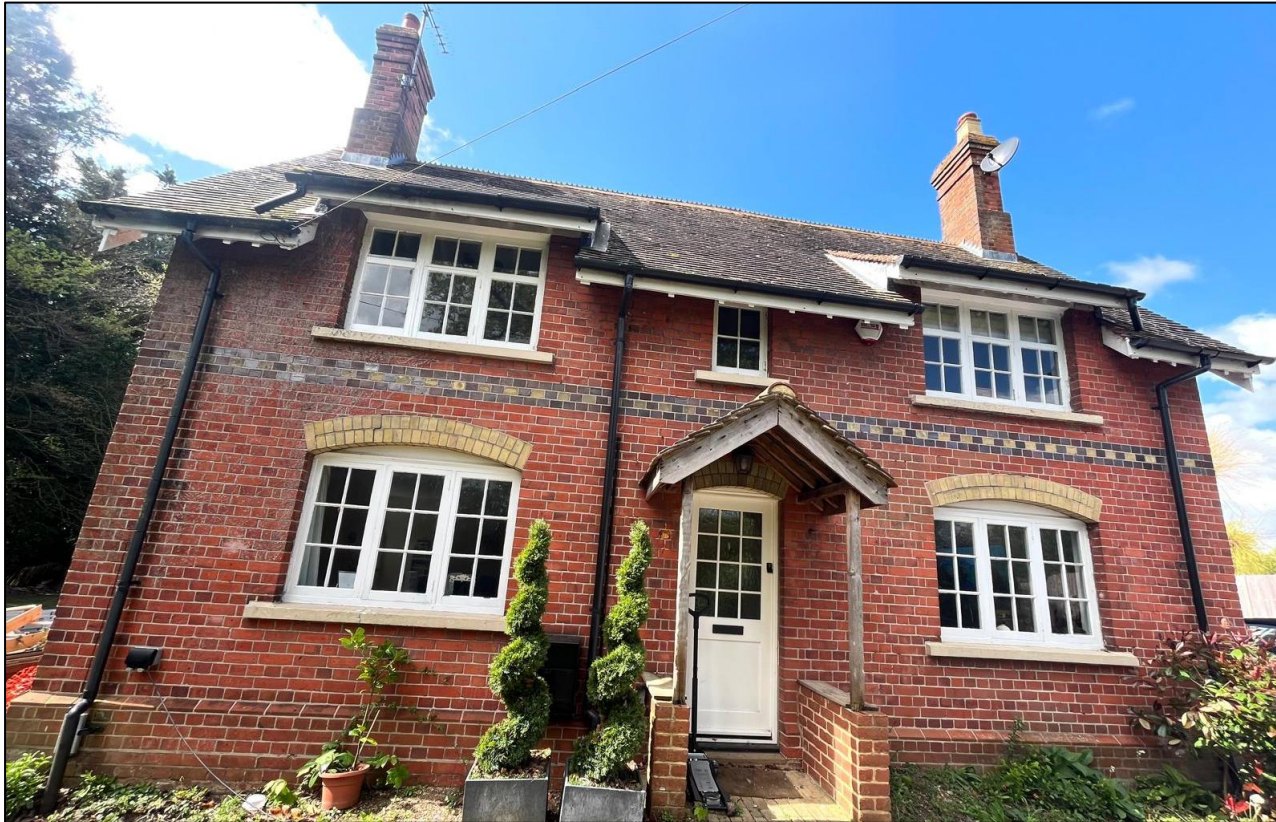
Photo 1: The eastern elevation of B1.

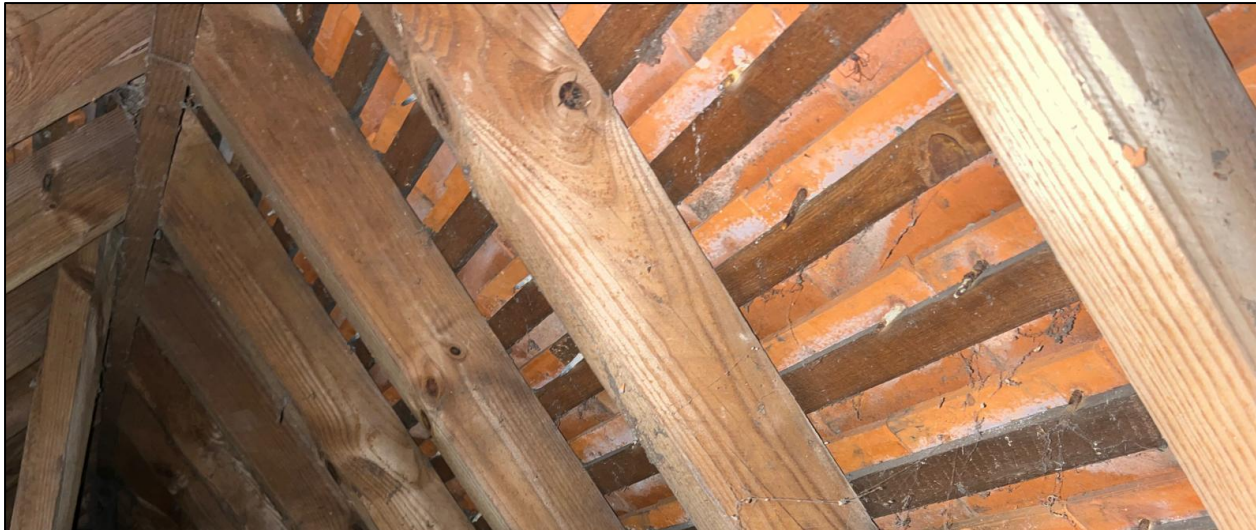
It is constructed from modern timber beams, including the ridge beam, rafters and struts. The beams provide roosting sites for void-dwelling bats. One section of the loft has no roof lining; however the other section is clad in bitumen felt which has some gaps in places and may provide internal roosting sites for bats. Bats can roost between the lining and the roof tiles, or within pockets created by sagging roofing felt.

Photo 2: Lack of roof lining and insulation in the eastern section of the loft.

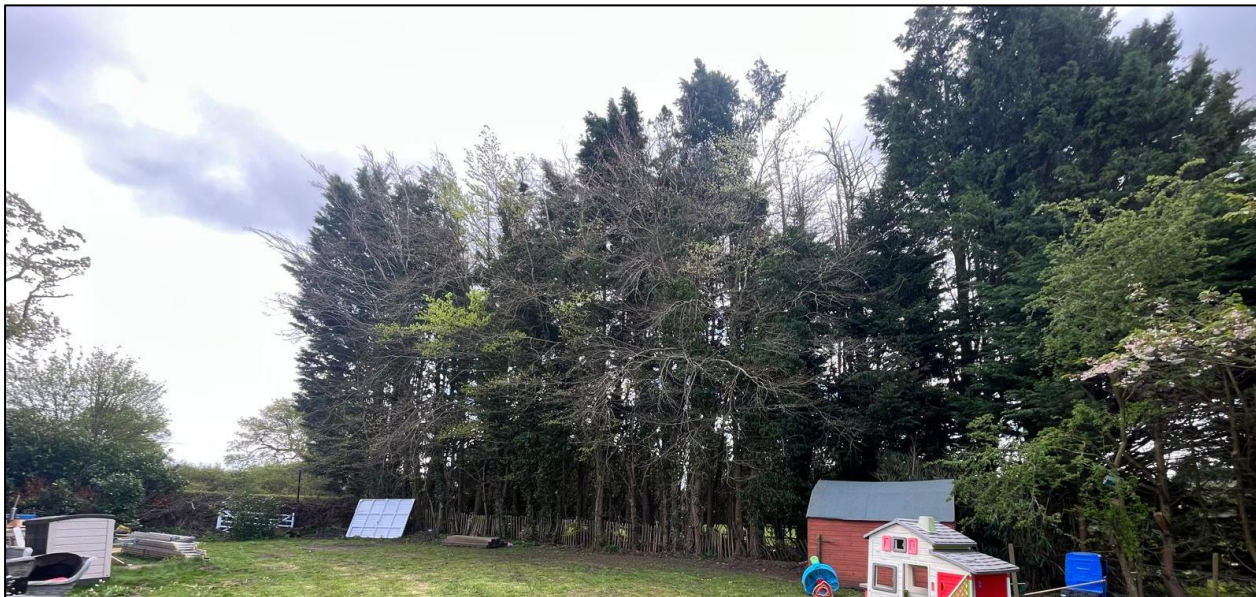
Photo 3: Looking south along the boundary of the site showing the tree line which will provide foraging and commuting habitat.
