**Discovery Strategy, Remediation Strategy
and | Residential Development
Verification Plan**

Report prepared at
Victoria Nurseries
Victoria Road
Wargrave
RG10 8AG

On behalf of
Palatine Homes Limited

Report reference
24-206.04
Version 1

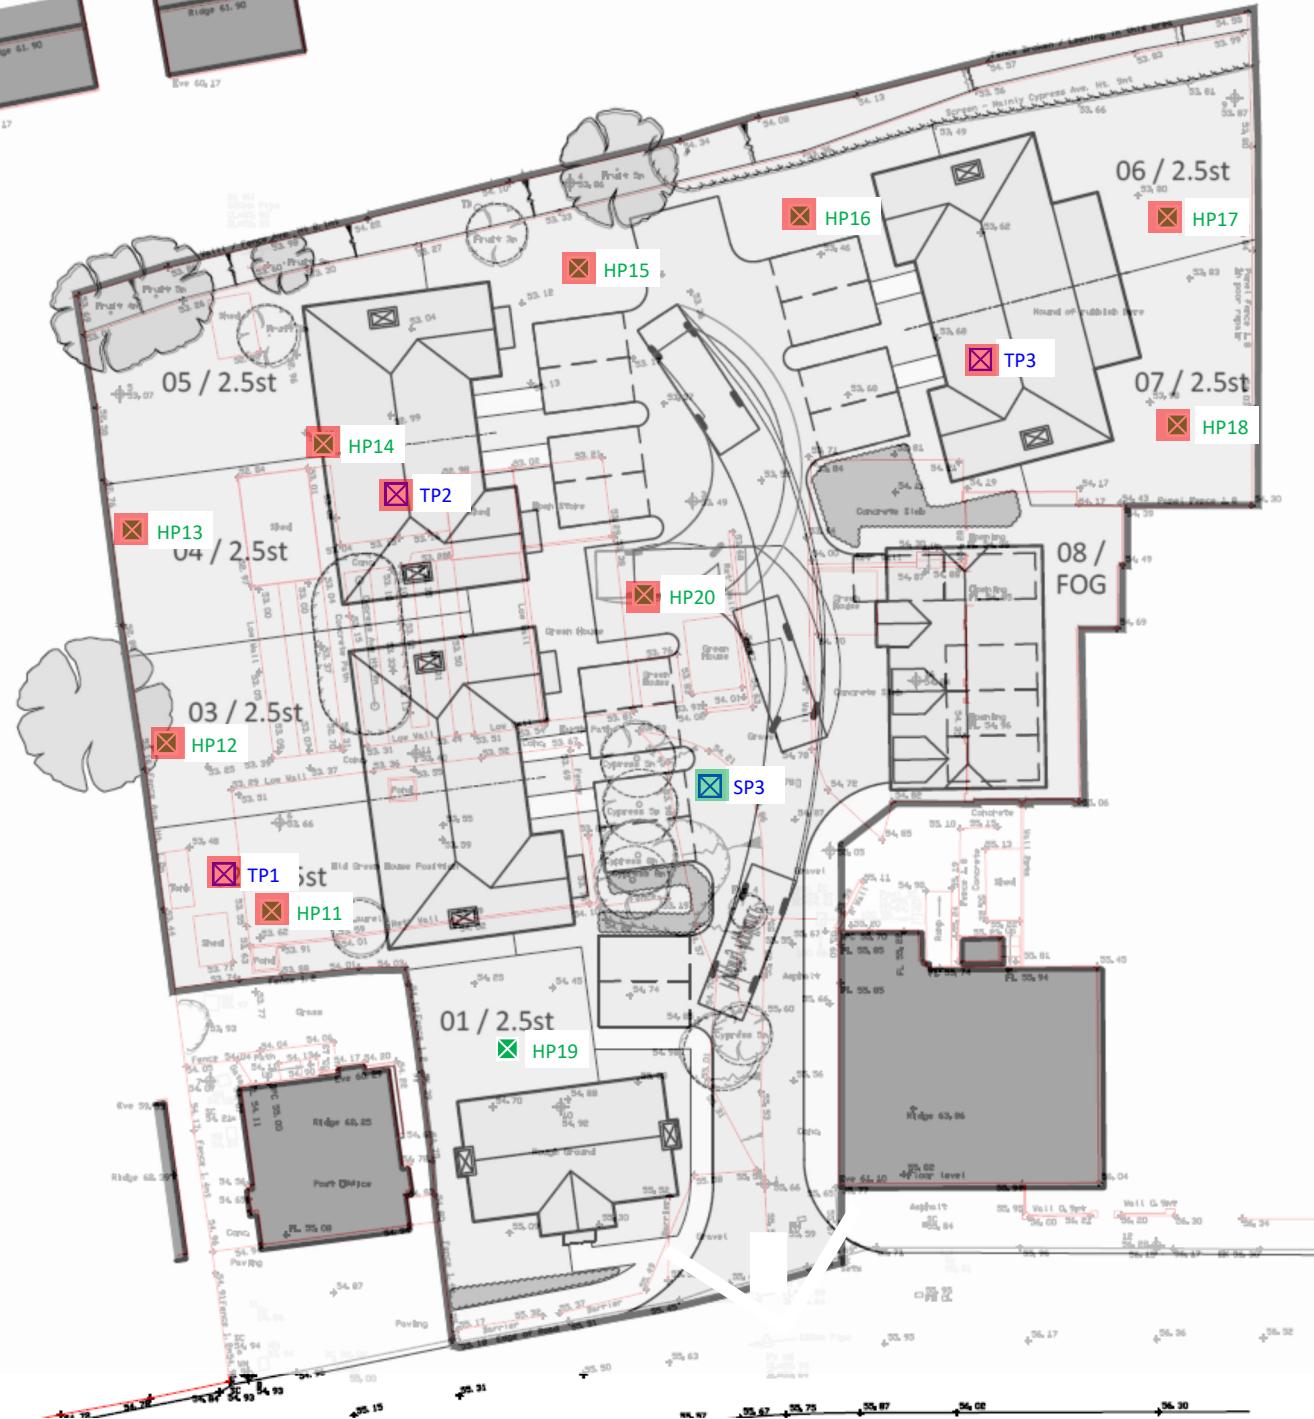
Drawing Title	Lead 'Topsoil' Contamination Plan
Project Number	24-206.04
Project Title	Victoria Nurseries, Victoria Road, Wargrave, RG10 8AG
Drawn by	DN
Checked by	JB
Scale	NTS

Table 1.2: Environment Risk Summary	
Medium	Comments/Recommendations
Soils	<p>Pervasive lead (reworked) Topsoil contamination exists across the site. Figure 1 is enclosed as a Lead ‘Topsoil’ Contamination Plan, which provides a visual indication of where re-worked Topsoil has been tested across the site and lead concentrations exceed 200mg/kg.</p> <p>A remedial cover system shall be required comprising 600mm of clean cover to private gardens and 300mm of clean cover to communal gardens/frontage/amenity areas.</p> <p>Construction workers should be aware local pockets of soil contamination may exist, which due to the nature of ground investigation cannot always be detected.</p>
	<p>Ensure material encountered is suitable for desired water main and consult local water authority prior to water main installation.</p>
Landfill (Bio) Ground Gas	<p>Preliminary risk assessment determined a VERY LOW risk from hazardous ground gas ingress and no potential sources of risk were identified.</p> <p>One round of ground gas monitoring has been completed which has reported ambient gas concentrations. Ground gas protection is not considered necessary.</p>

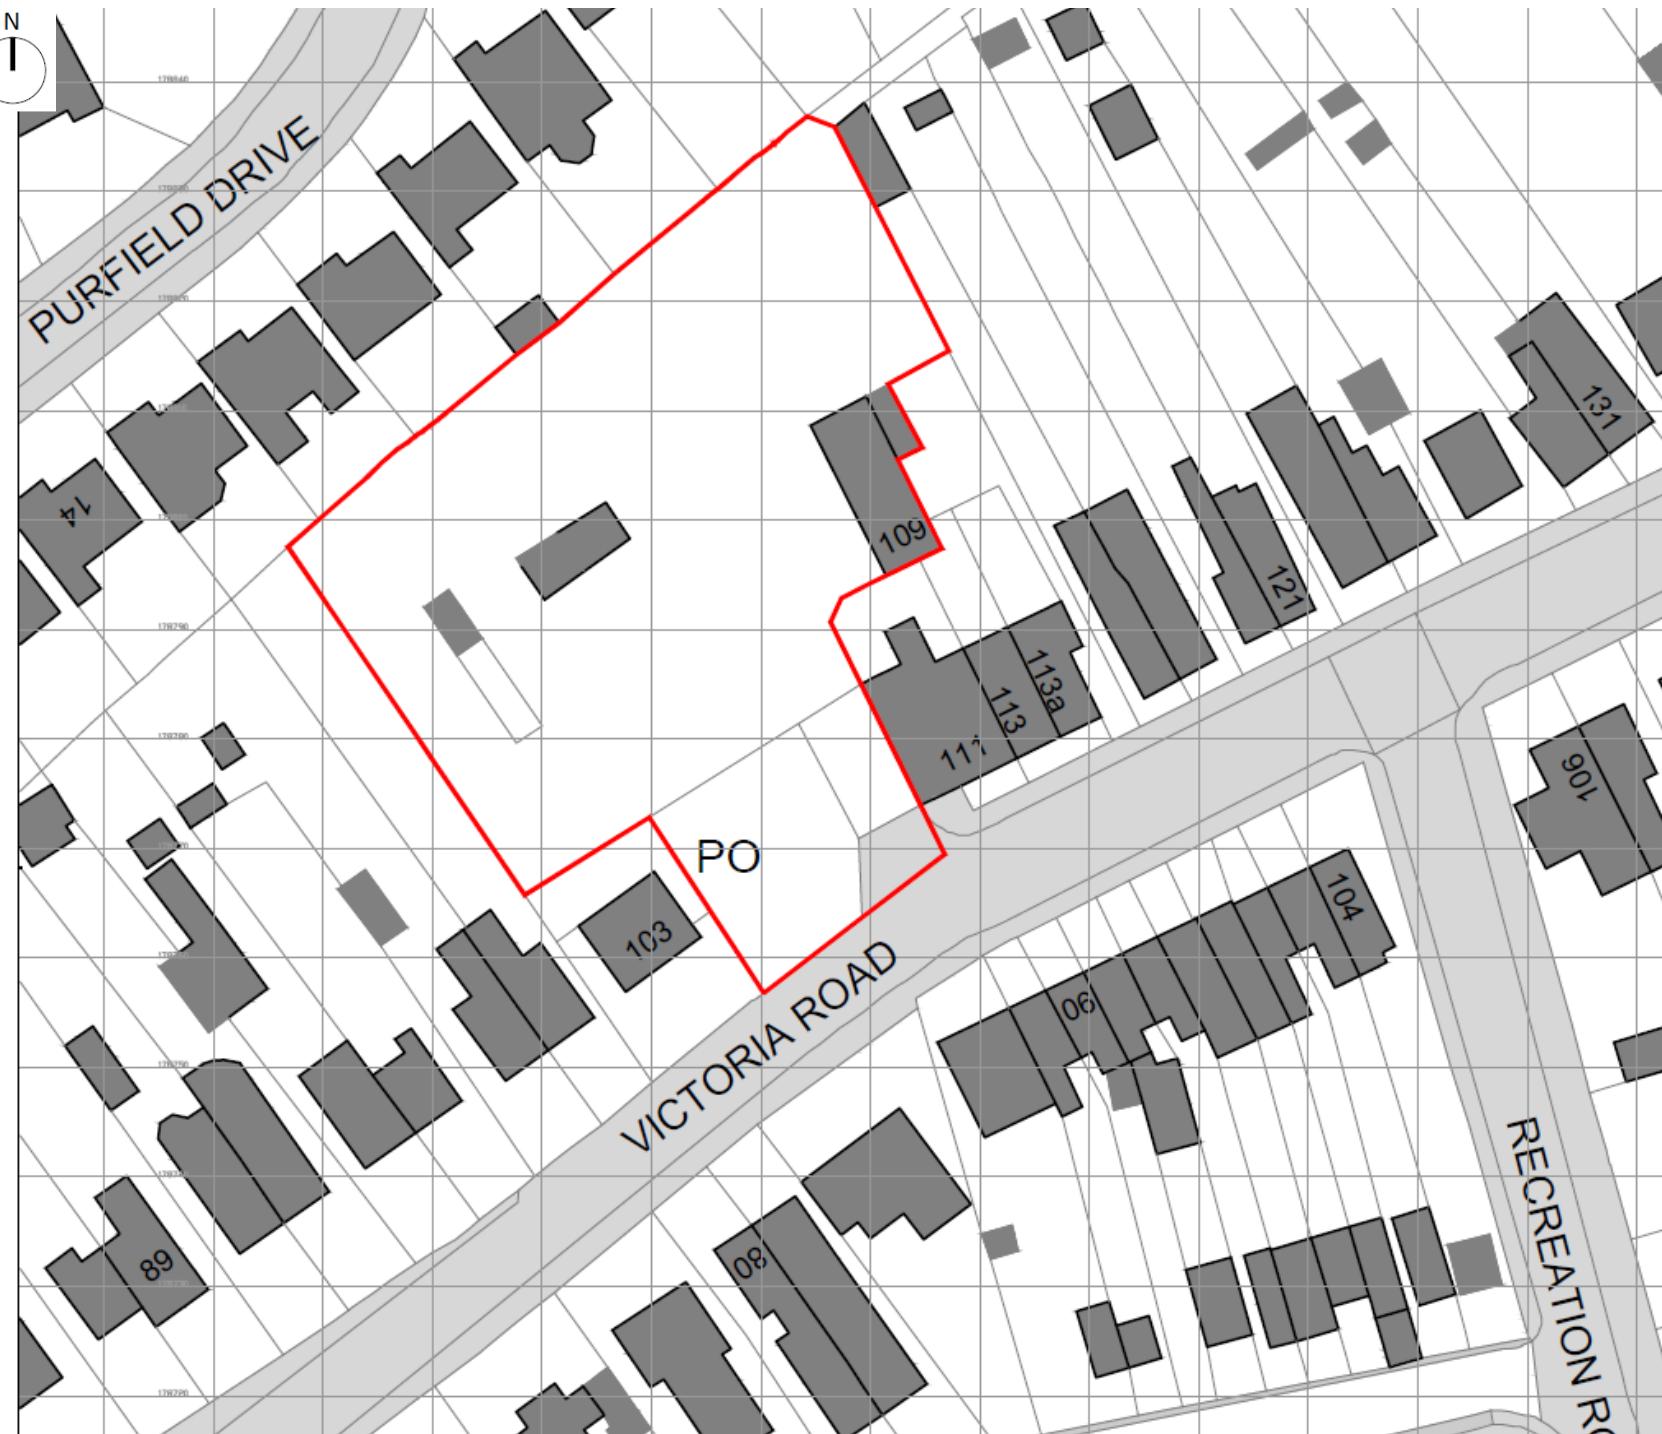
Drawing Title	Existing Site Layout and Location Plan
Project Number	24-206.04
Project Title	Victoria Nurseries, Victoria Road, Wargrave, RG10 8AG
Drawn by	DN
Checked by	JB
Scale	NTS

Figures 3 and 5 identify the location of the AST (Above Ground Tank) in the west of the site.

4. The AST (**Figures 3 and 5**) should be pumped dry, de-gassed, cleaned and readied for removal. As necessary appoint a suitable contractor to complete this task and retain waste transfer notes for the disposal of any product resultant from pumping and cleaning the tank.

6. Carefully complete excavation(s) within the area of the AST (**Figures 3 and 5**) to identify the vertical and lateral extent of potentially impacted/contaminated material. It is expected contamination material shall be easily identified by a dark grey/black colouration and hydrocarbon/oil odour. However, given the appearance of the AST (**Figure 5**) it is unlikely gross contamination shall exist.

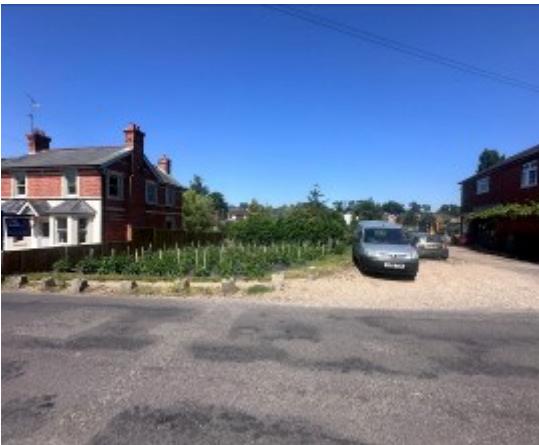
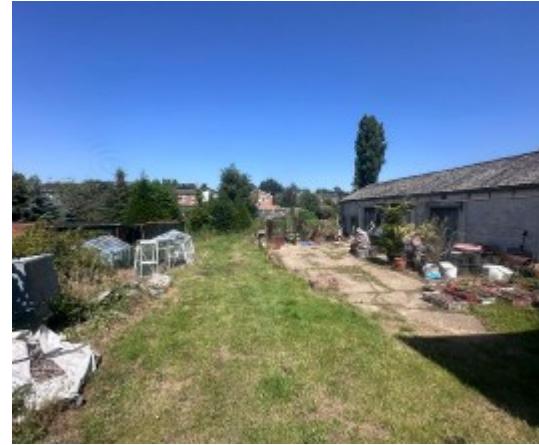
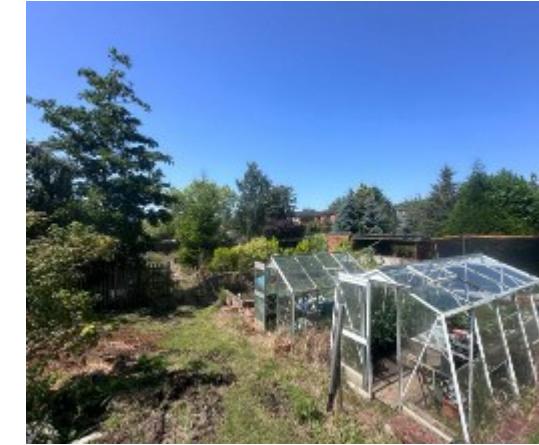
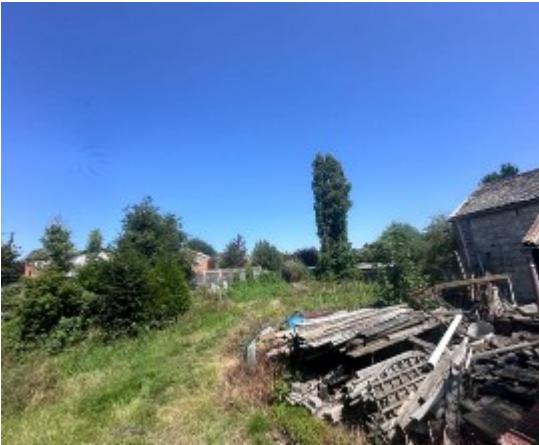
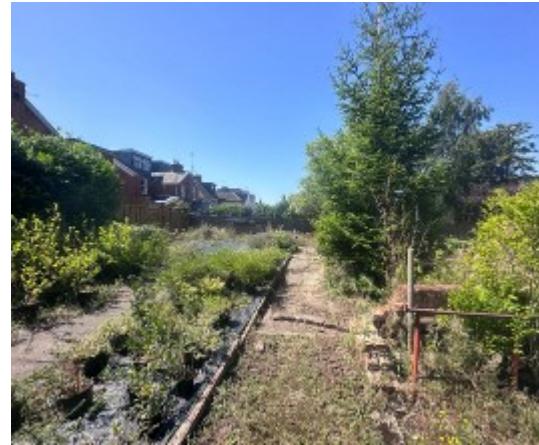
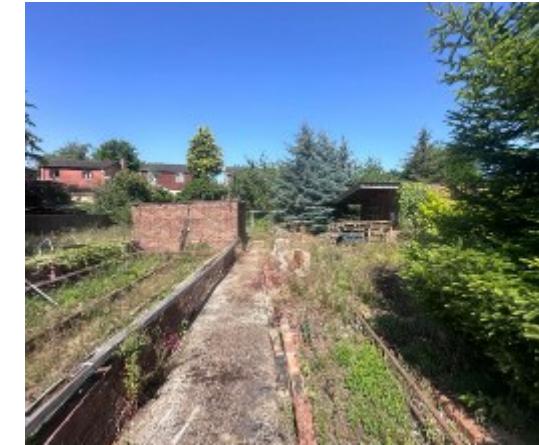
Photo 4	Photo 5	Photo 6	
			<p>Figure 4</p>
			<p>Drawing Title Site Photos (as of 19/07/2024)</p>
			<p>Project Number 24-206.02</p>
			<p>Project Title Victoria Nurseries, Victoria Road, Wargrave, RG10 8AG</p>
			<p>Drawn by DN</p>
			<p>Checked by JB</p>
			<p>Scale NTS</p>

Table 1.2: Site Details	
Site Location	The site is located at number 109 Victoria Road near the junction of Recreation Road, in Wargrave, approximately 5 kilometres (km) to the south-east of Henley on Thames. Figure 2 is presented as the Site Location Plan.
National Grid Ref.	Centred at approximately 479240 178795.
Current Land Use	<p>The site comprises Victoria Nurseries, including numerous disused planted beds, glasshouses and dilapidated buildings.</p> <p>A detached single storey building of brick and block construction under a pitched corrugated cement sheet roof is located in the east of the site, previously in use as a store and potting shed.</p> <p>Unmade surfacing is located in the site frontage on Victoria Road.</p> <p>An above ground storage tank (AST) noted in the west of the site (see Figure 4). No obvious staining was observed around the AST which was surrounded by scrub vegetation.</p> <p>Substantial tree stumps were observed in the west of the site. The tree stumps appear to be related to a line of cypress trees, as noted on a Detailed Survey by Survey and Engineering Services (reference 130/501 Topo, dated June 2001). Other cypress trees and a screen of cypress trees are noted on the Detailed Survey in the south and the north-east of the site, however these appear to have been removed. Off-site trees were observed in the vicinity, including what appears to be a poplar to the north-east.</p> <p>The site is shown to slope gently downwards in a north-westerly direction from approximately 55.7 metres (m) above Ordnance Datum (AOD) in the south to 53.0m AOD in the north-west.</p> <p>Figure 3 is presented as the Existing Site Layout Plan.</p> <p>Figures 4 and 5 are presented as the Site Photographs.</p>

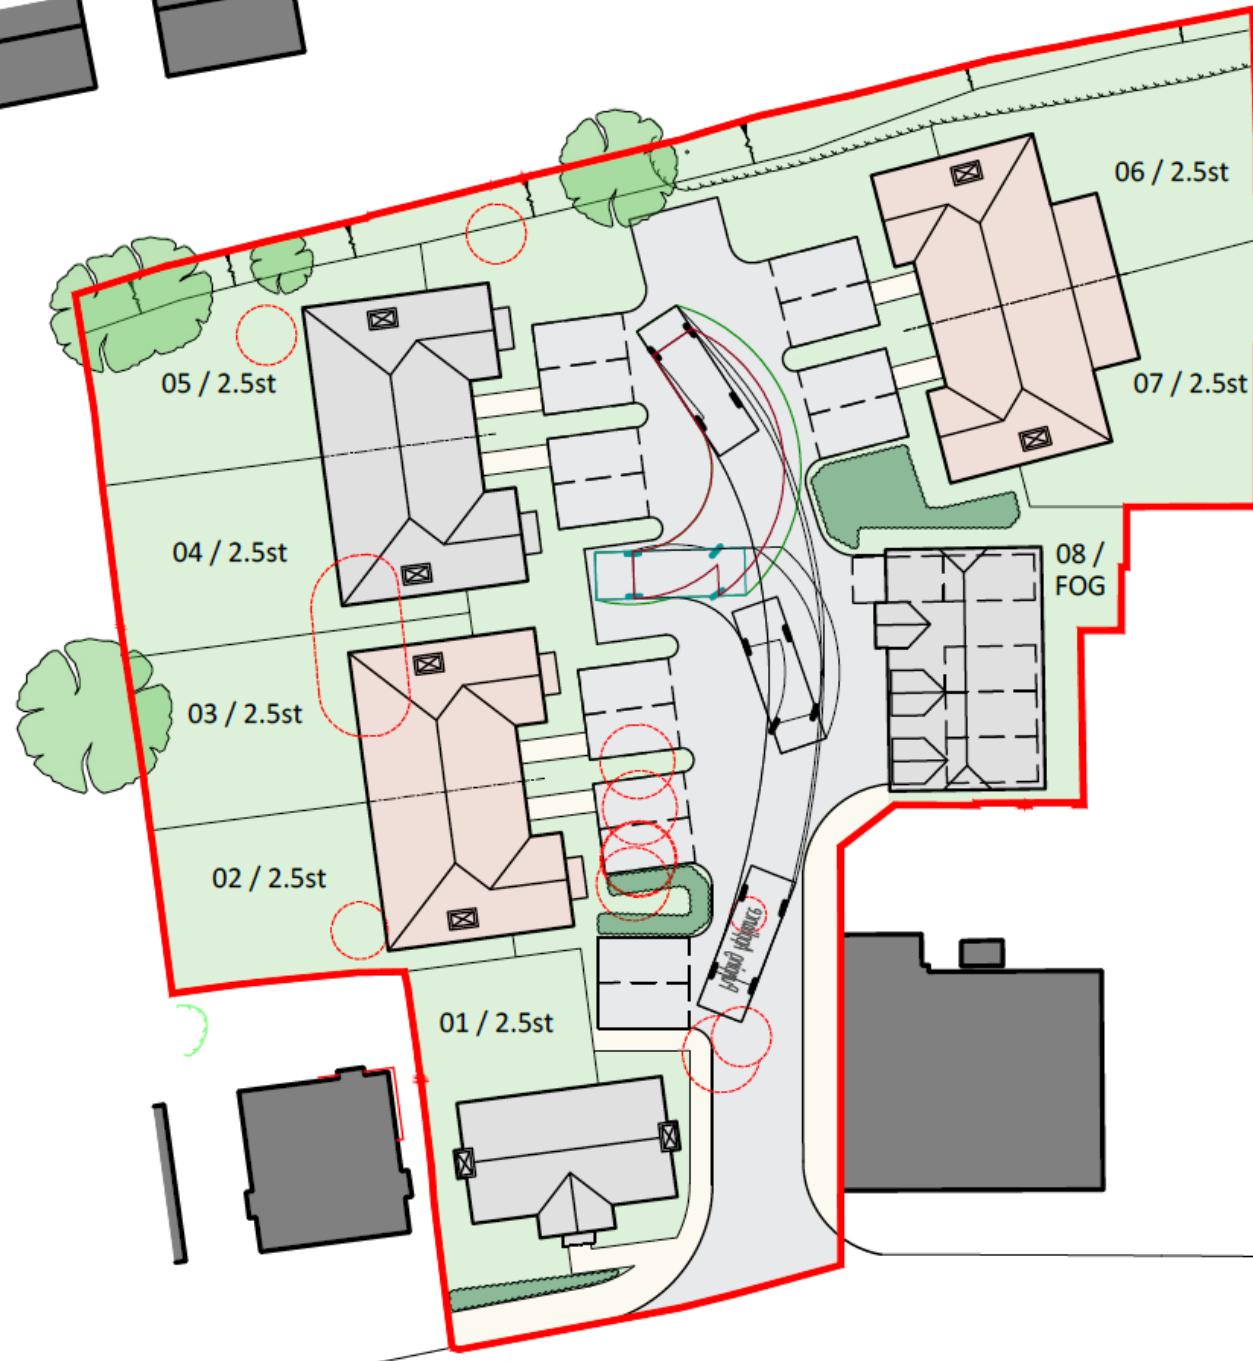
Surrounding Land Use	The site is surrounded by residential premises of Victoria Road and Purfield Drive, with Victoria News and a Mace convenience store located to the south-west and north-east of the site respectively.
Proposed Land Use	The proposed development works comprise the removal of the existing buildings and the construction of eight new detached and semi-detached dwellings, with private gardens and parking, as well as a new access road. Figure 6 is presented as the Proposed Development Plan.

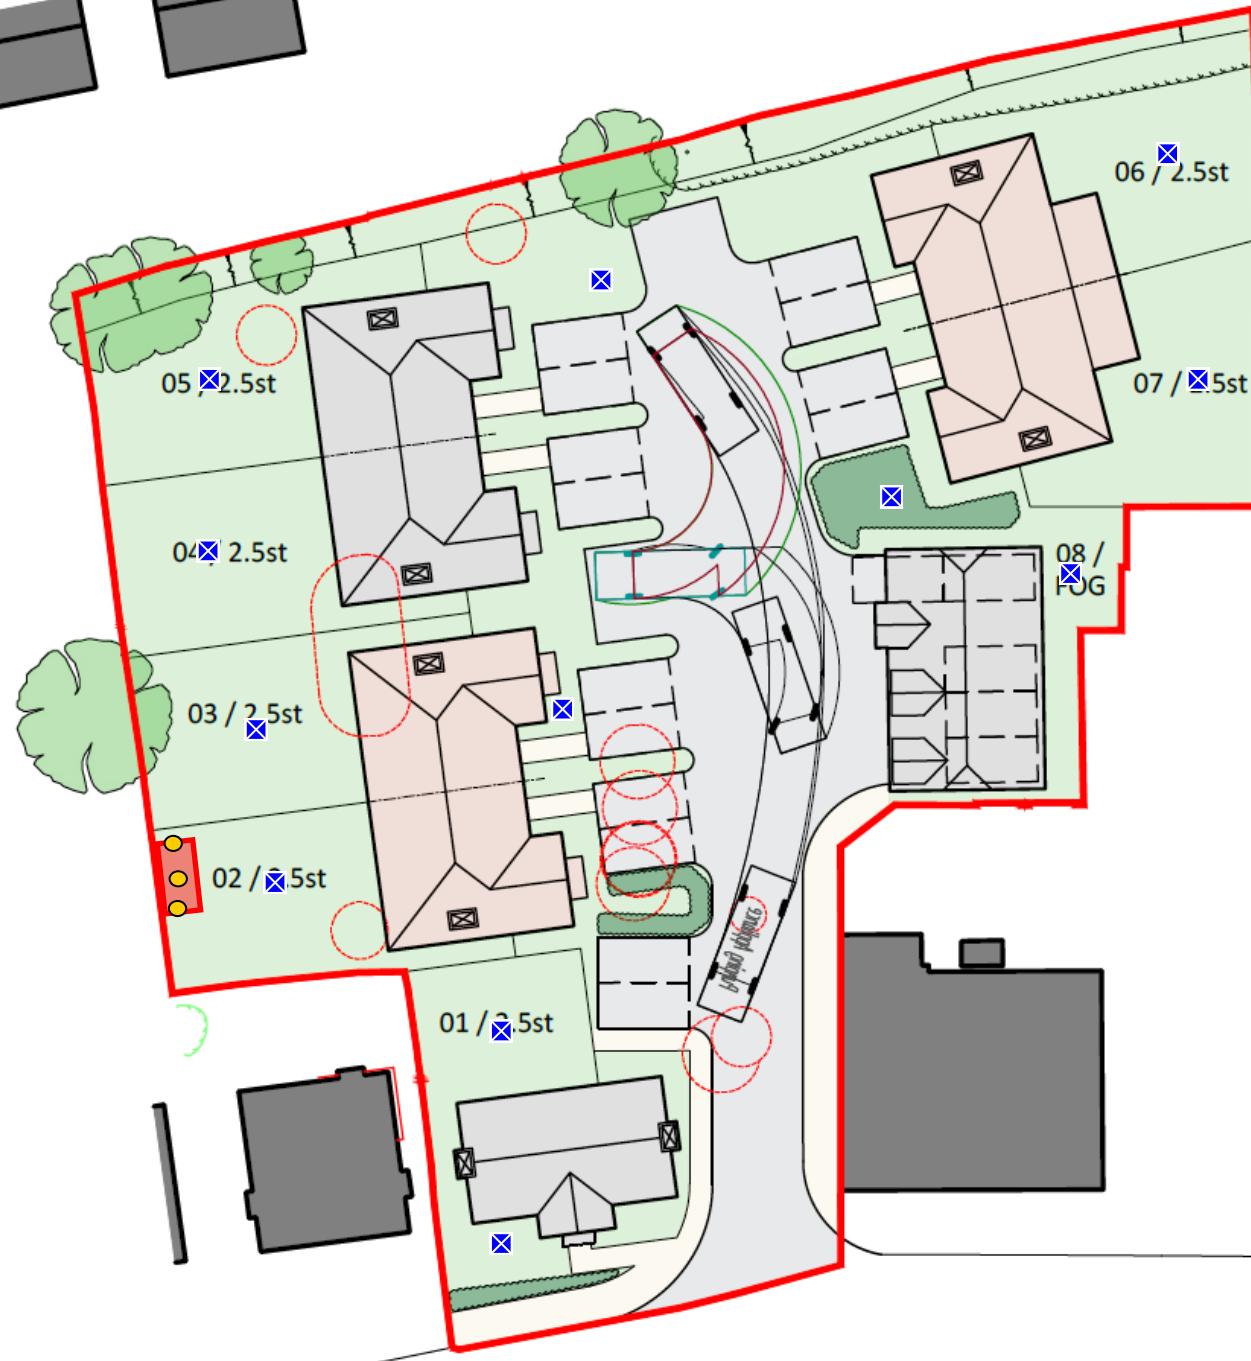
11. Verification sample locations shall targeted to the former footprint of the AST. Given the size of the area occupied by the AST it is recommended three (good science) soil samples are collected from the exposed formation following AST removal to determine if inspection/excavation works were successful in removing the suspected contamination. **Figure 7** is enclosed as a Remediation and Verification Plan.

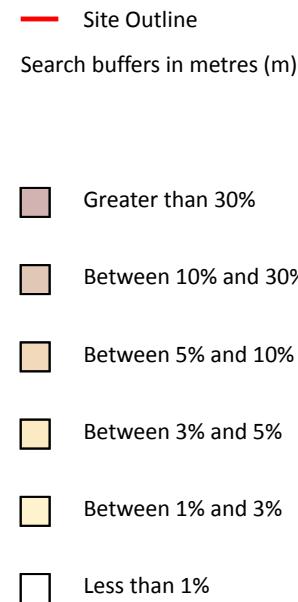
7 Radon

An extract of this report is enclosed within **Appendix I** which indicates the site is located in an area where less than 1% of homes are above the Action Level and that **radon protection is not required**.

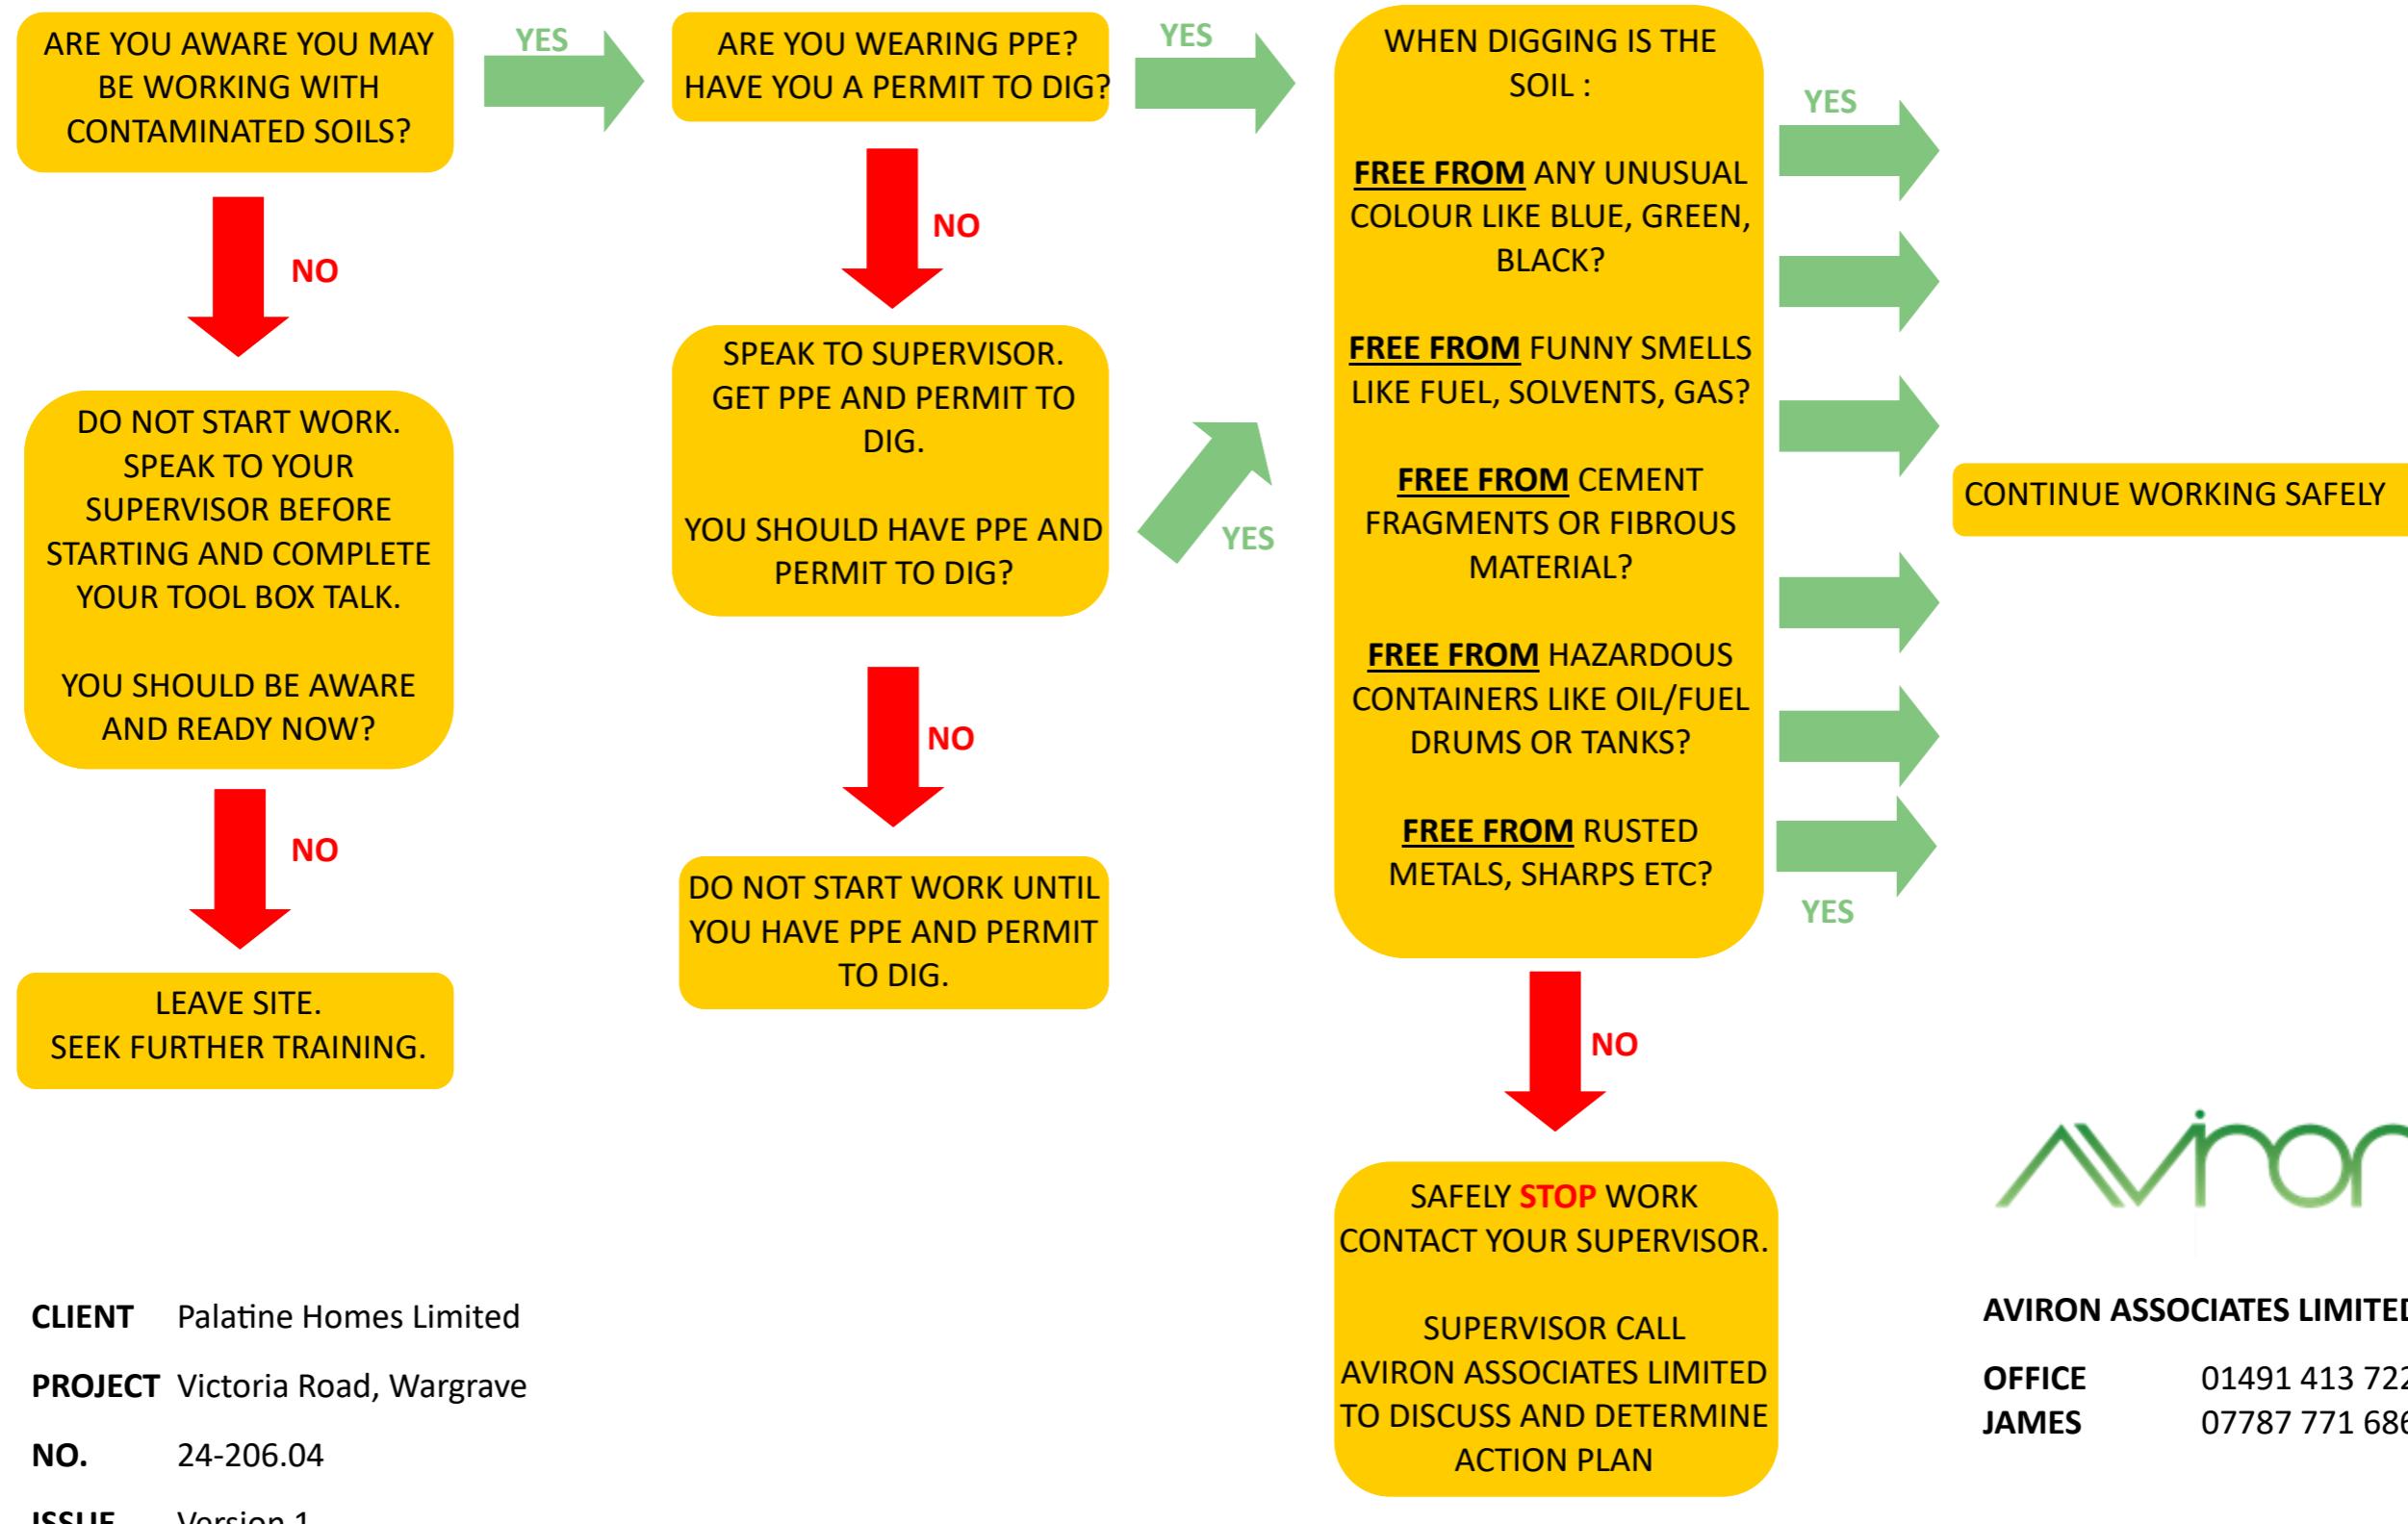
II Discovery Strategy Flow Chart

The Discovery Strategy flow chart is presented as **Appendix II**. This should be printed and laminated.

HOW TO IDENTIFY CONTAMINATED SOILS AND WHAT TO DO?

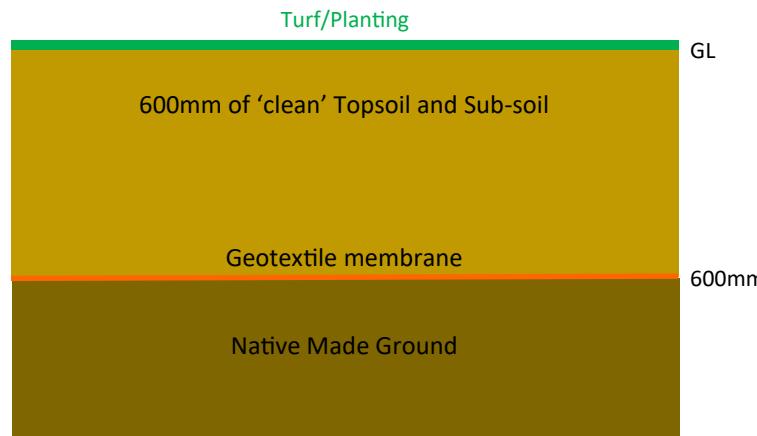
Scenario 1

1. Private Gardens (produce growing areas). Layer thickness of 600mm comprising 'clean' Sub-soil and Topsoil upon a geotextile Hi-Viz alert membrane to deter digging beneath.
2. Frontages/Amenity Areas (non-produce growing areas). Layer thickness of 300mm comprising 'clean' (Sub-soil and) Topsoil over a geotextile Hi-Viz alert membrane to deter digging beneath.

PRIVATE GARDENS

7. Excavated soils should be disposed of as they are unsuitable to remain on-site.
8. The cover system then requires construction as per the detail provided within **Appendix IV** and be of suitable construction dependant upon the final land use; private gardens/frontages.

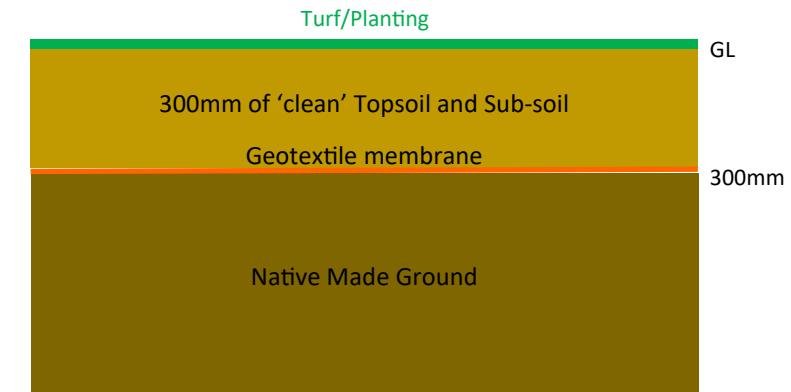
Scenario 2

FRONTAGES/AMENITY AREAS
