# Bat Roost Potential Report

Outbuilding

129 Victoria Road

Wargrave

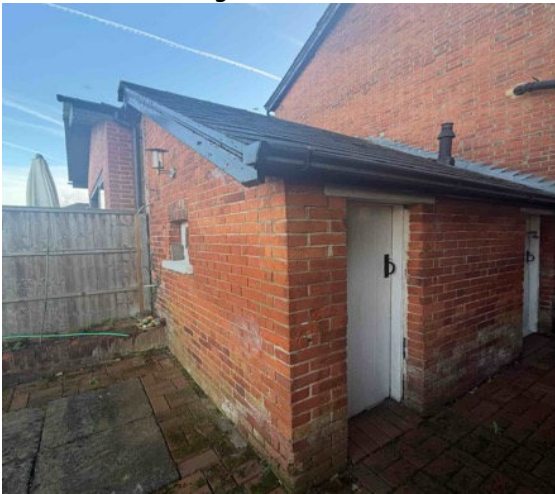
***Plate 1: Outbuilding***

- 4.10 The outbuilding is considered to present ***negligible*** potential for roosting bats based on the evidence gathered during the walkover survey. The structure was a small, single-storey brick-built outbuilding of relatively modern construction, with a pitched slate roof in good condition and fitted with modern guttering and fascia boards. Modern construction of this type typically offers very limited opportunity for bats to gain access to the roof void or wall cavities, as contemporary building materials and methods leave few of the gaps, crevices, and voids that older structures commonly present.

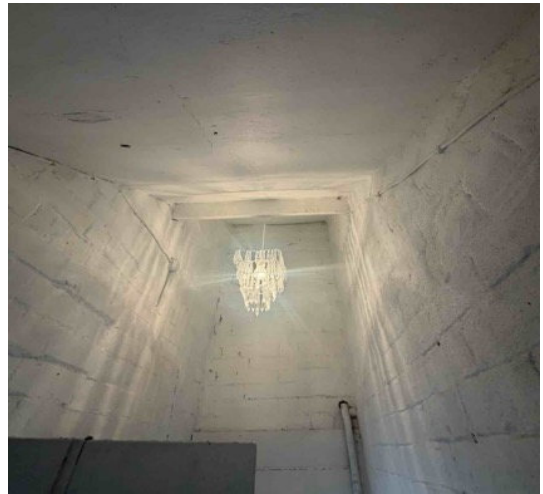
***Plate 2: First Internal Section***

- 4.11 Internal inspection of the outbuilding revealed a whitewashed brick interior with a flat painted ceiling and no visible access points into any roof void space above. The interior was actively used for storage, and showed no evidence of bat activity in the form of droppings, feeding remains, or staining around potential roost entry points. Externally, the roofline was inspected closely and whilst a small gap was noted between the brick gable and the roof covering but this feature was not considered to present sufficient depth or shelter to support a sustainable roost.
