## **ECOLOGICAL SURVEY REPORT (BATS) AT ROSE COTTAGE WOKINGHAM**

**Prepared for:  
Mr J Gibbs  
Rose Cottage  
Limmerhill Road  
Wokingham  
RG41 4BU**

**7 October 2024**

**Ref: SPH/ESR-24/21.09**

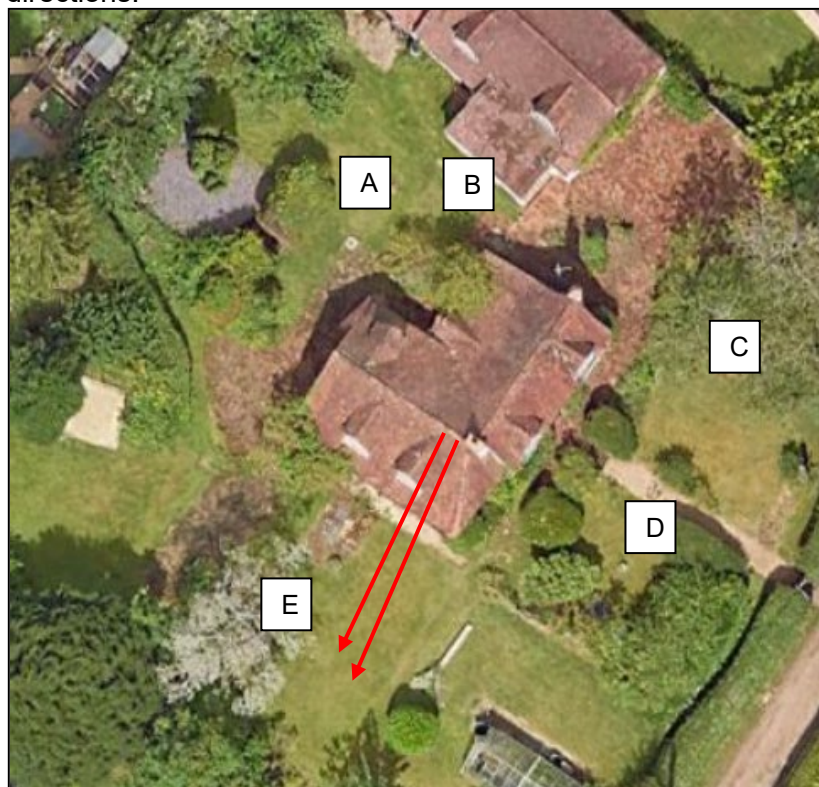
Figure 1 – Rose Cottage, Wokingham, surveyor/remote camera locations and emergence directions.

The surveyors/remote camera(s) were stationed (as shown in Figure 1), to ensure the features identified in the preliminary ecological appraisal (DBW) could be observed. Sample screenshots from the video cameras are included at Appendix 2.

At 21.08, during the first emergence survey (29.07.24), an individual soprano pipistrelle bat was seen and recorded emerging from under a roof tile, to the right of the right dormer window on the southwest facing elevation (referred to as the left side elevation on the plans). During the second emergence survey (22.08.24), at 20.31, an individual common pipistrelle bat was seen and recorded emerging from under a gap in the roof tile above the right dormer window on the same southwest facing elevation and, during the last emergence survey (21.09.24), at 19.04 an individual soprano pipistrelle bat was seen and recorded emerging from under the same lifted roof tile as on the first survey.

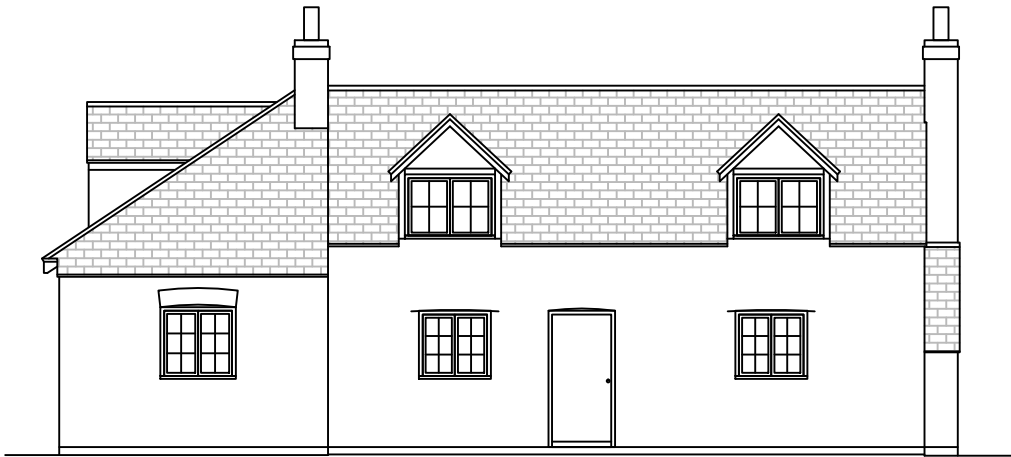
Front Elevation

- Brickwork finish to walls to match existing.
- Render finish to dormer walls to match existing.
- Roof tiles to match existing.
- Timber windows & doors.
- En-Suite & WC windows obscure glazed.

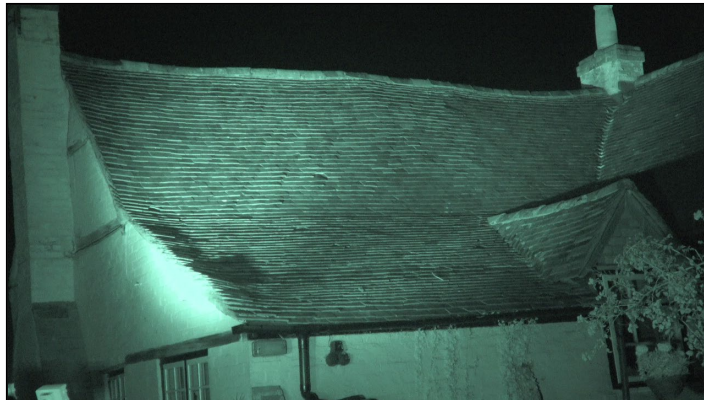
A

| Date | Surveyor Position | Time | Seen | Heard | Species | Comments |
|---|---|---|---|---|---|---|
| 29/07/24 | B | 20:40 – 22:30 | Y | N | Remote camera | During the survey, the camera did not record any bat activity. |

| Date | Surveyor Position | Time | Seen | Heard | Species | Comments |
|---|---|---|---|---|---|---|
| 22/08/24 | B | 19:55 – 21:40 | Y | N | Remote camera | During the survey, the camera did not record any bat activity. |
| 21/09/24 | B | 18:45 – 20:35 | Y | N | Remote camera | During the survey, the camera did not record any bat activity. |

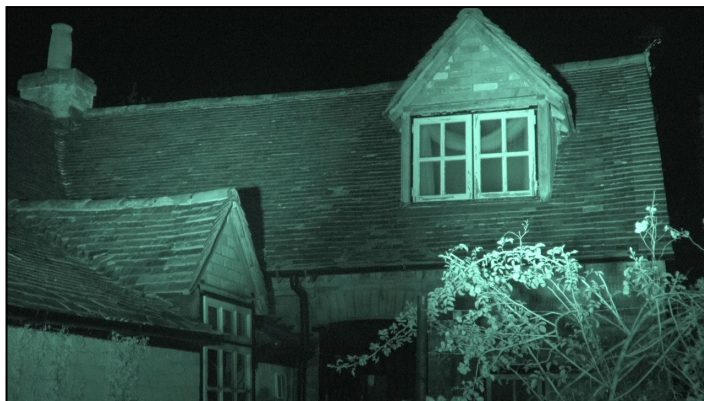
B

| Date | Surveyor Position | Time | Seen | Heard | Species | Comments |
|---|---|---|---|---|---|---|
| 29/07/24 | C | 20:40 – 22:30 | Y | N | Remote camera | During the survey, the camera recorded bats in transit across the front of the property only. |

| Date | Surveyor Position | Time | Seen | Heard | Species | Comments |
|---|---|---|---|---|---|---|
| 22/08/24 | C | 19:55 – 21:40 | Y | N | Remote camera | During the survey, the camera did not record any bat activity. |
