**Heritage Statement**  
Sussex Lodge  
Sussex Lane  
Spencer's Wood  
Reading

**Date of Issue**  
October 2022

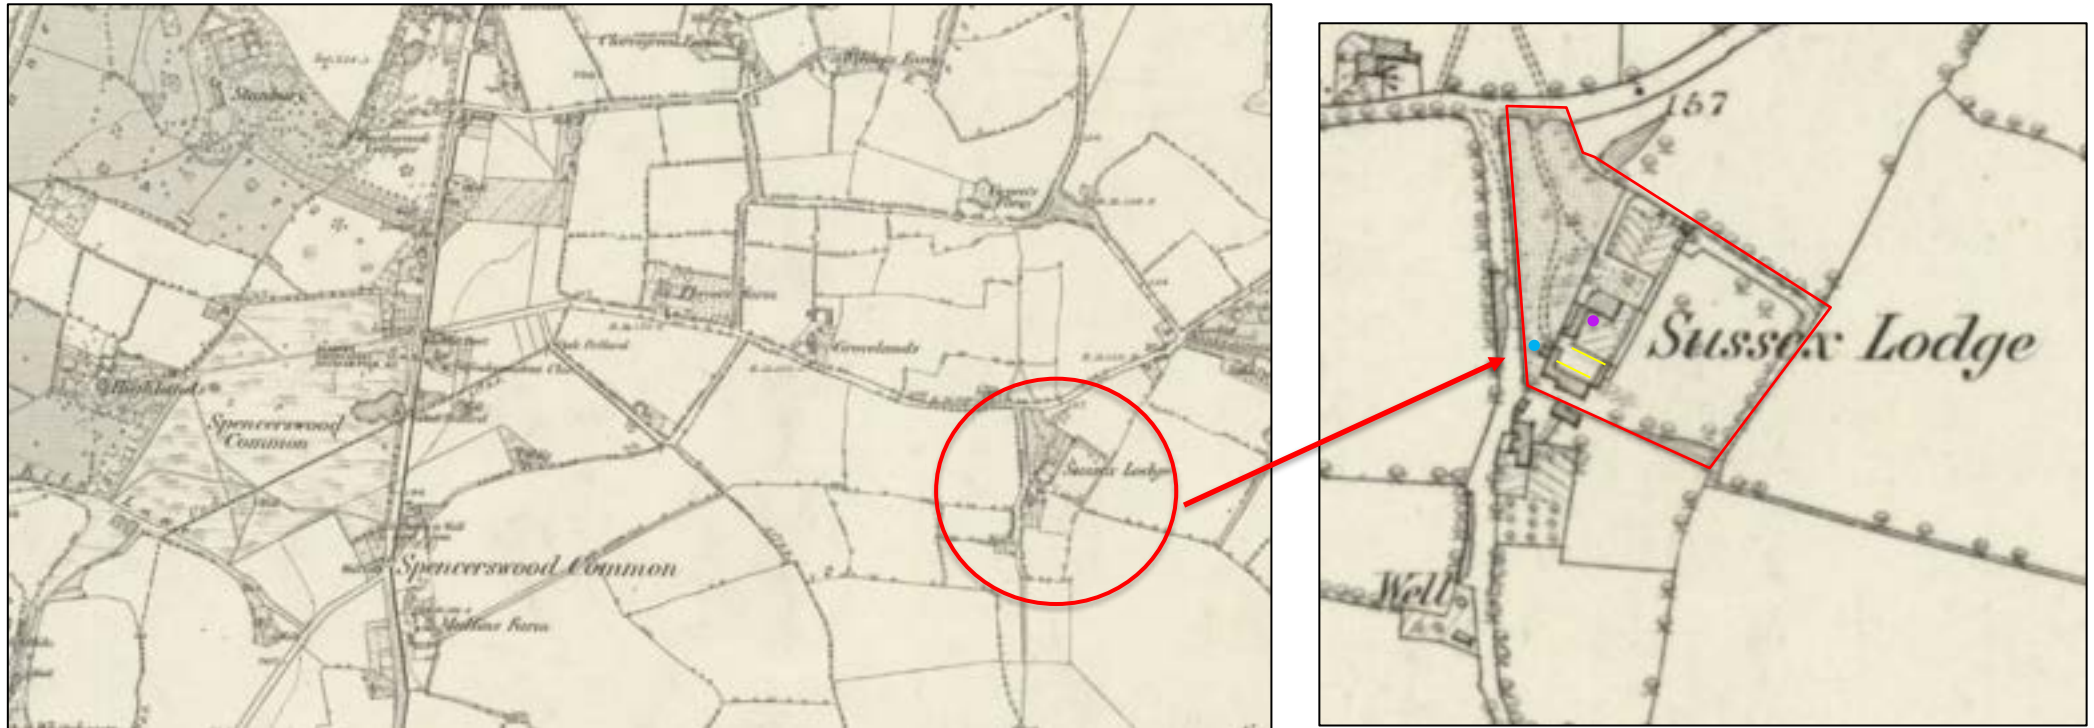
Figure 5: Extract of Ordnance Survey 25 Inch Map: Hampshire Sheet V Surveyed: **1881** & Published **1887**. Approx. site location highlighted in red  
Detail (right): Sussex Lodge and the adjacent outbuilding are highlighted in purple, to the south of the Lodge is a range of outbuildings, the majority of which have now been lost save for the small stable to the south-west highlighted in blue. To the north of the principal building there are a further handful of outbuildings which are no longer present on site. The landscaped gardens around Sussex Lodge appear to be bounded by walls, the surviving historic ones highlighted in yellow, the southernmost boundary wall, which in part survives today appears to be a remnant from the historic building (Figure 62 & Figure 63).

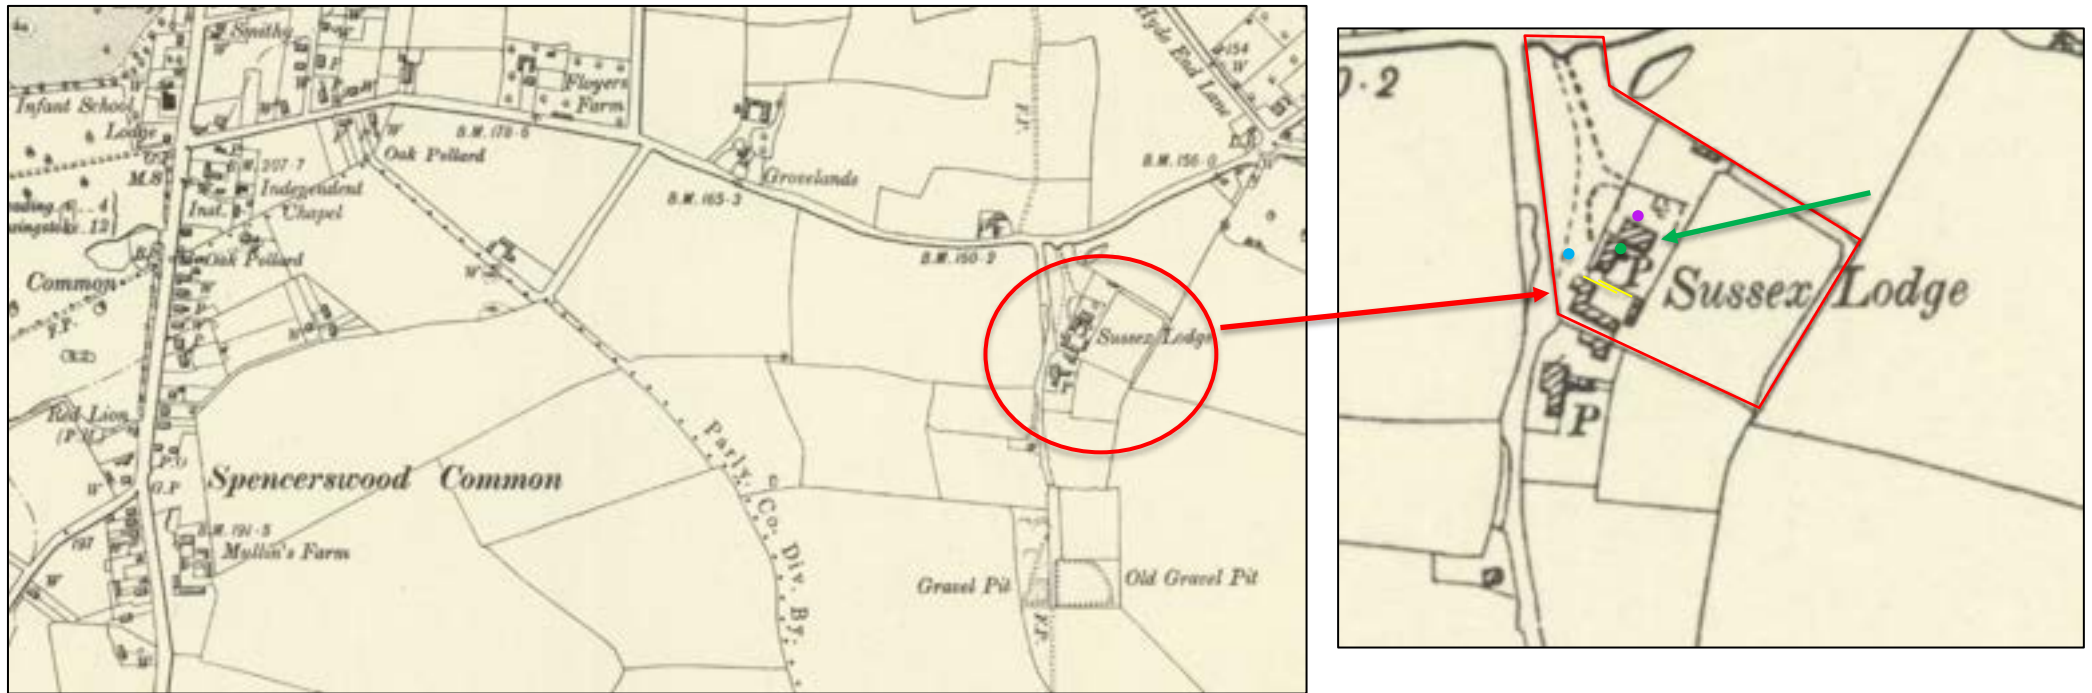
Figure 6: Extract of Ordnance Survey 12 Inch Map: Berkshire Sheet XLV.NE- Revised 1898 & Published 1900. Approx. site location highlighted in red

Detail (right): Sussex Lodge and the adjacent outbuilding are highlighted in purple, to the south of the Lodge is a range of outbuildings (the former agricultural yard), the majority of which have now been lost save for the small stable to the south-west highlighted in blue. To the north of the principal building there are a further handful of outbuildings which are no longer present on site. The landscaped gardens around Sussex Lodge appear to be bounded by walls, the surviving historic ones highlighted in yellow, the southernmost boundary wall, which in part survives today appears to be a remnant from the historic building (Figure 62 & Figure 63). The 'P' identified in green (arrow) indicates a pillar, post or pole which may be the small extension (highlighted in green dot) to the west elevation of the attached outbuilding

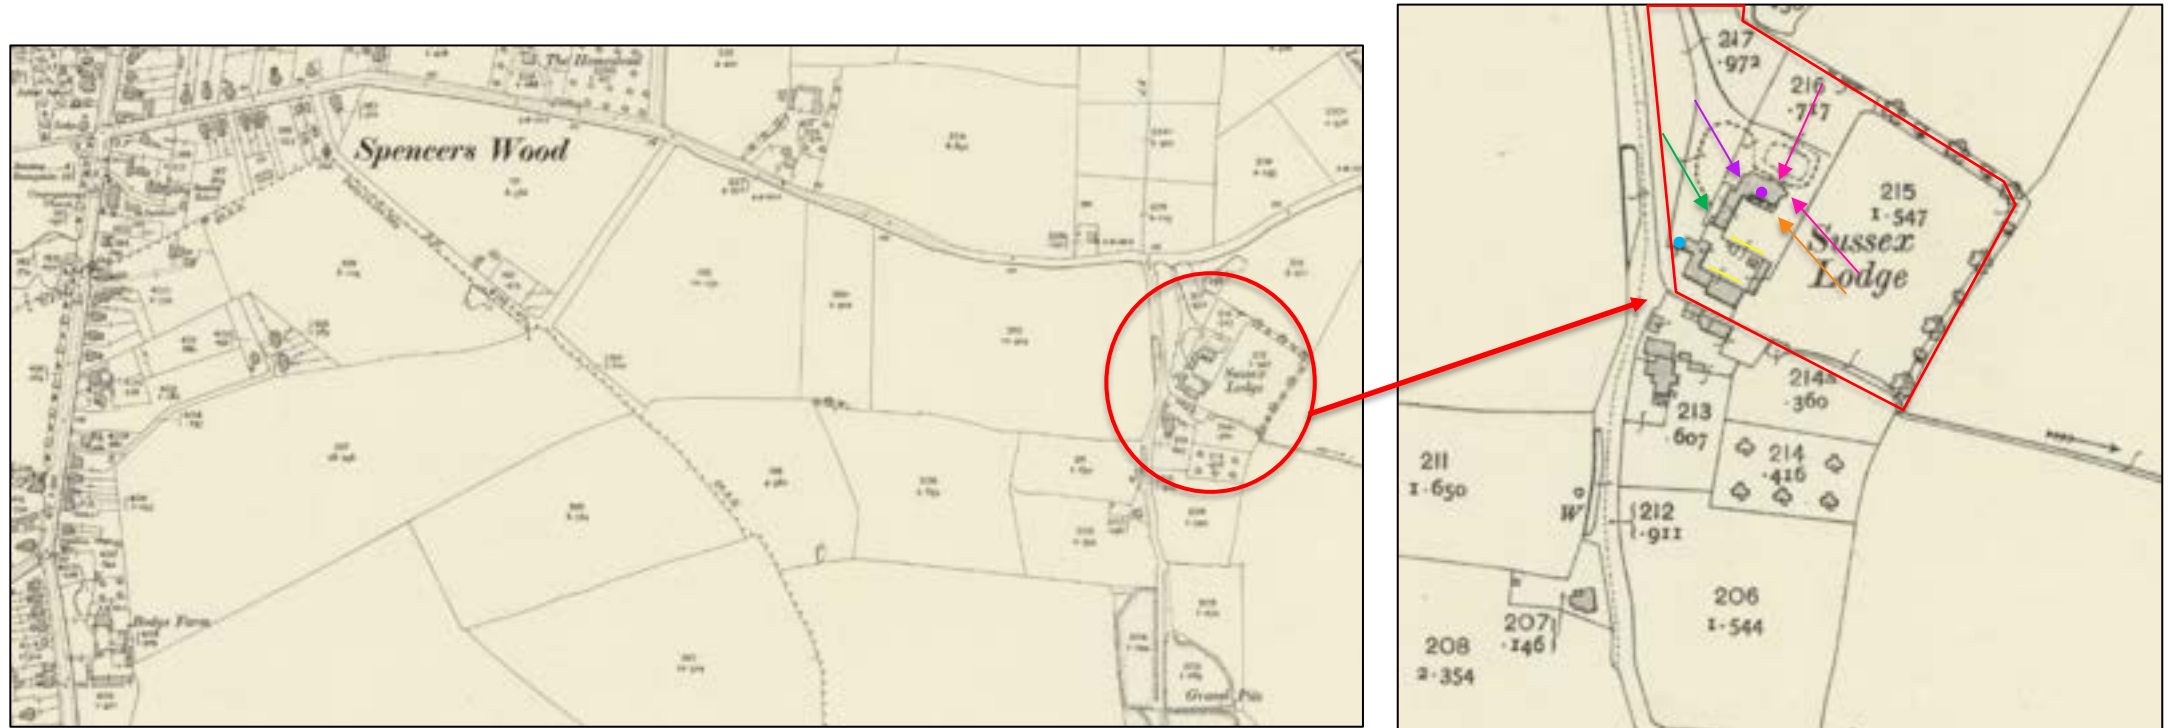
Figure 7: Extract of Ordnance Survey 25 Inch Map: Berkshire XLV.3- Revised 1909 & Published 1911. Approx. site location highlighted in red  
 Detail (right): Sussex Lodge and the adjacent outbuilding are highlighted in purple, note the infill between the outbuilding and principal house (highlighted purple arrow) which would now today be the pantry former kitchen area. To the south of the Lodge is a range of outbuildings (formerly the agricultural yard), the majority of which have now been lost save for the small stable to the south-west highlighted in blue. To the north of the principal building there a further handful of outbuildings which are no longer present on site. The landscaped gardens around Sussex Lodge appear to be bounded by walls, the surviving historic ones highlighted in yellow, the southernmost boundary wall, which in part survives today appears to be a remnant from the historic building. Identified in orange (arrow) a glass house/conservatory- not the one in existence today. Identified in green (arrow) an outhouse which still stands today. Identified in pink (arrow) the porch and bay window to the north and east of the house respectively

The north elevation comprises of 3 bay formerly sash windows (now unfortunately, uPVC replicas) under flat segmental heads (**Figure 16**). The windows on the ground floor are taller than the first floor. The solid sided painted porch with cornice capping (**Figure 15**), was once open now closed within a uPVC door; this feature first appeared on OS maps in 1909 (**Figure 7**).

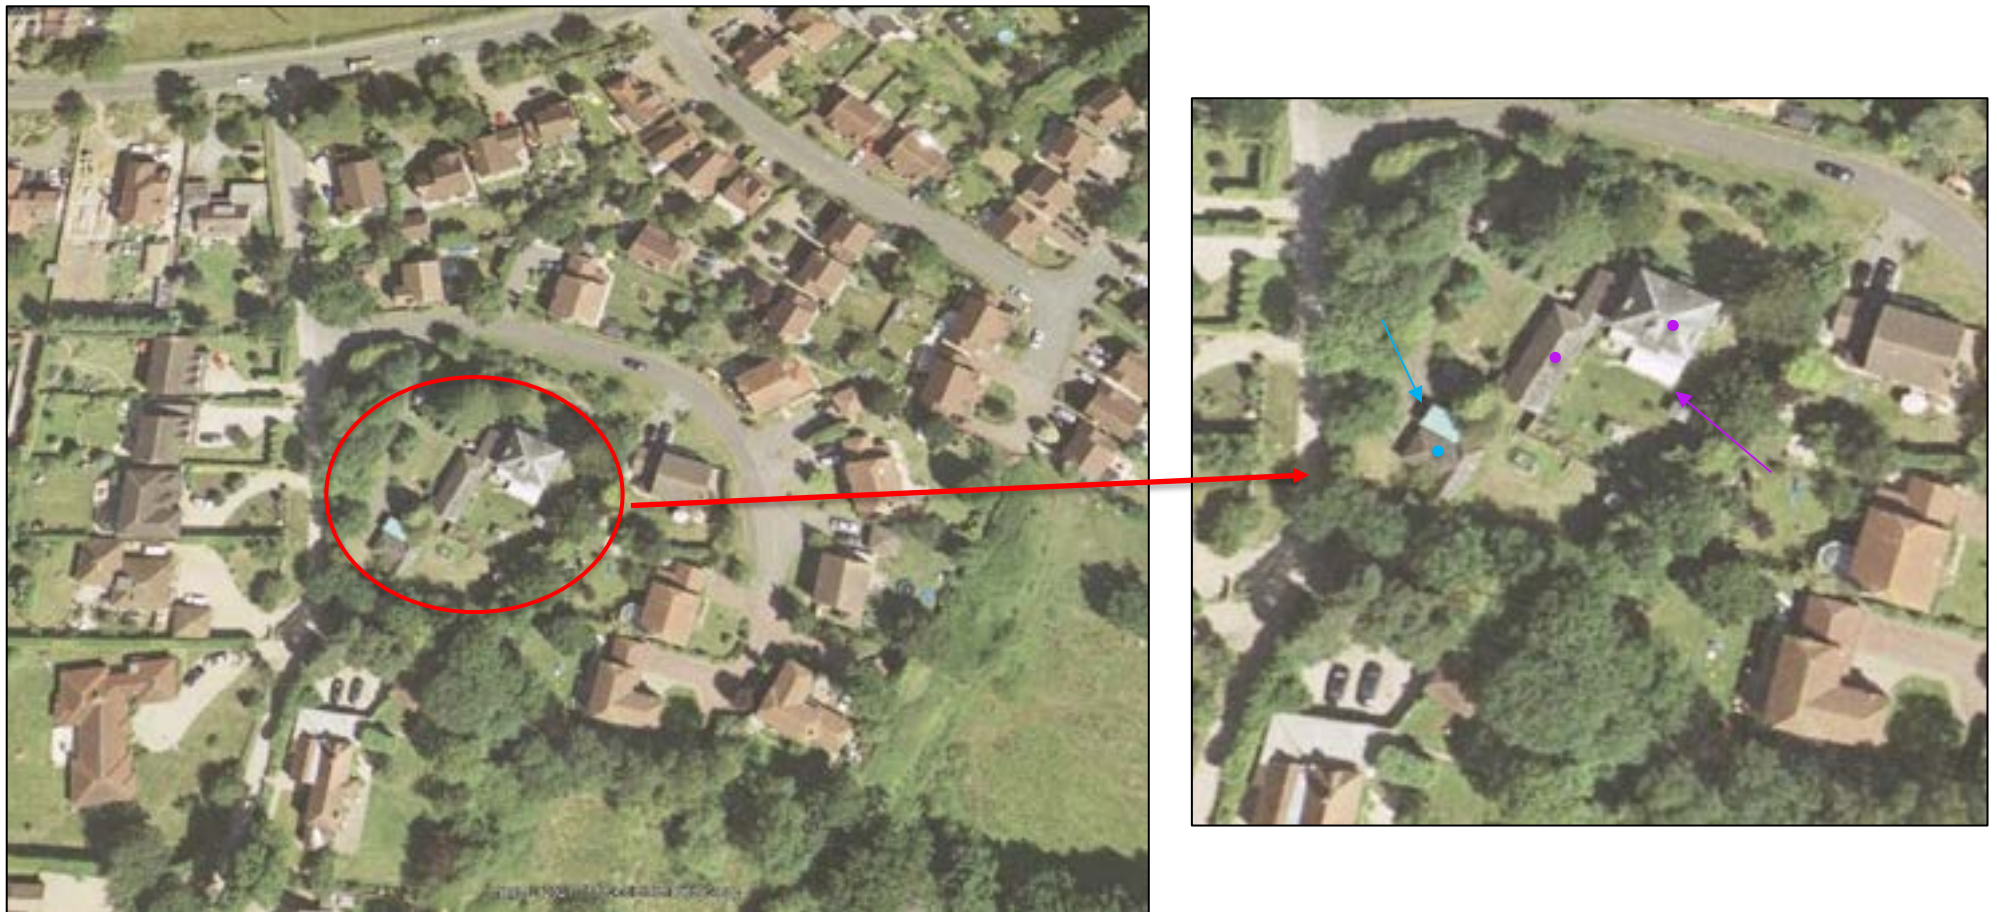
*Figure 9: 2003 Google Aerial Image, approx. site location outlined in red  
Detail (right): Sussex Lodge and attached outbuilding highlighted in purple dot, detached stable/garage building highlighted in blue dot. Note the detached structure north of the stable/garage (blue arrow) and the structure attached to the conservatory on the south elevation (purple arrow) visible in the birds eye image 2021*

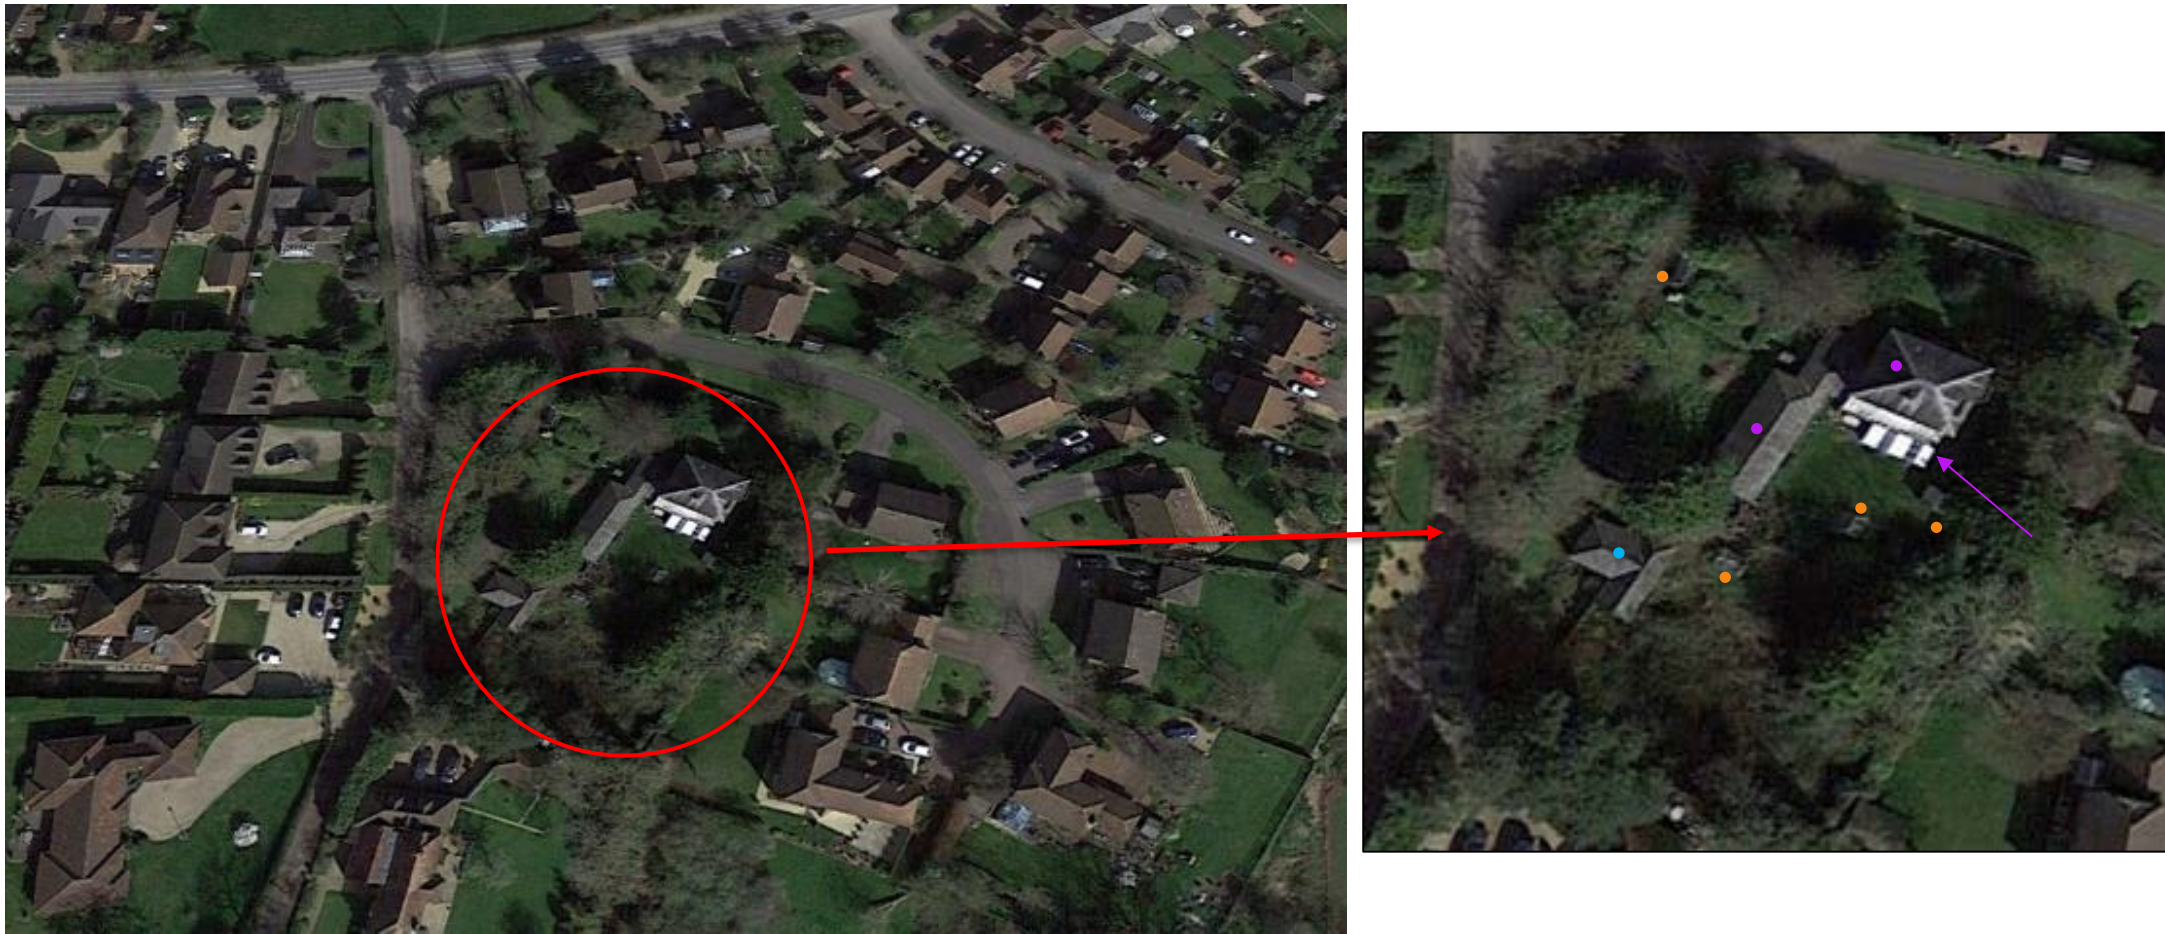
*Figure 10: 2017 Google Aerial Image, approx. site location outlined in red  
Detail (right): Sussex Lodge and attached outbuilding highlighted in purple dot, detached stable/garage building highlighted in blue dot. Note the detached structure north of the stable/garage identified on the image above is gone, however there are a number of satellite structures within the garden (orange dots). The structure attached to the conservatory on the south elevation (purple arrow) has remained*

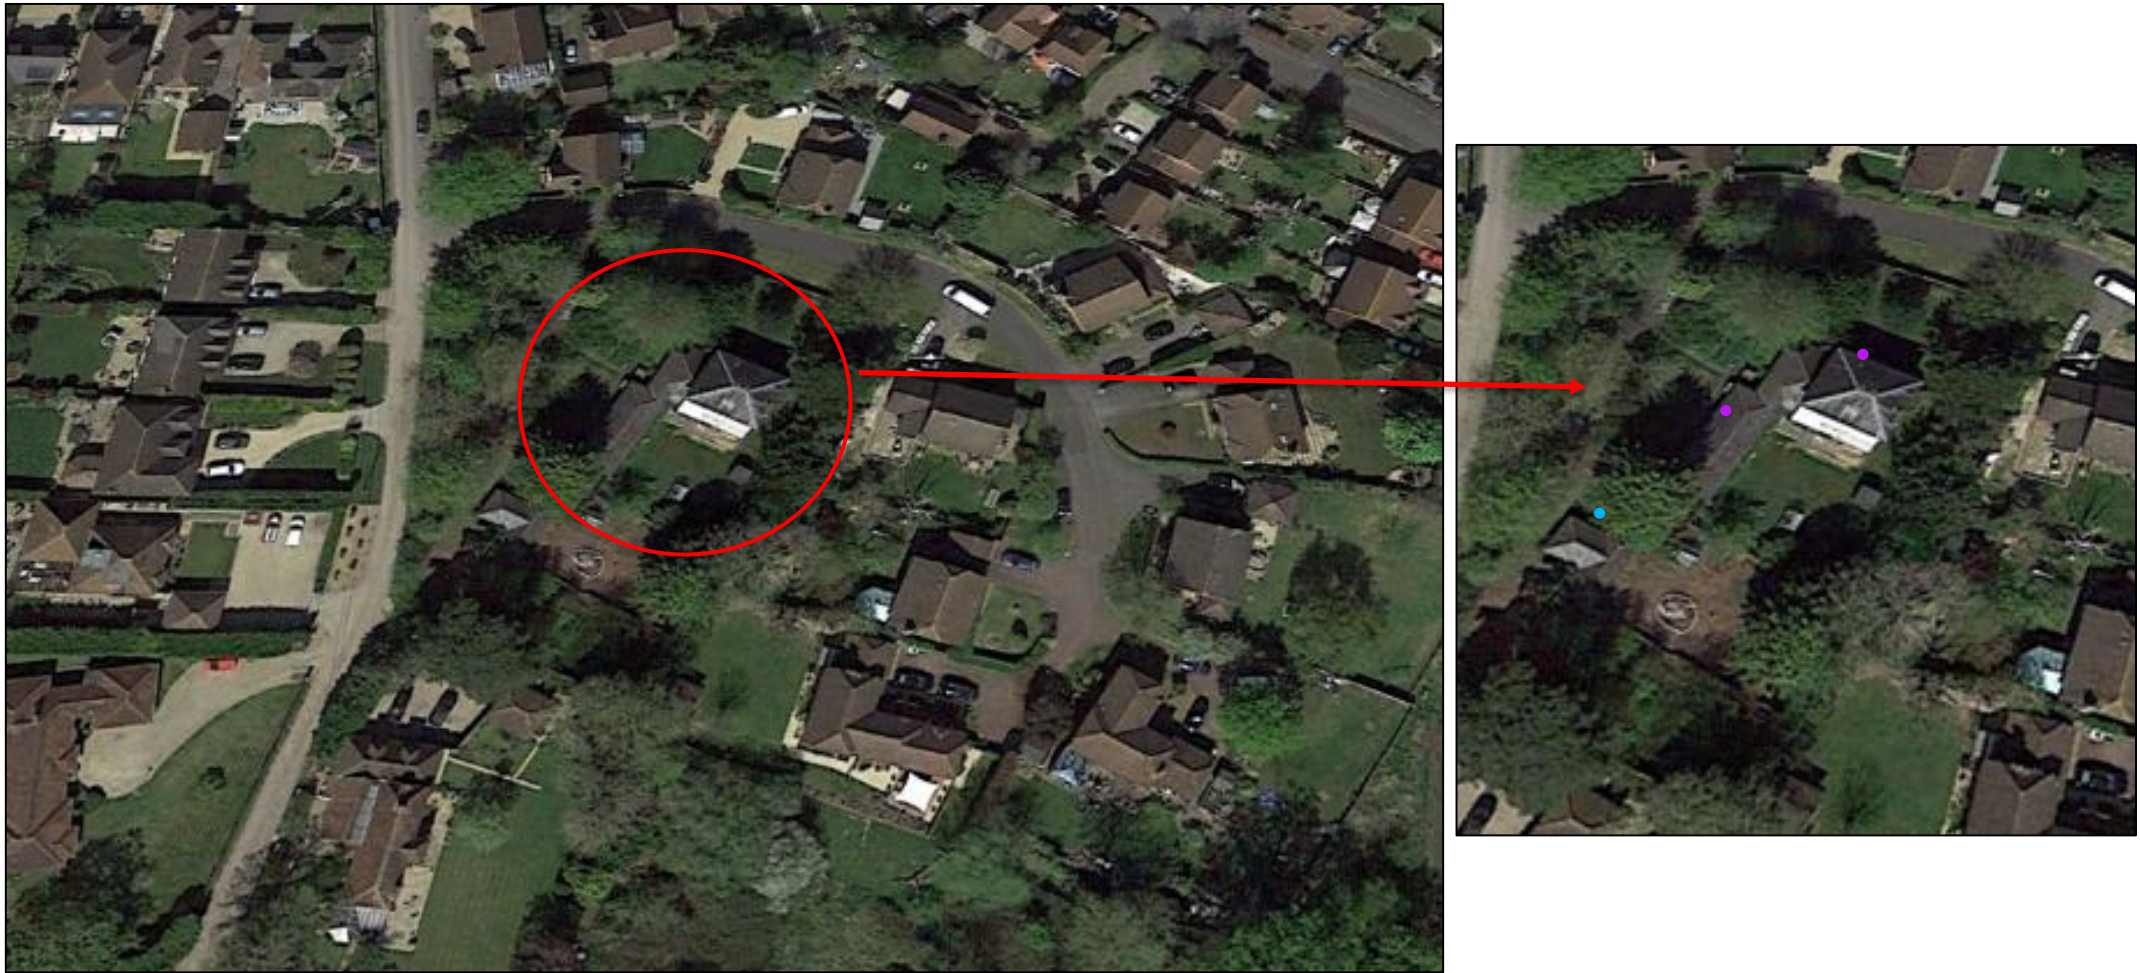
*Figure 11- 2020 Google Aerial Image, approx. site location outlined in red  
Detail (right): Sussex Lodge and attached outbuilding highlighted in purple dot, detached stable/garage building highlighted in blue dot. Note the satellite structures within the garden have remained (orange dots). The structure attached to the conservatory on the south elevation has been removed.*

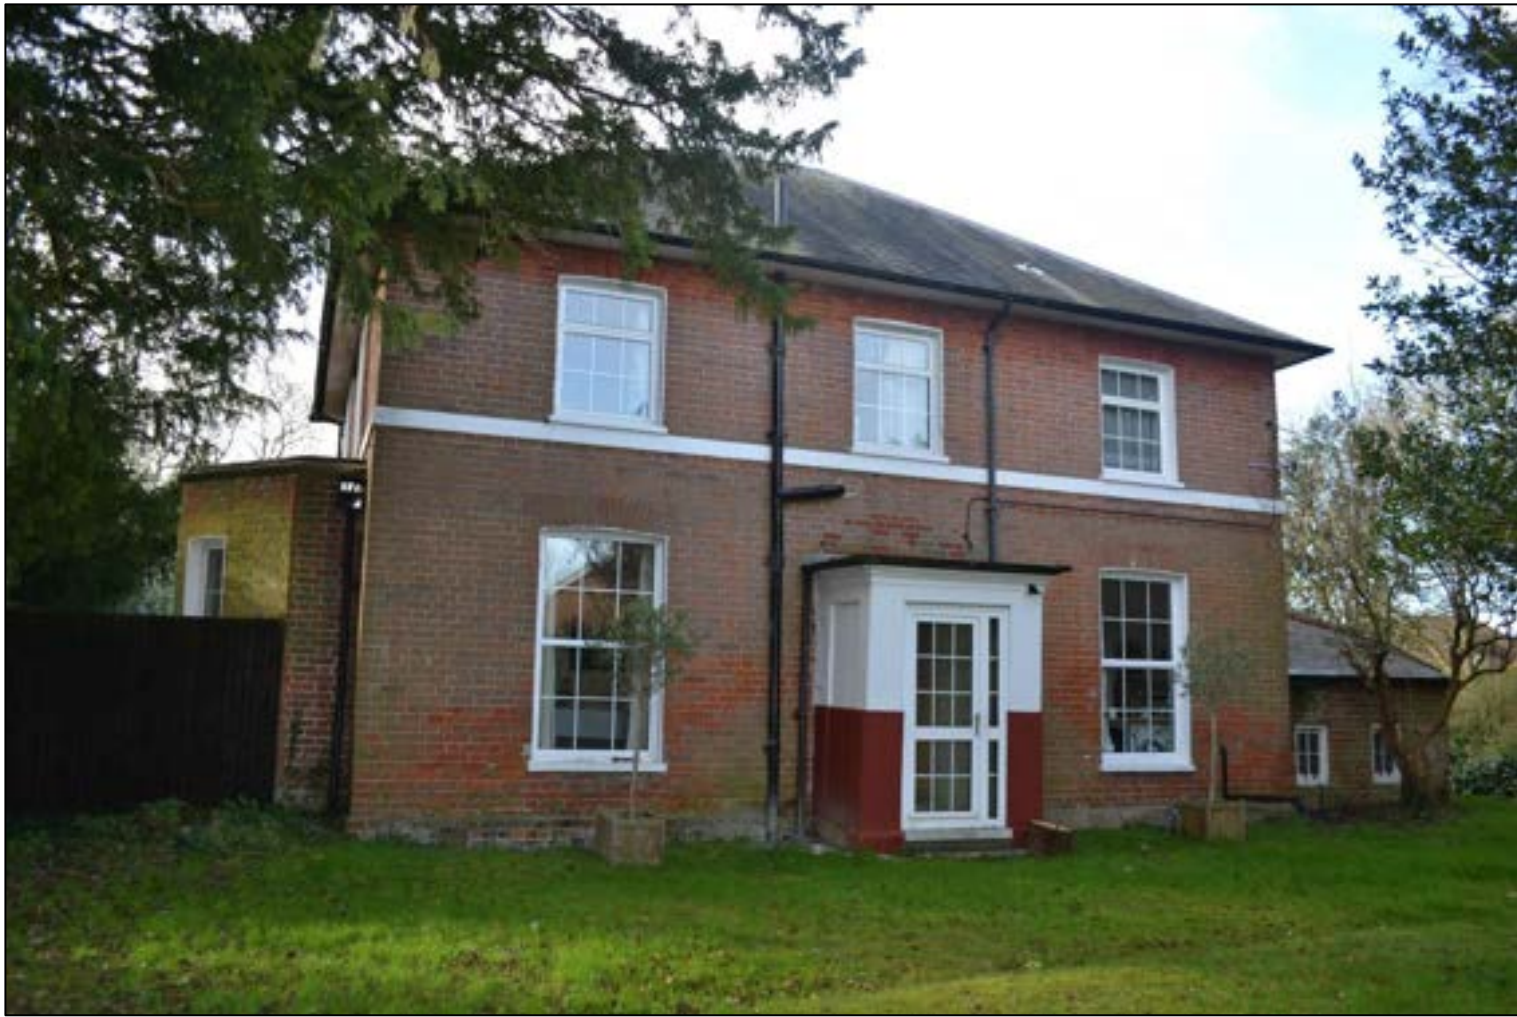
*Figure 14: North (front) elevation of Sussex Lodge*

Sussex Lodge is an early 19<sup>th</sup> century former farmhouse predominantly constructed of brick (laid in a Flemish Bond) under a steeply pitched hipped slate roof. The property is a rectangular plan made up of 2 storeys and an attic, with flanking chimneys. A brick painted string course separates the floors around the entire property. It is thought that in the late 19<sup>th</sup> century the property was once, briefly, a school. A sales catalogue from the 1920s however describes the property as 'country residence' - see [Appendix F](#).

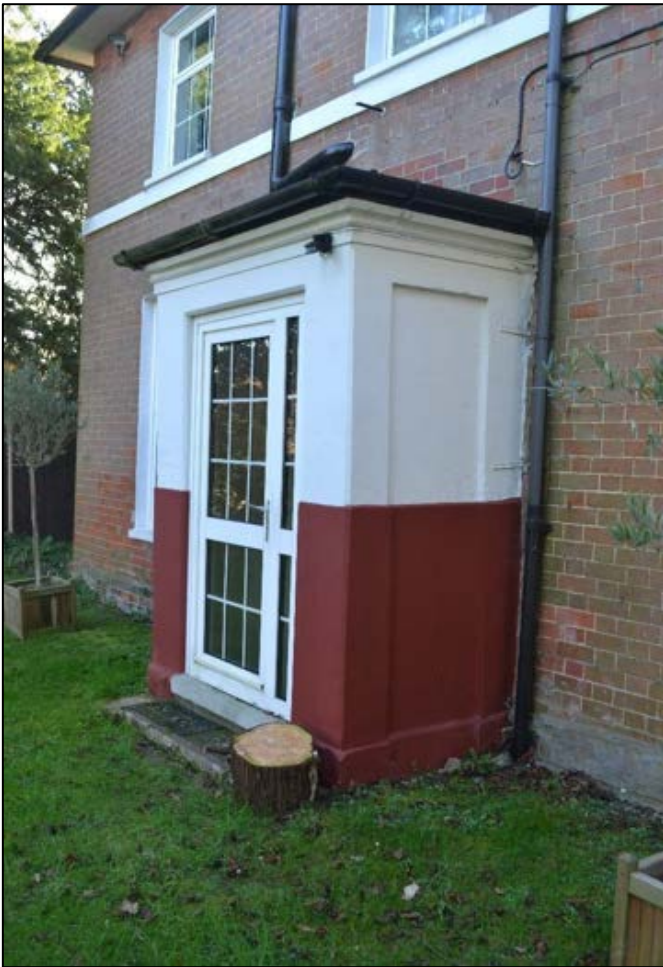
Figure 15: (left) Solid side painted porch, once open now enclosed by uPVC door. The earliest the porch appears on OS Maps is 1909 (**Figure 7**)

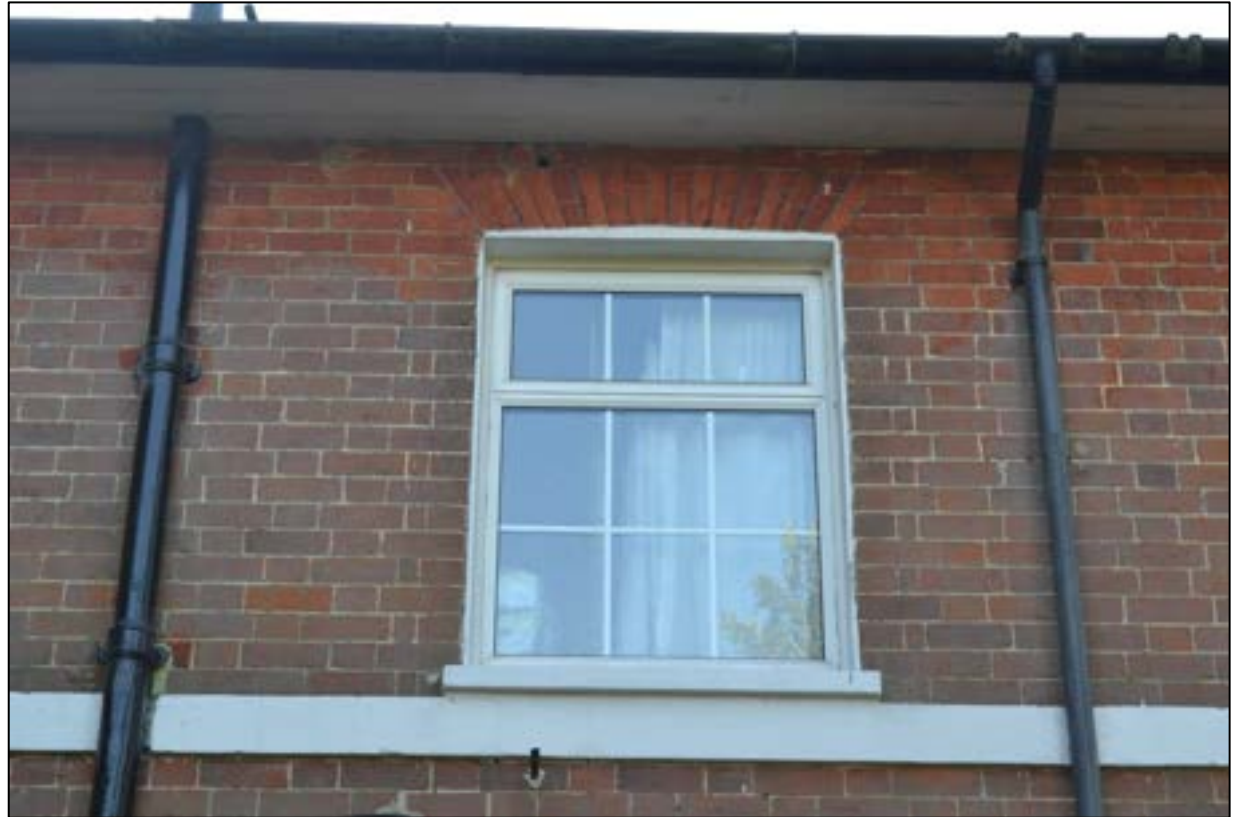
Figure 16: (right) Painted string course detail and flat segmental head - note the window has been replaced with a uPVC replica of inappropriate material and detailing

Furthermore the replacement of windows throughout, which are at present double glazed uPVC, with timber double glazed windows in a more appropriate style that are in keeping with the age of the property would not only restore the original appearance of the building but would also go some way towards balancing out any harm potentially caused by other proposals on the site. Therefore balancing out and mitigating any adverse impacts (which, where present, are considered to be minor). Whilst it is appreciated that single-glazed units might have been in originally it is felt that the proposed double glazed timber units both sustain (match the thickness of the glazing in at present) and enhance (improve the design of the windows to a more appropriate style) as per para 197 of the NPPF.

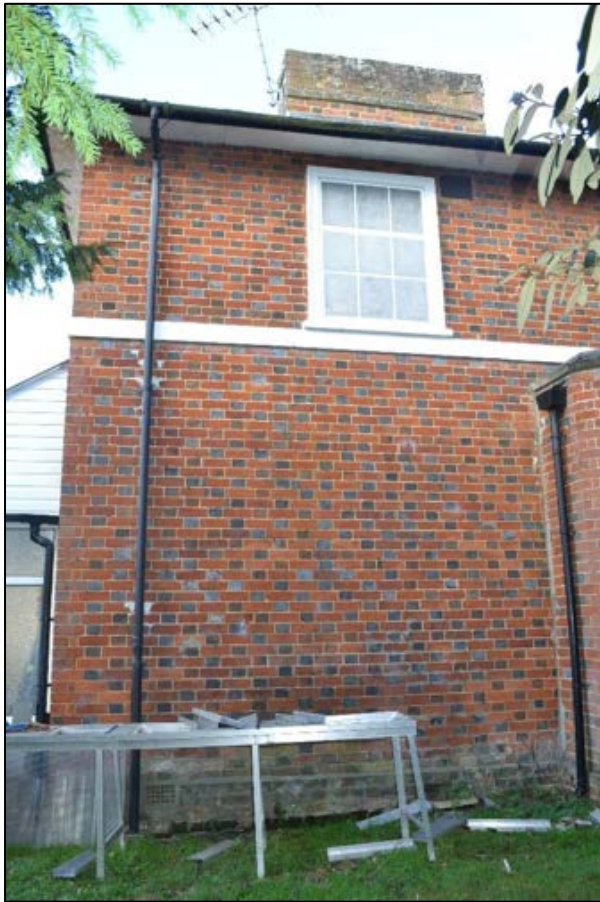
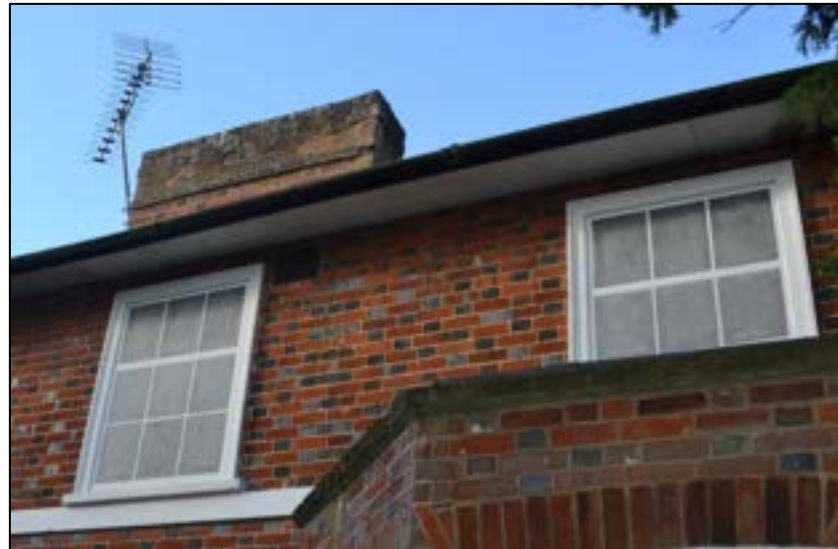
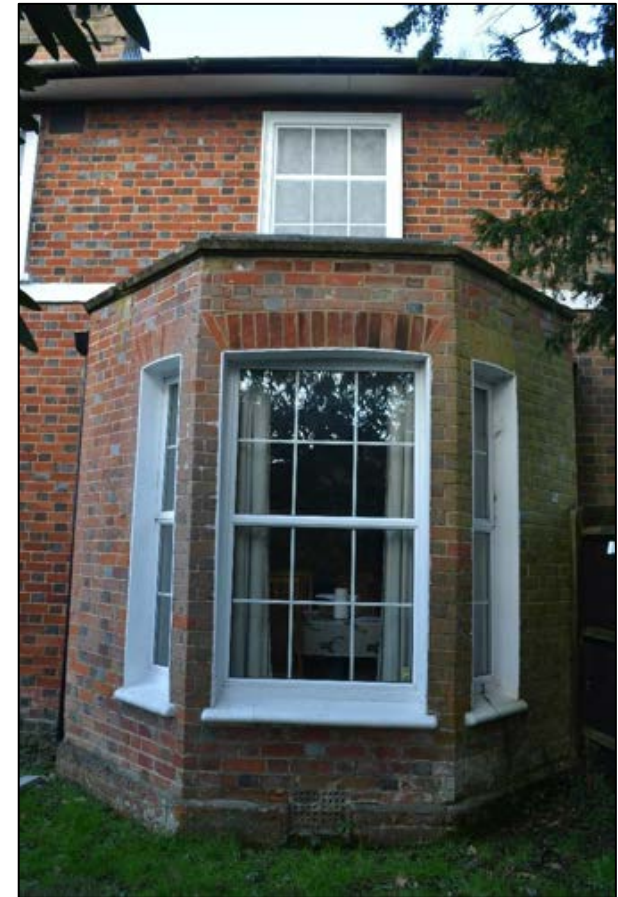
*Figure 17: Details of the east elevation - note the painted blind windows on the first floor. The projecting bay window of the ground floor is thought to date from the late 19<sup>th</sup>/early 20<sup>th</sup> century*

- **Pink**- As above, rebuild and repair chimney stacks on east and west gable ends (**Figure 17 & Figure 21**).
- **Yellow**- Insert rooflights to the east and west roof slopes of the attached outbuilding to correspond with its proposed conversion (see [Attached Outbuilding](#)).
- **Green**- Insert 3 aluminium casement windows along west elevation of attached outbuilding to correspond with its proposed conversion (see [Attached Outbuilding](#)).
- **Red**- Insert 2 full height aluminium double sliding doors along eastern elevation of attached outbuilding to correspond with its conversion (see [Attached Outbuilding](#)).

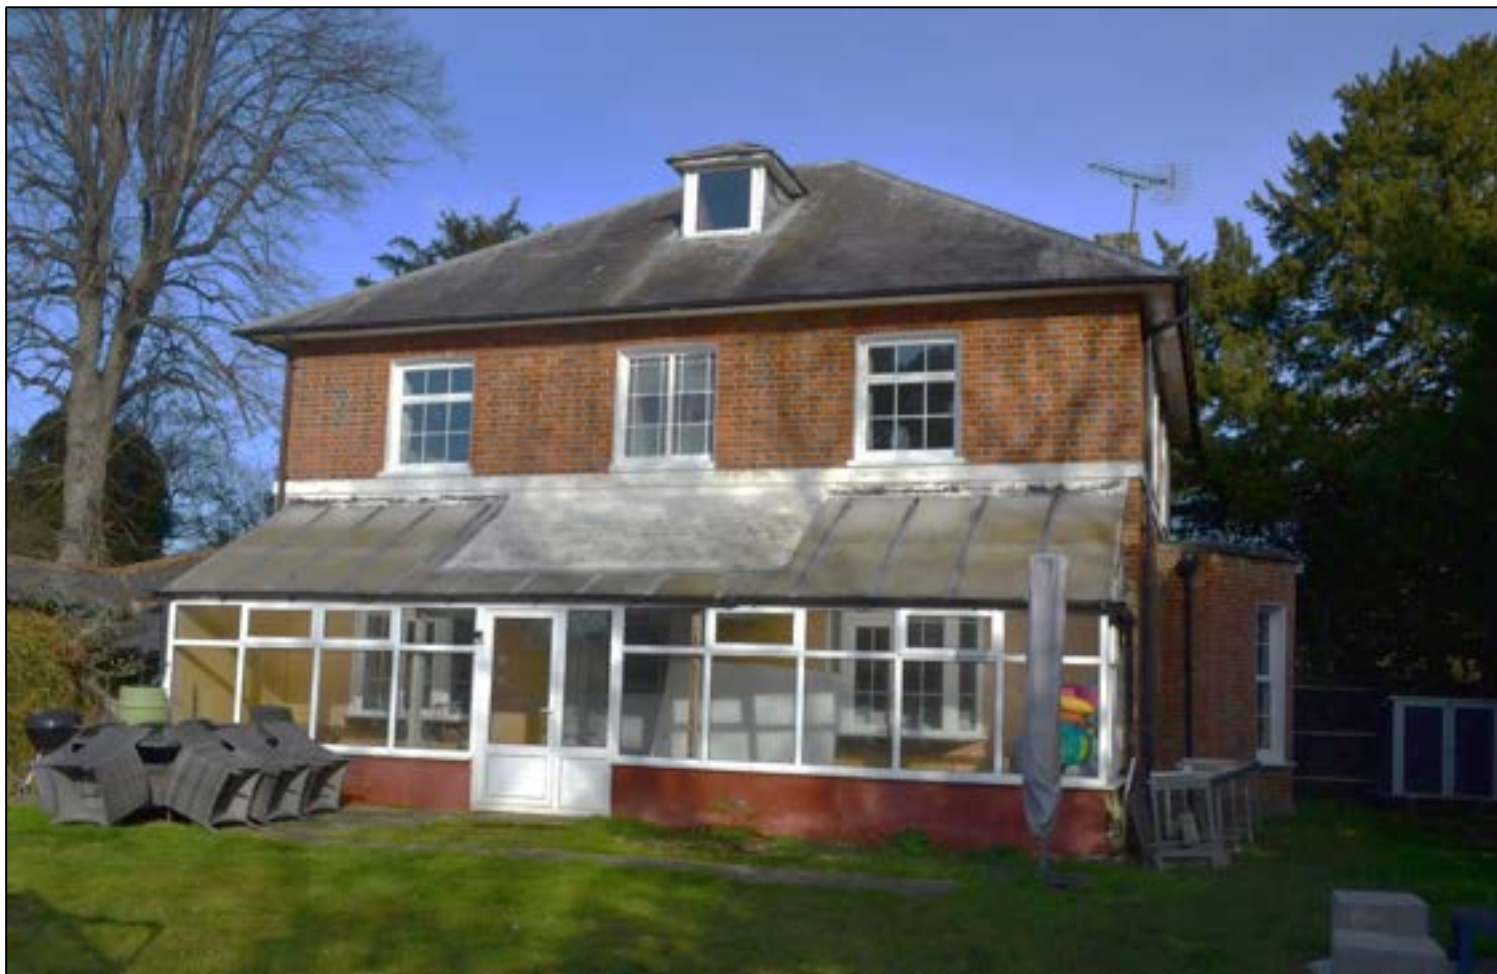
The ground floor of the south elevation is part obscured by a conservatory which, in one form or another has been on site since the early 20<sup>th</sup> century, the current structure however is not original (**Figure 18**). Behind the conservatory there is a half-glazed timber door with pillared door surround

*Figure 18 - The conservatory along the south elevation has been in situ in one form or another since the late 19<sup>th</sup>/early 20<sup>th</sup> century. The roof is currently in poor condition having been very heavily repaired with flashband and sealant. Beneath this in the central part of the roof there are evidence of tiles, which may contain asbestos.*

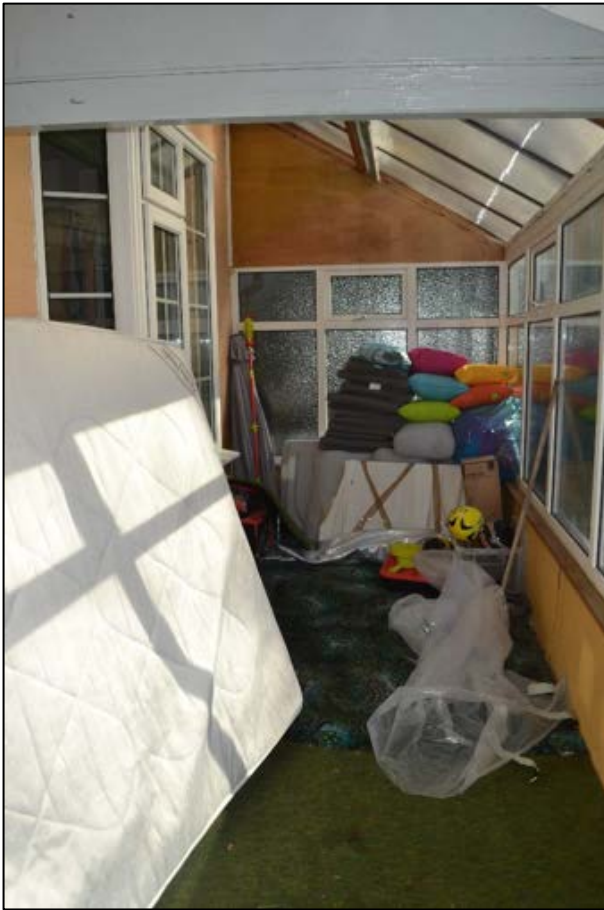
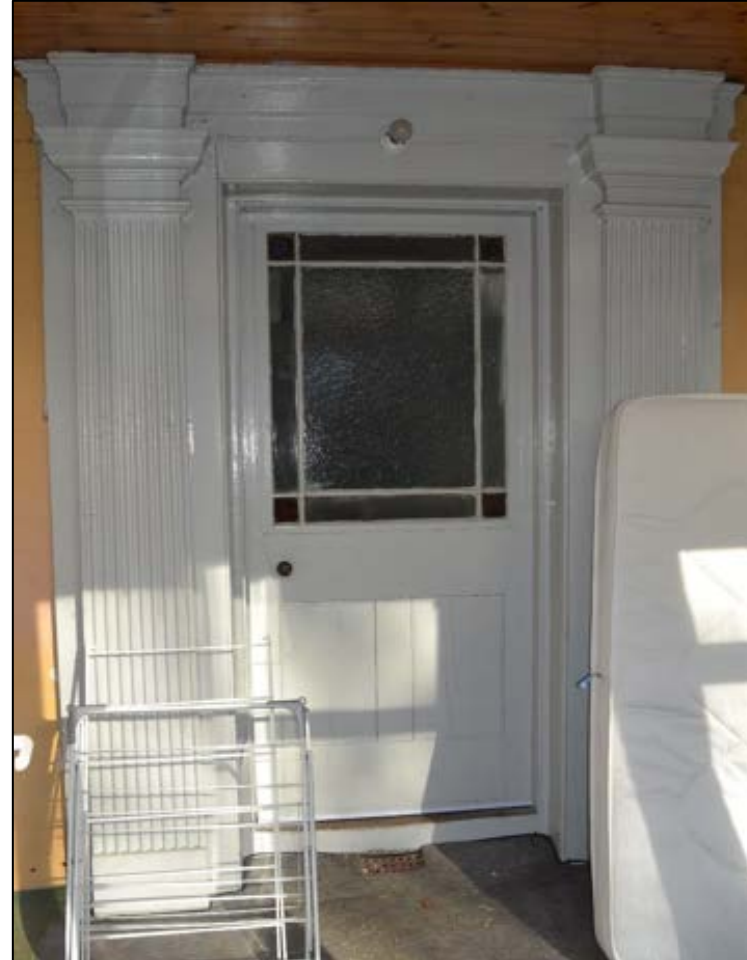
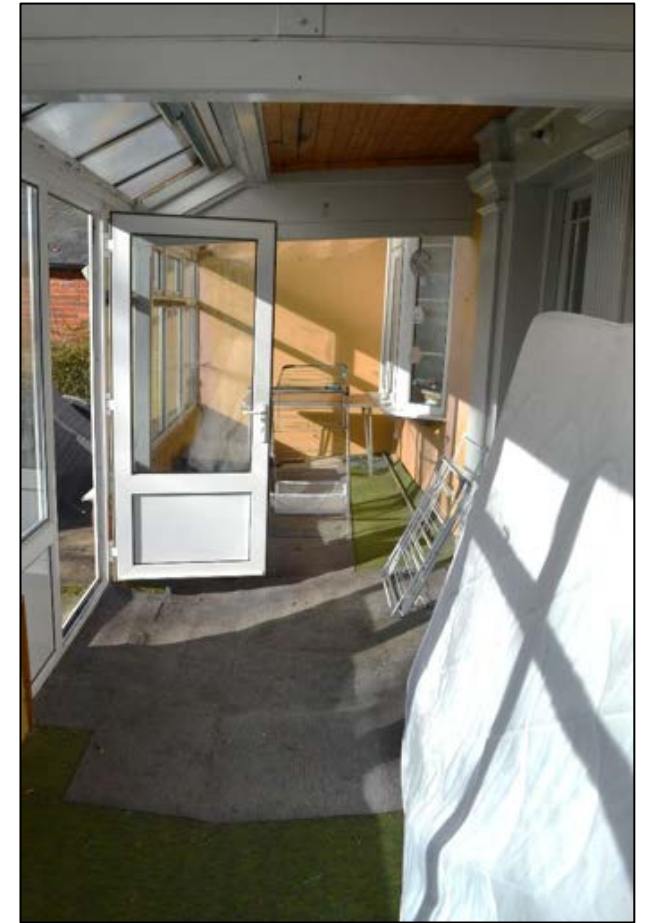
*Figure 19: Details of the conservatory – note the uPVC bay windows which, whilst 20<sup>th</sup> century, are thought to structurally be early 19<sup>th</sup>/early 20<sup>th</sup> century, a similar date to the bay window on the east elevation. (centre) Half-glazed timber door with pillared door surround - thought to once have a projecting porch however the date of this is unknown.*
