**Heritage Statement**  
Sussex Lodge  
Sussex Lane  
Spencer's Wood  
Reading

**Date of Issue**  
October 2022

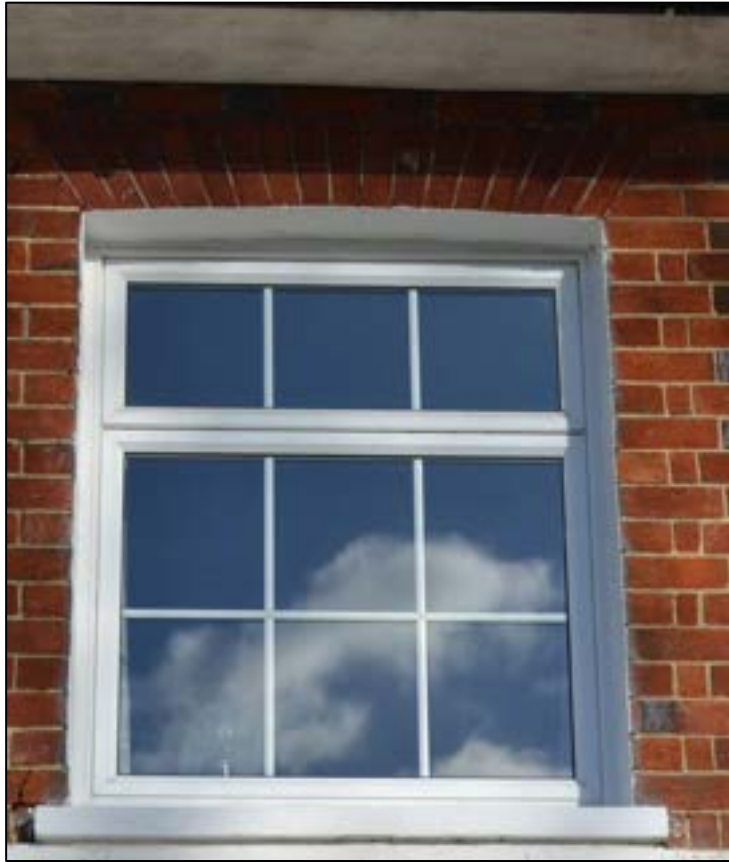
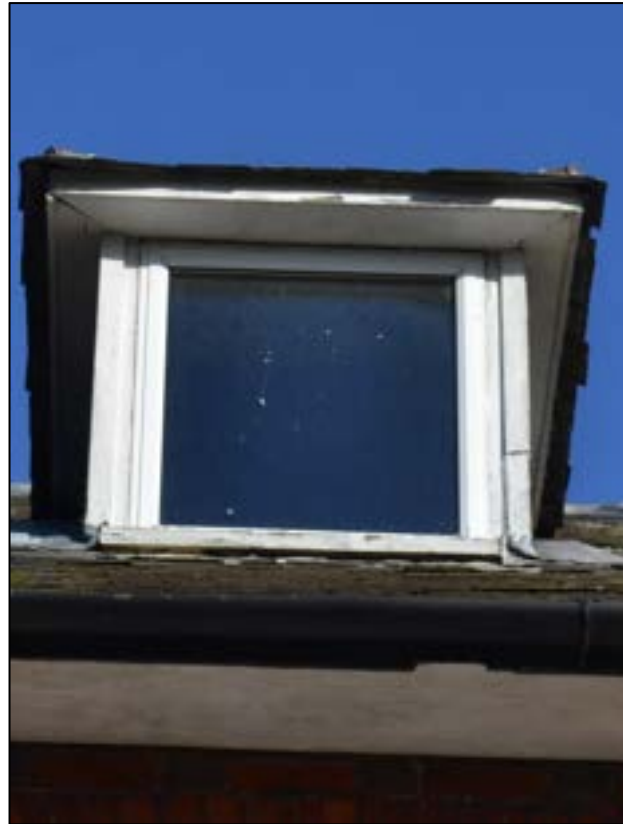
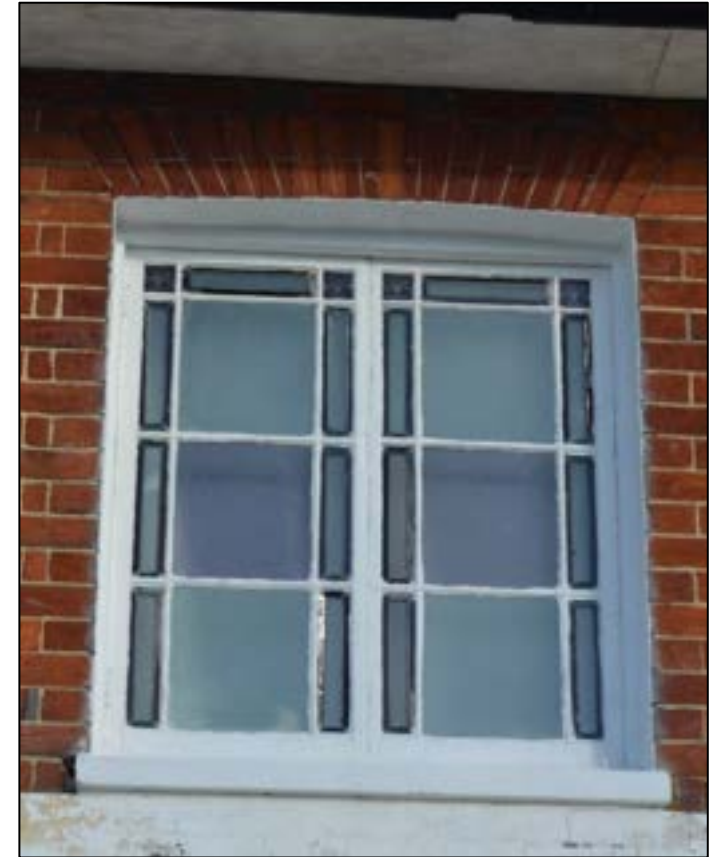
*Figure 20 - Details of windows on the south elevation (left) inappropriate 20<sup>th</sup> century uPVC top hung casement window, (centre) dormer window thought to originally house the clock when the house was briefly a school. (Right) Original timber single glazed leaded window - internally there is secondary glazing behind it. Note both windows (left and right) have flat segmental arches above*

According to the list description, the southern elevation originally had 2 wooden cross windows with leaded lights- the accuracy of this is questionable. The surviving original window is ornate with some coloured glazing (**Figure 20**). The list description also states that there was once a clock in the gable, potentially where the dormer window is now and an arched bellcote above with pedimented top (**Figure 18**). Finally, the description also mentions that there was once a stone panel with the inscription of 1860 however there was no evidence of that on site. There is however an iron plaque on the first floor of the west elevation that has an inscription and the word 'UNION' beneath it (**Figure 22**).

Furthermore the replacement of windows throughout, which are at present double glazed uPVC, with timber double glazed windows in a more appropriate style that are in keeping with the age of the property would not only restore the original appearance of the building but would also go some way towards balancing out any harm potentially caused by other proposals on the site. Therefore balancing out and mitigating any adverse impacts (which, where present, are considered to be minor). Whilst it is appreciated that single-glazed units might have been in originally it is felt that the proposed double glazed timber units both sustain (match the thickness of the glazing in at present) and enhance (improve the design of the windows to a more appropriate style) as per para 197 of the NPPF.

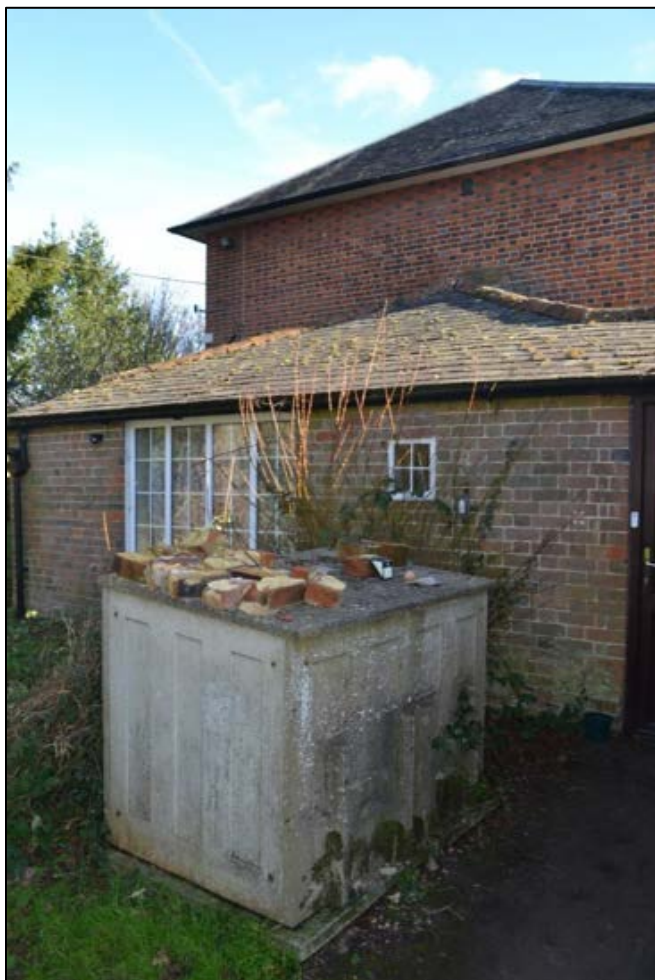
*Figure 21- The west elevation mostly obscured from view due to the later 20th century link extension attaching the principal building and outbuilding*

The west elevation is completely blind save for a small window on the ground floor cut through and for the most part completely obscured by a 20<sup>th</sup> century single storey extension linking the principal building to the outbuilding (**Figure 22**).

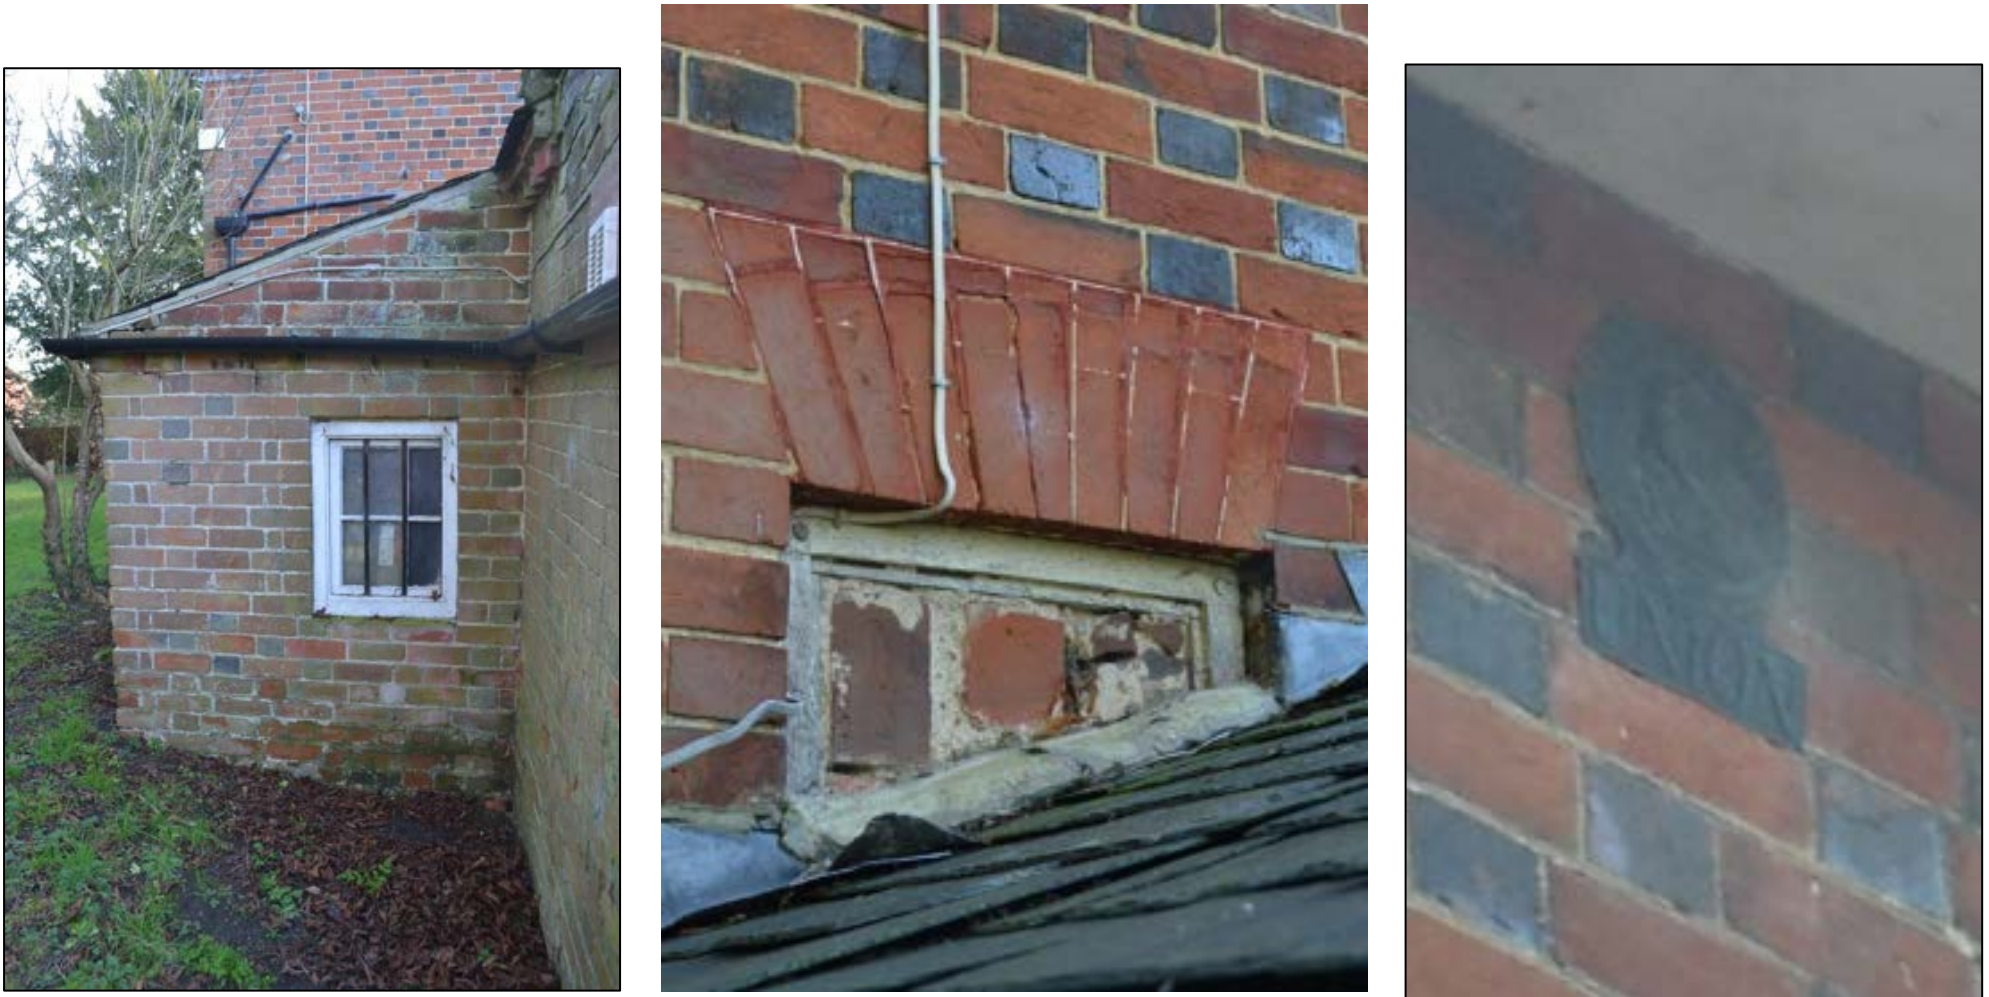
*Figure 22: Details of the west elevation- (left) 20<sup>th</sup> century link extension attaching the outbuilding to the principal building, (centre) blocked off window which would have originally opened into what is now the kitchen, (right) iron plaque under the eaves - date unable to be read from ground level or images, however, the word 'UNION' can be clearly seen.*

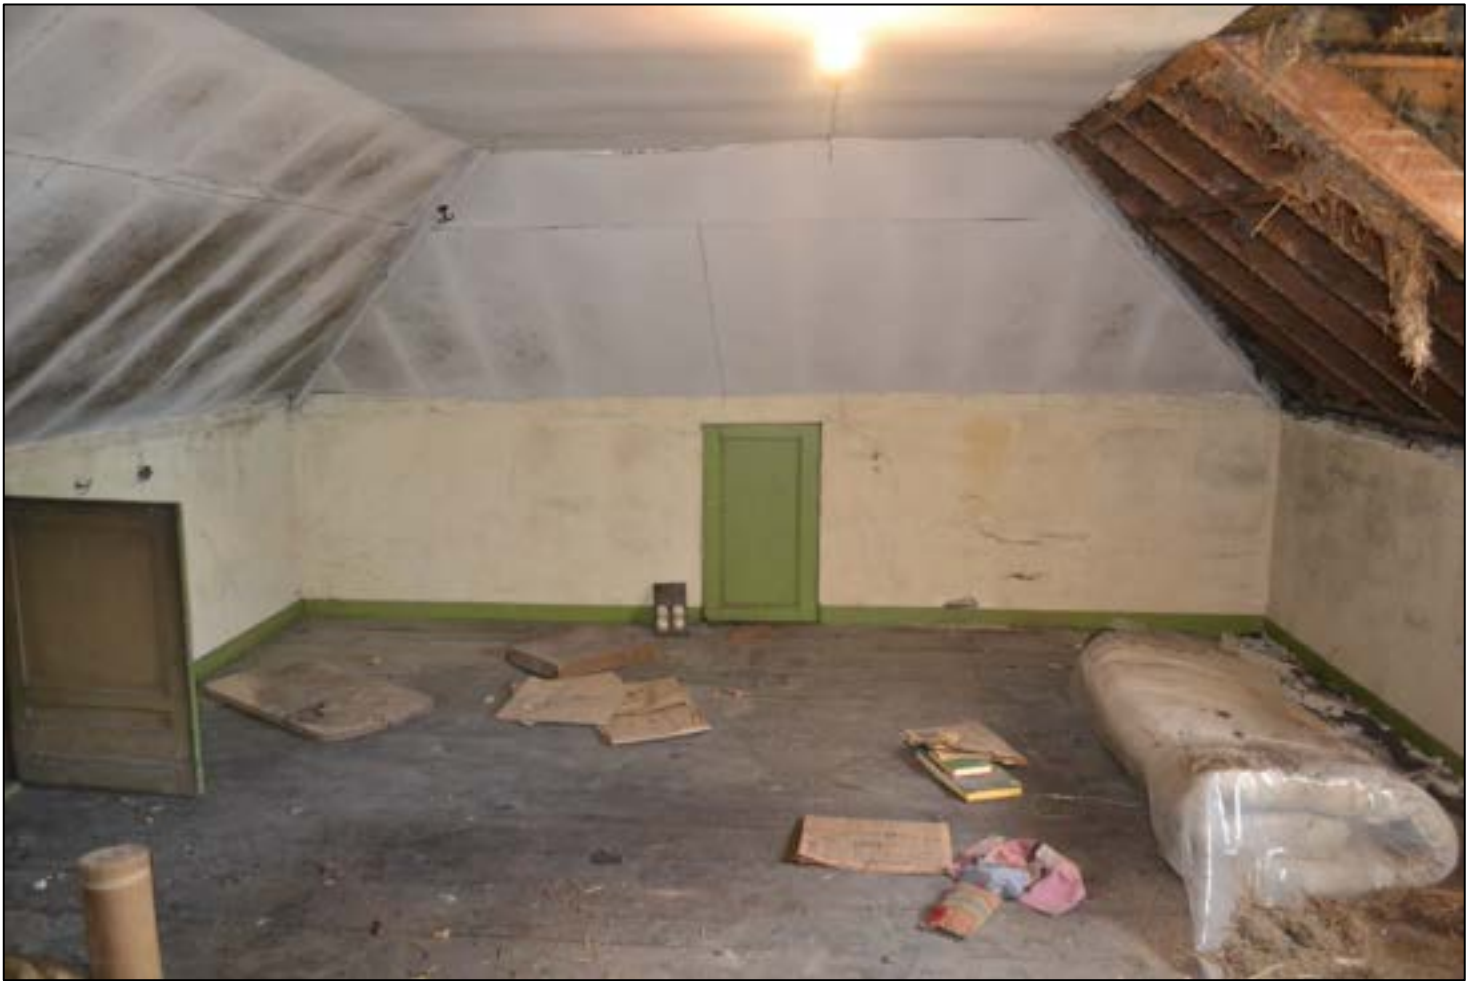
*Figure 23:Attic room*

Internally, Sussex Lodge is for the most part a symmetrical building. The attic room is thought to have been made accessible in the late 19<sup>th</sup>/early 20<sup>th</sup> century (**Figure 23**). Accessed by a steep timber plank stair on the first floor, the room comprises of compartments into the roof void and a solid wood floor. The plaster has been removed in sections exposing the original timber structure (**Figure 24**). The plaster along the walls is thought to be historic as there is evidence of the lath and plaster (**Figure 25**).

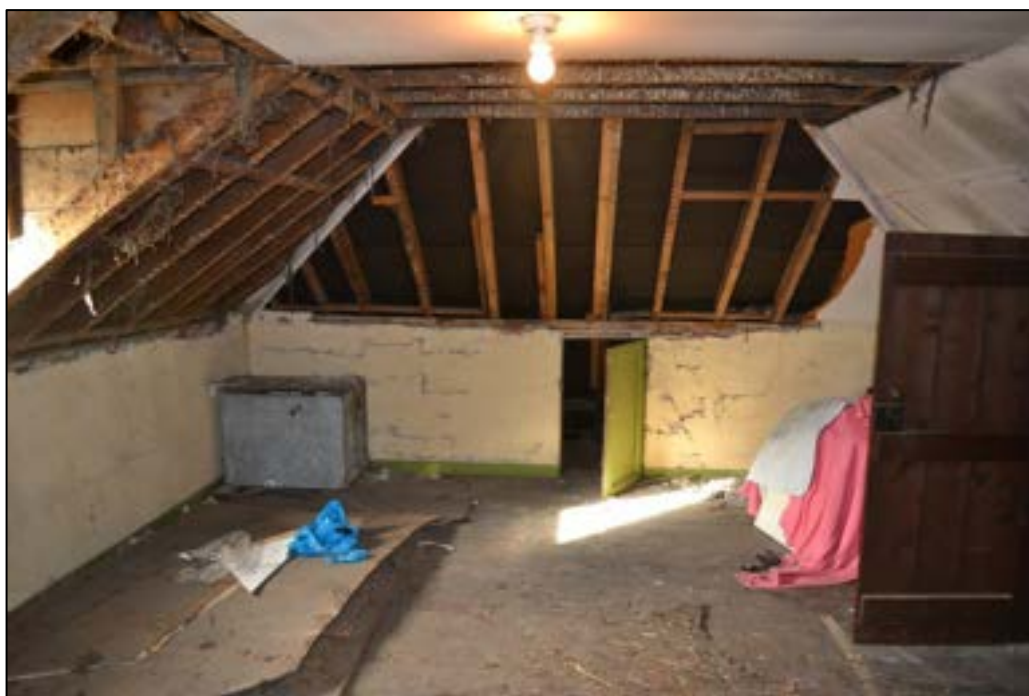
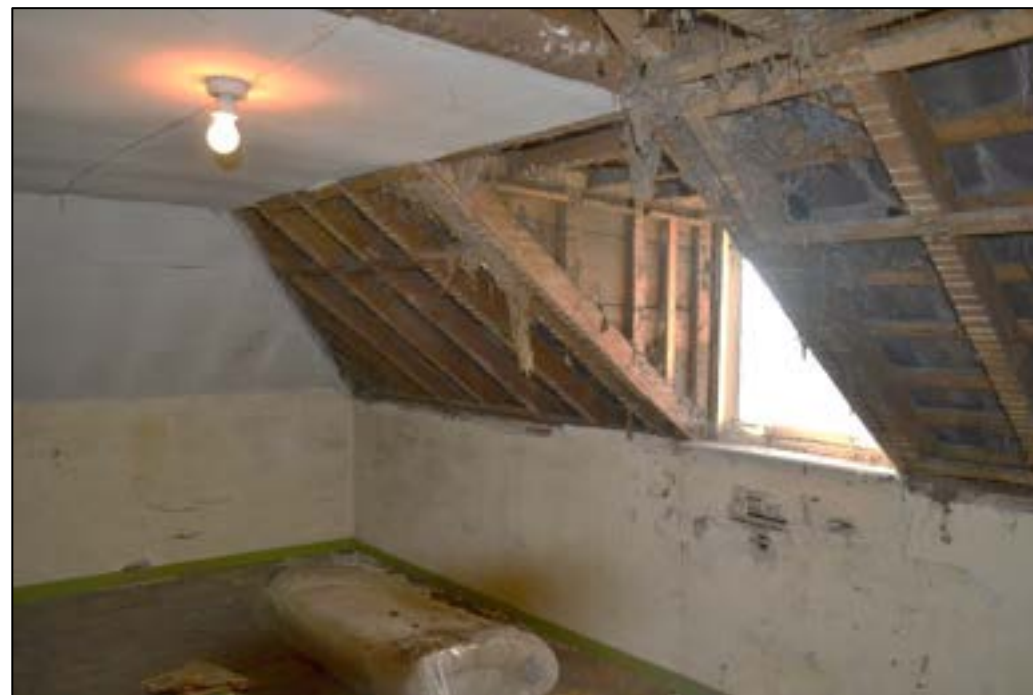
*Figure 24: Attic room, note the exposed roof timbers and dormer window (right)*

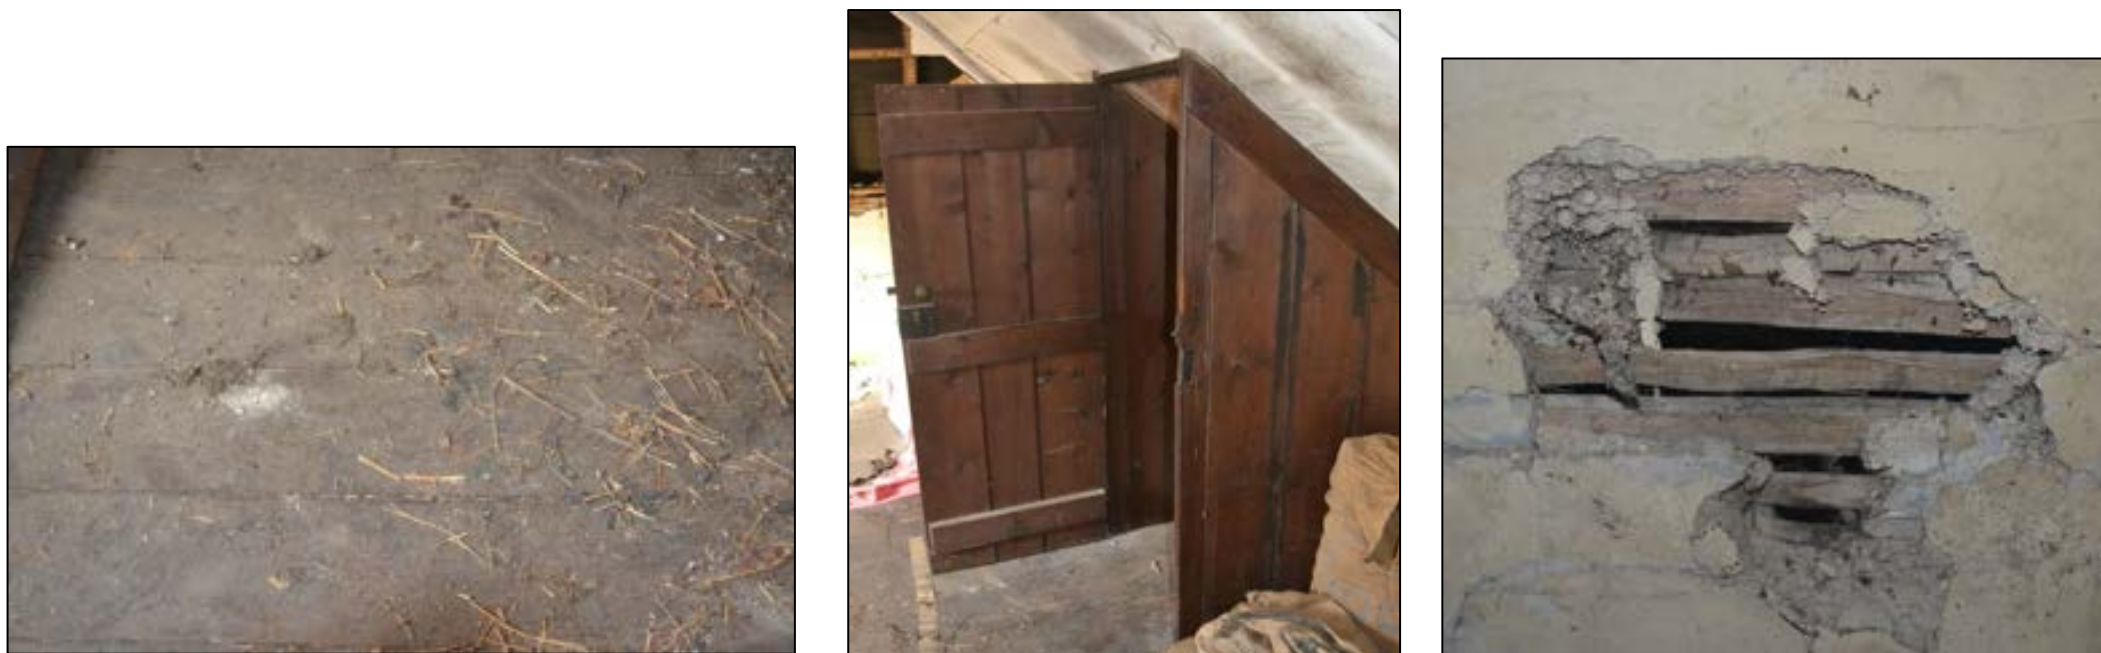
*Figure 25: Attic room details (left) solid timber floor, (centre) timber door leading to stairs to access the ground floor, (right) exposed historic lath and plaster*

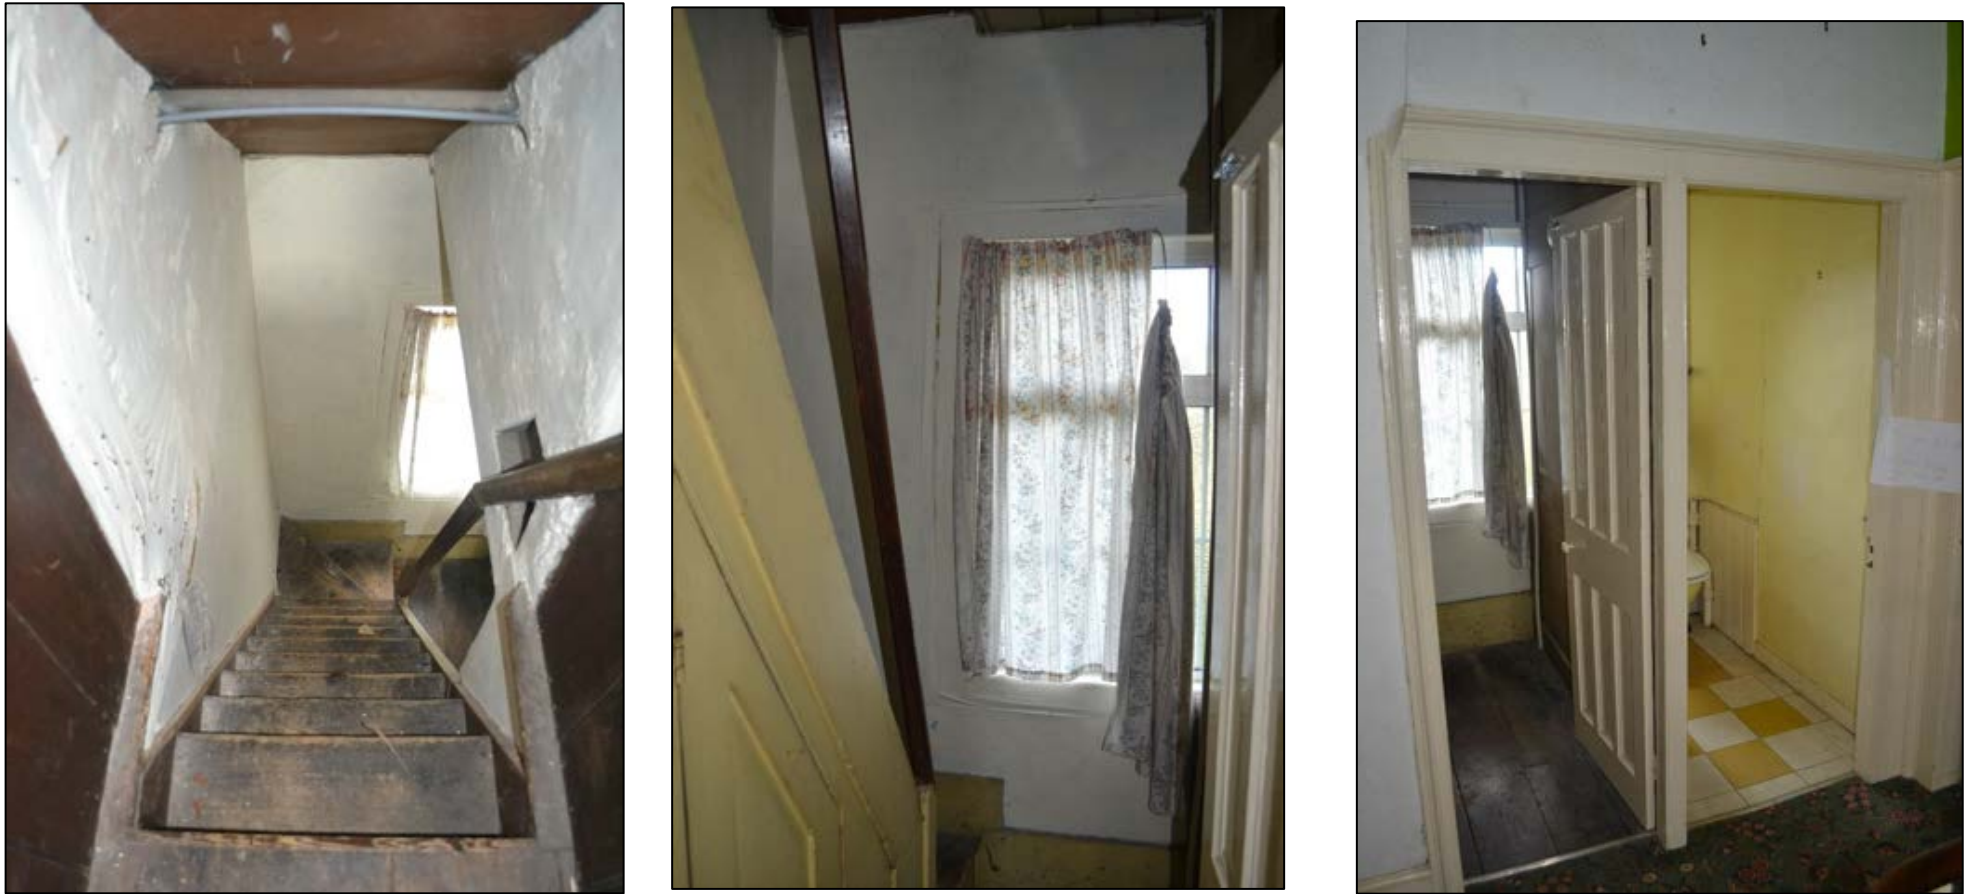
*Figure 26: (left) steep timber stair leading from attic room to ground floor, (centre) window that is cut through on the ground floor to accommodate stud partition wall, (right) stud partition wall- later 20<sup>th</sup> century addition to allow the insertion of a toilet*

- **Green-** Insertion of door to connect the two rooms (**Figure 31 & Figure 32**).
- **Pink-** Removal of stud walls and reconfiguration/alteration to staircase to allow easier access up to the second floor (**Figure 26 & Figure 27**).
- **Blue-** Similar to the above, insertion of stud wall and doorway to create 'Jack and Jill' bathroom between the two rooms (**Figure 28 - Figure 30**).
- **Yellow-** Alteration of stud walls to facilitate alteration of stairwell (**Figure 24 - Figure 26**).

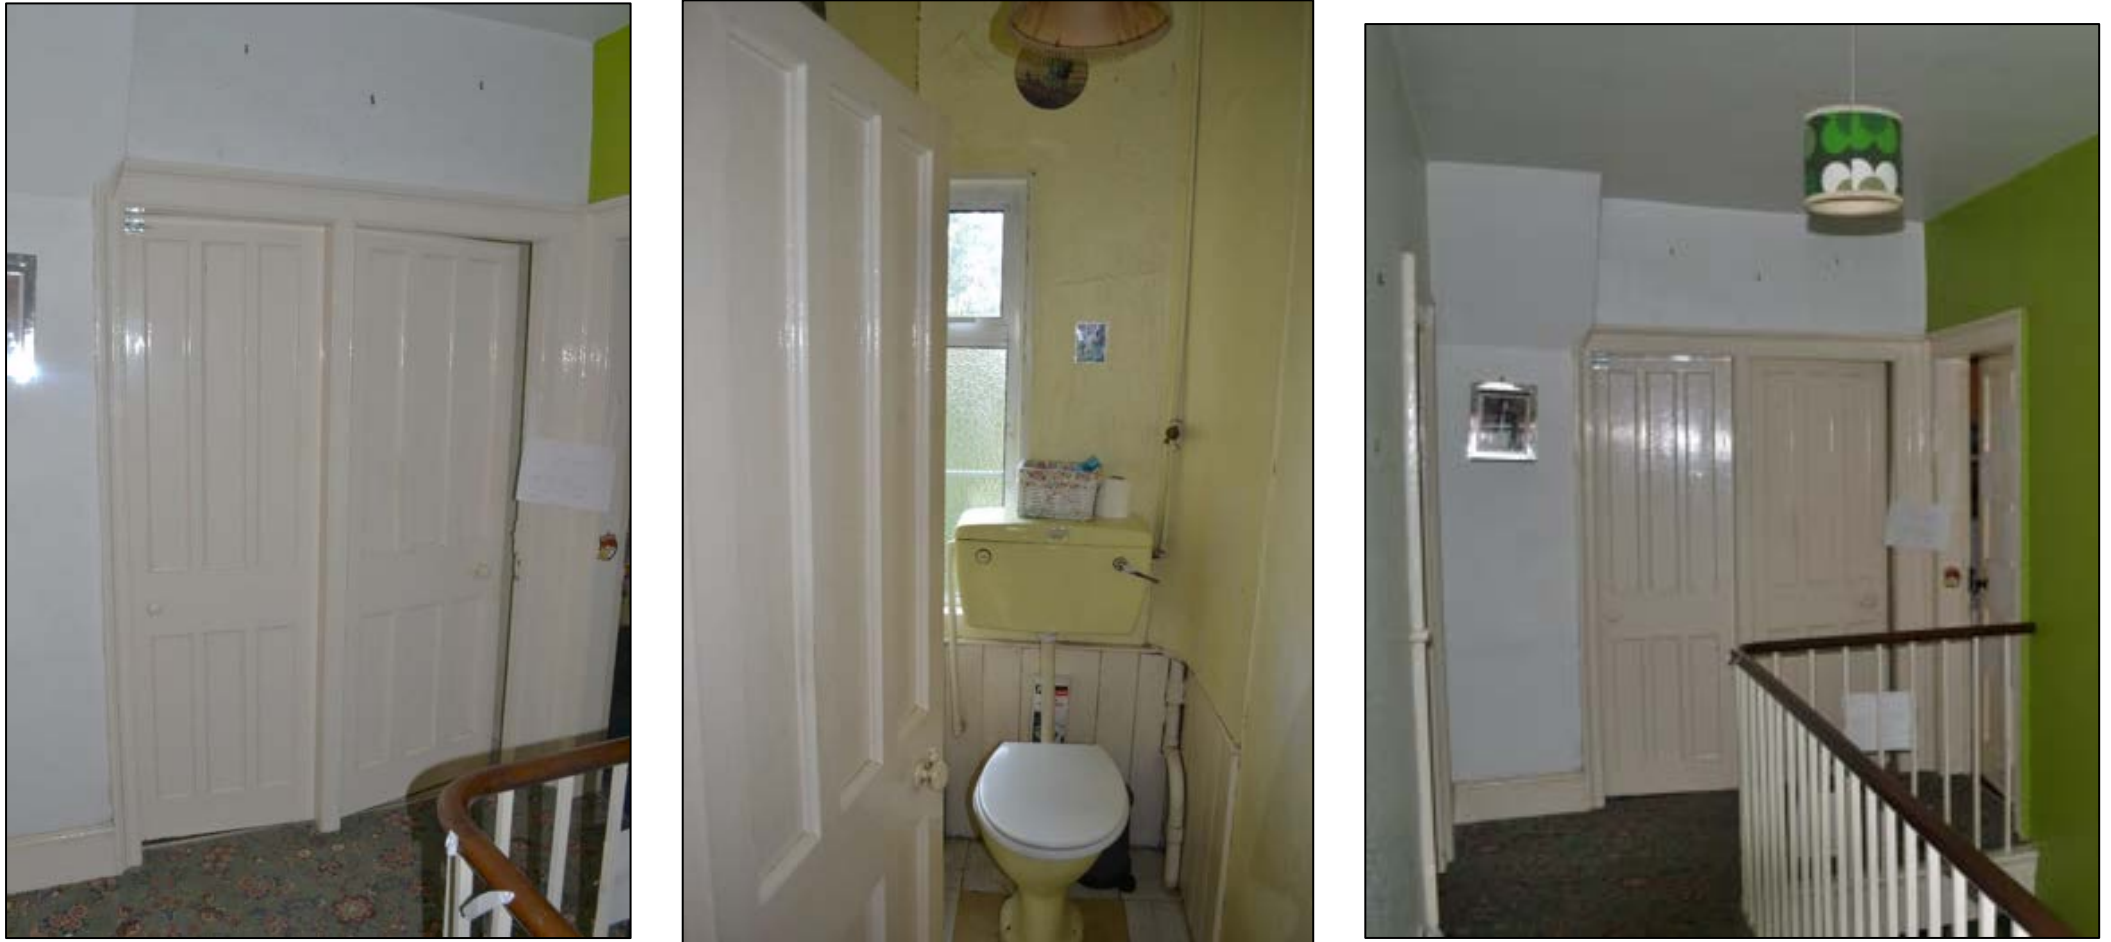
*Figure 27: (left) 19<sup>th</sup> century doors accessing the attic rooms and toilet taken from the ground floor sitting room and kitchen, (centre) later 20<sup>th</sup> century toilet, (right) hallway leading to rooms at the front of the house, toilet, and attic room*

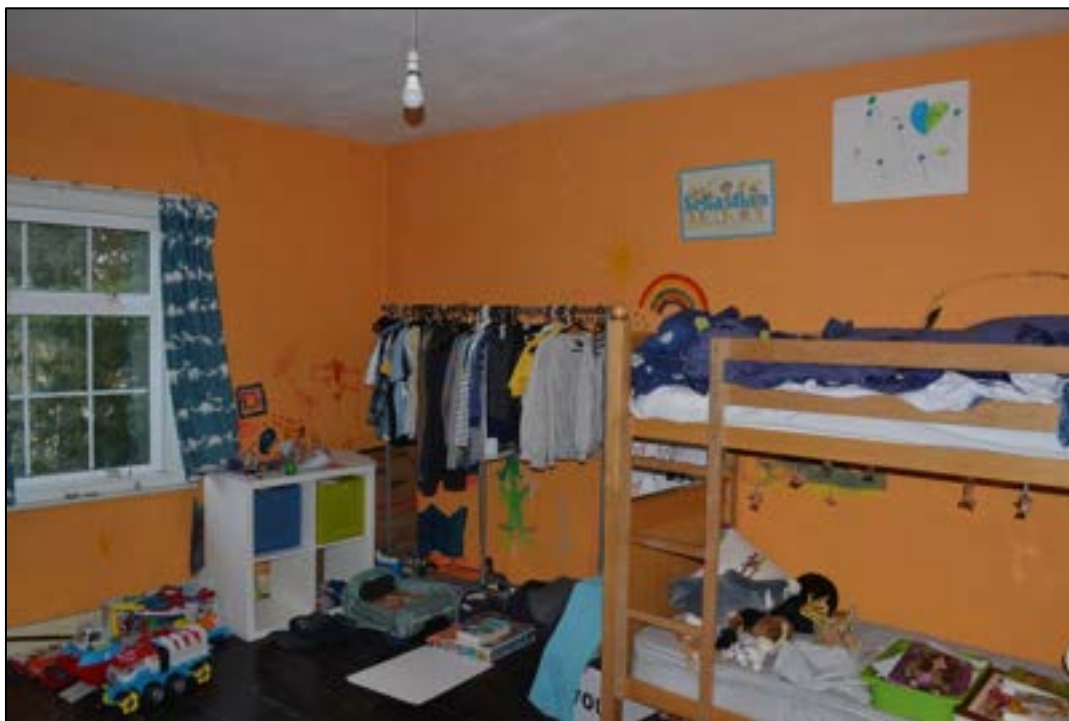
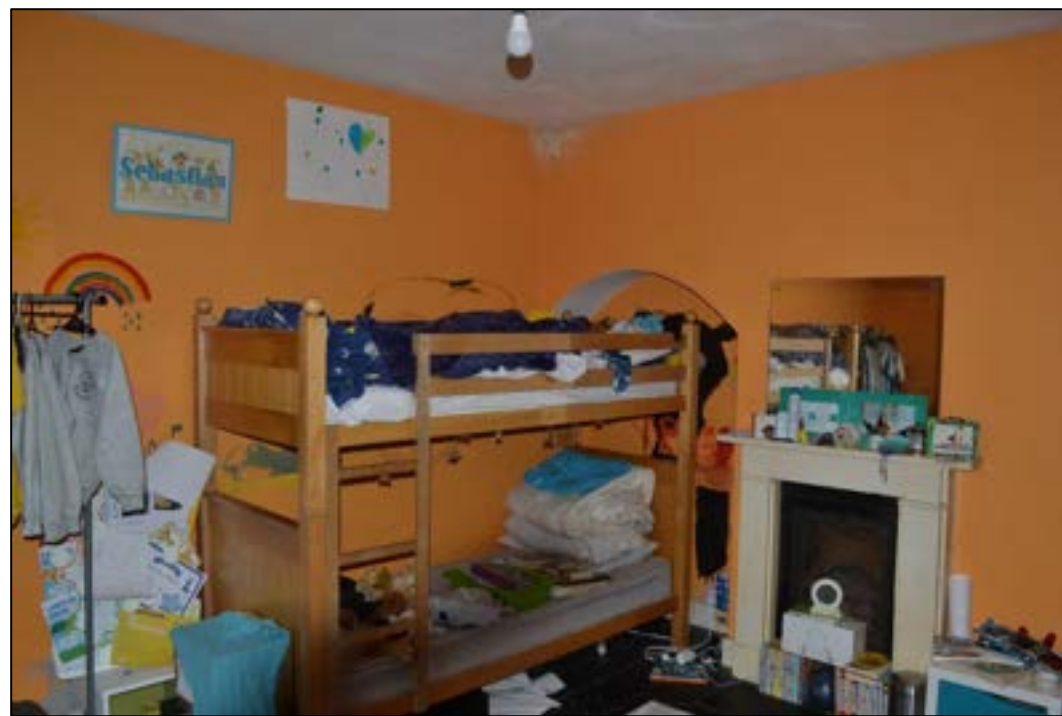
*Figure 28: Bedroom one - note the decorative recessed arch and fireplace*

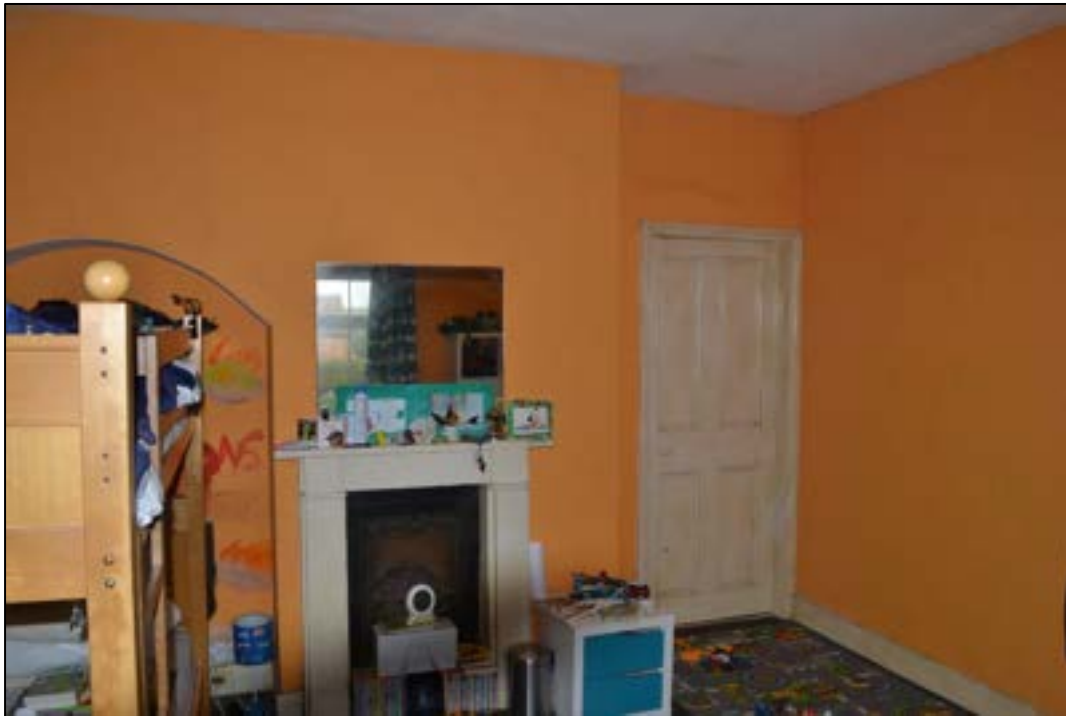
*Figure 29: Bedroom one - note the solid wood exposed floor and 4 panelled timber doors. (left) door leads into Bedroom three - thought to be a later alteration*

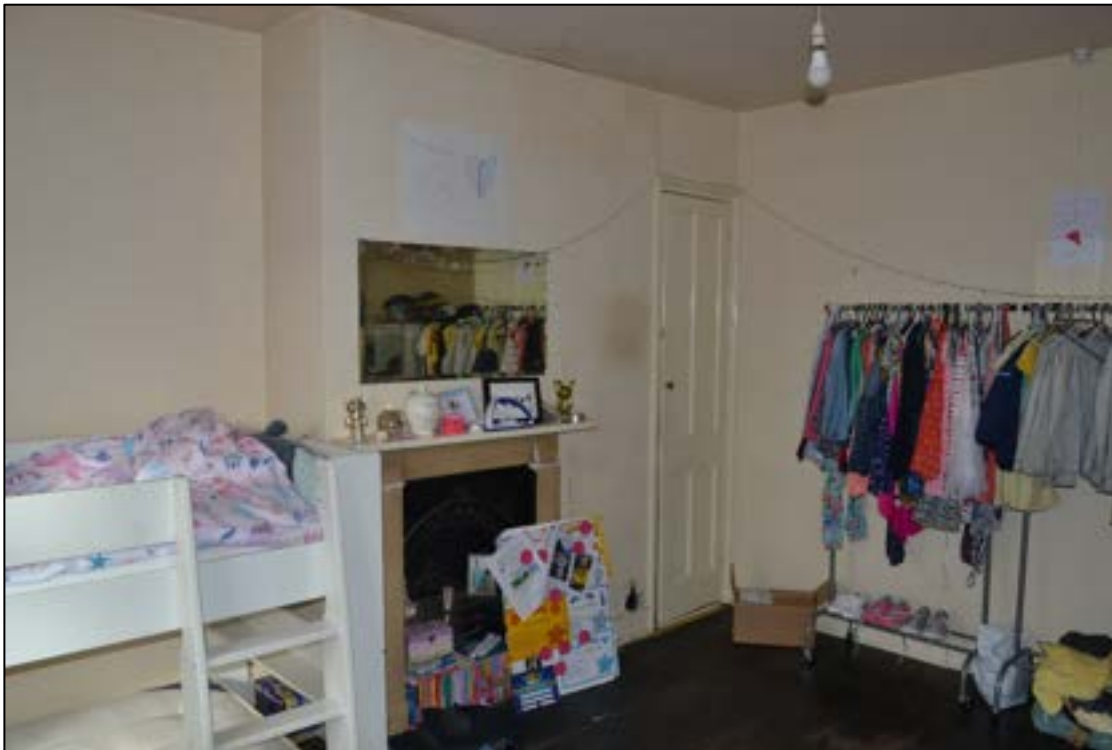
*Figure 31: Bedroom two - note the exposed original timber floor, inbuilt cupboard space, and fireplace*

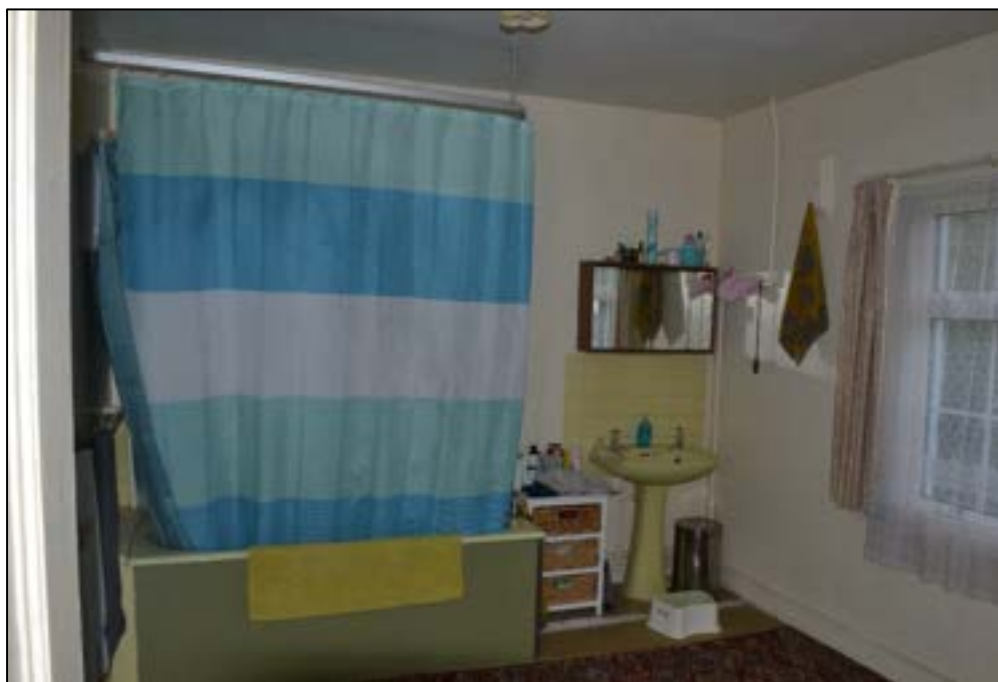
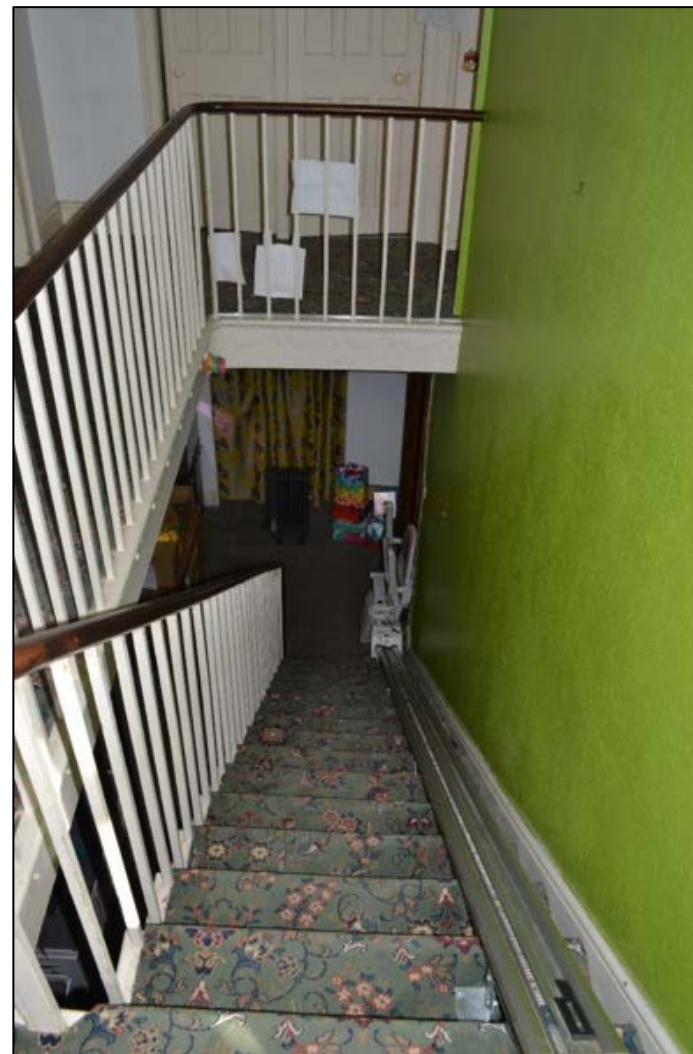
*Figure 32: (left) Family bathroom and (right) early 19<sup>th</sup> century staircase down to the ground floor*

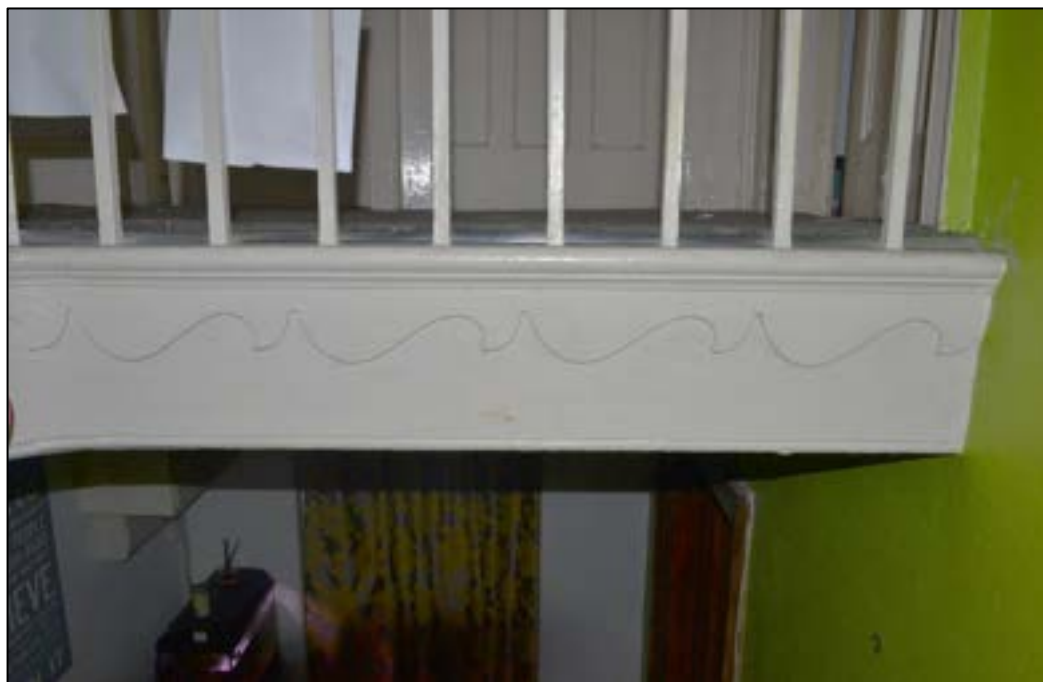
*Figure 33 - Details of early 19<sup>th</sup> century staircase, note the stick balusters, mahogany banister, and carved brackets under the treads*

The winding staircase of stick balusters, mahogany handrail and carved brackets under the tread ends is typical of the early 19<sup>th</sup> century (**Figure 33**). The hallway on the ground floor is double aspect with matching half glazed doors at the northern and southern ends (**Figure 35**).

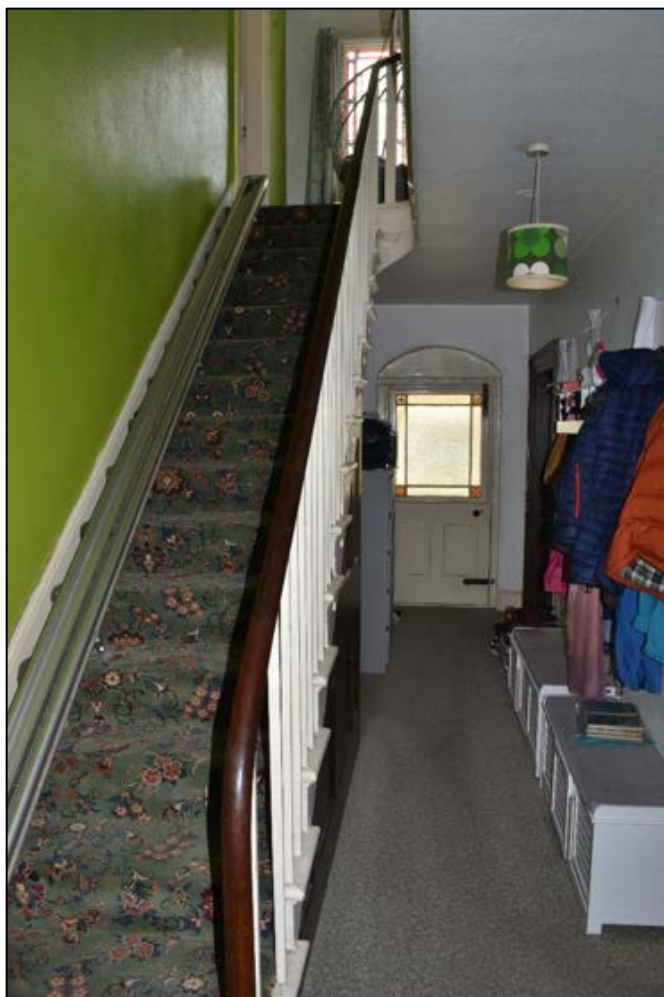
*Figure 34: Ground floor hallway - double aspect*

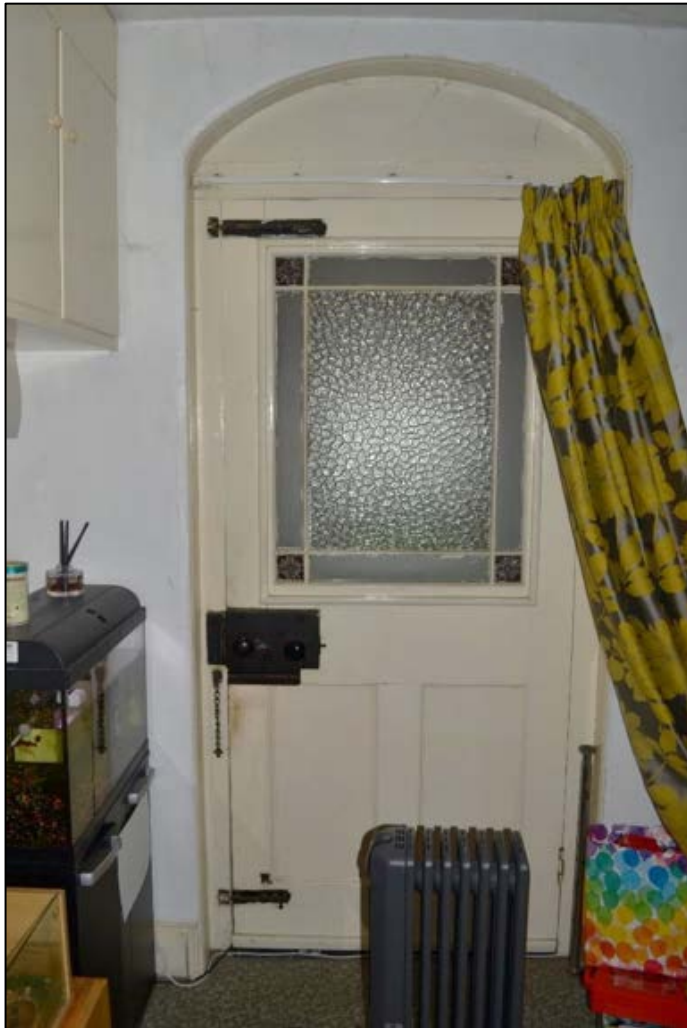
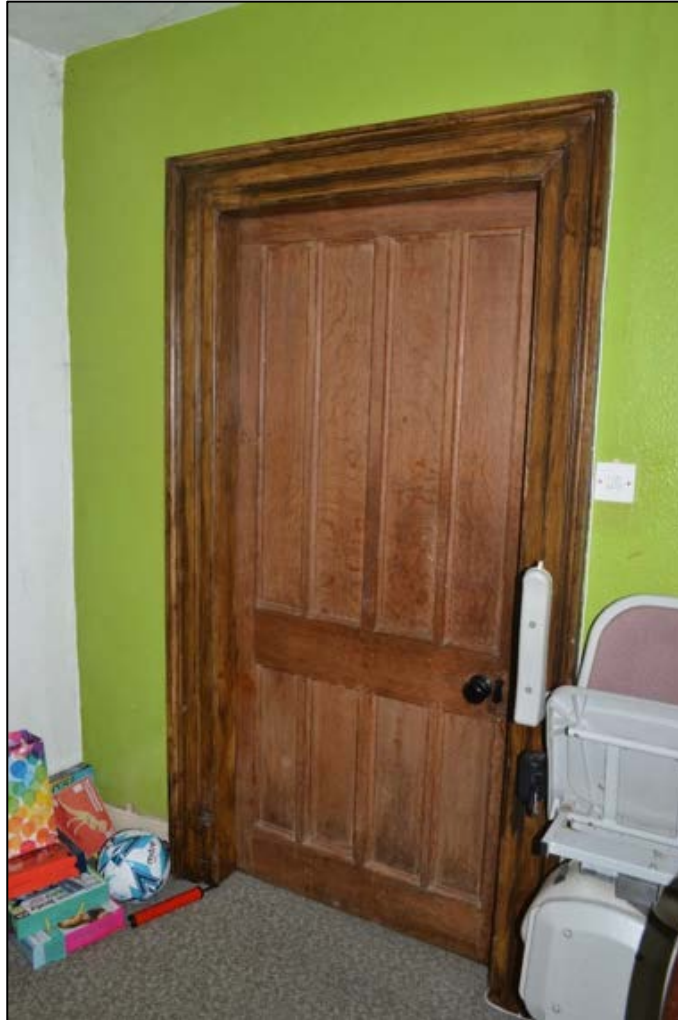
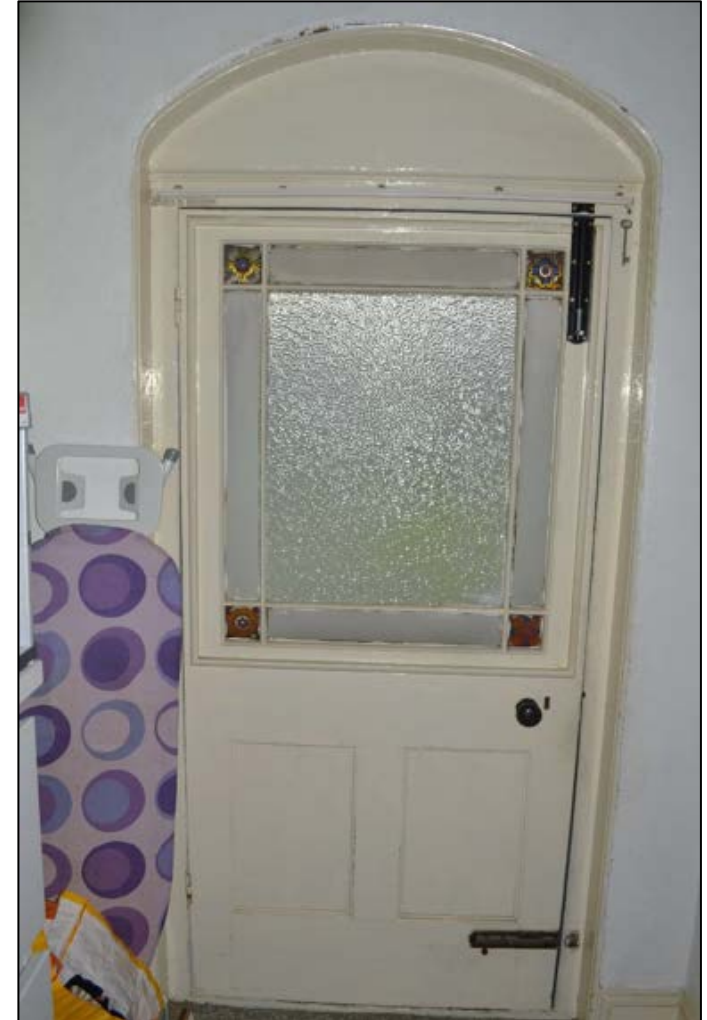
*Figure 35: Identical north and south half glazed doors in the double aspect hallway, (centre) one of the solid oak doors taken and reused from Arborfield Church*
