**Heritage Statement**  
Sussex Lodge  
Sussex Lane  
Spencer's Wood  
Reading

**Date of Issue**  
October 2022

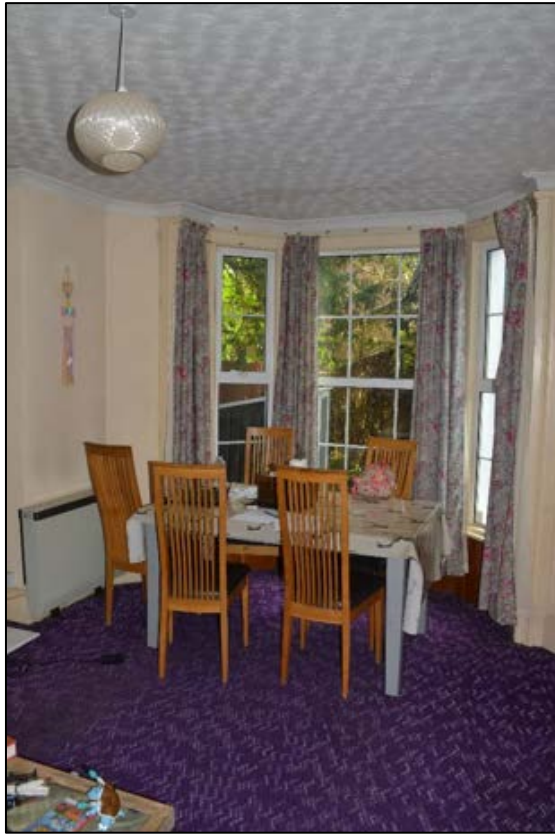
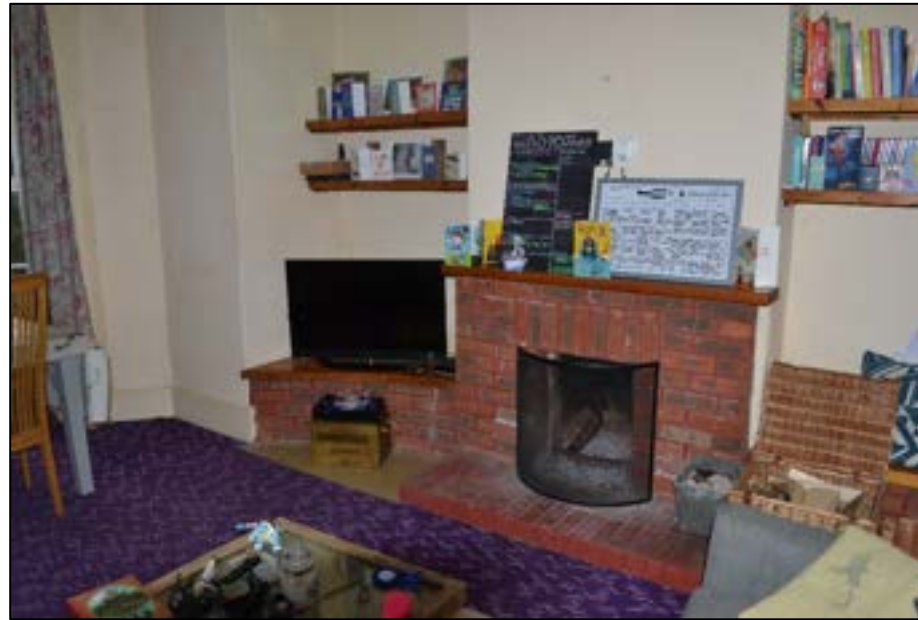
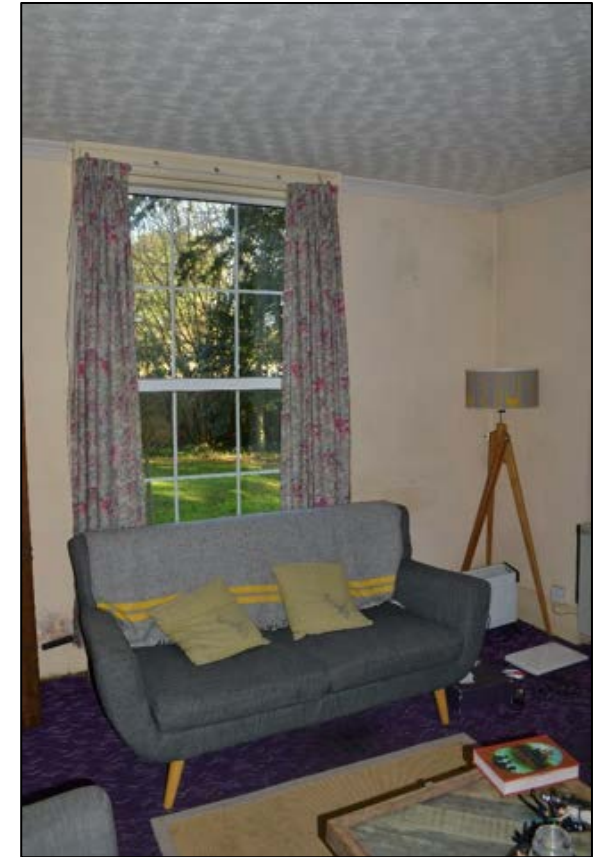
*Figure 36: (left) bay window thought to be an early 20<sup>th</sup> century addition, (centre) mid-20<sup>th</sup> century fireplace in location of original, (right) picture window facing out onto northern lawn*

The ground floor comprises of a sitting room, family room, kitchen, and study. The sitting room contains a 20<sup>th</sup> century floor to ceiling bay window and later 20<sup>th</sup> century brick fireplace (**Figure 36**). The adjacent family room, now currently a bedroom, has a bay window (no shutters), evidence of a fireplace (currently covered), and a picture rail (**Figure 37**).

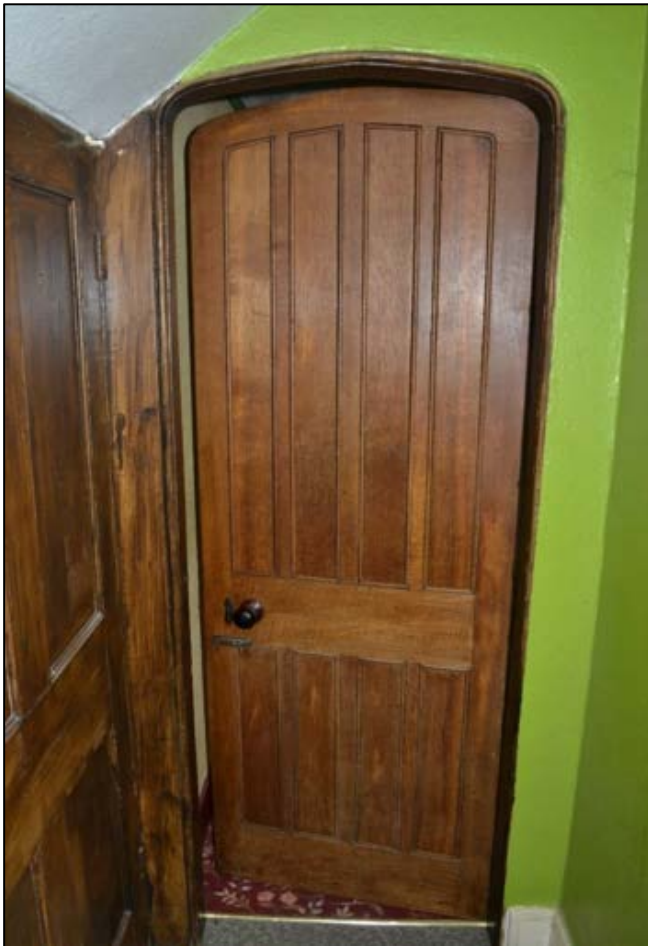
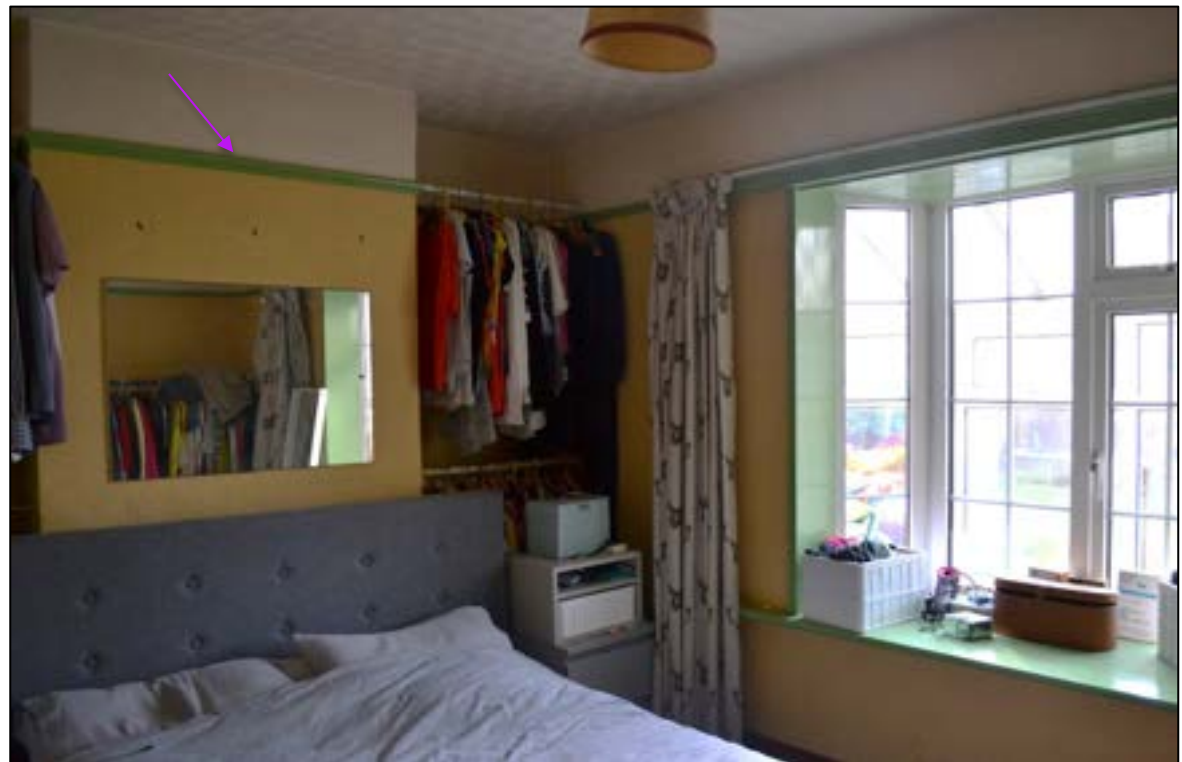
*Figure 37: (left) oak door taken from Arborfield Church, (right) interior of room note the picture rail (highlighted in purple) and bay window with shutters missing, potentially reused in pantry/utility room*

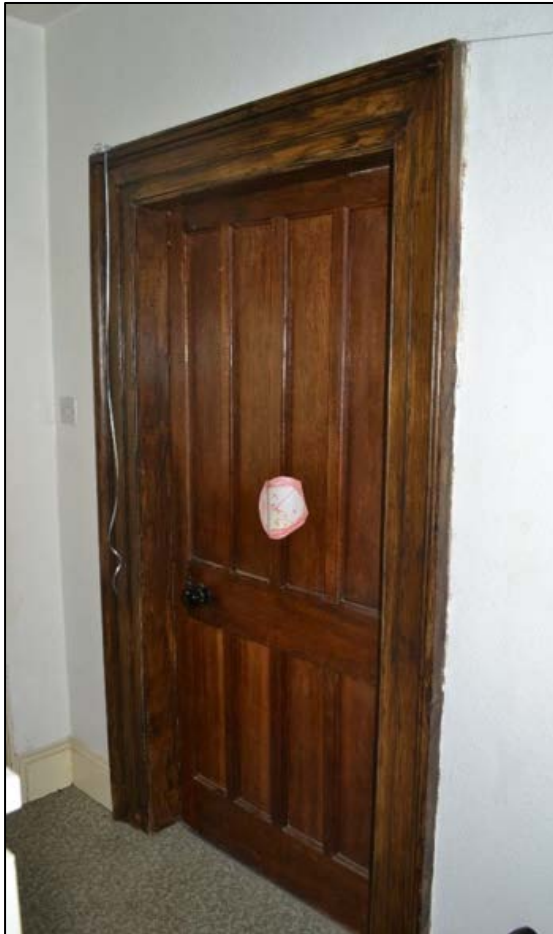
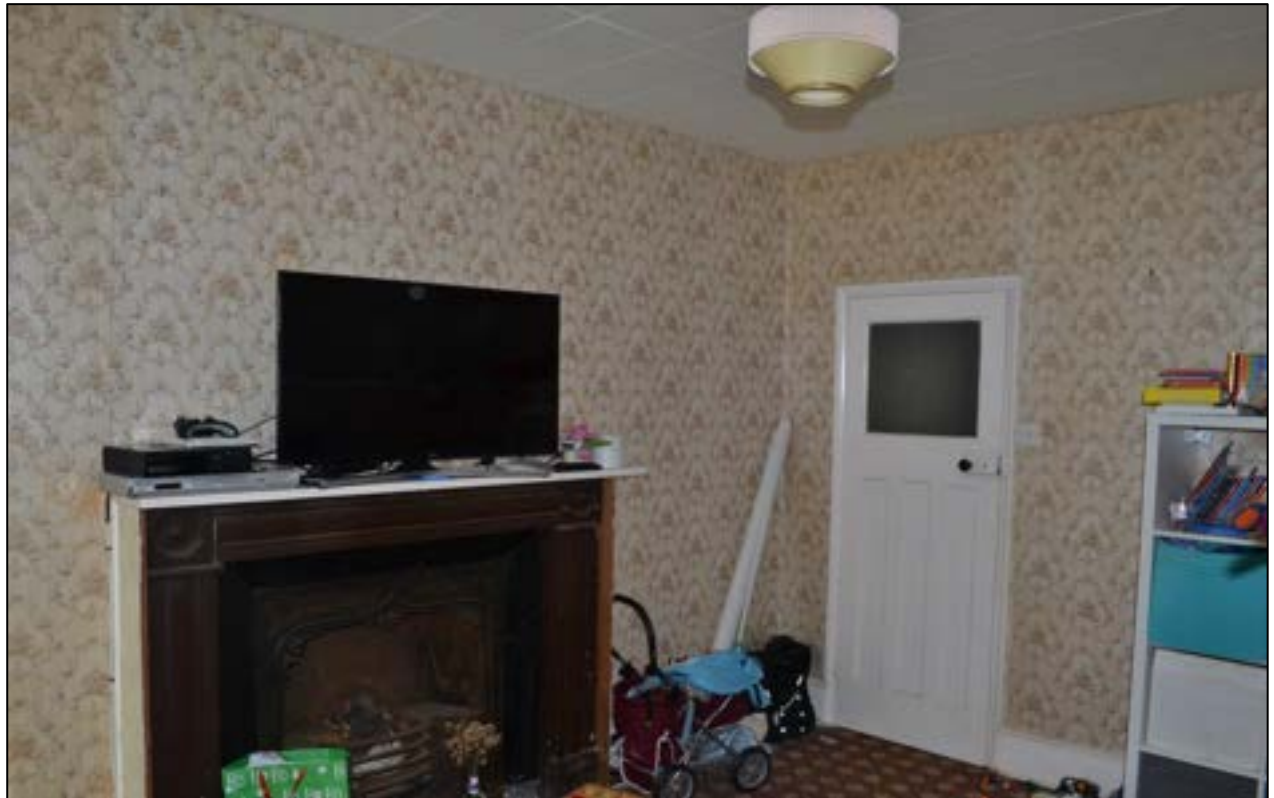
*Figure 38: (left) One of the original oak doors from Arborfield Church, (right) interior of room with original fireplace and early/mid-20<sup>th</sup> century door. Note - the original door was removed and reused on the first floor*

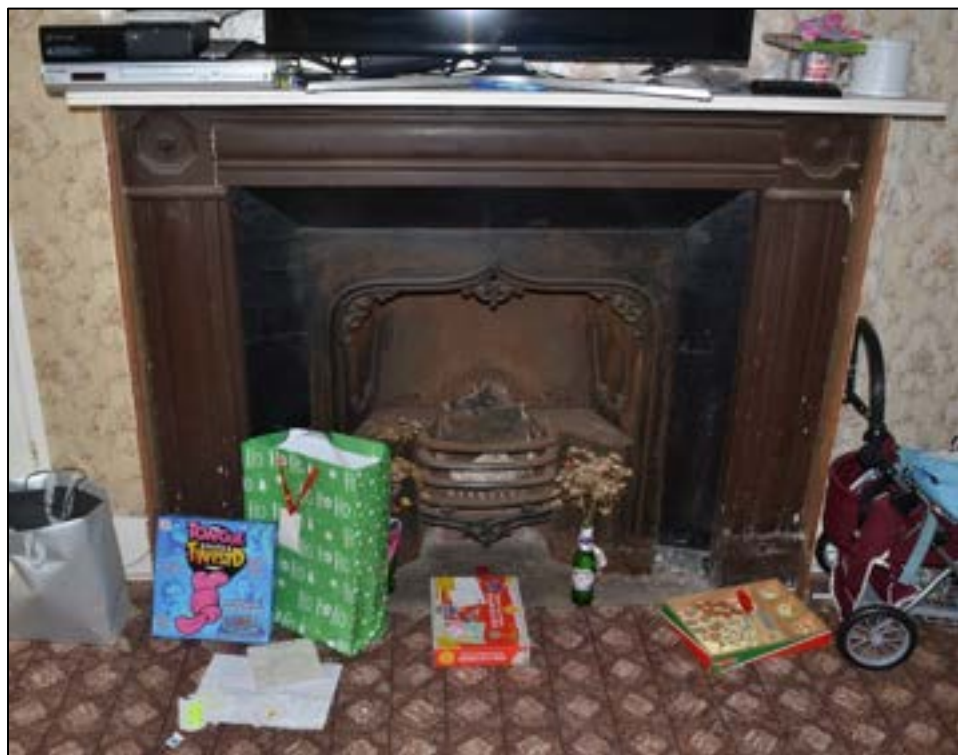
*Figure 39: (left) detail of original fireplace, (right) bay window with later 20th century uPVC window yet surviving original timber shutters either side*

The opposite family room includes an exposed fireplace, in built cupboard, and bay window with surviving timber shutters (**Figure 38 & Figure 39**). The kitchen opposite has very few surviving original features however interestingly has an internal window which looks out into the hallway that connects the main body of the house to the utility space and attached outbuilding (**Figure 40**).

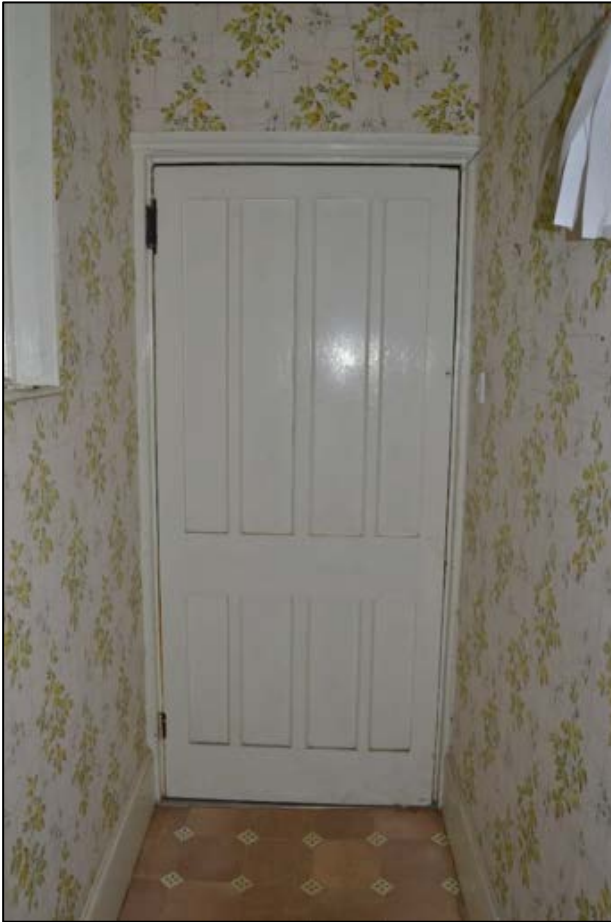
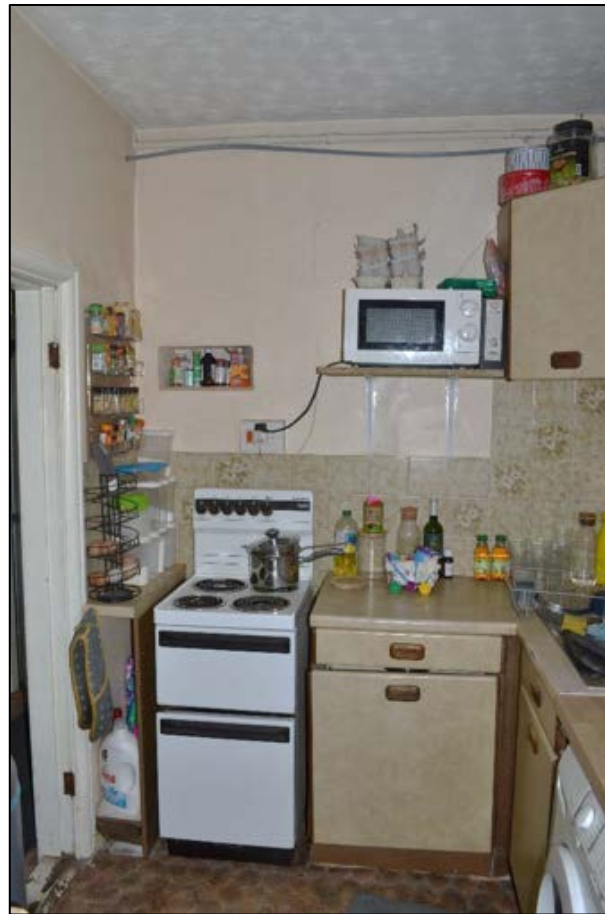
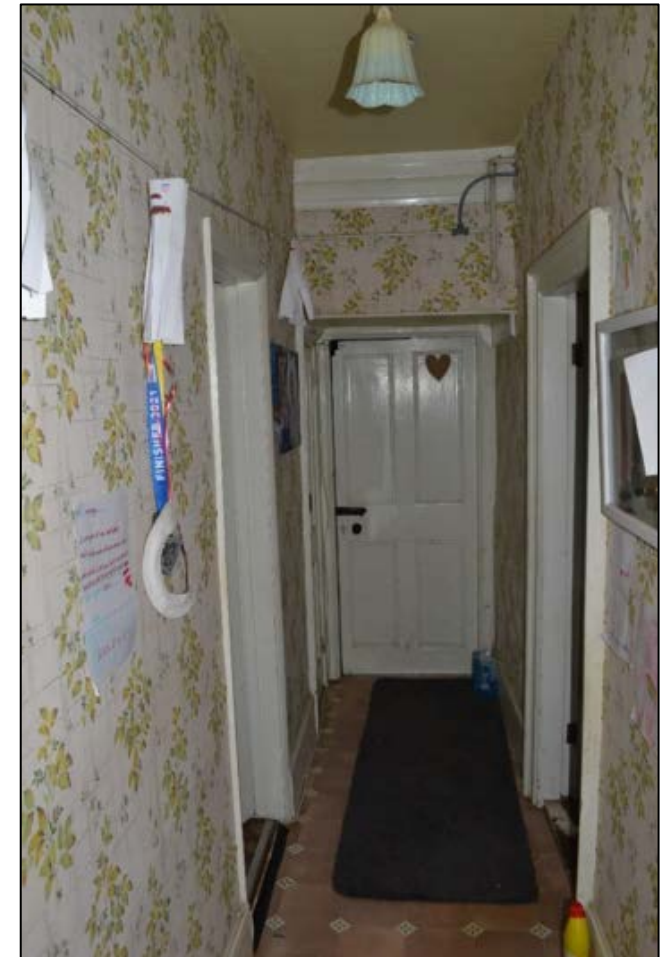
Figure 40: (left) door leading from hallway into main central staircase - note, the detail of the door matches the two re-used upstairs for the attic and toilet rooms, (centre) view of kitchen), (right) hallway leading towards utility/pantry

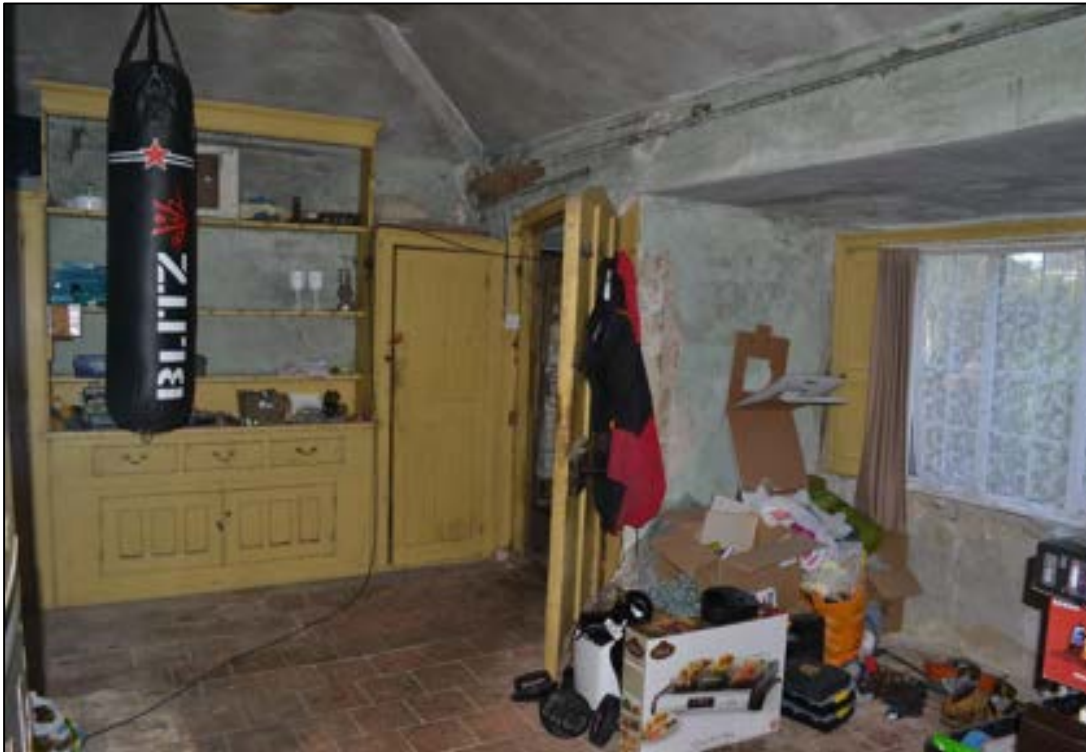
*Figure 41: View of utility/pantry room thought to date from early 19<sup>th</sup> century - note, inbuilt dresser, fireplace, and tiled floor*

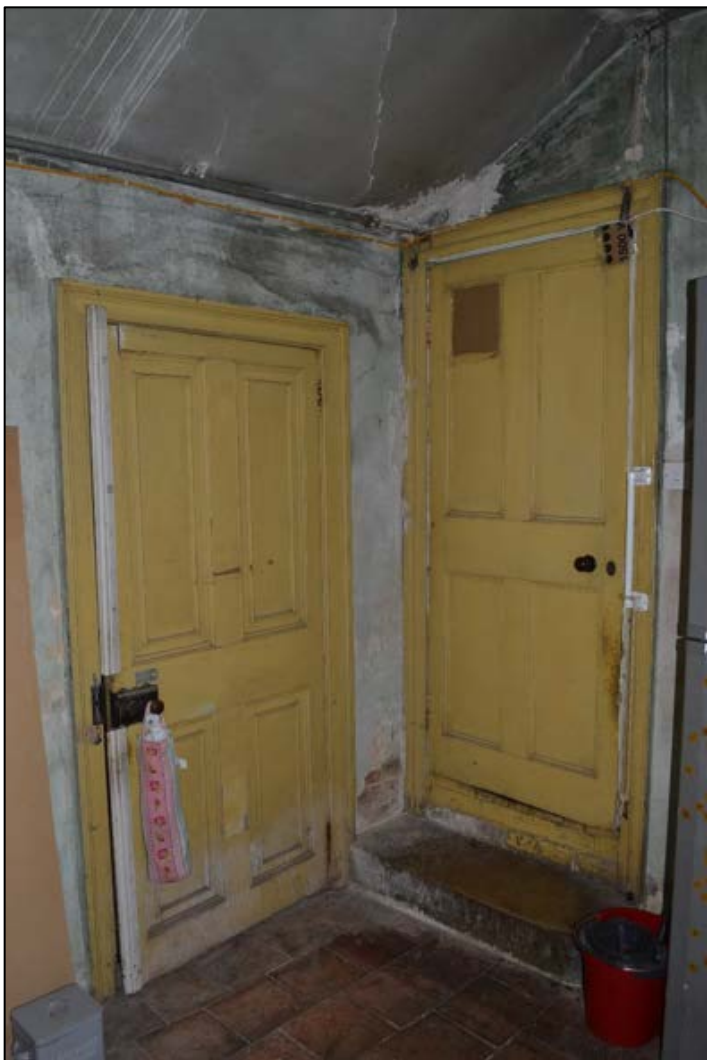
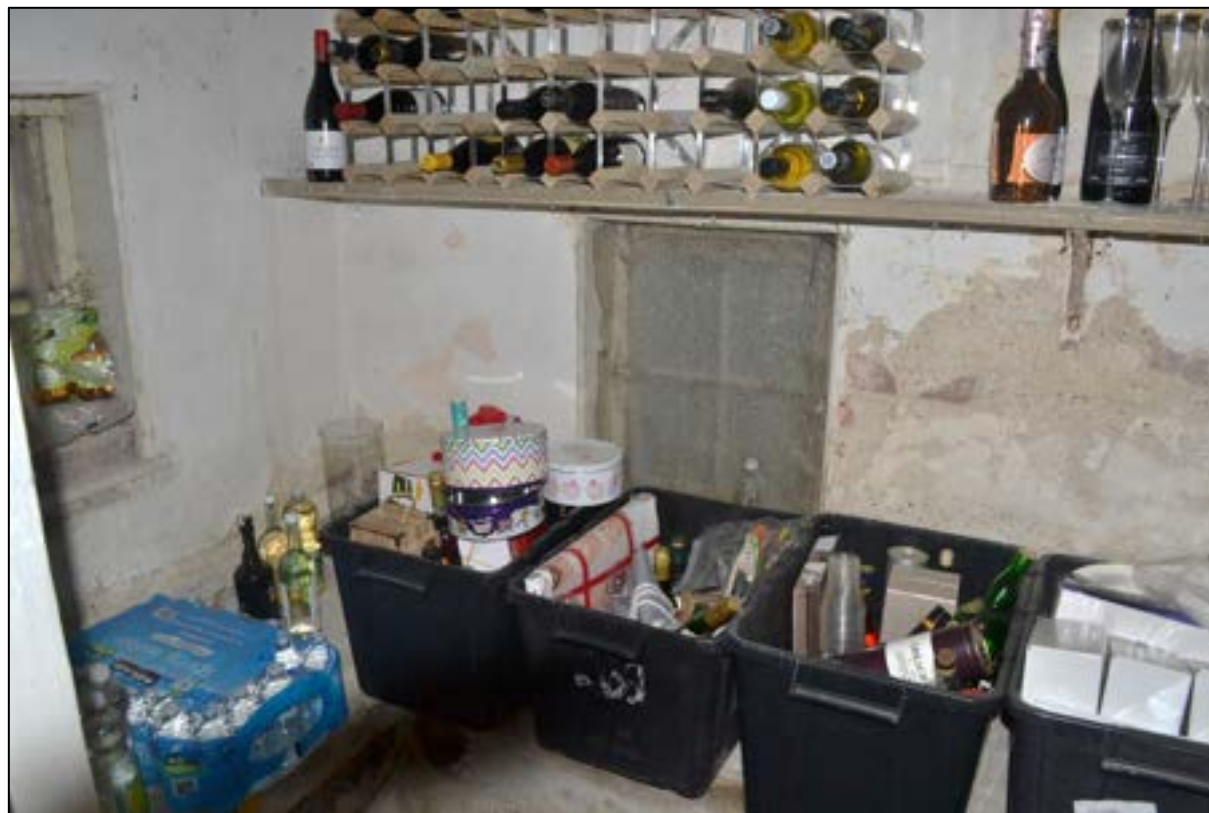
Figure 42: (left) doors leading into the principal house (highlighted in blue) and later attached pantry (highlighted in red, (right) view inside pantry

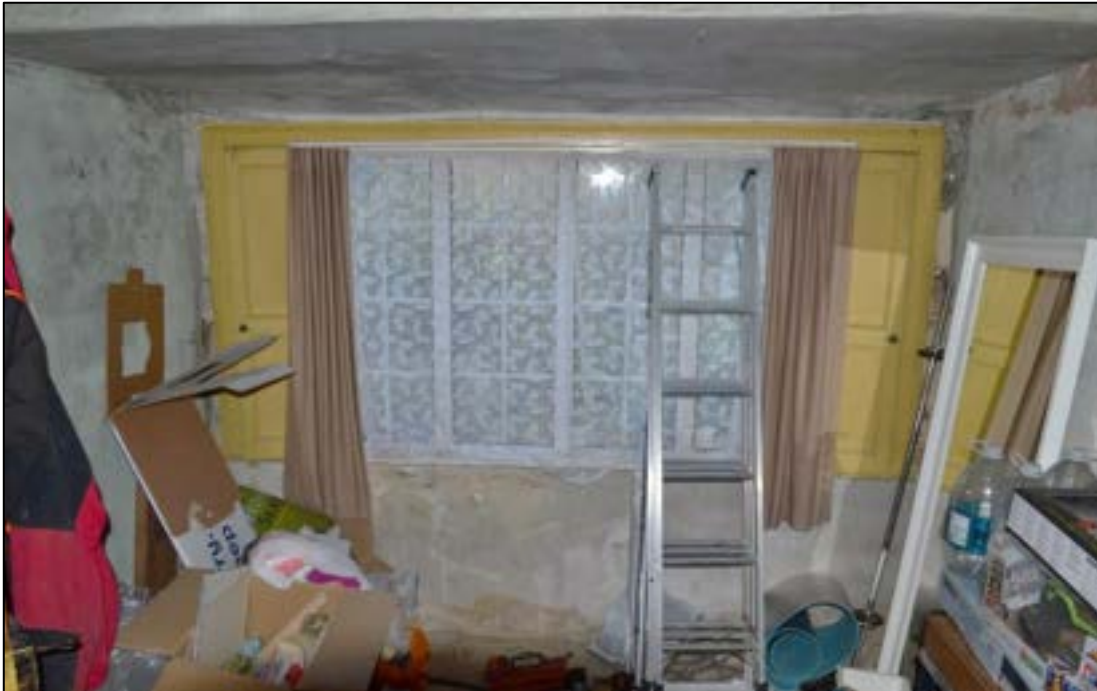
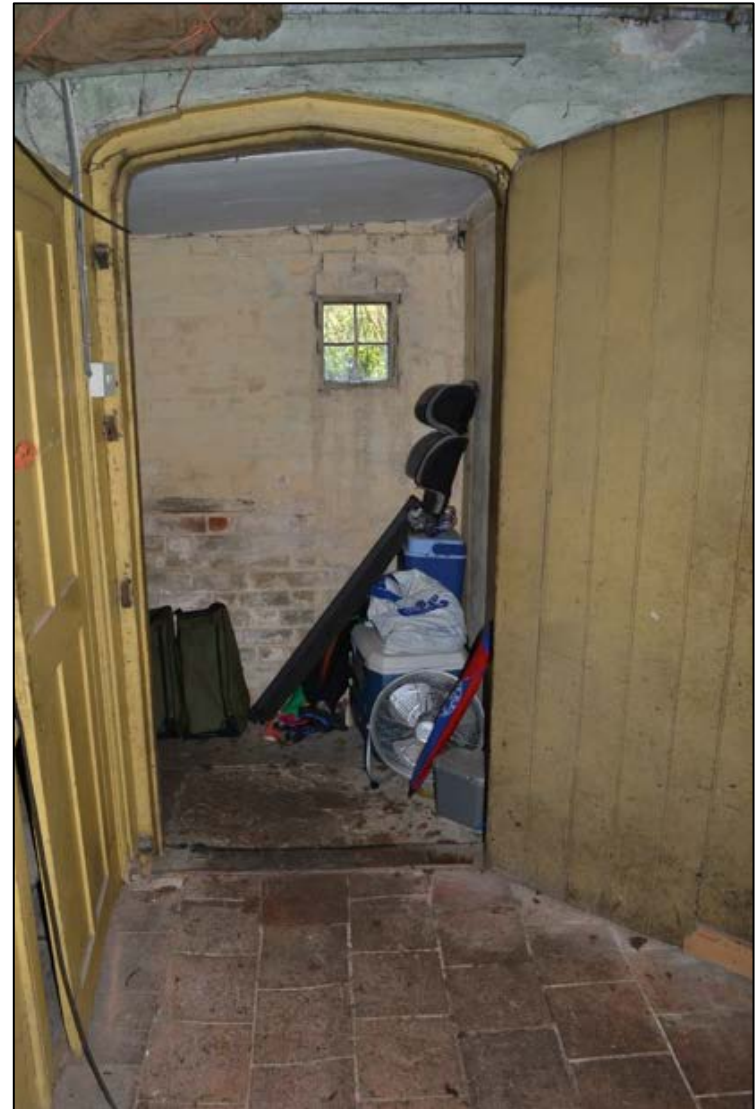
*Figure 43: (left) later 20<sup>th</sup> century extension to utility and window insert, note the shutters (highlighted in green) are thought to come from spare bedroom/family room, (right) another door and frame taken from Arborfield Church*

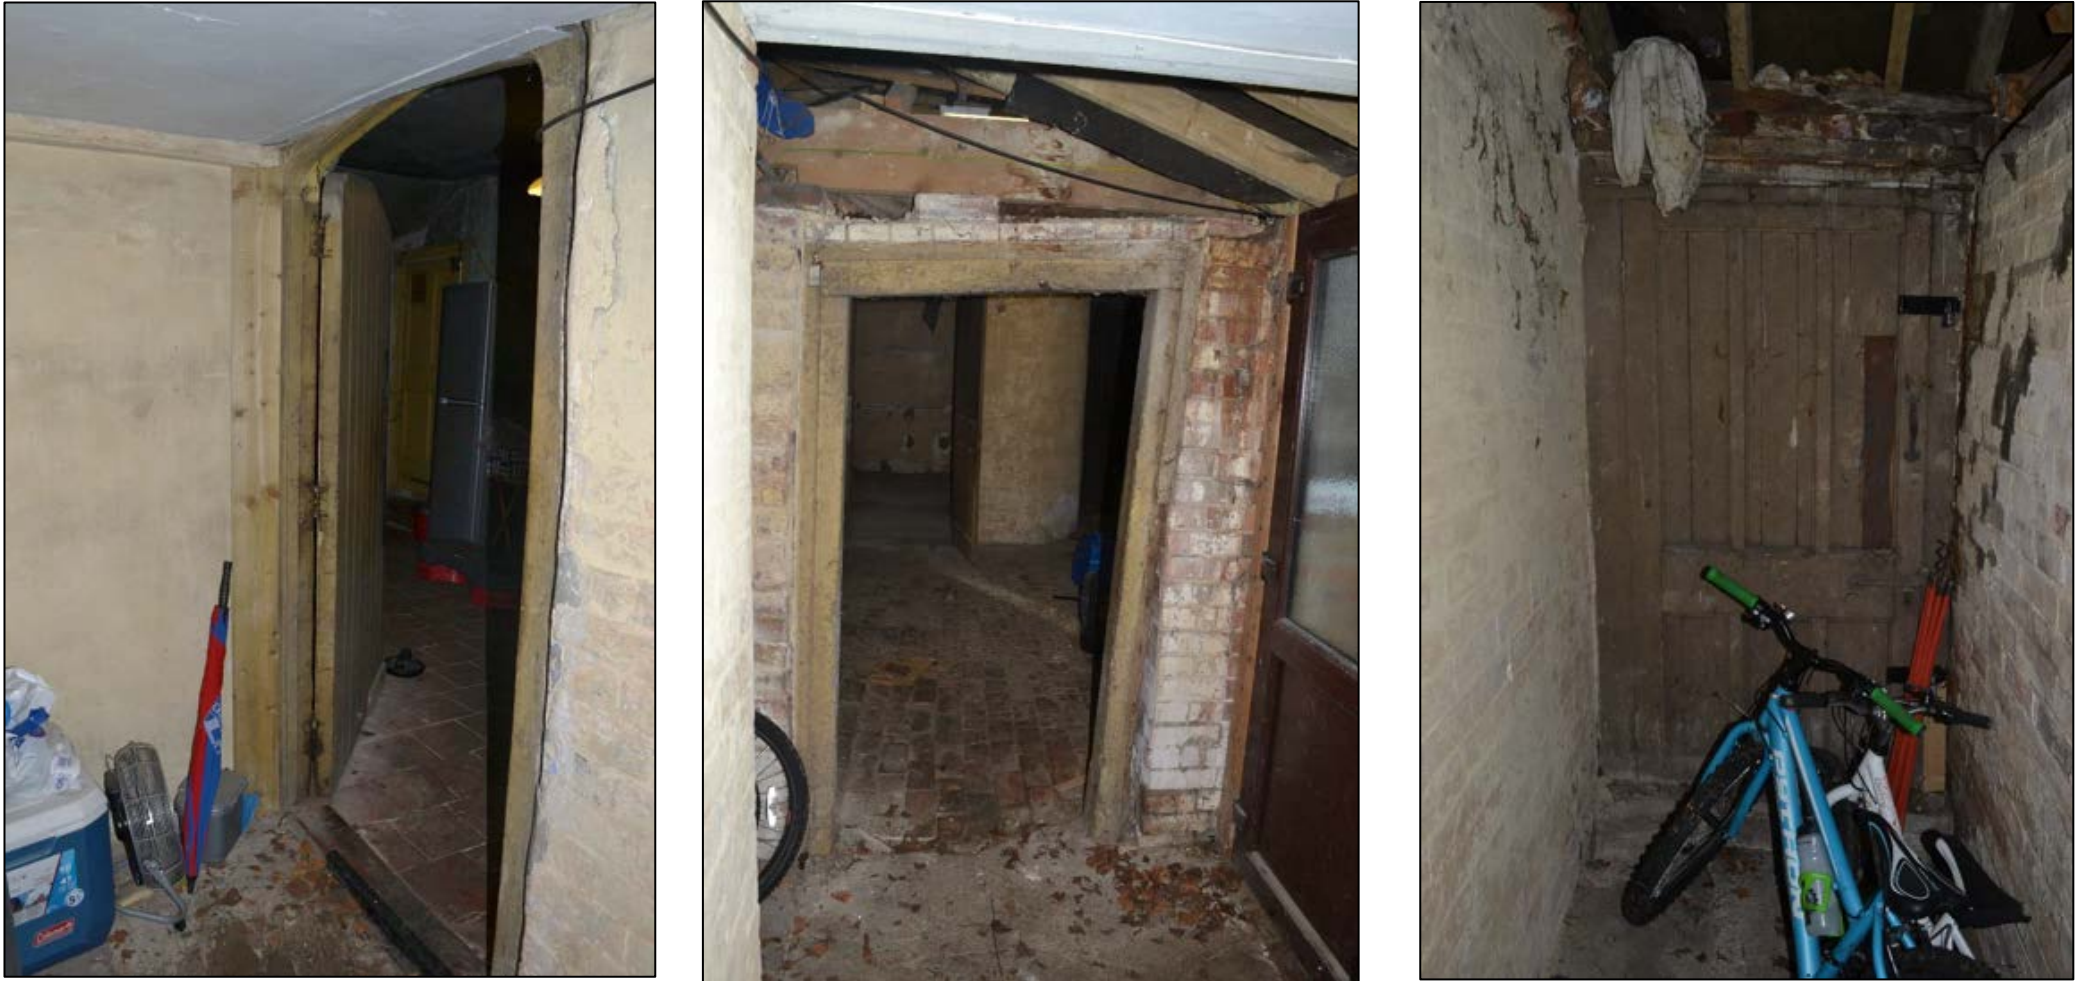
*Figure 44: View inside later 20<sup>th</sup> century extension that attaches the outbuilding to the principal house - (left) view of doorway taken from Arborfield Church, (centre) door way leading into outbuilding, (right) 19<sup>th</sup> century door leading out into the southern garden at the rear of the property*

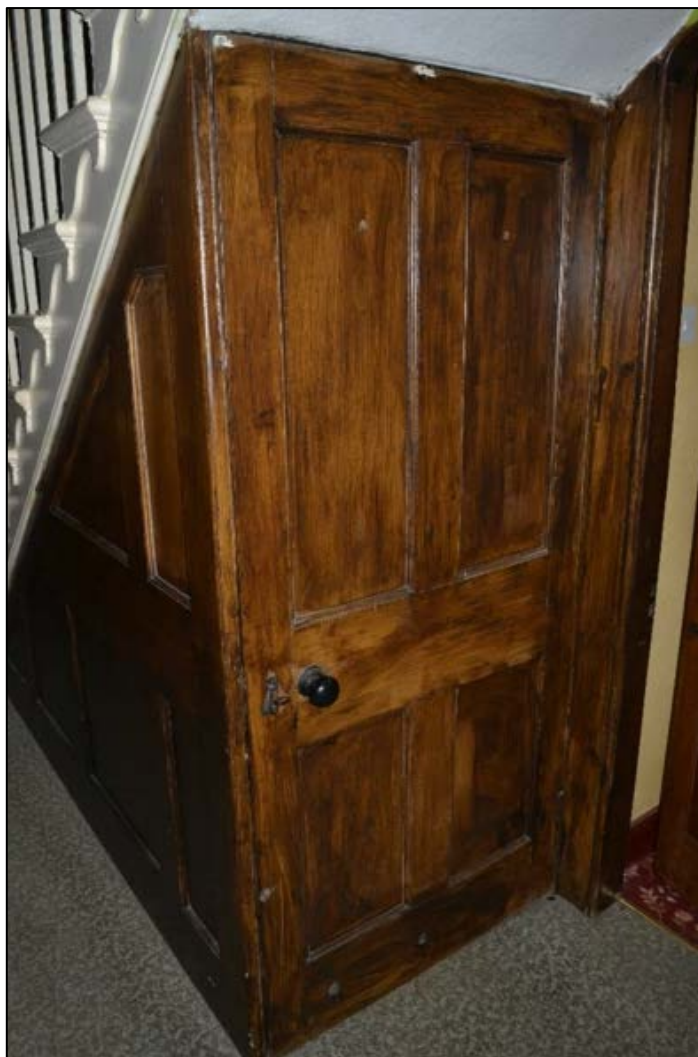
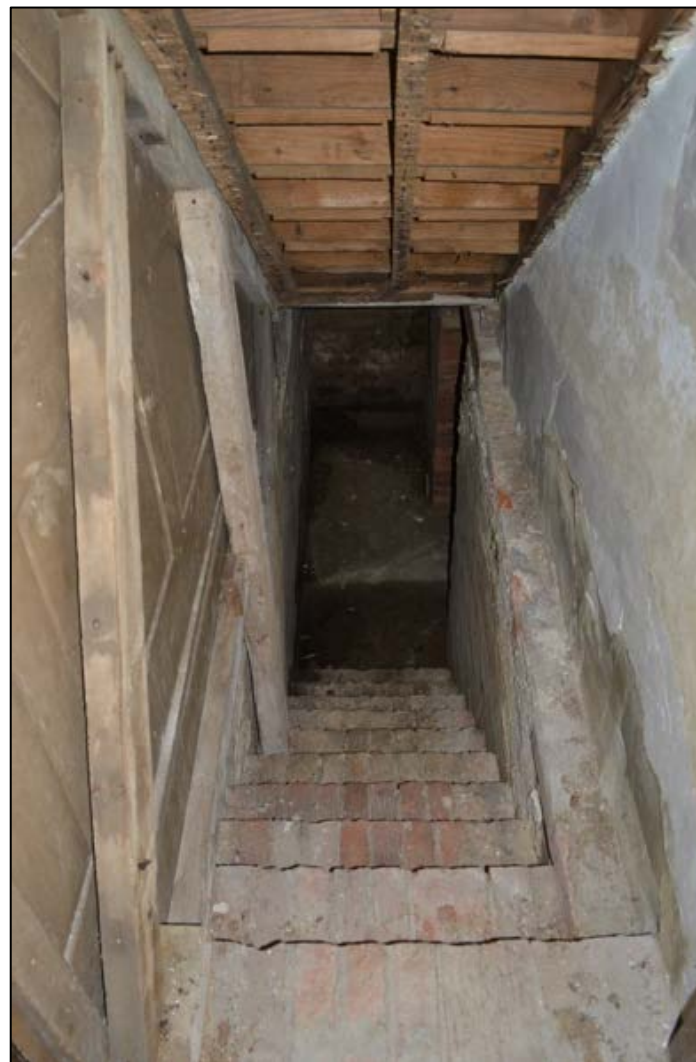
*Figure 45: (left) door leading into the cellar, (right) brick steps leading down into the cellar*

The cellar is thought to date from the construction of the principal house, early 19<sup>th</sup> century and comprises of 2 brick lined rooms with exposed ovens recesses (**Figure 45 & Figure 46**).

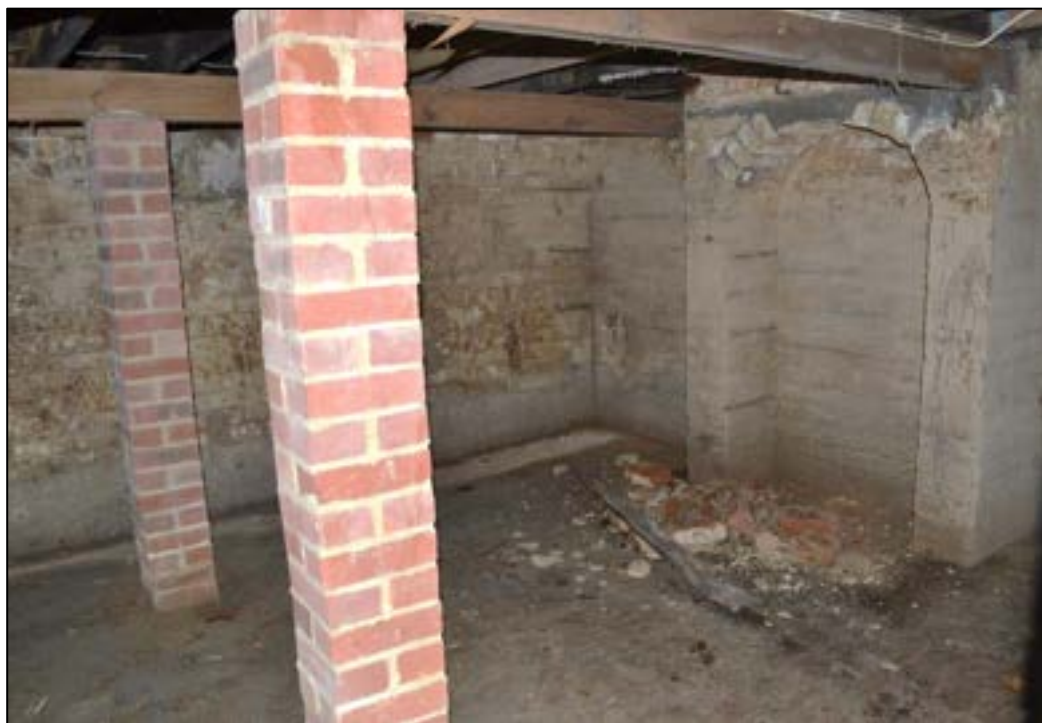
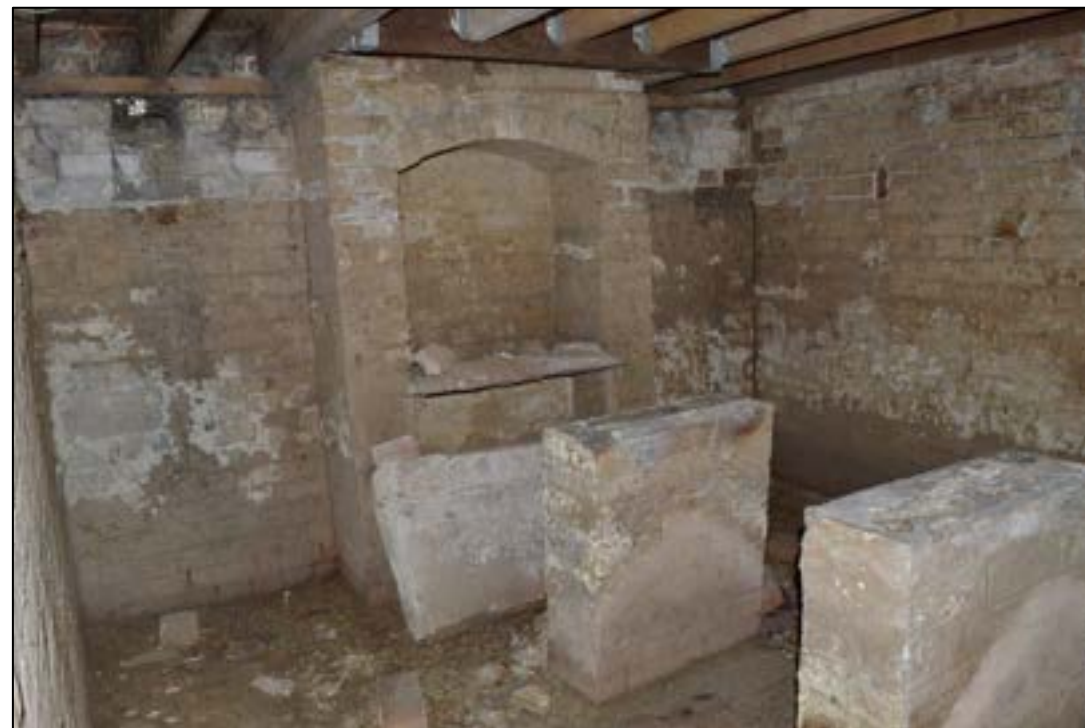
*Figure 46: Cellar rooms - note the walls are brick lined and there are recessed oven arches*

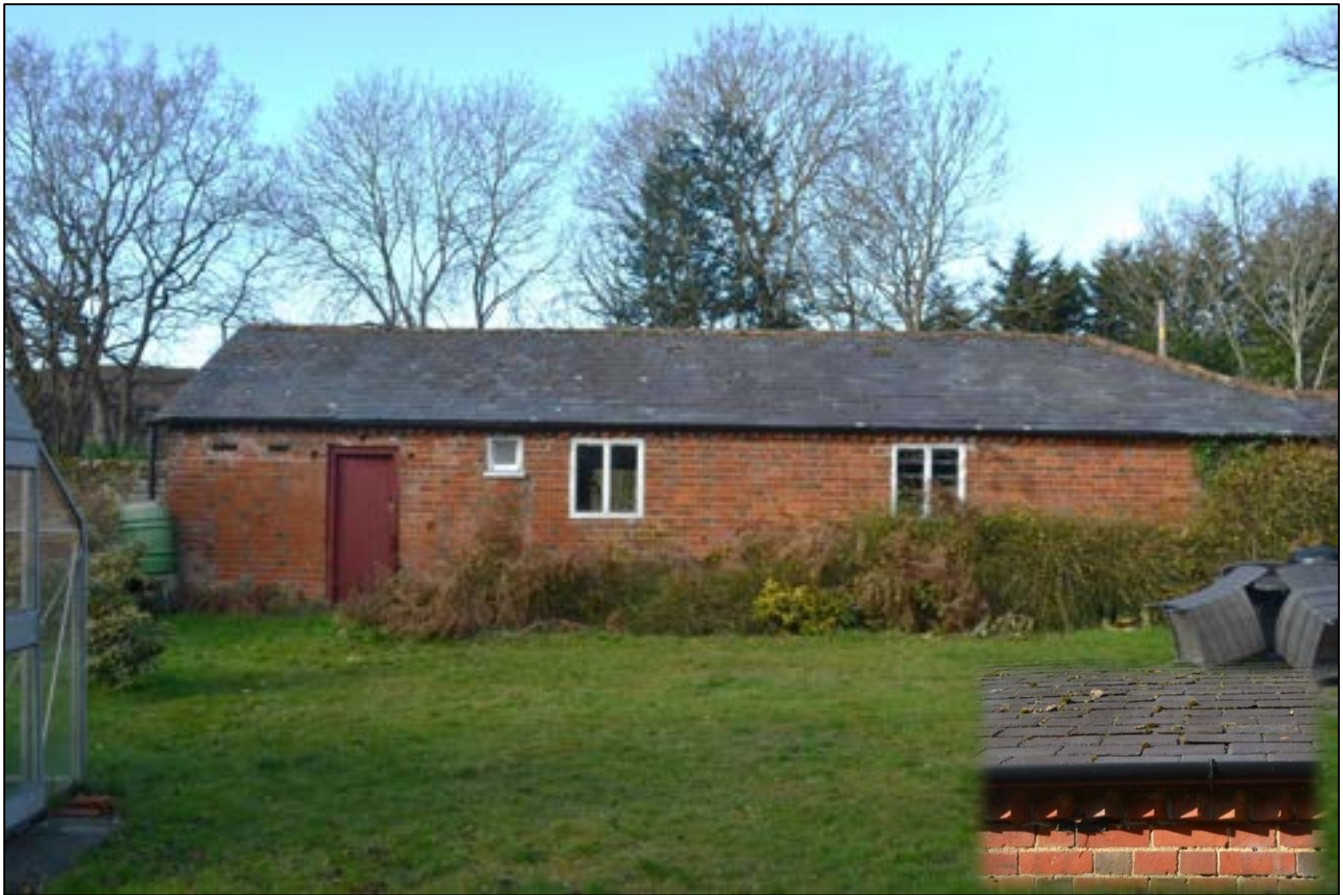
*Figure 47: Eastern elevation of attached outbuilding (inset corbelling detail)*

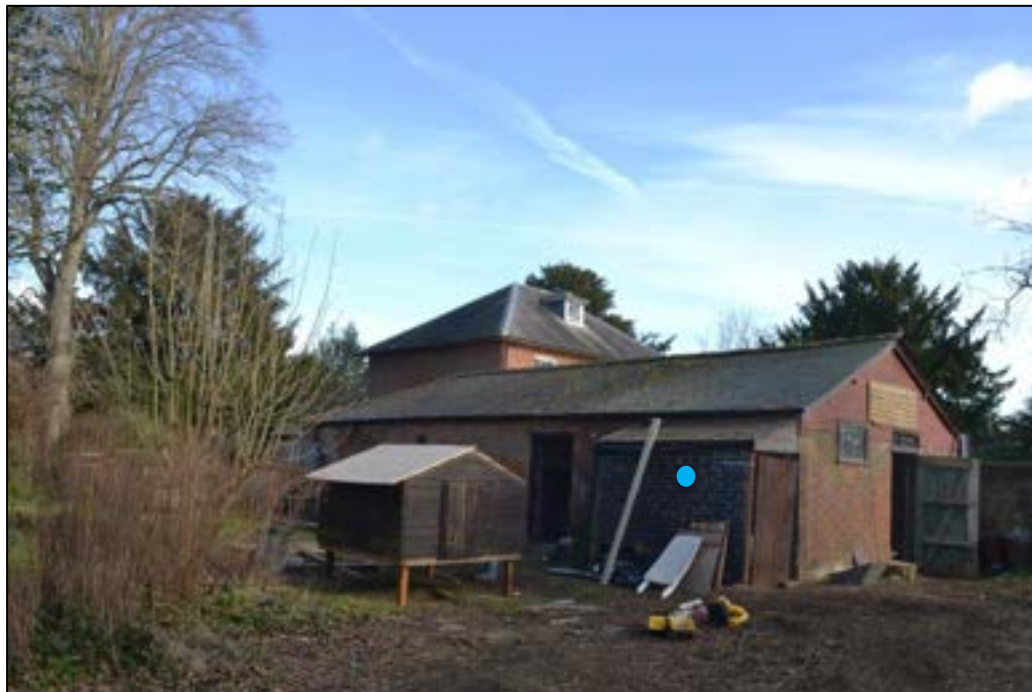
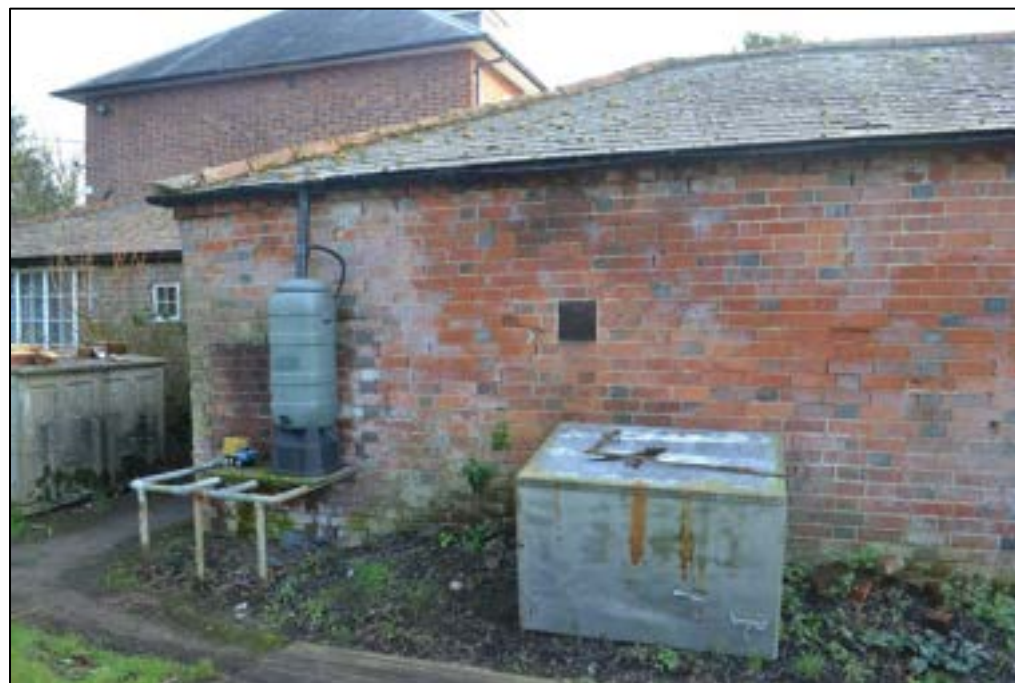
*Figure 48: Western elevation of attached outbuilding- note the timber outhouse identified in blue*

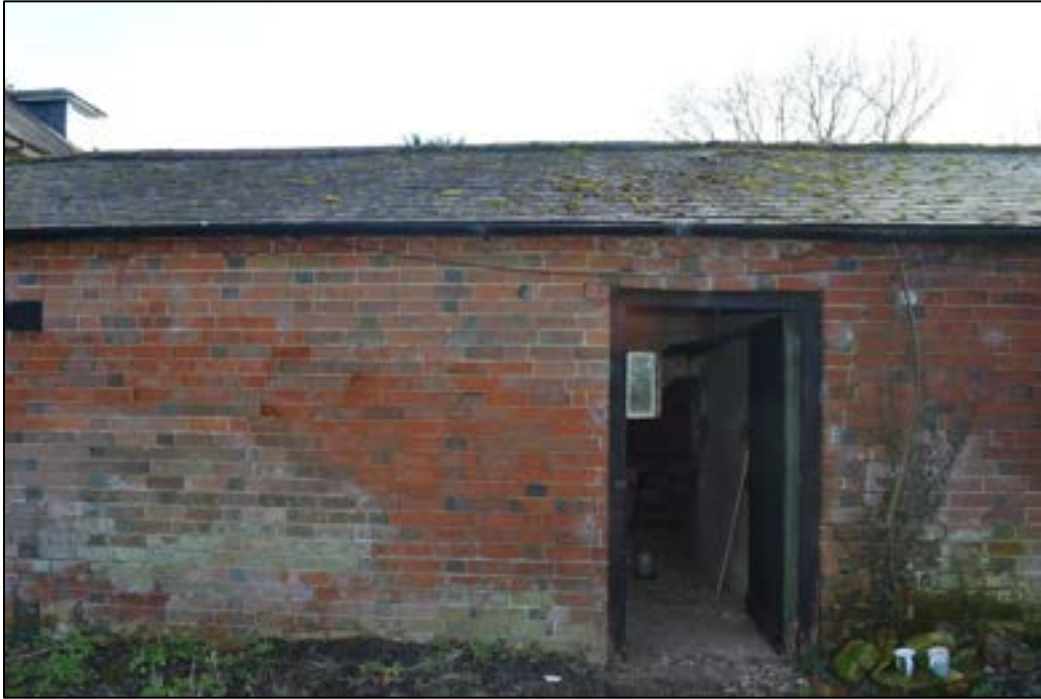
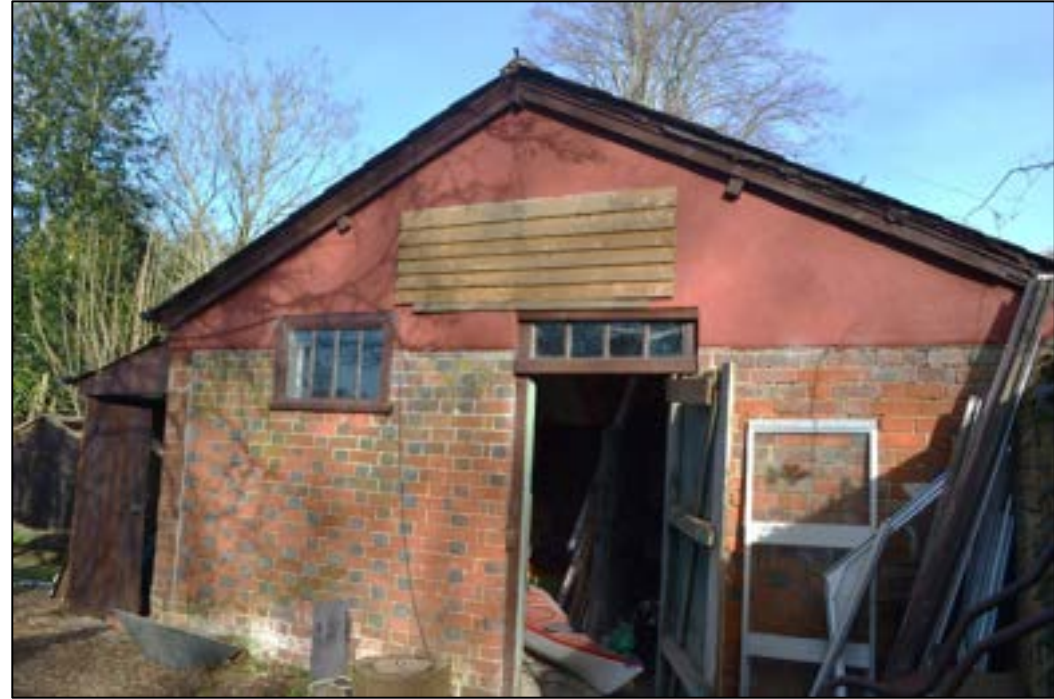
*Figure 49: (left) Doorway into former tack room/store along western elevation, (right) southern elevation note the window and door inserts and the rendered top half*

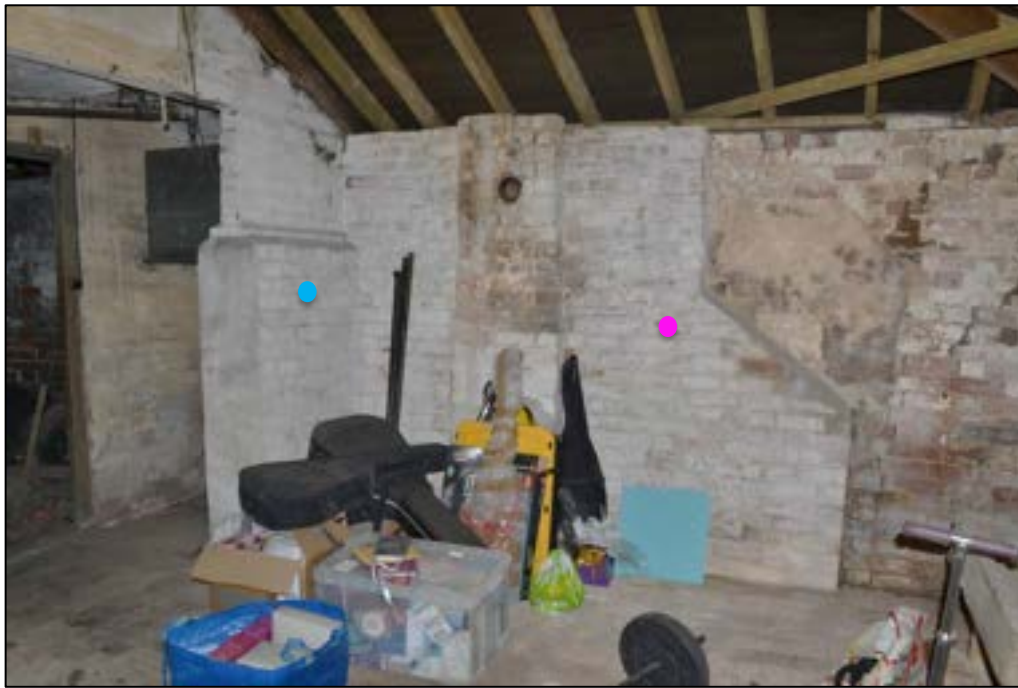
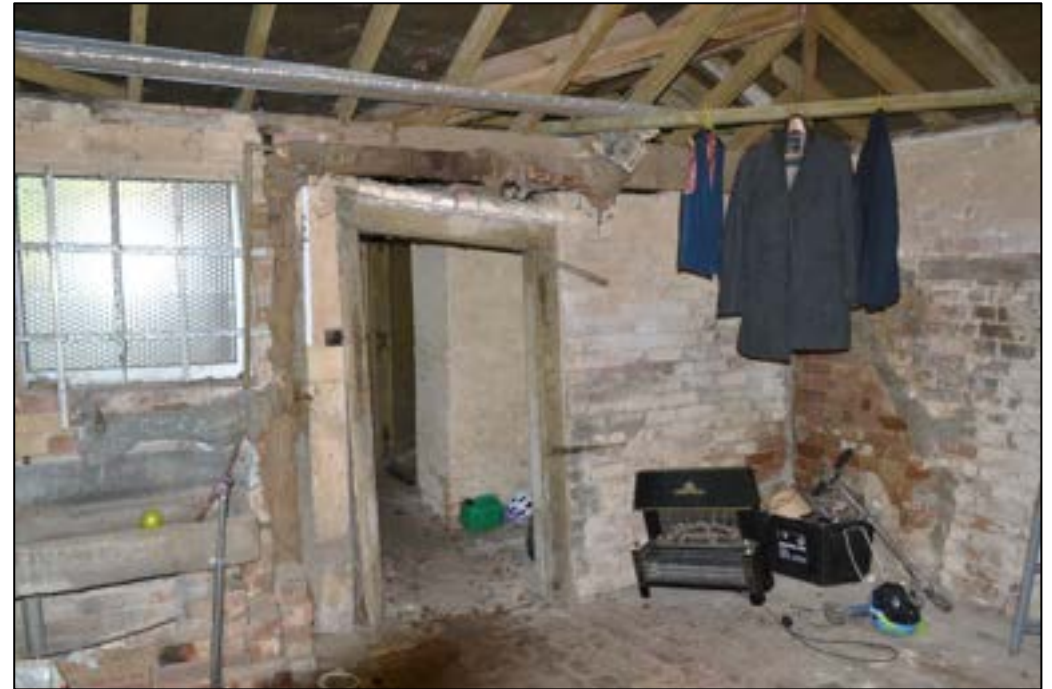
*Figure 50: Main store, first room of the outbuilding you enter upon exiting the utility/pantry, (left) note remnants of the original dividing wall highlighted in blue and evidence of a flue/chimney at one point in time highlighted in pink, (right) door that leads into 20<sup>th</sup> century link between the outbuilding and principal house*
