**Heritage Statement**  
Sussex Lodge  
Sussex Lane  
Spencer's Wood  
Reading

**Date of Issue**  
October 2022

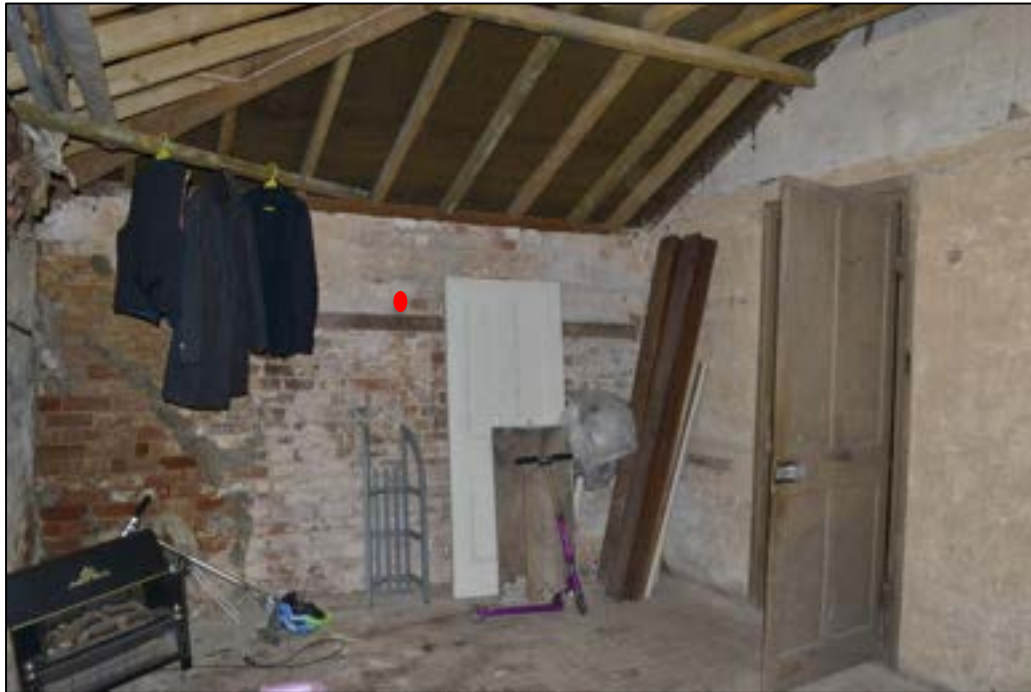
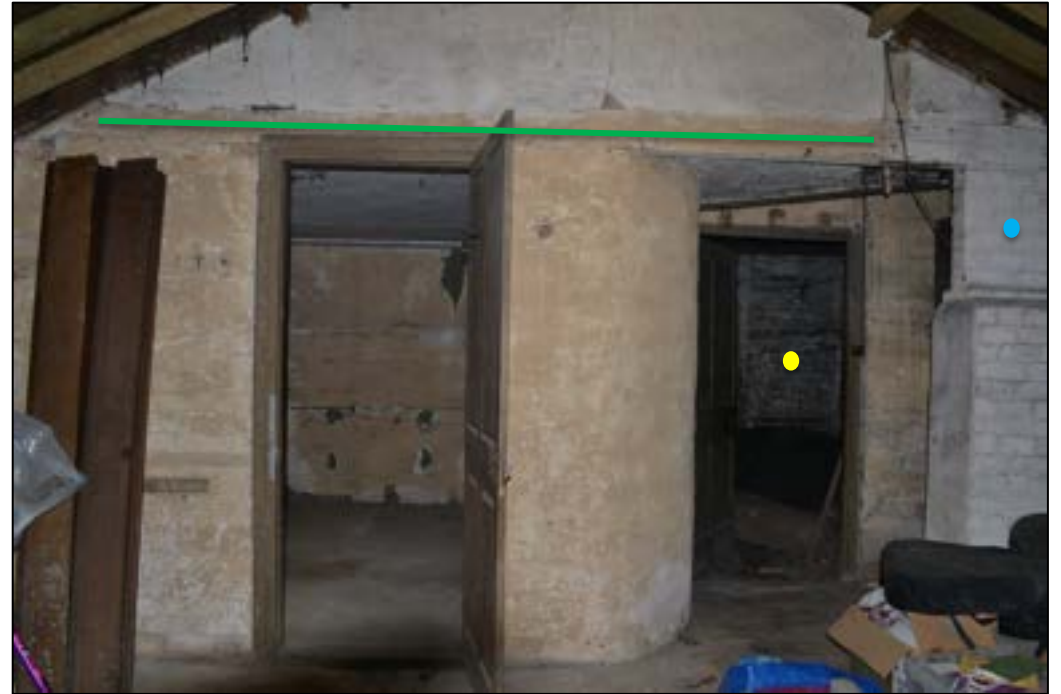
*Figure 51: Further interior images of initial store - note the timber lintel highlighted in red indicating a potential former opening, the section of wall highlighted in green (which includes the curved wall) appears to be a later insertion and post-date the original masonry wall highlighted in blue, the coal store is highlighted in yellow.*

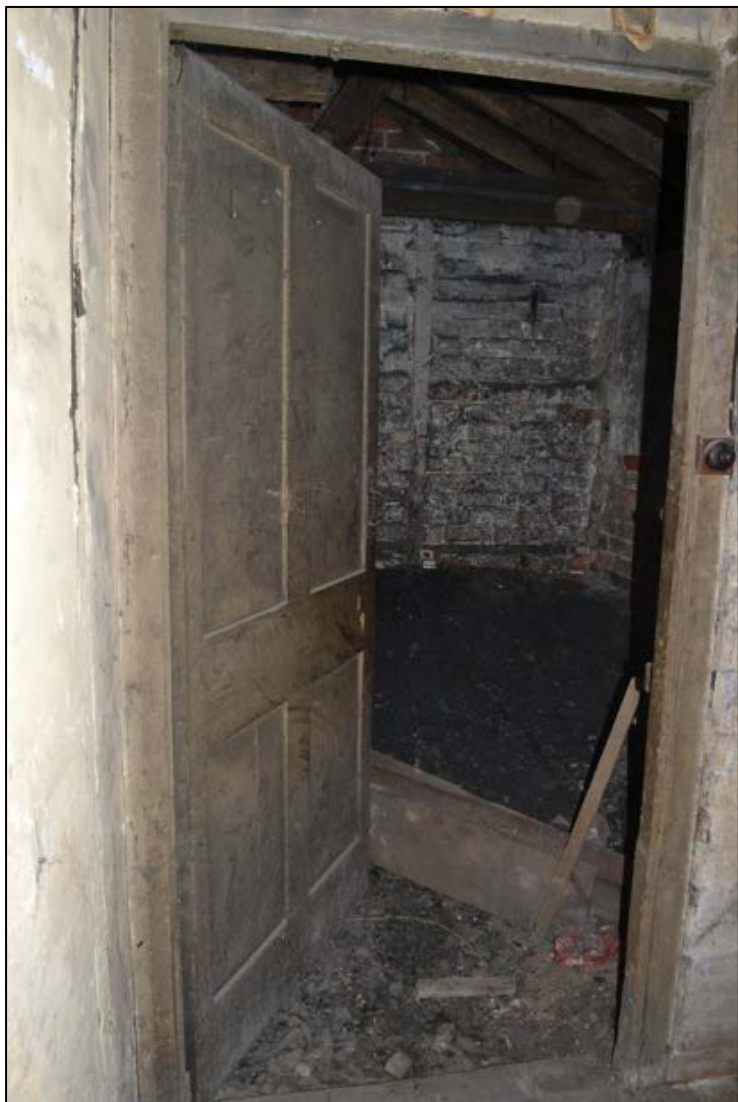
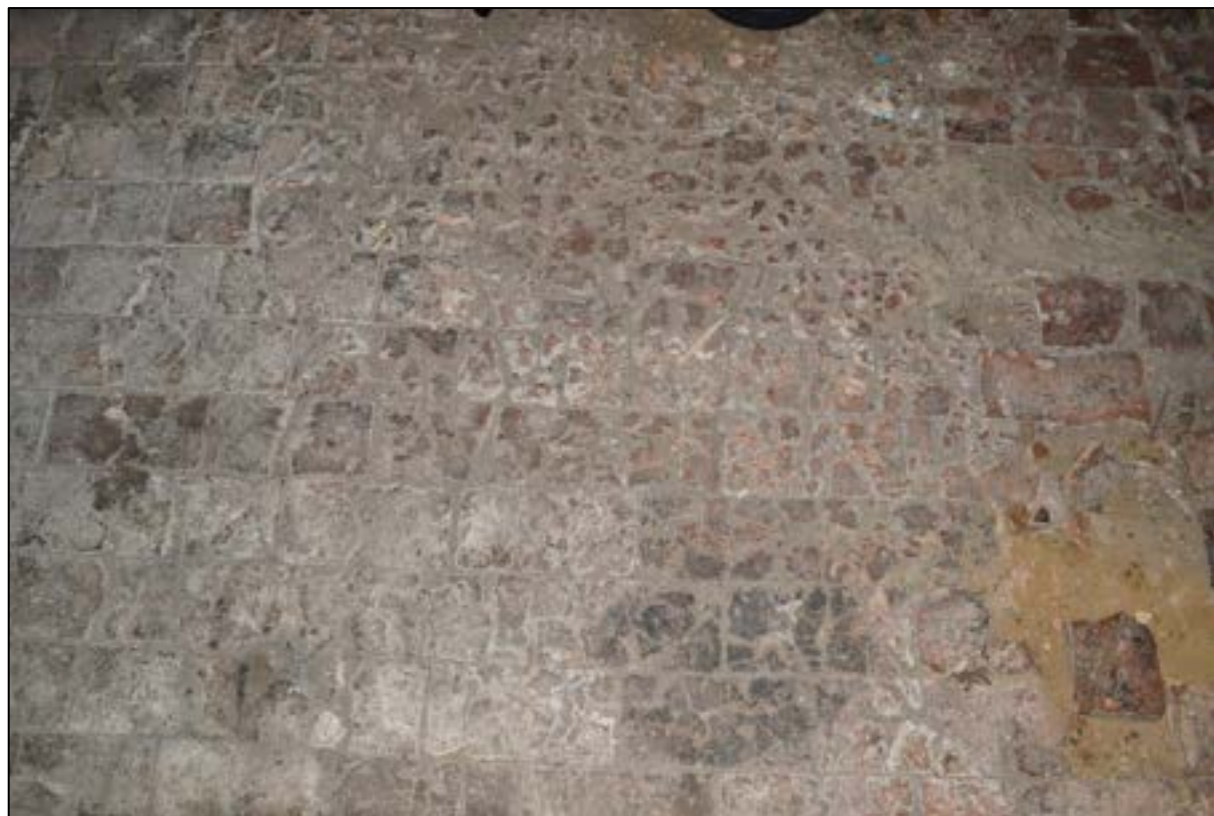
*Figure 52: (Left) Coal store, and (right) brick flagstone floor damage of which illustrates the use of the room as a potential former workshop*

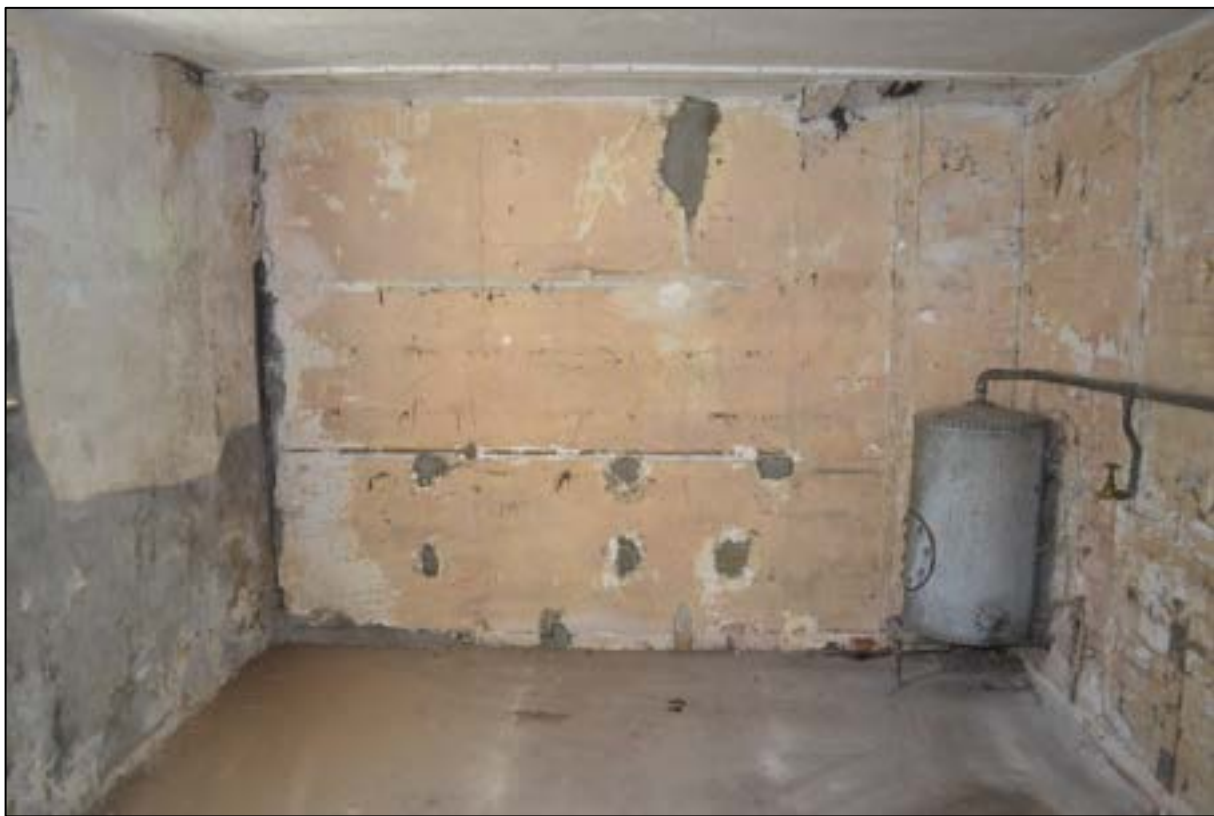
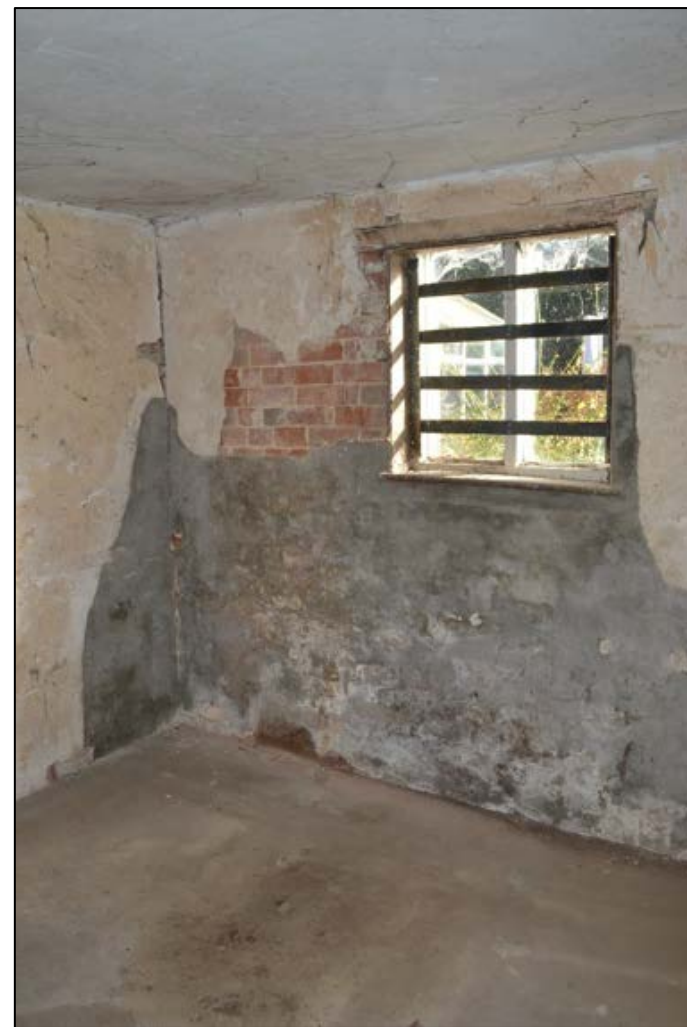
*Figure 53: Internal view of boiler room- note (left) the evidence of the later timber frame and brick infill wall visible through the plaster/render. The concrete floor is a later 20<sup>th</sup> century addition*

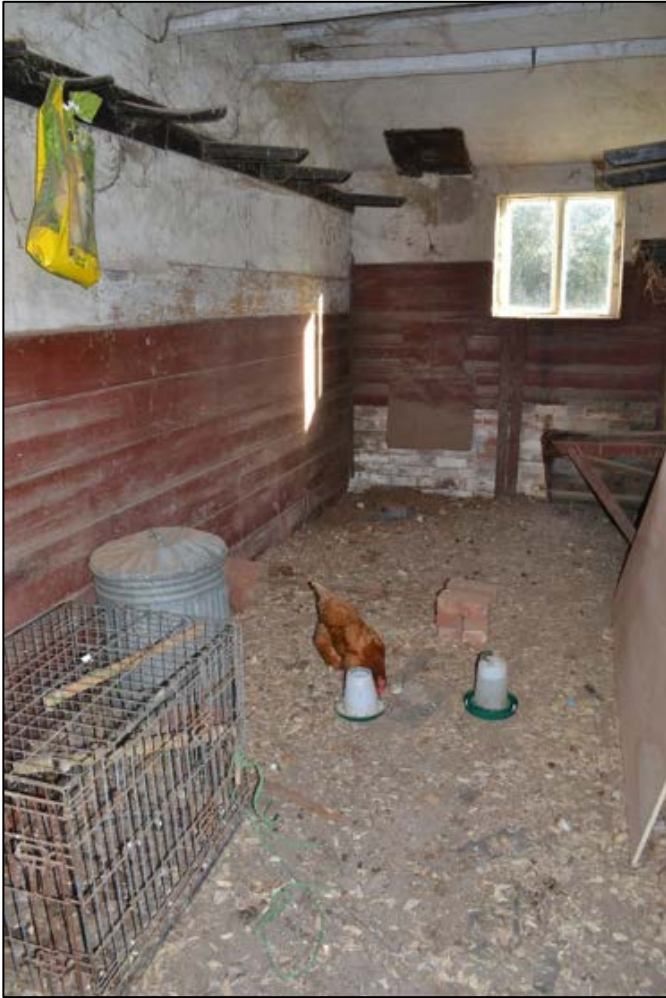
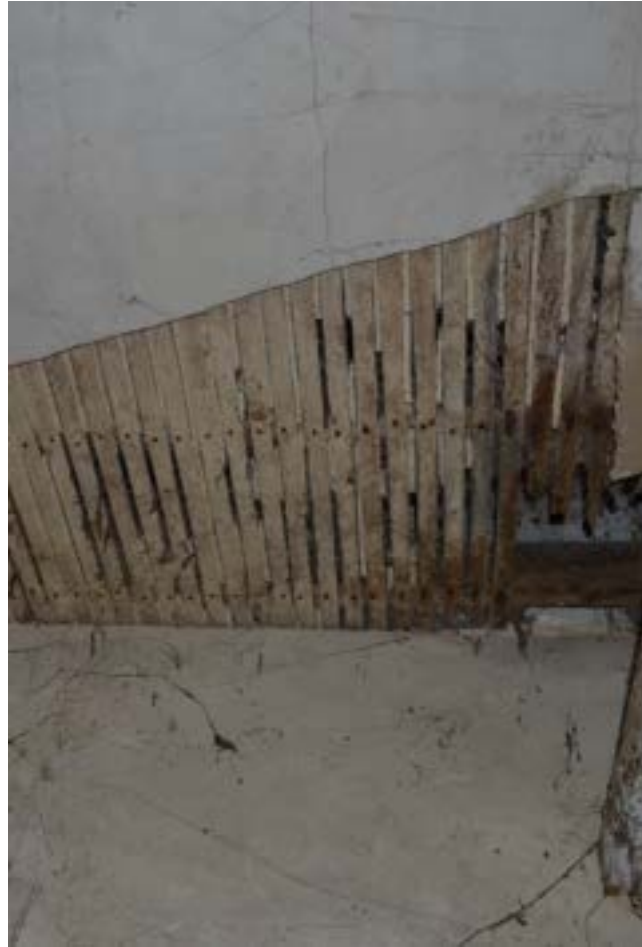
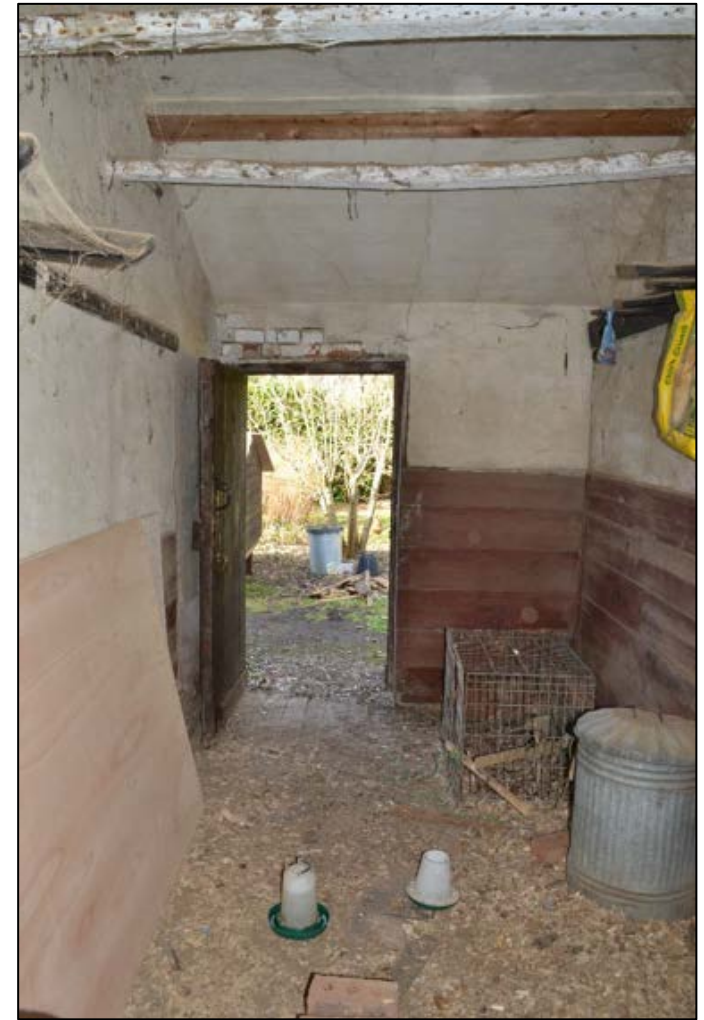
*Figure 54: Tack room and store adjacent to the coal store and boiler room. The walls are lined with timber however parts of the plaster along the roof have been lost exposing timber laths beneath*

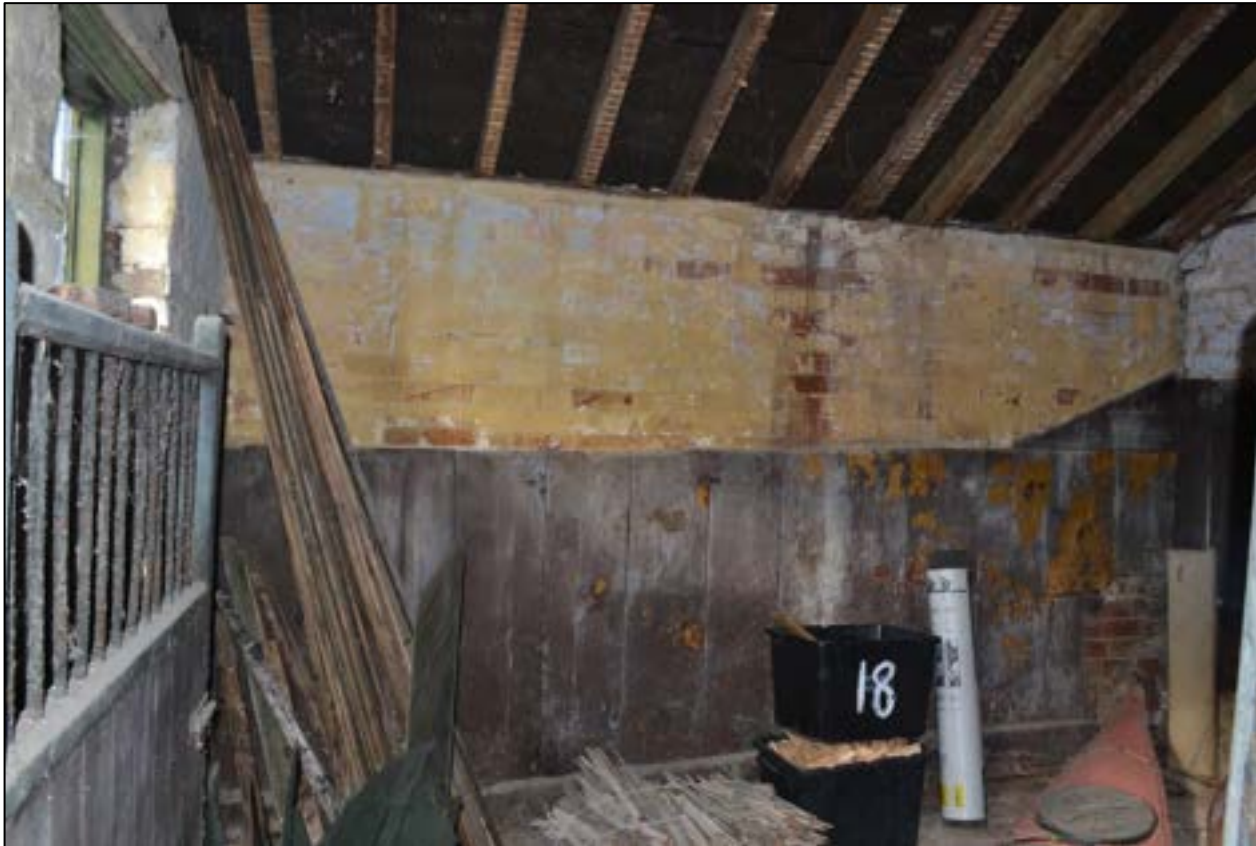
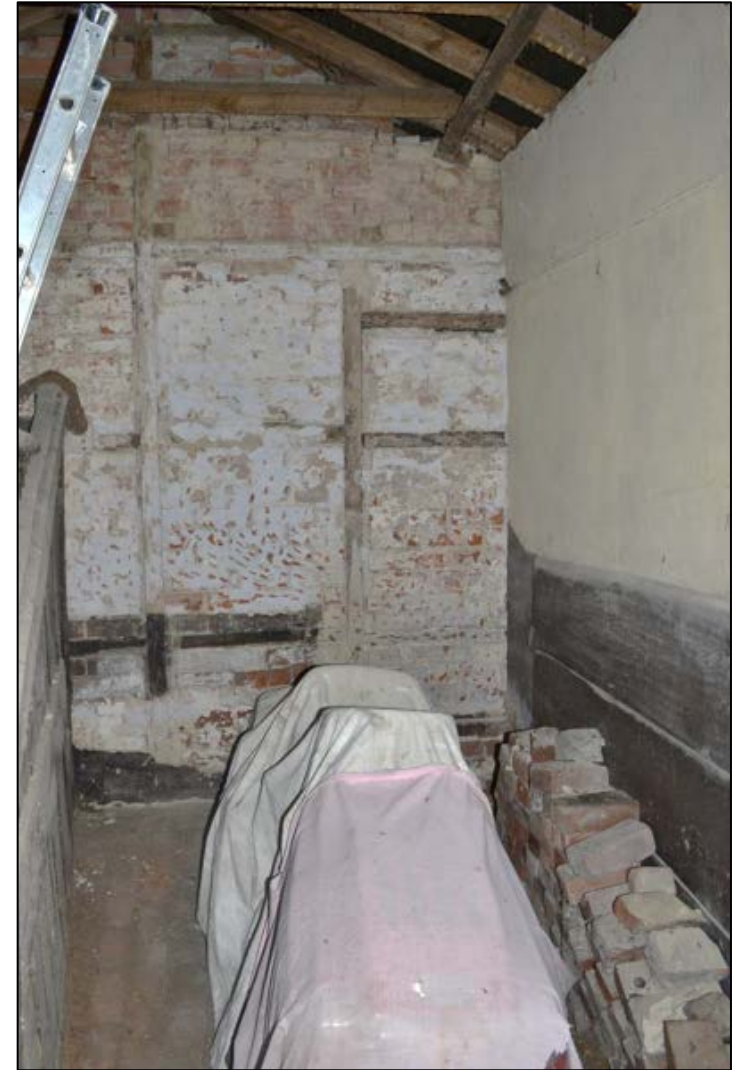
*Figure 55: Final store room, now stable, (left) exposed roof timbers and bitumastic sarking felt, suggesting that the roof was last recovered in the late 1970s or 1980s. (Right) Evidence again of timber and brick stud wall separating the stable from the tack room*

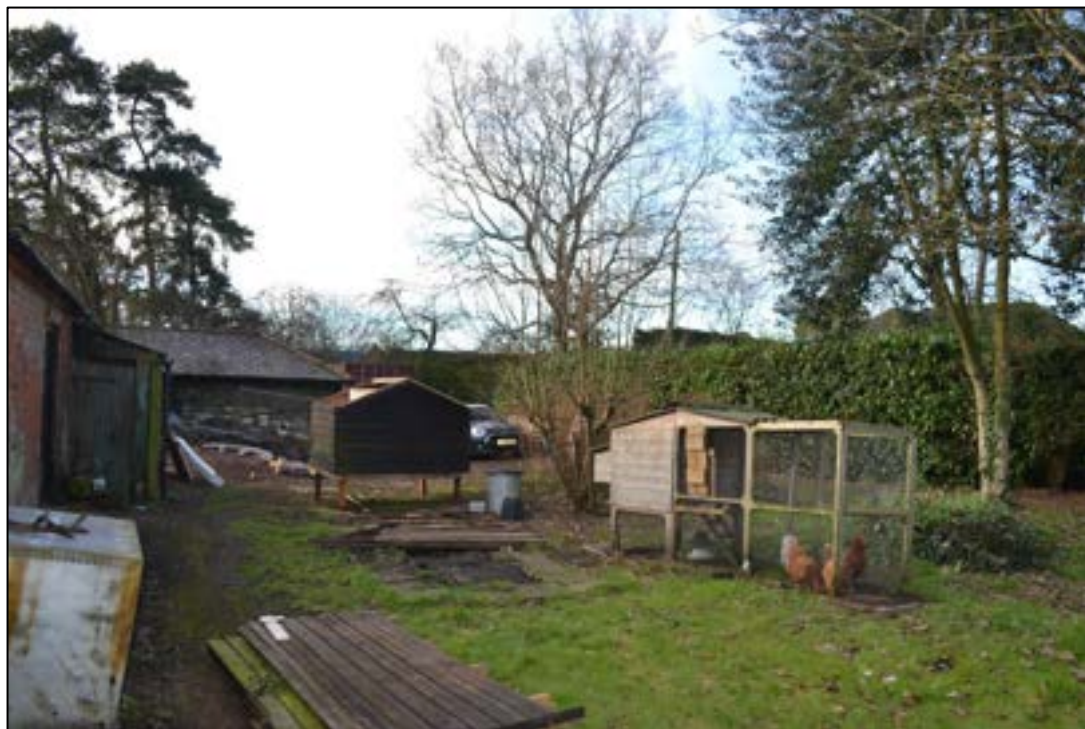
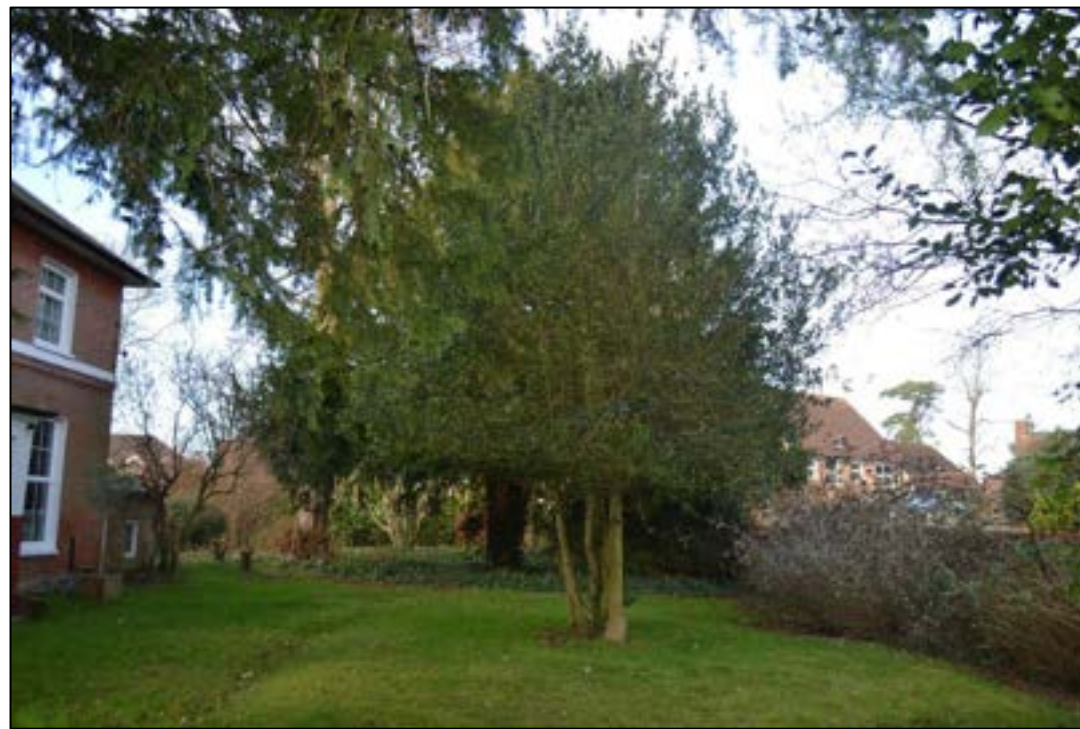
Sussex Lodge is sited within substantial tree lined garden which (**Figure 59, Figure 60, & Figure 61**), whilst historically would have been larger as is evident on [OS maps](#), has maintained a level of seclusion even amongst the surrounding development which encroached upon it from the mid-20<sup>th</sup> century onwards (**Figure 8**). It should be noted that a number of these trees are covered by a Tree Preservation Order which means an application must be submitted to the LPA prior to works taking place to them.

*Figure 59: Western and northern gardens respectively*

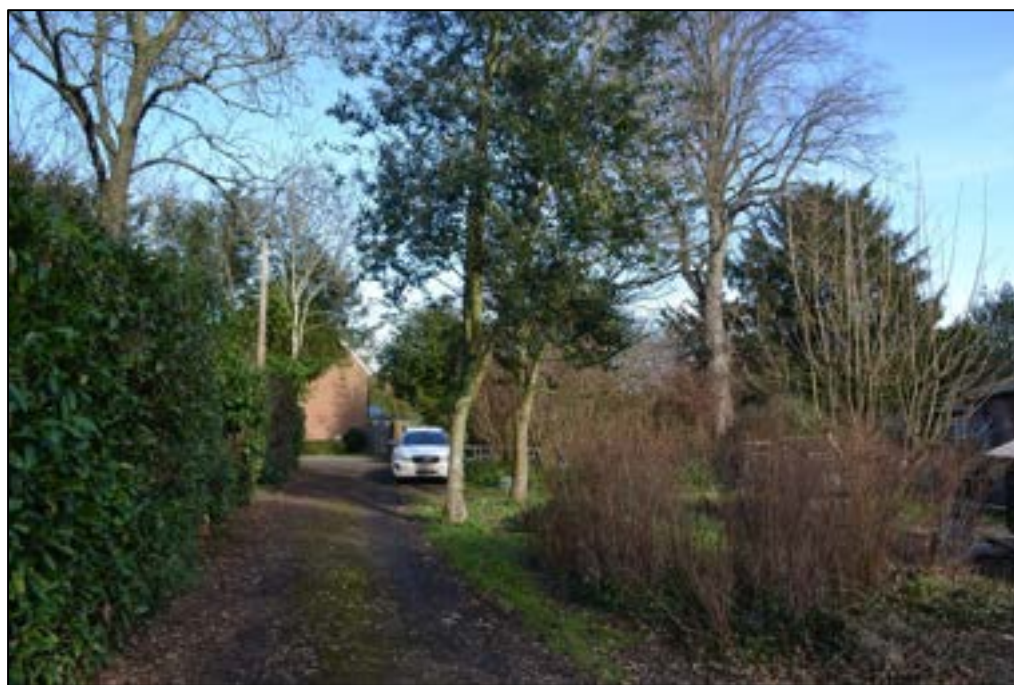
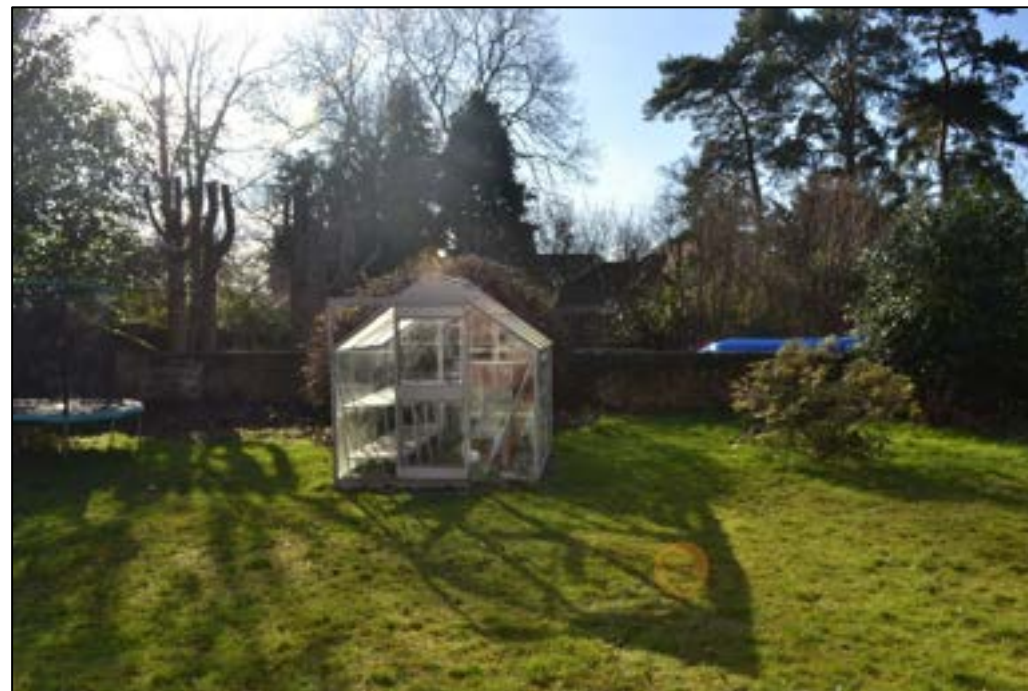
*Figure 60: (left) Driveway into Sussex Lodge plot, (right) southern garden*

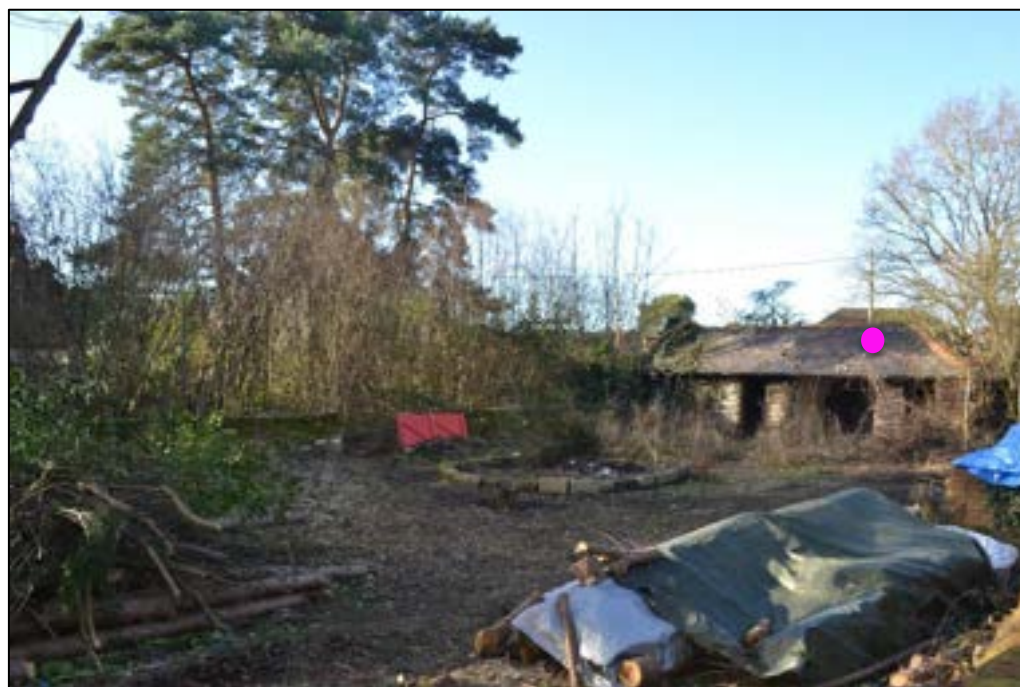
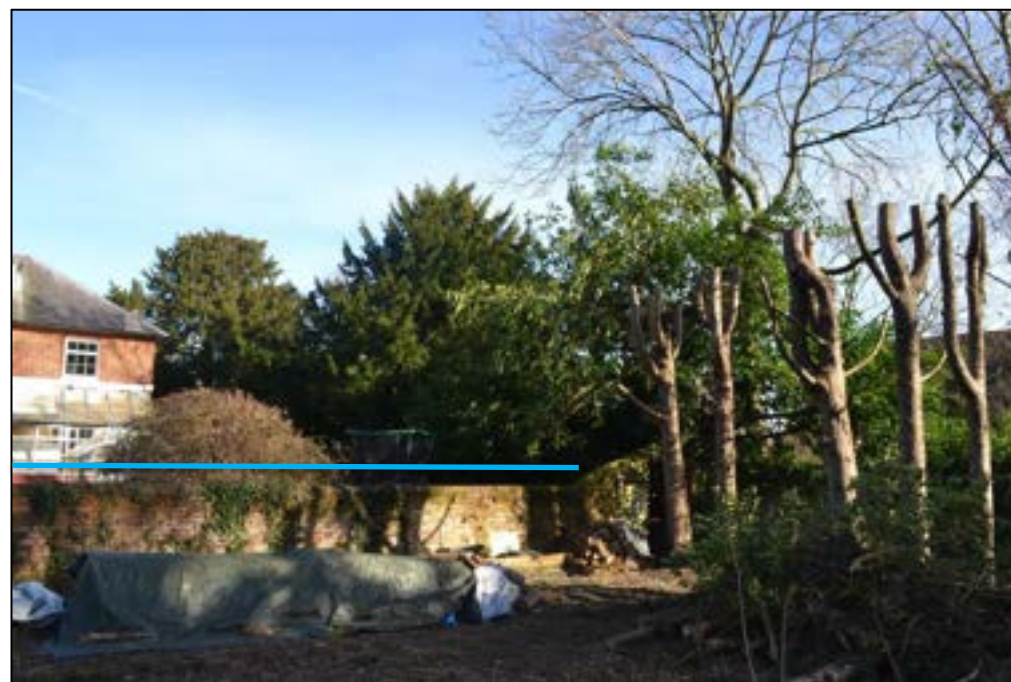
*Figure 61: Southern garden and historic outbuilding (highlighted in pink), and historic brick boundary walls (highlighted in blue)*

- **Green**- The installation of solar panels on the southern and western roof-slopes of the ancillary garage/outbuilding on site. The location of the panels will mean they are not visible from the principal listed building nor the public streetscape (**Figure 67**).
- **Yellow**- Removal of a small section of the garden wall to allow access to all parts of the garden (**Figure 61**).

| Proposed Works and Area of Impact | Heritage Value | Level of Change | Overall Impact |
|---|---|---|---|
| The opening up of the central garden wall in the southern garden (Figure 68) | Aesthetic- Low-Medium<br>Historic- Low-Medium<br>Evidential- Medium<br>Communal- Negligible/Low | Minor Change | <b>Neutral/Slight Impact</b> - As is evident from the images above ( <b>Figure 61</b> ), to access to the southern parts of the garden is through a gate to the east. The wall needs some repair and as such the insertion of a small opening in the central section along with the rest of the walls upkeep is considered to results in a <b>neutral/slight impact</b> . |

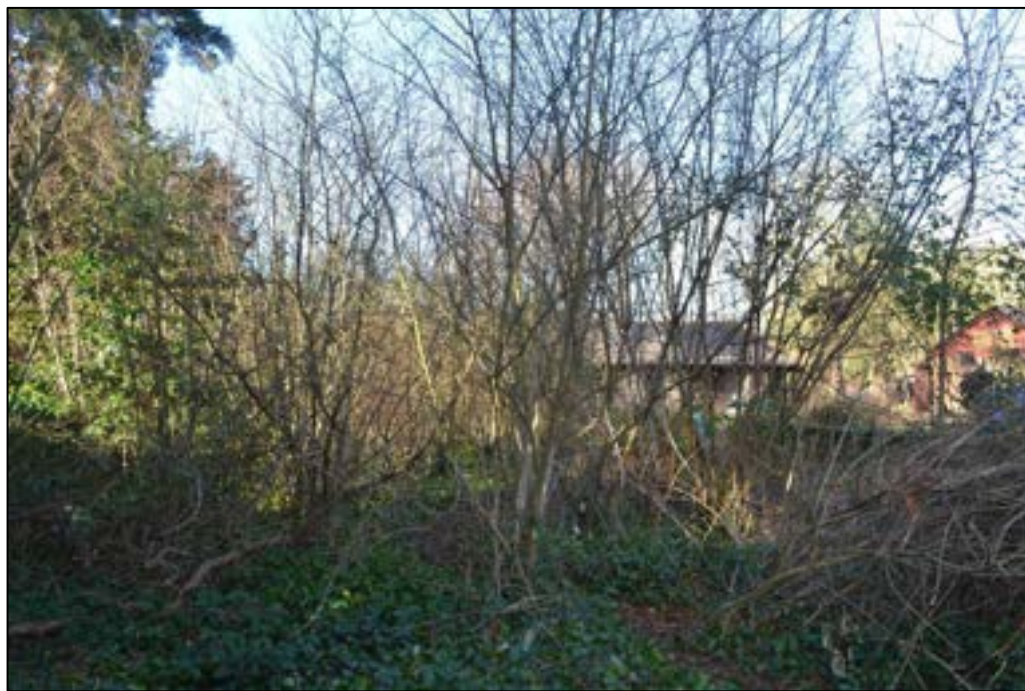
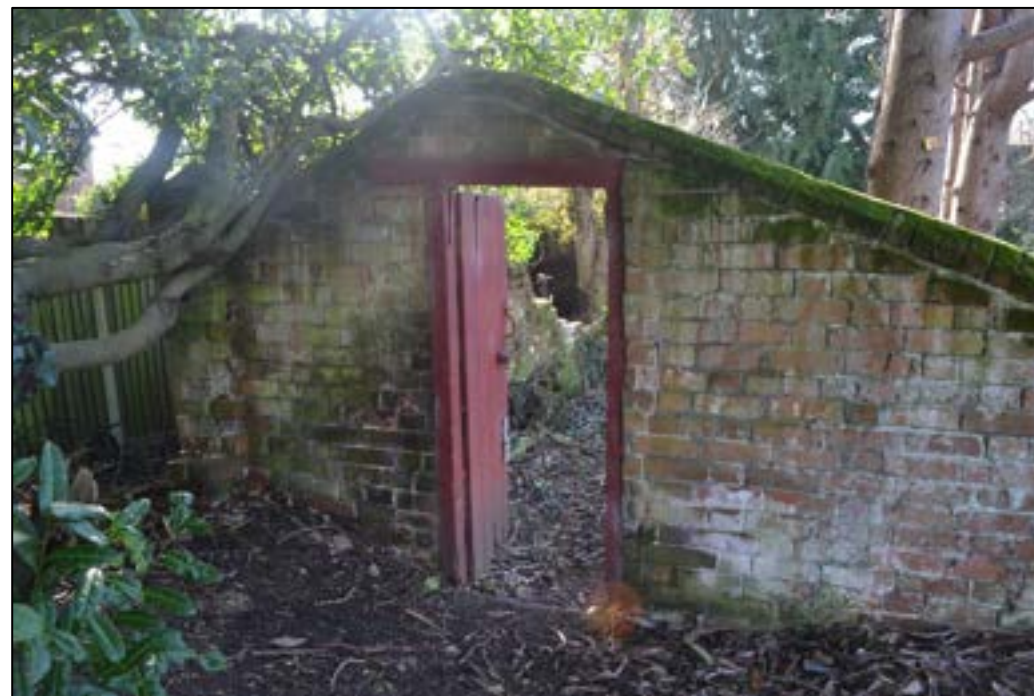
Remnants of the landscaped garden and other outbuildings on the site survive such as the garden walls - the central one always being a garden wall (**Figure 62**) whilst the southern appears to have been part of a wall of a former outbuilding (**Figure 63**) and part of an iron gate delineating a landscaped footpath around the periphery of the garden (**Figure 63**) - see [OS Maps](#).

*Figure 62: (left) Further most part of the southern garden, (right) doorway through central brick boundary wall which separates the southern gardens*

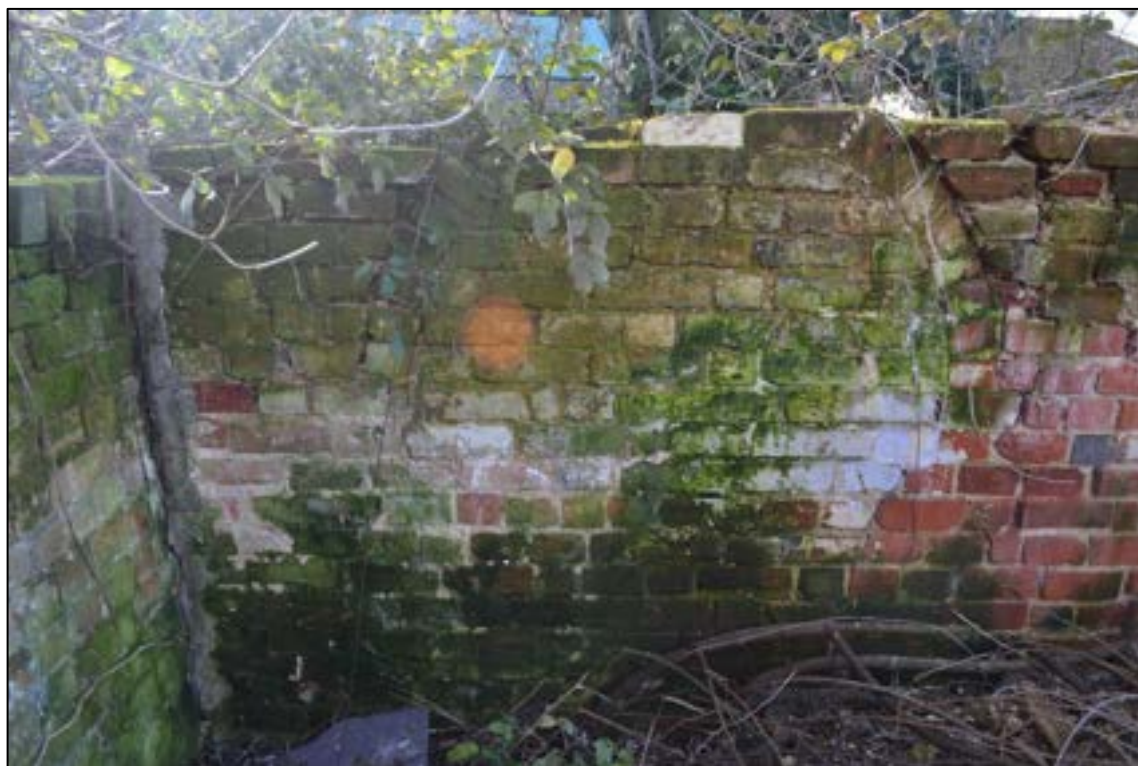
*Figure 63: (left) circular former opening within brick boundary wall which would have originally been part of an historic building, (right) wrought iron gate along eastern boundary of garden which would have delineated a break in a path as part of the designed garden*

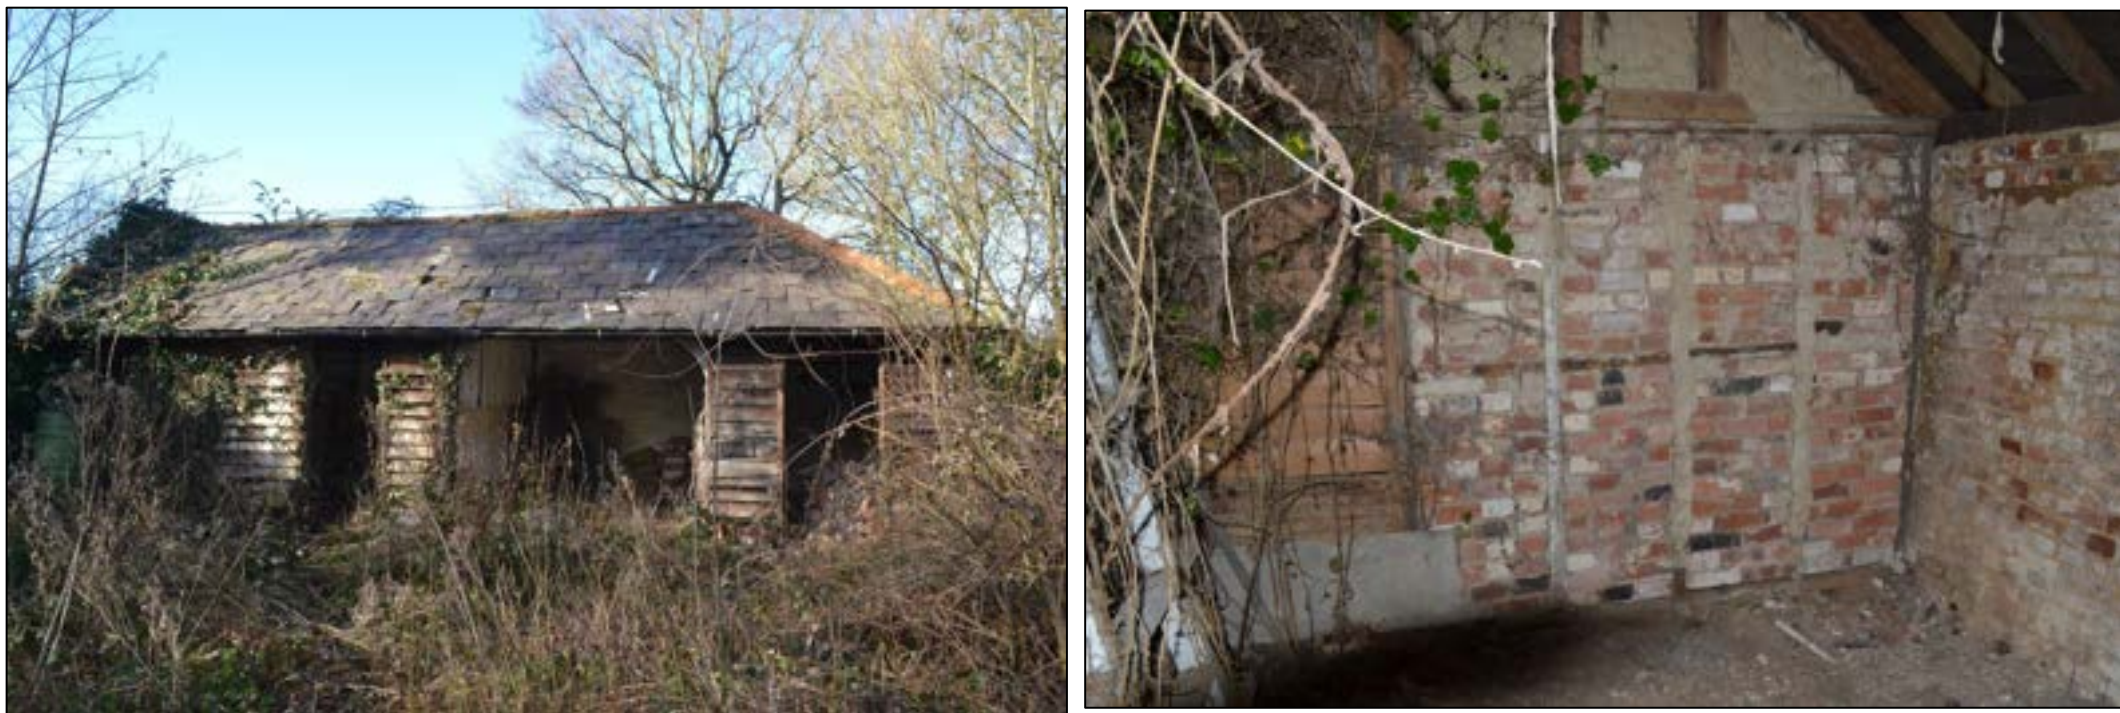
There is also part of an historic outbuilding located in the south west-corner of the plot (**Figure 64**). The building is predominantly constructed of timber and brick under a slate roof. Originally part of a much larger building (see [OS Maps](#)) sections have survived with one part being extended and turned into a garage (**Figure 65, Figure 66, & Figure 67**). Due to the age of the building, it should be noted that building may be considered curtilage listed and therefore require listed building consent before works to it can be undertaken.

*Figure 64: Historic outbuilding in south-west corner of the plot, (left) eastern elevation illustrating the various partitioned stables, (right) example of internal brick and timber partition wall*

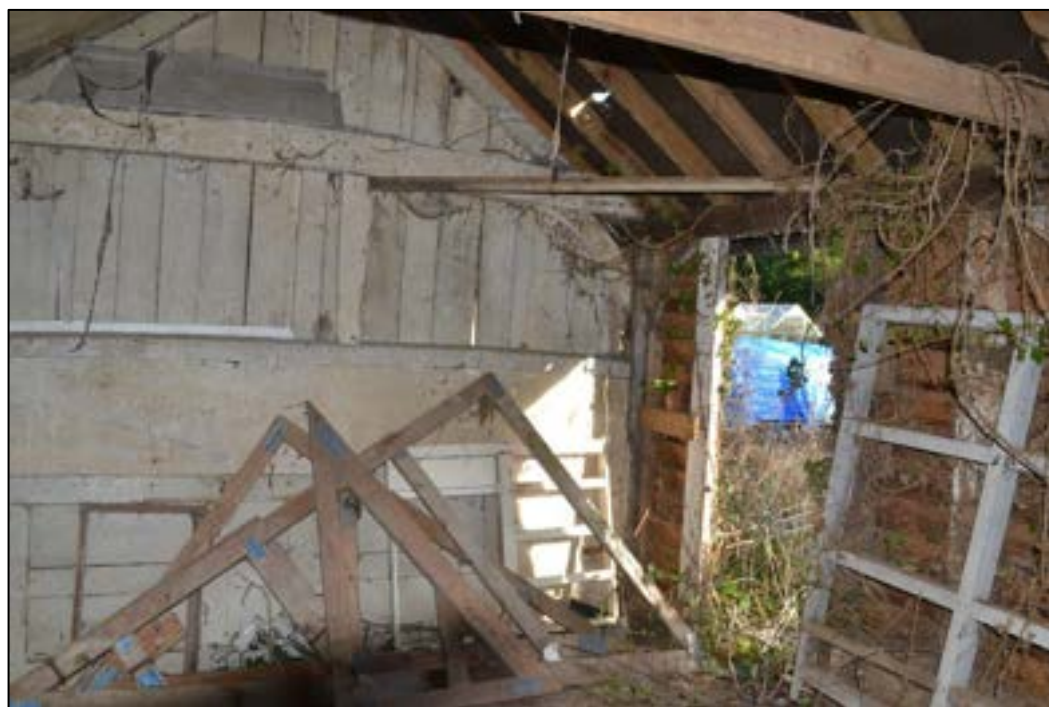
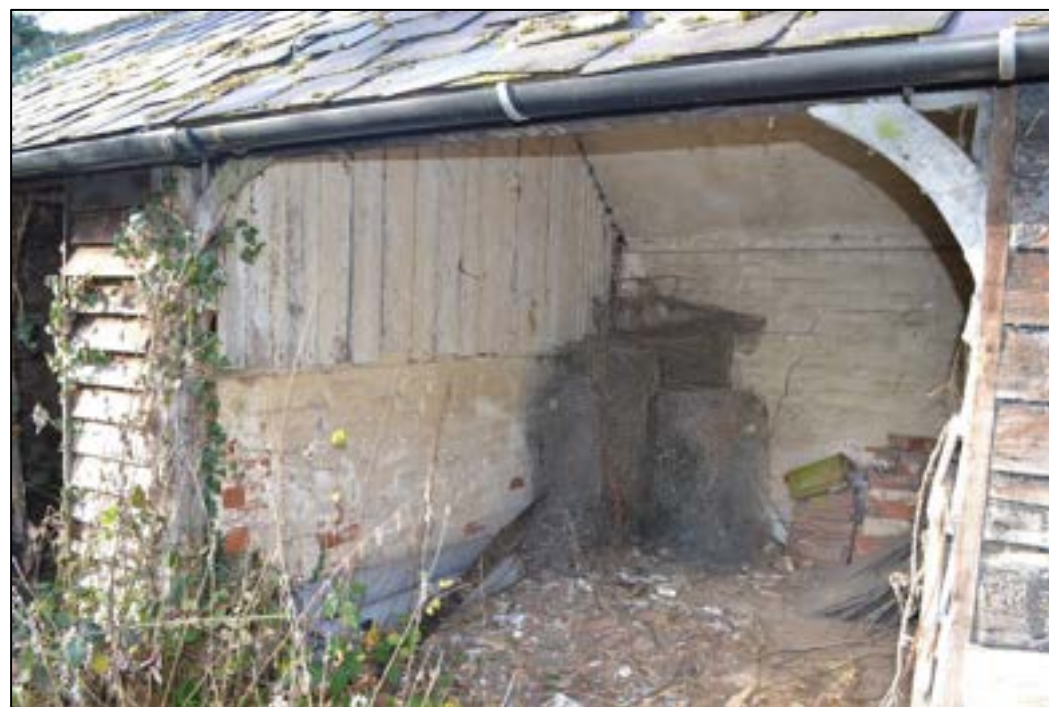
*Figure 65: Further images of internal parts of former agricultural building*

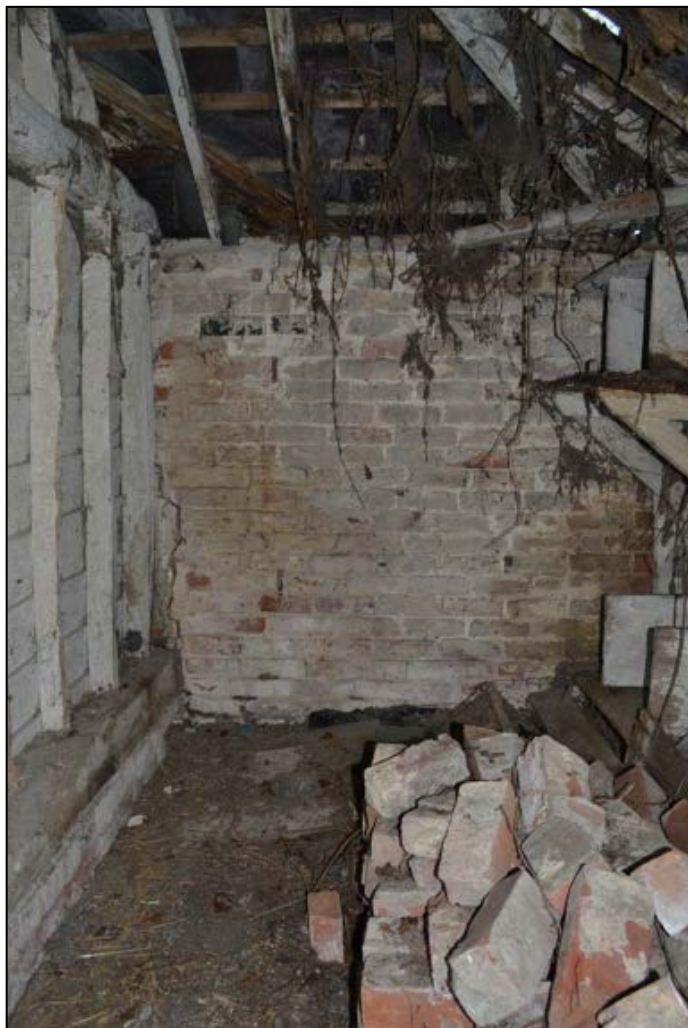
*Figure 66: (right) internal view of former agricultural building, (left) north elevation of building - note mixture of brick and timber*

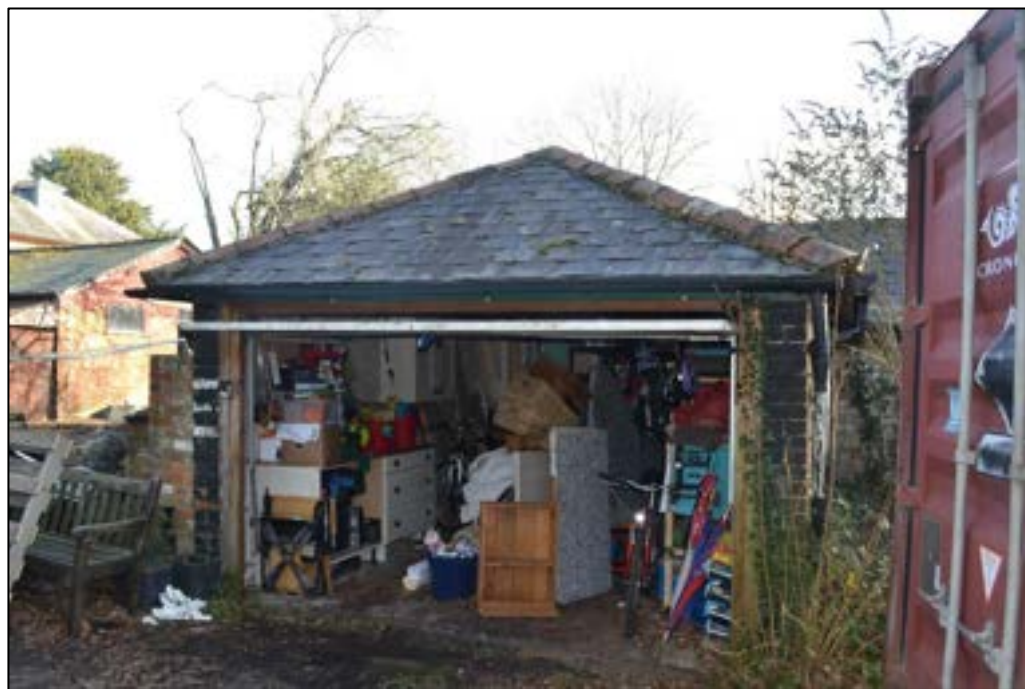
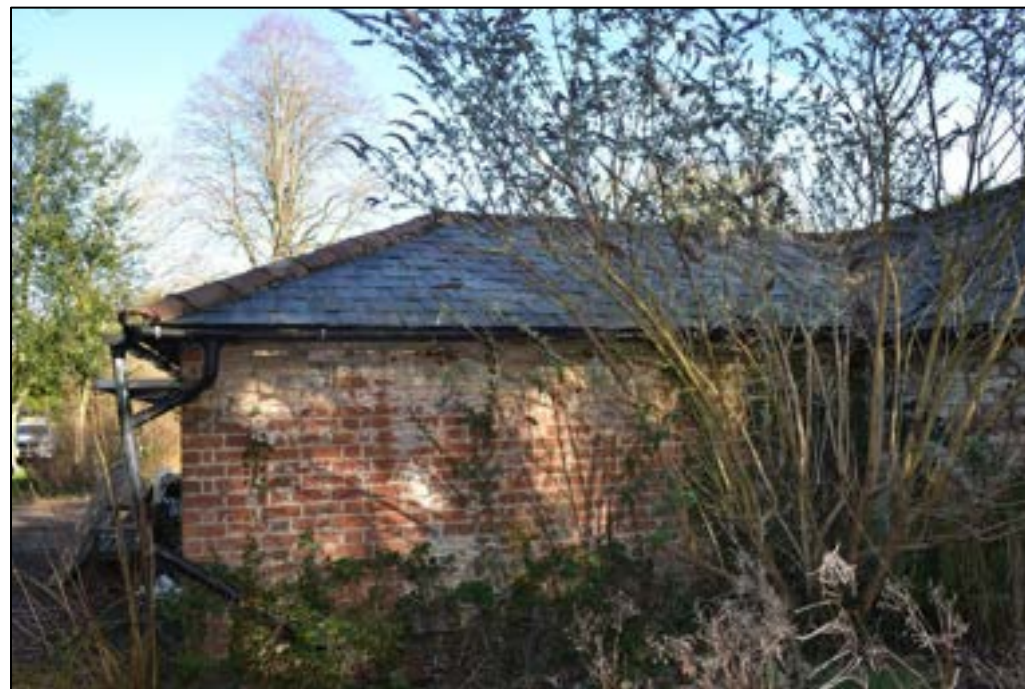
*Figure 67: Modern garage (western projecting) part of the historic outbuilding*

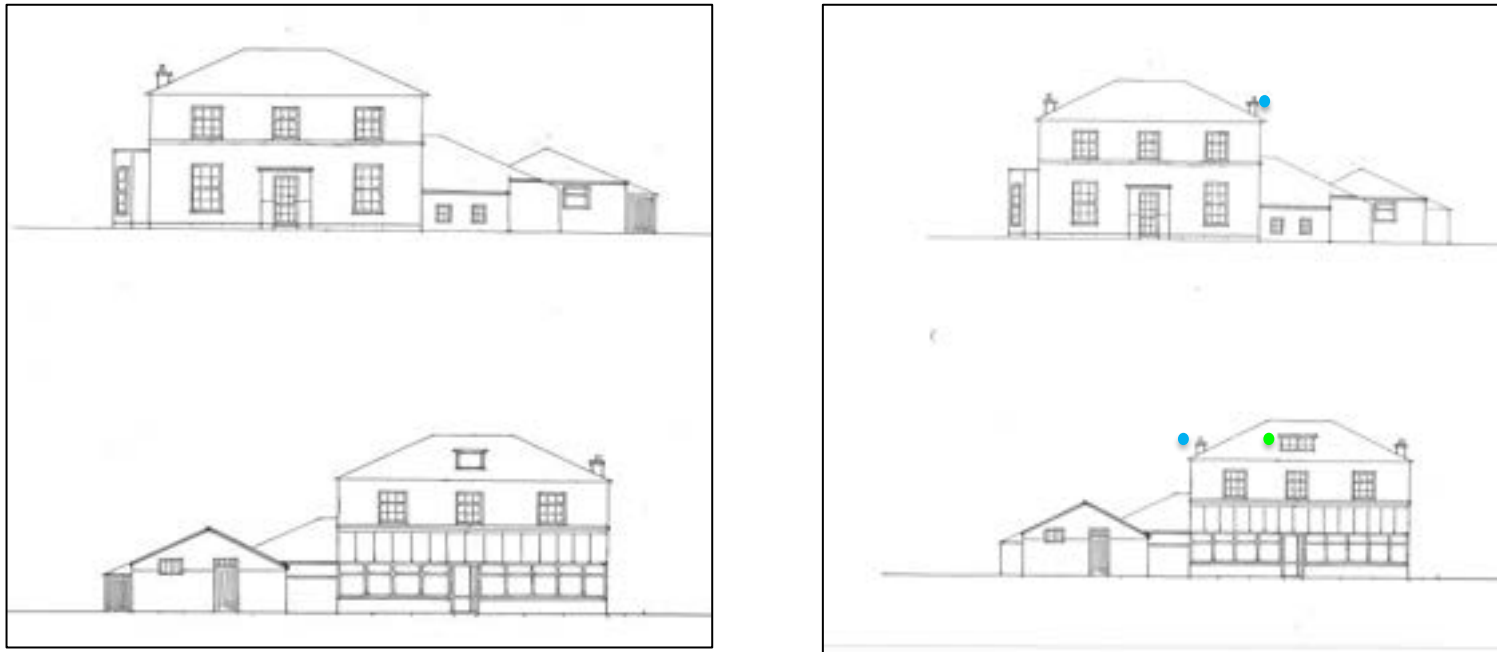
Figure 69: (left) Existing front and rear elevations, (right) Proposed front and rear elevations.

- **Blue**- Rebuild the chimney on the west gable end. Originally there was a full chimney stack here however that has been removed by past owners. Also repair identical chimney (top section) of chimney on east gable end. In both cases existing brick on site will be used (**Figure 17 & Figure 21**).
- **Green**- Slightly enlarge rear dormer window and replace current glazing with new timber double glazed units to match fenestration of the rest of the building (**Figure 18 & Figure 20**).
- **Windows and doors**- Existing inappropriate double glazed uPVC windows are to be removed and replaced with timber double glazed windows of an appropriate design and style in keeping with the character of the property.
