**Heritage Statement**  
Sussex Lodge  
Sussex Lane  
Spencer's Wood  
Reading

**Date of Issue**  
October 2022

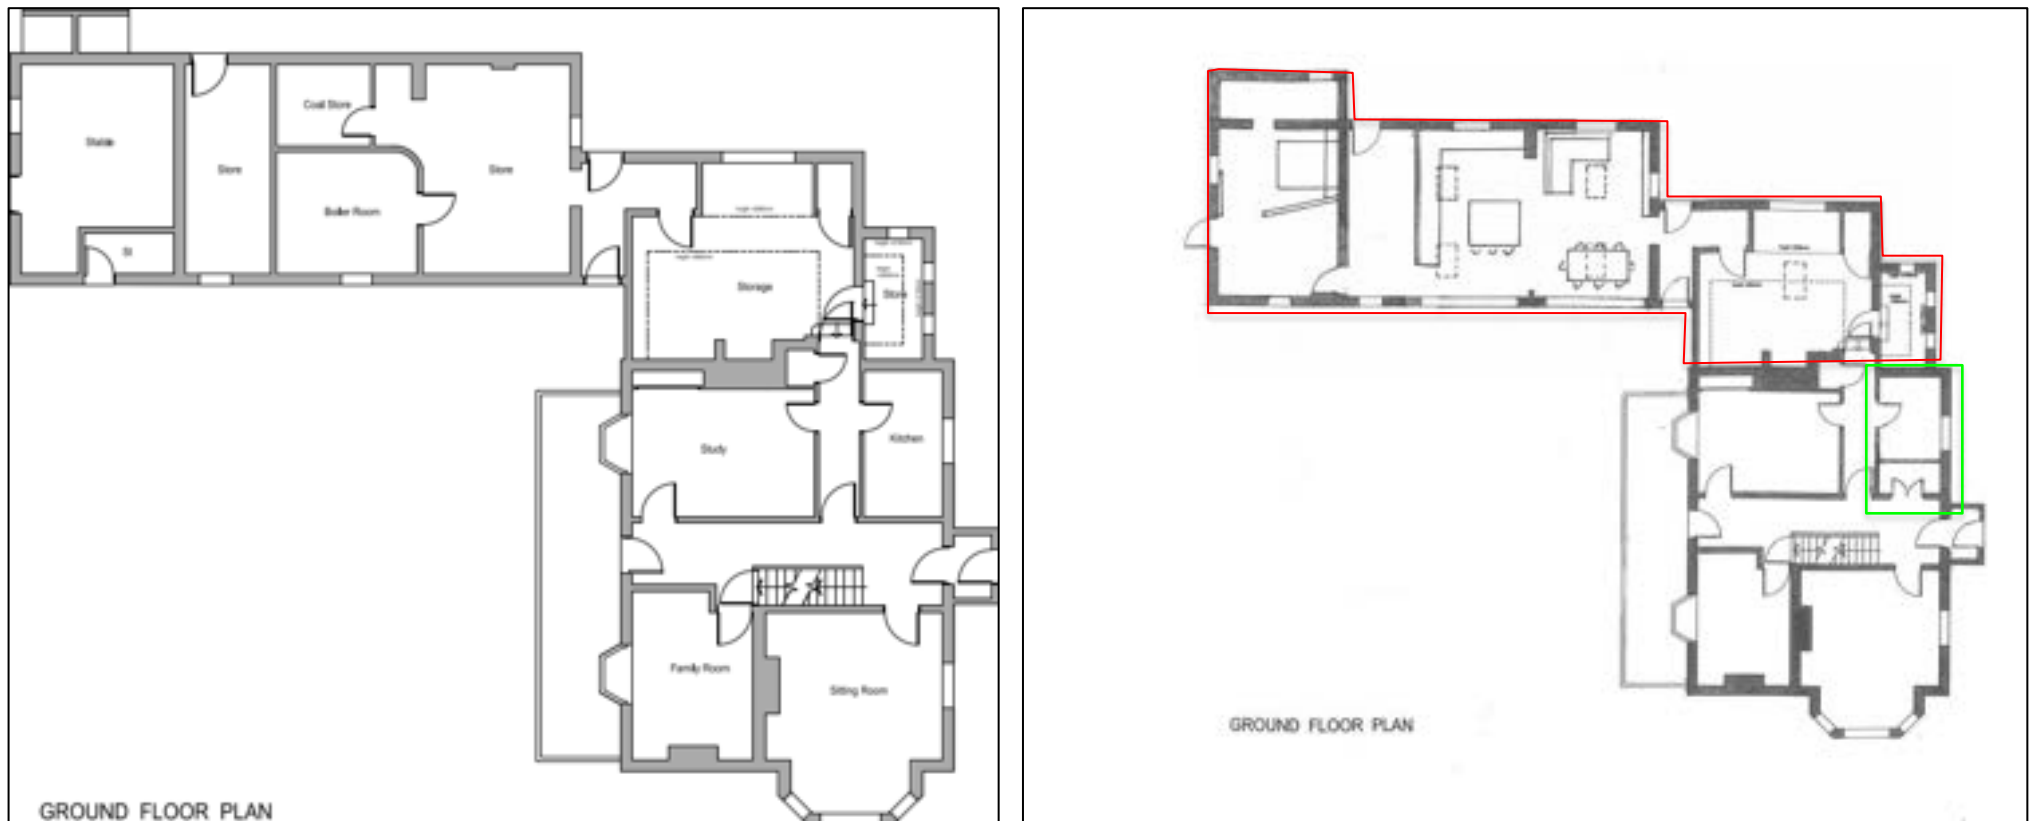
Figure 71: (left) Existing floor plan, (right) Proposed floor plan.

- **Red-** Reconfigure the attached outbuilding and utility. It is proposed to remove parts of the internal walls between the northern store, coal room and boiler room (see [Attached Outbuilding](#)) to allow the space to be used as an open plan kitchen/diner- nibs of the wall will remain to indicate position of removed wall. The southern store will be reconfigured to allow the space to be used as a bedroom and en-suite. This will require the removal of a small section of wall, the insertion of a door on the western wall, and the re-building of the existing attached outside toilet on the western elevation of the outbuilding.
- **Green-** Insertion of a stud wall in the existing kitchen and a new cupboard opening into the central corridor (**Figure 40**).
