## **PRELIMINARY ECOLOGICAL APPRAISAL (DBW) AT 190 HURRICANE WAY WOODLEY**

**Prepared for:  
Mr J Atkins  
190 Hurricane Way  
Woodley  
RG5 4UH**

**1 September 2025**

**Ref: SPH/NP/PEA-24/19.08**

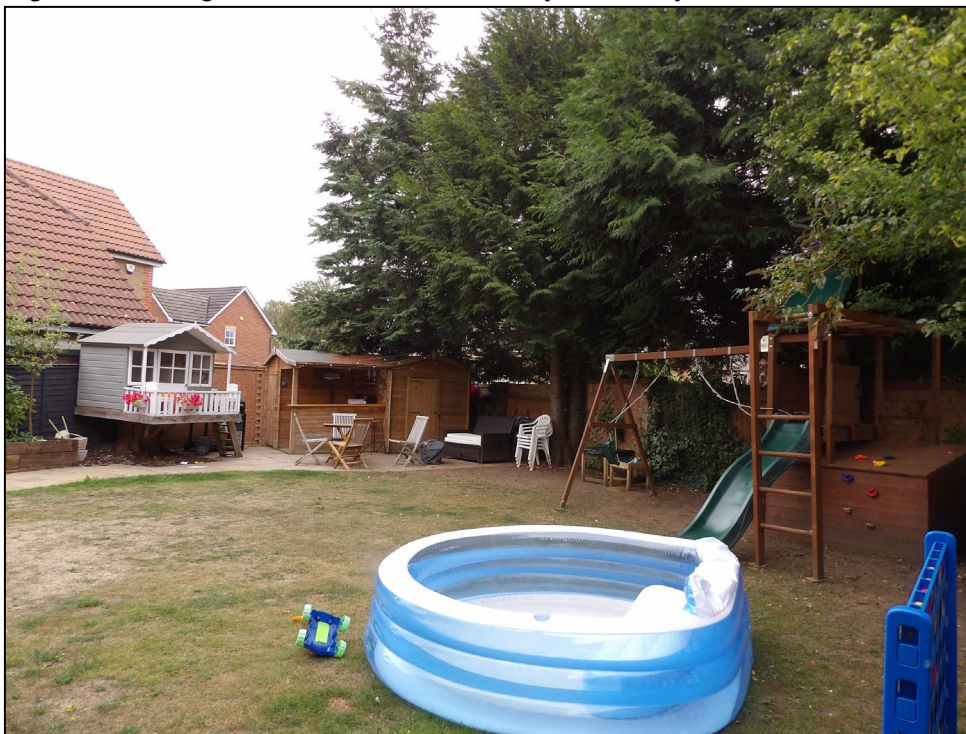
The application site comprises a detached, 2 storey brick-built dwelling with link attached garage (to the neighbouring garage). The remainder of the site comprises a front garden with driveway/parking area and lawn with flower bed and shrubs, see cover photograph. The rear garden, which has an area of patio, is mainly laid to lawn with shrubs and trees on the boundary, see Figure 3 below. The site itself offers some foraging and commuting habitat for bats and there is ecological connectivity to the wider landscape via the garden network.

Figure 3. Rear garden. 190 Hurricane Way, Woodley. 19.08.25

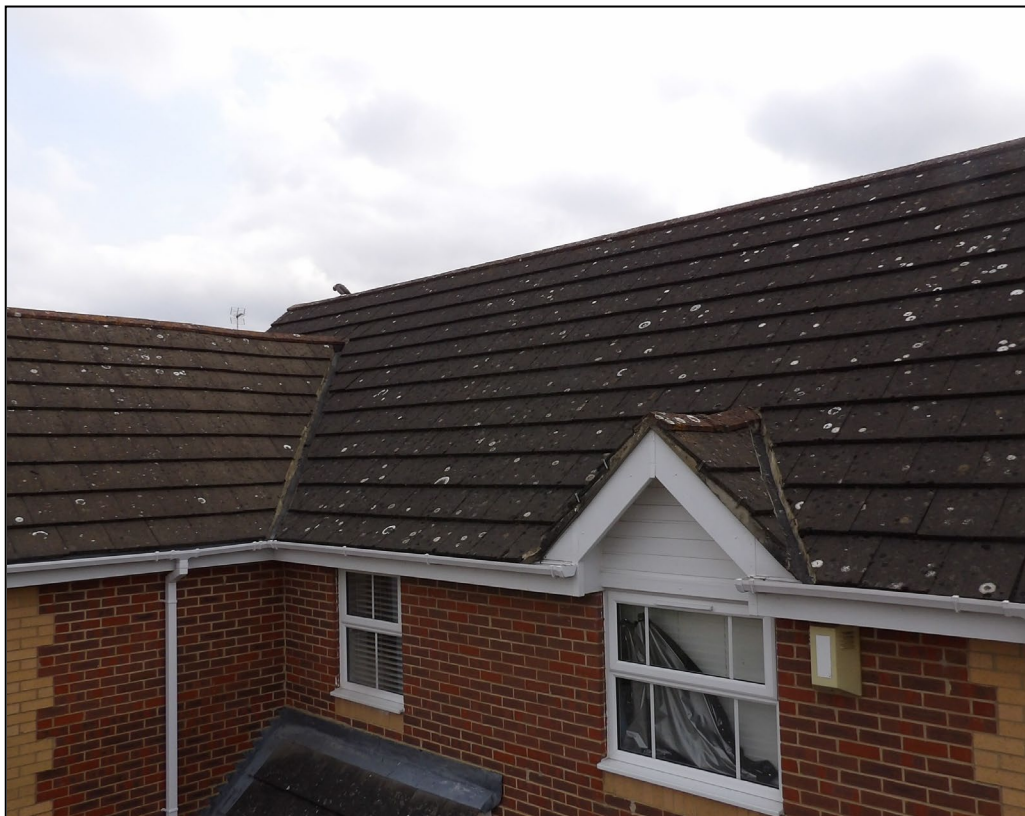
The property is a detached, brick-built building that is in a good condition externally. The cross-pitched roof is covered in close fitted composite tiles, none of which are missing or broken, see Figure 4 below. The ridge tiles and valleys are all in a good condition (see Figure 4 below) and there is no missing mortar from the verges that crevice dwelling bat species could exploit, see Figure 5 on page 9. The uPVC soffits and fascias are all tightly fitted to the walls and had no cracks or splits which could be used by roosting bats, see Figure 6 on page 9. On the rear elevation is a bay window, the roof of which is covered in well fitted lead with no gaps that could be exploited by crevice dwelling bat species, see Figure 7 on page 10. The lead flashing around the chimney stack is flush and offers no roosting opportunities for bats, see Figure 8 on page 10.

Figure 4. Example of roof and ridge tiles. 190 Hurricane Way, Woodley. 19.08.25

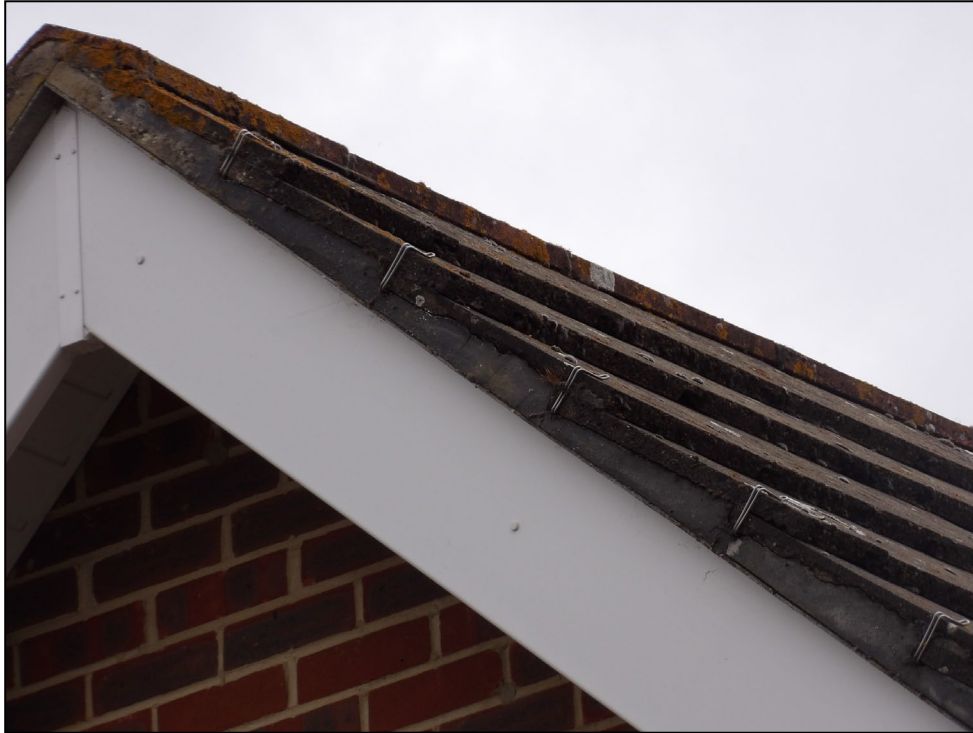
Figure 5. Example sealed verges. 190 Hurricane Way, Woodley. 19.08.25

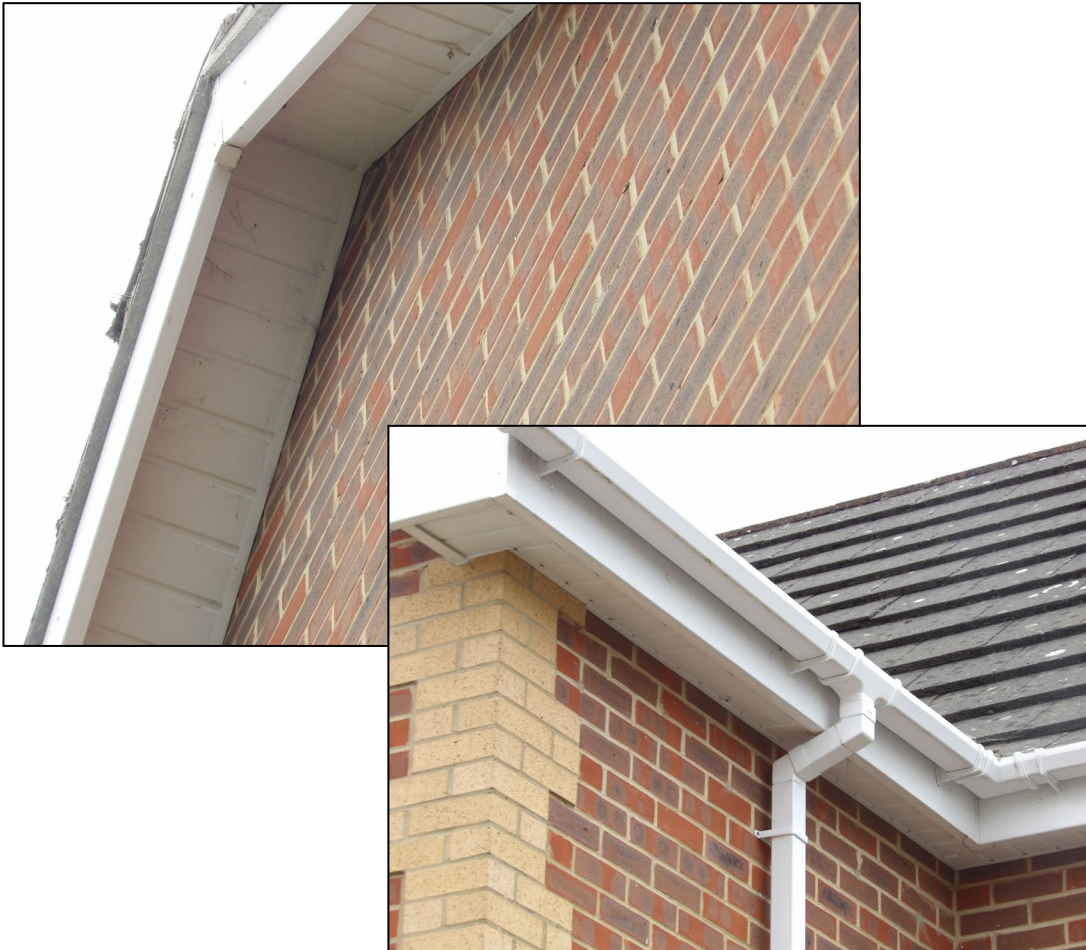
Figure 6. Example sealed uPVC soffits/fascias. 190 Hurricane Way, Woodley. 19.08.25

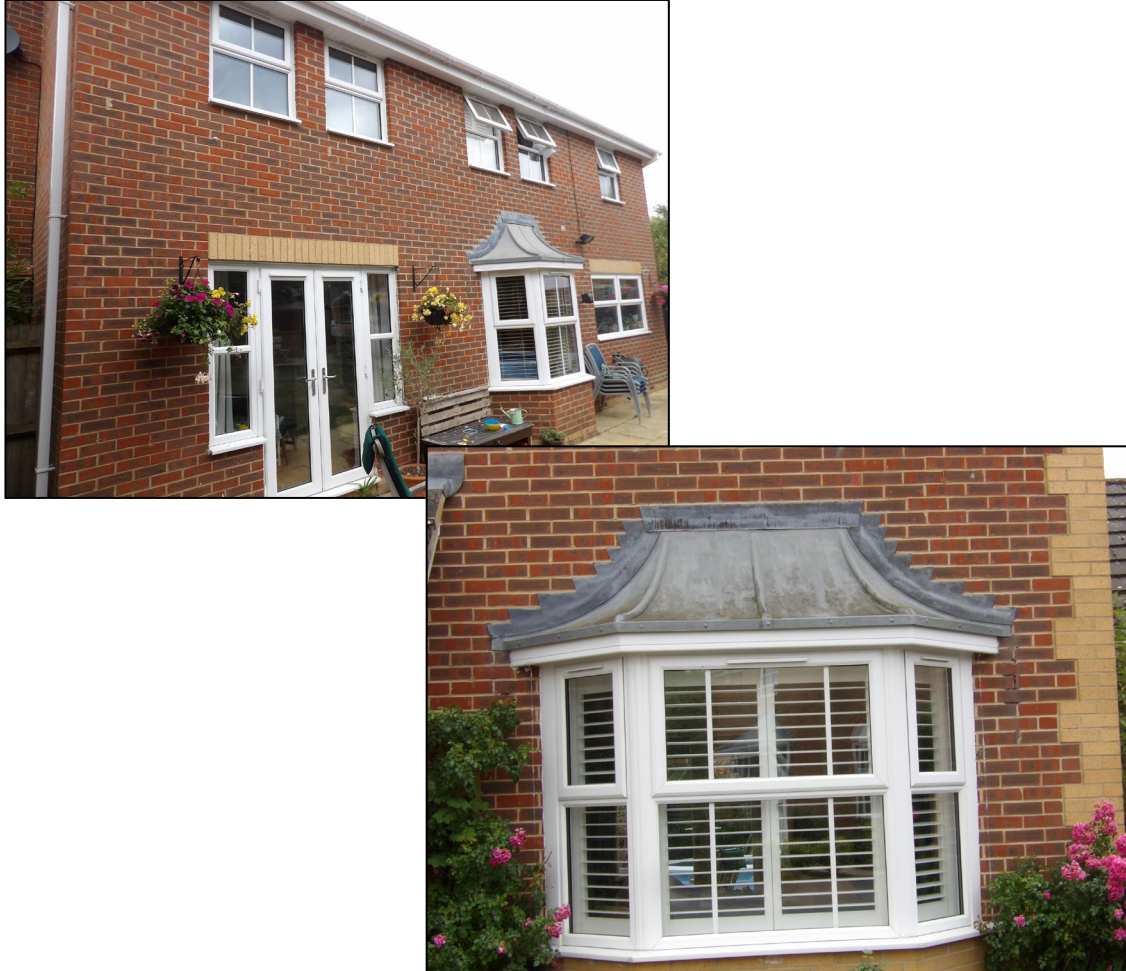
Figure 7. Rear view of property and flush lead flashing over rear, bay window. 190 Hurricane Way, Woodley. 19.08.25

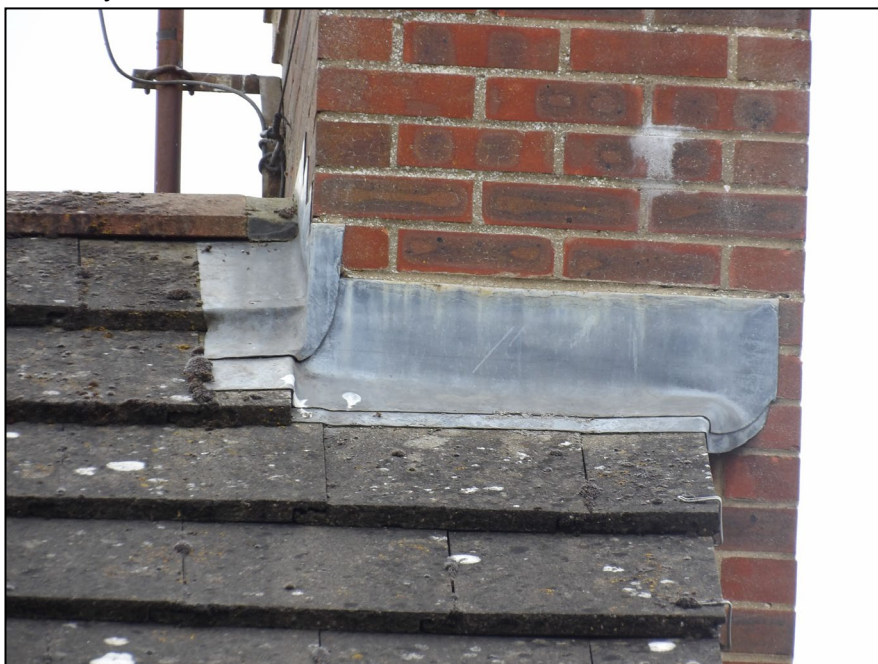
Figure 8. Example sealed lead flashing around chimney stack. 190 Hurricane Way, Woodley. 19.08.25

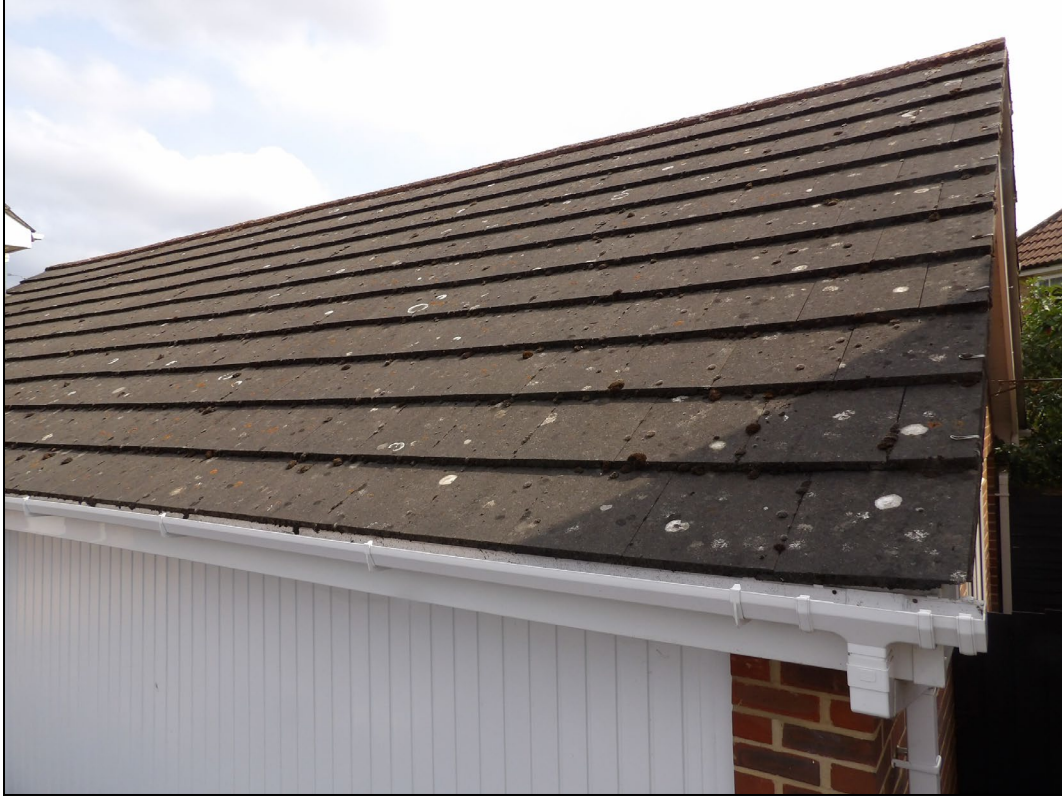
The link attached part converted garage is attached to the neighbouring garage and is also constructed of brick and in a good condition, see Figure 9 on page 11. The pitched roof is also covered in close fitted composite tiles, all of which are in a good condition and the uPVC soffits and fascias are tight to the wall and there is no missing mortar from the verge, see Figure 10 on page 11.

Figure 9. Well fitted roof and ridge tiles on garage. 190 Hurricane Way, Woodley.  
19.08.25

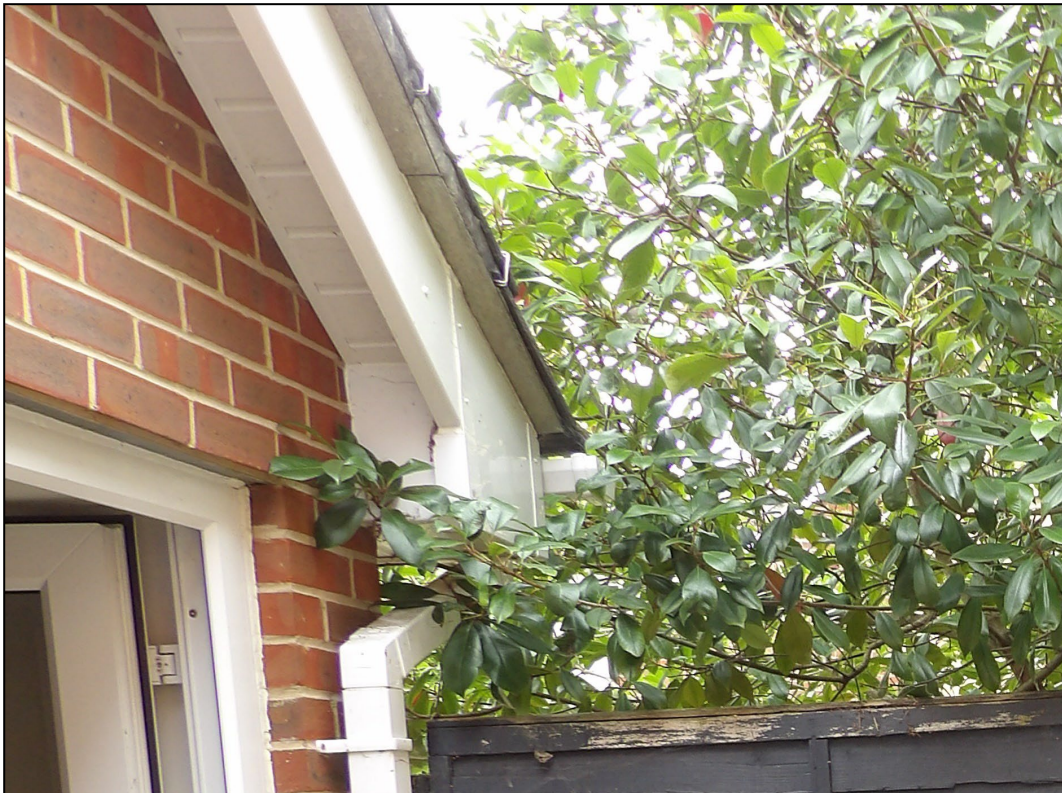
Figure 10. Example sealed soffits/fascias/verges on garage. 190 Hurricane Way,  
Woodley. 19.08.25

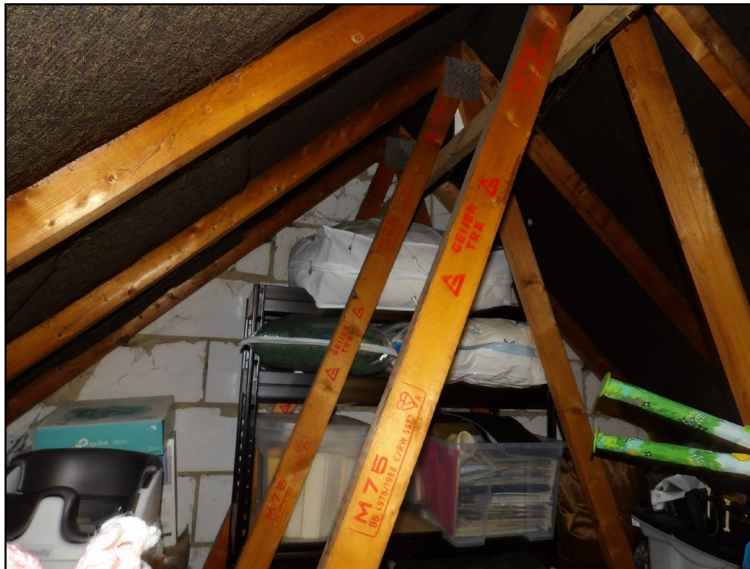
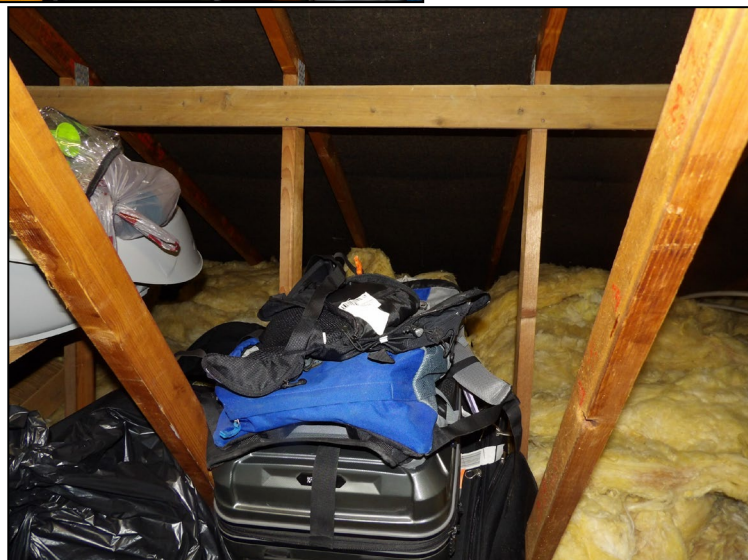
The loft in the property was accessed through a hatch via a loft ladder and is in a good condition. The loft is used for storage however this did not hinder the inspection. The loft is lit, partially boarded and insulated, see Figure 11 below. The roof tiles are lined with bitumen felt, which is all tightly fitted and had no rips or tears in which roosting bats could utilise, see Figure 11 below.

Figure 11. Example of loft space and bitumen felt in property. 190 Hurricane Way, Woodley. 19.08.25

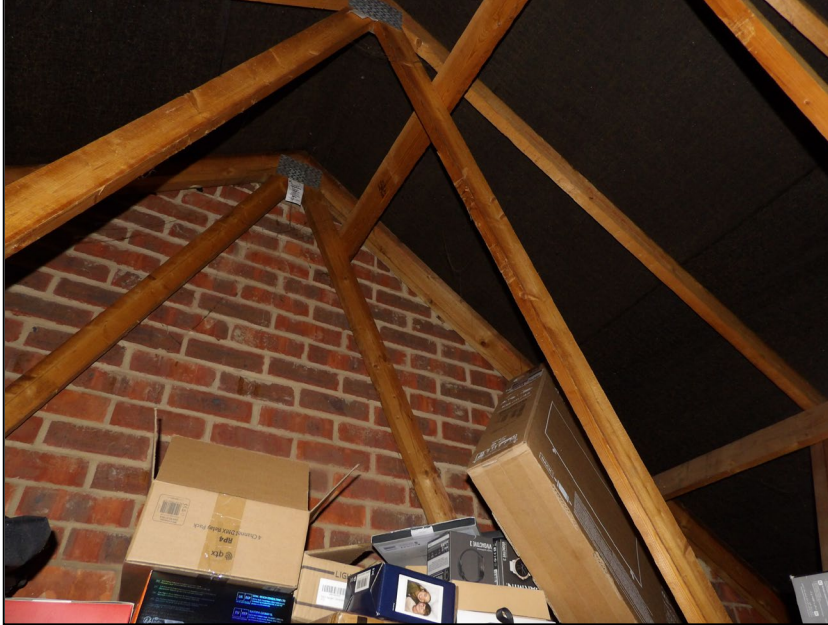
The loft space in the garage was also accessed via a ladder and is in a good condition. The space is used for storage, is unlit and boarded and the roof tiles are lined with bitumen felt, all of which is in a good condition with no rips or tears, see Figure 12 on page 13.

Figure 12. Example of loft space in garage and bitumen lining to tiles. 190 Hurricane Way, Woodley. 19.08.25
