## EXTENDED PHASE 1 ECOLOGICAL AND BAT ROOST ASSESSMENT

YOUNGS FARM, KENTON'S LANE, UPPER CULHAM, RG10 8NX

FINAL REPORT

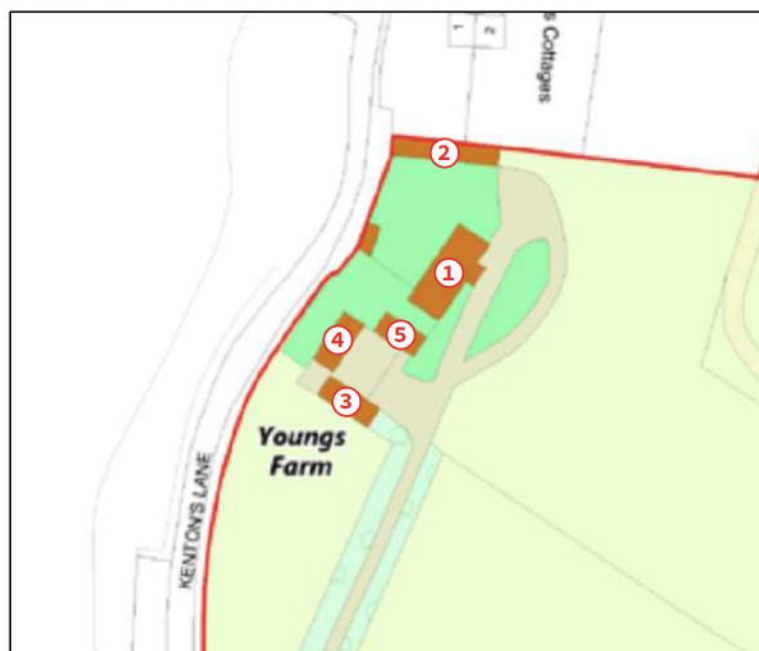
**Figure 12** – Youngs Farm buildings layout. 1 = main house, 2 = northern outbuilding, 3 = southern stable block, 4 = western stable block, 5 = northern stable block.

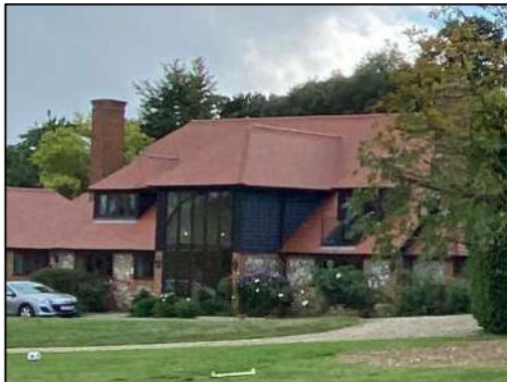
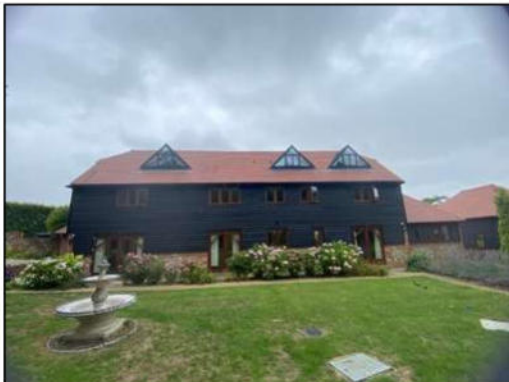
| Building | Description | Photographs | Access/egress and roost suitability notes | Evidence | Suitability |
|---|---|---|---|---|---|
| The main house<br>(Building 1) | <p>The house is a three-storey brick and stone-built structure with a half hipped and pitched roof design. The building is oriented southeast to northwest. Multiple extensions protrude from the house including two, single storey lean-to extensions on the south-western and north-eastern sides and a two-storey hipped extension on the south-eastern elevation. Additionally, a total of six dormer windows are present, including three which are metal framed and glass built on the north-western roof face, and three which are hipped, clay tiled and clad with wooden boarding on the south-eastern roof face.</p> <p>The eaves are infilled with wooden boards and underboards in places. Two brick-built chimneys are located on the house, one at the north-eastern end and one at the south-western end. The top three quarters of all the elevations are clad with wooden boarding. The windows and doors are set in wooden frames.</p> <p>Internally, ceilings are primarily vaulted. A single roof void is located along the side eaves of the north-western roof face. The roof of the void is lined with</p> | <p><b>Figure 13</b> – South-eastern elevation of the house.</p> <p><b>Figure 14</b> – North-western elevation of the house.</p> | <p>The following access/egress, roosting or relevant features were recorded:</p> <ul style="list-style-type: none"> <li>- Multiple gaps are present under the roof tiles on the building.</li> <li>- Mortar has fallen away from some of the pan tiles at the roof hips.</li> <li>- Some gaps are present at the eaves above the wooden board infills.</li> <li>- Gaps are present under the exterior wooden cladding on the house.</li> <li>- Light spill was recorded inside the roof void at eaves height indicating potential access/egress opportunities for bats.</li> </ul> | <p>The following evidence of bat activity was recorded during the survey:</p> <ul style="list-style-type: none"> <li>- A total of three pipistrelle type bat droppings were recorded scattered inside the roof void of the house during the survey.</li> <li>- Although no droppings were recorded externally during the survey, it was difficult to identify if droppings were present due to the black staining of the wooden cladding.</li> </ul> | Moderate |

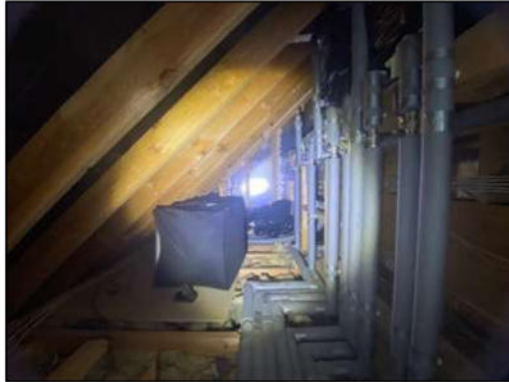
| Building | Description | Photographs | Access/egress and roost suitability notes | Evidence | Suitability |
|---|---|---|---|---|---|
| | bitumen felt and the floor features rockwool insulation. | <p><b>Figure 15</b> – Interior roof void along north-western side eaves of the house.</p> | | | |

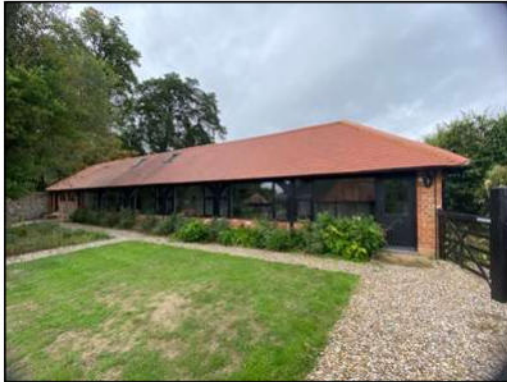
| Building | Description | Photographs | Access/egress and roost suitability notes | Evidence | Suitability |
|---|---|---|---|---|---|
| Northern outbuilding (Building 2) | <p>The outbuilding consists of a single storey, brick-built structure which rises to a pitched and hipped roof clad with clay roof tiles. The building is oriented south to north. The eaves remain exposed with bitumen lining visible however the gaps between the rafters are infilled with wooden boards. Two Velux windows are situated on the southern roof face. The southern elevation features multiple windows set in wooden frames.</p> <p>Internally, the building is mostly vaulted however there is a small roof void present at the western end of the building. The roof is</p> | <p><b>Figure 16</b> – southern elevation of the northern outbuilding.</p> | <p>The following access/egress, roosting or relevant features were recorded:</p> <ul style="list-style-type: none"> <li>- A small amount of mortar was recorded missing from under a single ridge tile however upon further inspection it was observed that the crevice formed was deemed too shallow to support roosting bats.</li> </ul> | No evidence of bat activity was recorded during the survey. | Negligible |

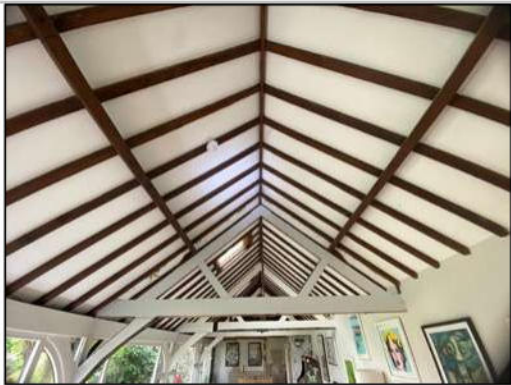
| Building | Description | Photographs | Access/egress and roost suitability notes | Evidence | Suitability |
|---|---|---|---|---|---|
| | lined with bitumen felt and the floor is boarded. There was heavy cobwebbing present throughout the space. | <p><b>Figure 17</b> – Interior of the northern outbuilding.</p> | | | |

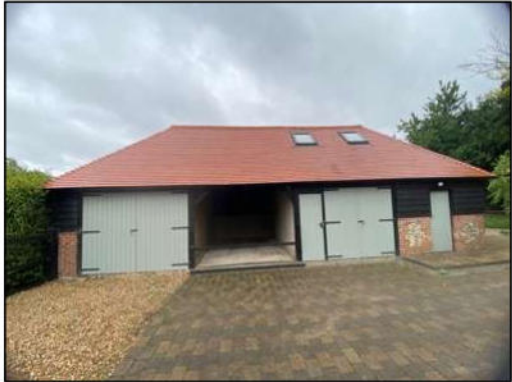
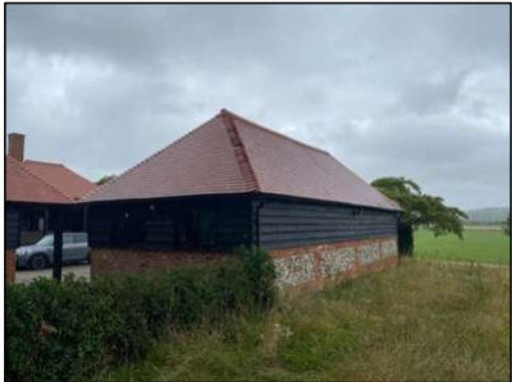
| <p>Southern stable block (Building 3)</p> | <p>The stable building comprises a single storey pitched and hipped structure clad with clay roof tiles. The building is oriented northeast to southwest. The eaves are exposed with the wooden rafters and bitumen lining visible but are infilled with wooden boarding. Two Velux windows are situated on the north-eastern roof face. In total four wooden doors and an open bay carport are present on the north-eastern elevation of the building. The upper halves of all elevations are clad with wooden boarding.</p> <p>Internally, there are no roof voids present. A mezzanine floor is located at the south-eastern end of the building. The roof space at the north-western end of the building has been converted into a living space.</p> | <p><b>Figure 18</b> – North-eastern elevation of the southern stable block.</p> <p><b>Figure 19</b> – Western corner of the southern stable block.</p> | <p>The following access/egress, roosting or relevant features were recorded during the survey.</p> <ul style="list-style-type: none"> <li>- Continuous access/egress is possible via the open carport entrance.</li> <li>- Gaps were recorded around the eaves of the building.</li> <li>- Gaps are present under the exterior wooden cladding on the building.</li> </ul> | <p>The following evidence of activity was recorded during the survey:</p> <ul style="list-style-type: none"> <li>- A large number (hundreds) of long-eared bat type droppings were recorded scattered inside the carport and on top of the mezzanine floor. Additionally, droppings were also found in lesser quantities in the converted roof space.</li> <li>- Scattered pipistrelle bat type droppings (tens) were also recorded within the carport of the building.</li> </ul> | <p>Moderate</p> |

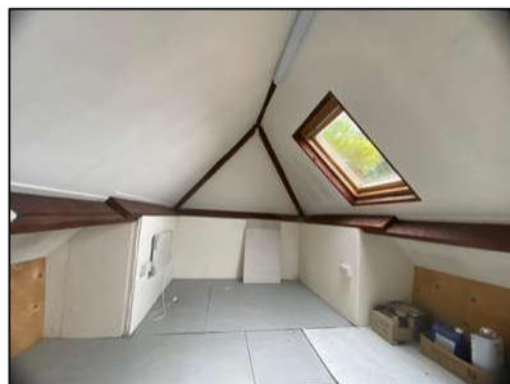
**Figure 21** – Interior converted living space inside the southern stable block.

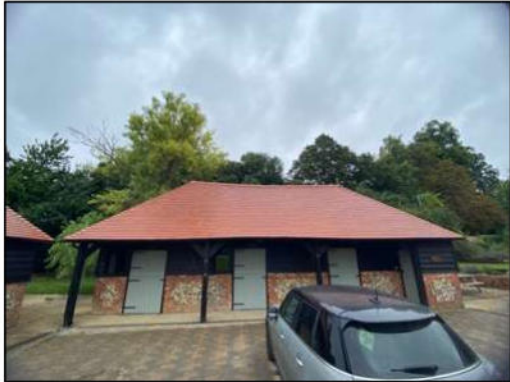
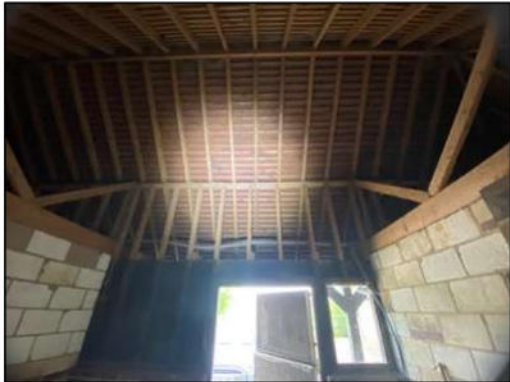
| Building | Description | Photographs | Access/egress and roost suitability notes | Evidence | Suitability |
|---|---|---|---|---|---|
| Western stable block (Building 4) | <p>The western stable building is single storey, brick and stone-built, rising to a hipped and pitched roof design clad with clay roof tiles. The structure is oriented southeast to northwest. The rafters and bitumen felt lining are exposed at the eaves with wooden infilling present. A roof overhang and four wooden doors are present on the south-eastern elevation. The top halves of all elevations are clad with wooden boarding.</p> <p>Internally, there are no roof voids. Three disused stables divided by half height block-built walls are present. The roof remains unlined with the undersides of the clay tiles exposed. Moderate levels of cobwebbing were recorded throughout the space.</p> | <p><b>Figure 22</b> – South-eastern elevation of the western stable block.</p> <p><b>Figure 23</b> – Interior of the western stable block.</p> | <p>The following access/egress, roosting or relevant features were recorded:</p> <ul style="list-style-type: none"> <li>- Some gaps are present around the eaves of the building.</li> <li>- Gaps were recorded between the exterior wooden cladding.</li> </ul> | <p>The following evidence of roosting activity was recorded during the survey:</p> <ul style="list-style-type: none"> <li>- A total of three pipistrelle type droppings were recorded adhered to one of the exterior doors on the building.</li> </ul> | Moderate |

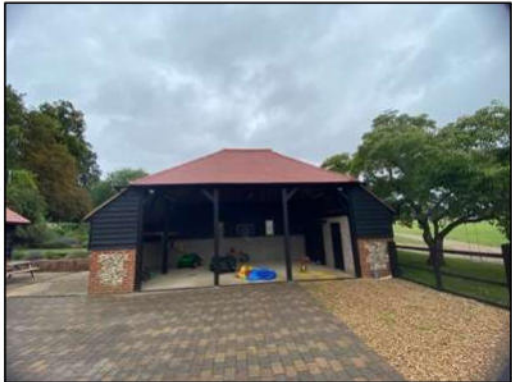
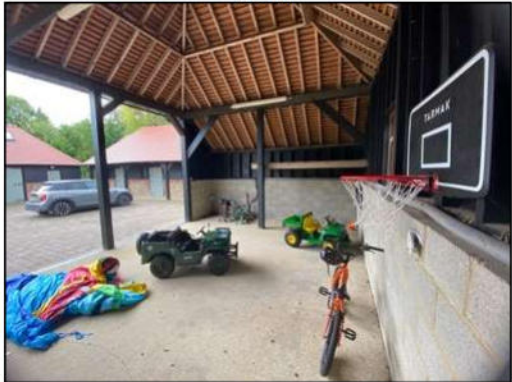
| <p>Northern stable block (Building 5)</p> | <p>The northern stable building consists of a single-storey brick and stone-built structure with a hipped and pitched roof clad with clay roof tiles. The building is oriented southwest to northeast with the southwestern elevation remaining open and resembling a carport.</p> <p>Internally, no roof voids are present. The underside of the roof is not lined and the tiles are visible.</p> | <p><b>Figure 24</b> – South-western elevation of the north stable block.</p> <p><b>Figure 25</b> – Interior of the northern stable block.</p> | <p>The following access/egress, roosting or relevant features were recorded:</p> <ul style="list-style-type: none"> <li>- The open south-western elevation allows for continuous interior access/egress.</li> <li>- There is a suitable ridge board and joins in the rafters for bats to roost.</li> </ul> | <p>The following evidence of roosting activity was recorded during the survey:</p> <ul style="list-style-type: none"> <li>- A concentration of hundreds of long-eared type bat droppings was recorded inside the building underneath the ridge board. Additional droppings from the same species were recorded scattered around the interior of the building.</li> </ul> | <p>Moderate</p> |

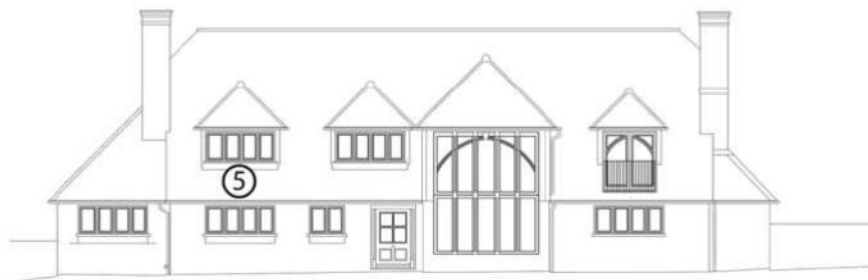
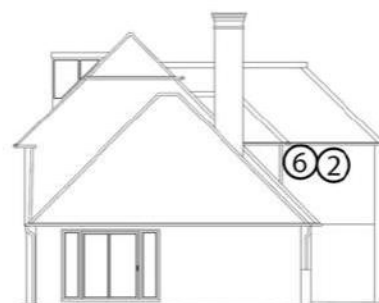
Main House Existing North West Elevation  
1:100

Main House Existing South East Elevation  
1:100

Main House Existing North East Elevation  
1:100

Main House Existing South West Elevation  
1:100

**Figure 26** – emergence locations from the main house, Youngs Farm.
