17 Wilderness Road  
Earley  
Reading  
Berkshire  
RG6 7RU

## Preliminary Roost Assessment

Report ref.: R2707\_PRA\_a

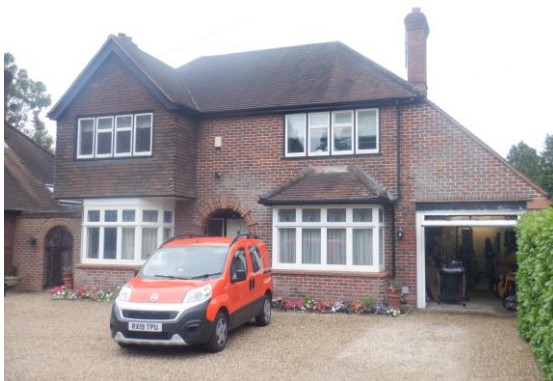
- 5.2.2** The detached house had a hipped roof with catslide roof on the southern side, a pitched front and rear gable, with a single-storey hipped roof extension on the northern and rear elevation, a glass roofed conservatory and a single-storey pitched extension to the rear of the garage (**Photographs 1 & 2**).

*Photograph 1. Front of property viewed from the northwest.*

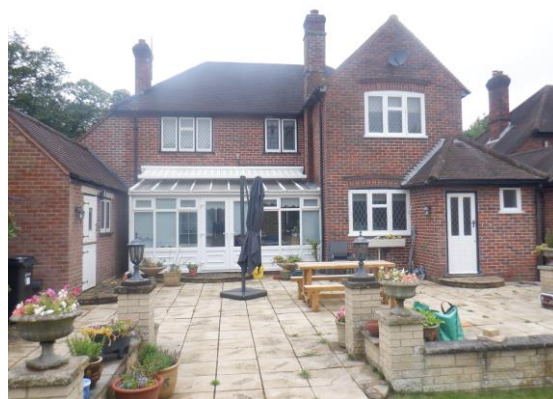
*Photograph 2. Rear of property viewed from the east.*

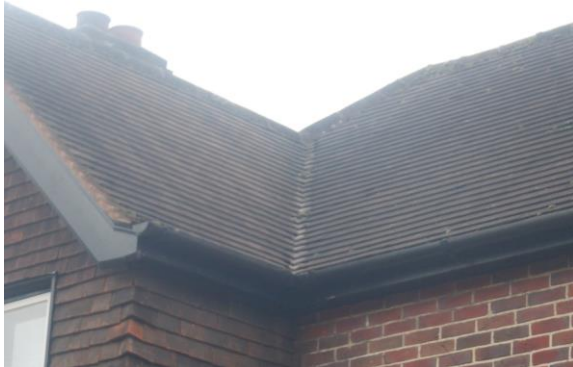
**5.2.3** The roof was covered with tightly fitting roof tiles, with two broken roof tiles on the rear elevation, with half the tile remaining in situ, and therefore there was no roosting opportunities (**Photographs 3 & 4; Target note 1**). The hip and ridge tiles were all fully mortared across the second-storey roof (**Photograph 5**).

*Photograph 3. Closely fitted roof tiles (front elevation).*

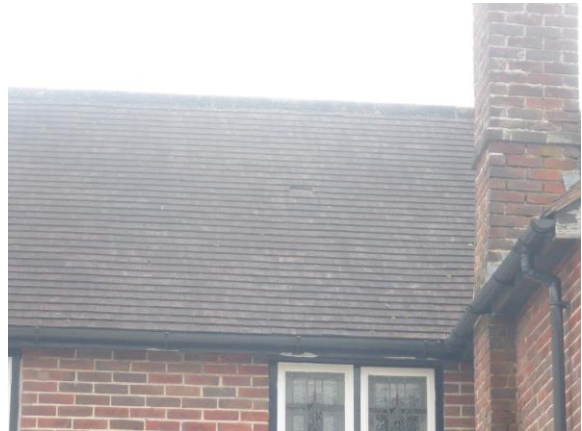
*Photograph 4. Mostly tight roof tiles; broken roof tile, offering no roosting opportunities (rear elevation).*

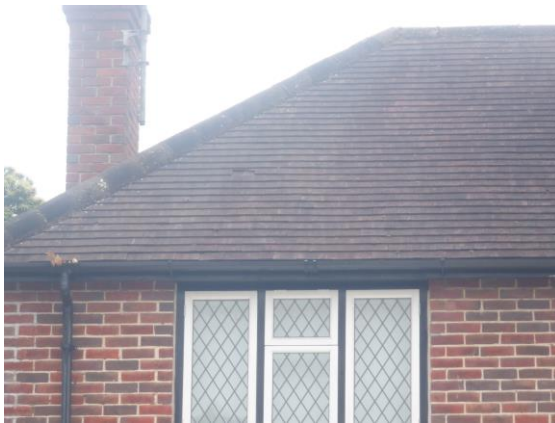
*Photograph 5. Intact hip and ridge mortar.*

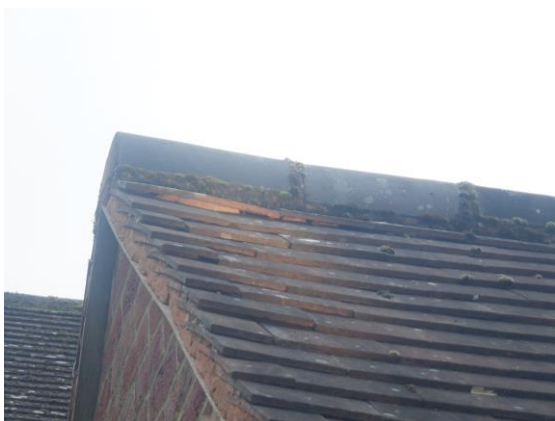
*Photograph 6. Lifted verge tiles; no suitable gap observed (rear elevation).*

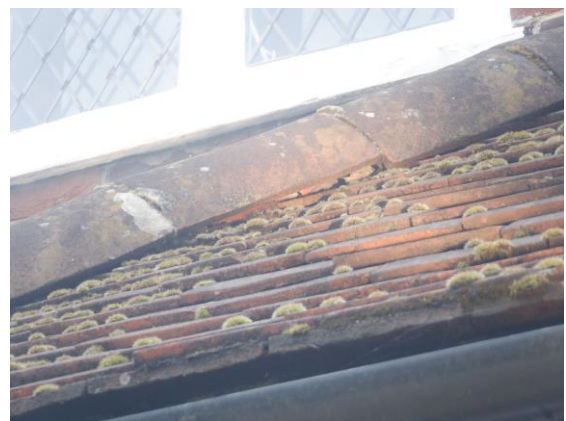
**5.2.4** A gap was observed under verge tiles on the single-storey extension to the rear of the garage, but upon closer inspection, the gaps were filled with mortar, deemed to be of limited extent and offered no roosting opportunities for bats (**Photograph 6; Target note 2**). Mortar was missing beneath the hip tiles on the single-storey rear extension, creating roost access opportunities for crevice-dwelling bats (**Photograph 7; Target note 3**).

*Photograph 7. Missing mortar under the hip of the single-storey roof (rear elevation).*

- 6.1.2** The suitable/potential bat access points on the property included gaps under hip tiles on the rear elevation (**Photograph 7; Target note 3**) and lifted and uneven hanging tiles on the front gable end (**Photographs 10 & 11; Target note 4**). These external features are likely to have sufficient space, shelter, protection, conditions and surrounding habitat for use by small numbers of crevice-dwelling bats, such as the locally recorded common and soprano pipistrelle bats.

- 7.1.2** The development proposals will result in the direct removal of the hip tiles with roost access features on the rear elevation in order to construct the proposed rear elevation, which may result in the damage and/or destruction of bat access points and roost sites. The construction activities could therefore lead to direct/indirect disturbance, injury and/or death of bats during the removal of the hip tiles. All construction activities are focused on the rear elevation and therefore the confirmed roost under hanging tiles on the front elevation will not be impacted during the construction phase.

- 7.2.1** The development proposals cannot be altered to avoid the potential adverse effects on bats in the house. Therefore, further surveys are recommended to determine the presence or likely absence of bat roosts in the property, in order to be able to assess fully whether the development proposals will have an adverse effect on bats (see **Appendix 3** for further survey rationale). The recommended further surveys are detailed in **Section 8.1** below.

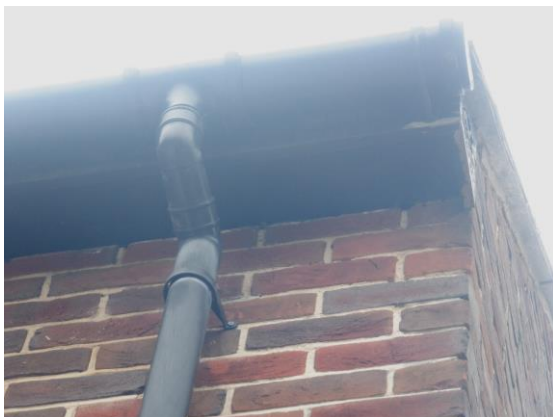
- 5.2.5** The soffit box around the eaves was tightly fitted to the external wall around the property offering no potential access opportunities for bats (**Photograph 8**). The lead flashing was tight around the chimneys and above the glass-roofed conservatory (**Photograph 9**).

*Photograph 8. Timber soffit tight to brickwork (rear elevation).*

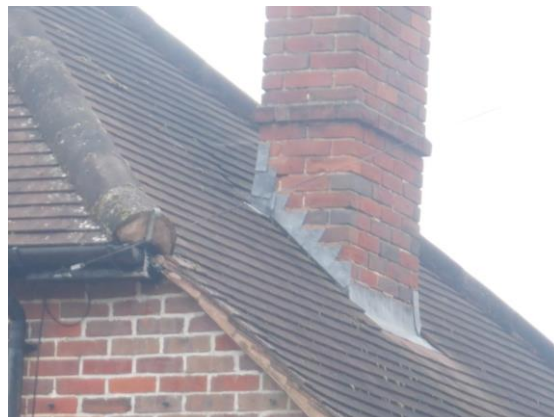
*Photograph 9. Tight lead flashing around chimney (southern elevation).*

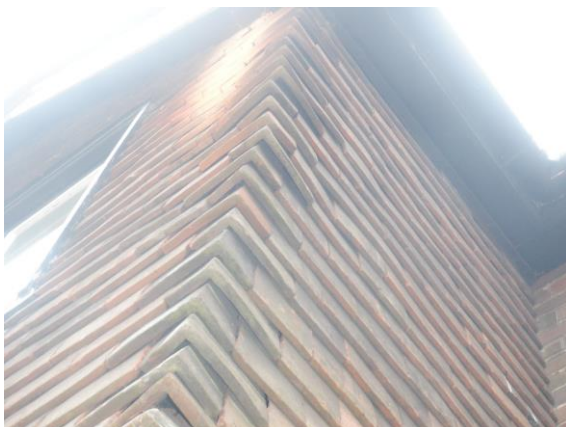
- 5.2.6** The front gable and area above the bay window were clad with hanging tiles that were uneven and lifted, especially on the corners, and offered multiple roosting opportunities behind the tiles (**Photograph 10**; **Target note 4**). Further investigation of the gaps with a torch revealed a small number of small-sized bat droppings beneath a lifted tile on the northern corner of the gable (**Photograph 11**; **Target note 5**).

*Photograph 10. Lifted and uneven hanging tiles on front gable (front elevation).*

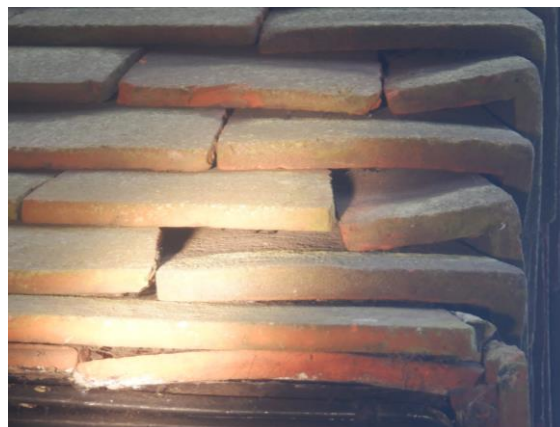
*Photograph 11. Small-sized bat droppings observed under lifted hanging tile (front elevation).*

- 6.2.2** Approximately 5 small-sized bat droppings, of a typical size and shape to those deposited by *Pipistrellus* sp., were observed beneath hanging tiles on the north-western corner of the gable end (**Photograph 11; Target note 5**). This confirms the presence of a roost within the property, likely to be a day roost used by a small number of crevice-dwelling bats. The external features offer roosting opportunities for a range of crevice-dwelling species, such as the abundant, widespread and locally recorded common pipistrelle (*P. pipistrellus*) bat and potentially the rarer Brandt's / whiskered bats (*Myotis brandtii* / *mystacinus*). The presence of a maternity colony is considered unlikely given the scale and nature of the features and extent of evidence observed.

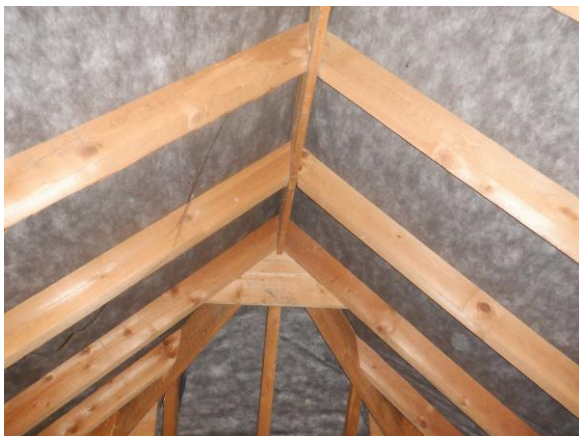
- 5.2.7** There was one roof void in the property, that was accessible via a loft hatch on the first floor and covered the second-storey footprint of the house. The main section was of hipped construction with front and rear pitched gable ends. The main hipped section had a ridge height of 1.75m, was lightly cobwebbed at the ridge beam and was lined by a breathable roofing membrane that was tight throughout (**Photograph 12**). The floor was centrally boarded and insulated with fibreglass, which went up to and covered the eaves in places, with polystyrene boards blocking the eaves along the front pitched gable

*Photograph 12. Cobwebbed ridge; intact breathable membrane (roof void).*

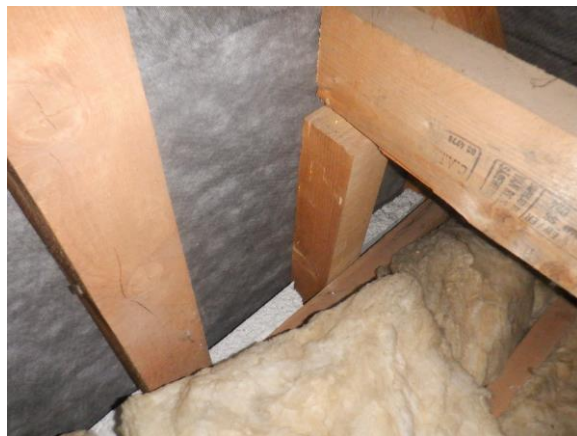
(**Photograph 13**). A chimney was present at the eaves at the southern hipped end, with tight timber boarding and cobwebs visible (**Photograph 14**).

*Photograph 13. Eaves blocked with polystyrene boards (roof void).*

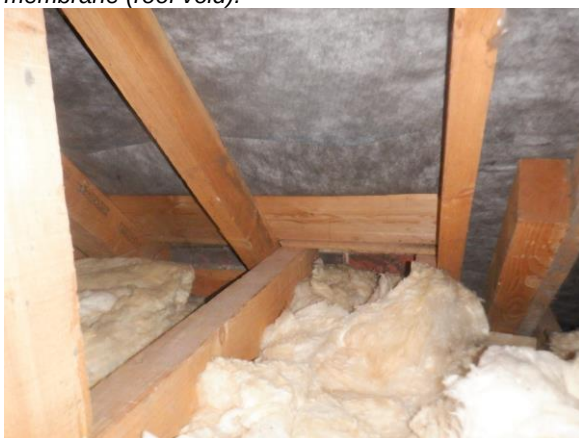
*Photograph 14. Tight timber boarding around chimney at the eaves (roof void).*

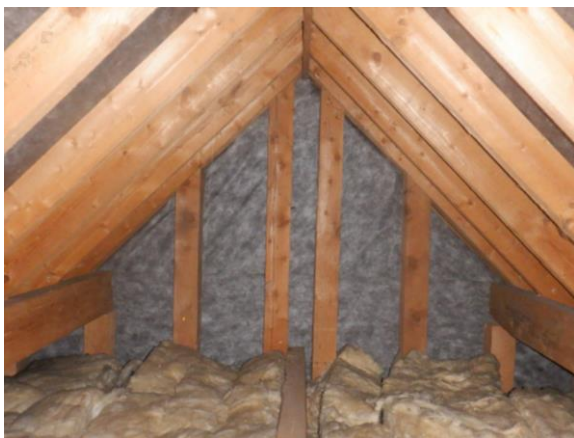
**5.2.8** The front pitched gable was covered with breathable membrane that was tight to the timbers (**Photograph 15**). The rear pitched gable was of brickwork construction and was tight to the rafters along the edge. Shredded cavity insulation was visible coming out of gaps where the timber beams entered the gable (**Photograph 16**).

*Photograph 15. Breathable membrane on the front gable end (roof void).*

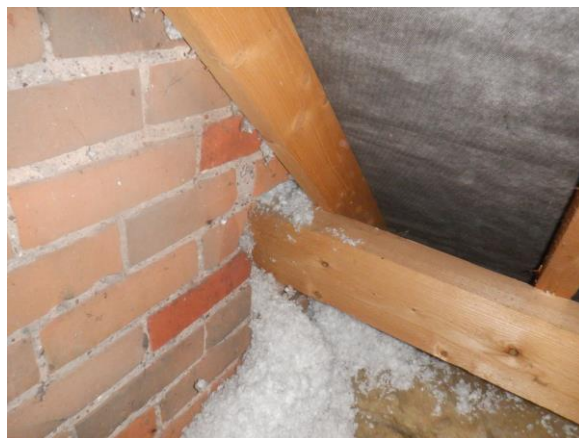
*Photograph 16. Shredded cavity insulation coming out of the rear gable around the timber beams (roof void).*

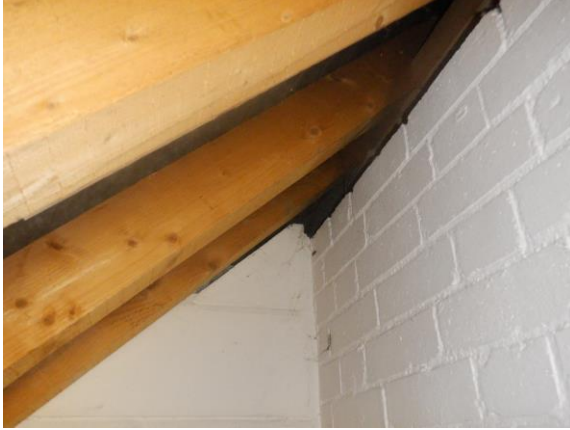
**5.2.9** A small lofted area was present at the front of the garage, beneath the catslide roof. The half gable was of blockwork construction, which was tight to the roofing felt and rafters with the brickwork wall of the house on the northern side (**Photograph 17**). The top of the brickwork wall was open up to the roof void, while the eaves were blocked by fibreglass insulation (**Photographs 18 & 19**).

*Photograph 17. Blockwork front gable (garage loft).*

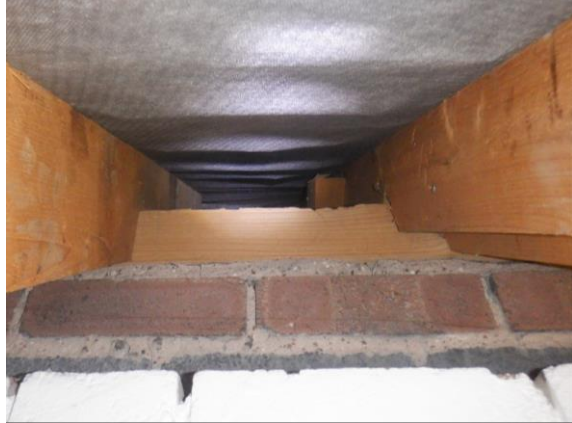
*Photograph 18. Gap above brickwork wall (garage loft).*
