## **PRELIMINARY ECOLOGICAL APPRAISAL (DBW) AT 33 PITTS LANE EARLEY**

**Prepared for:  
Mr N Bullah  
33 Pitts Lane  
Earley  
Reading  
RG6 1BX**

**10 June 2025**

**Ref: SPH/PEA-25/03.05**

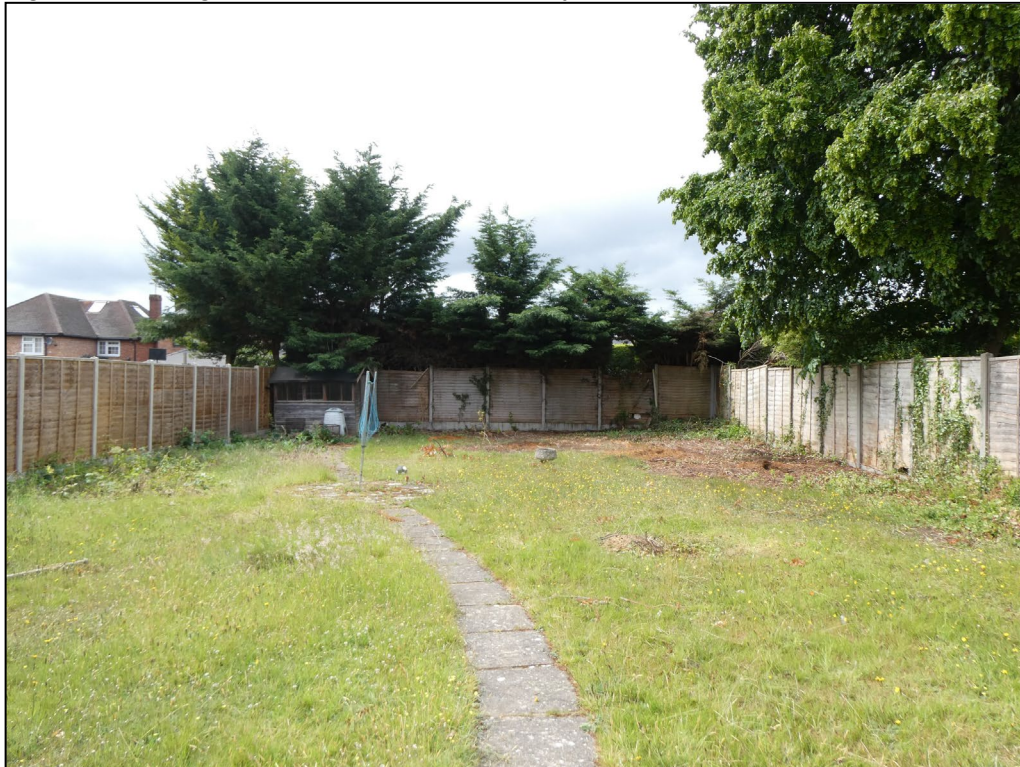
Figure 3. Rear garden. 33 Pitts Lane, Earley. 03.06.25

The application site comprises a detached, 2 storey brick-built property with attached garage and rear conservatory. The remainder of the site comprises a tarmacked paved driveway/parking area with lawn. The rear garden is mainly laid to lawn with mature trees on the boundaries, in the neighbouring gardens, see Figure 3 below. The site offers limited foraging and commuting habitat for bats and there is some ecological connectivity to bat foraging and commuting habitat in Bulmershe Park.

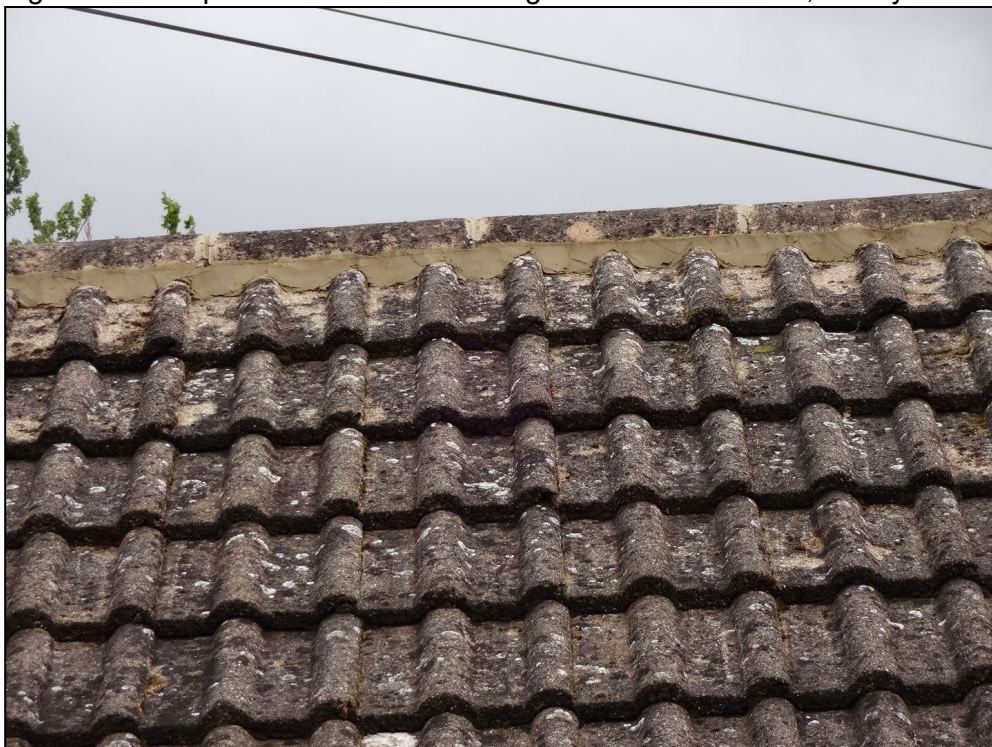
Figure 4. Example of sealed roof and ridge tiles. 33 Pitts Lane, Earley. 03.06.25

The property is a detached, brick-built 2 storey building which is in a good condition externally. The pitched roof is covered in well fitted composite tiles, none of which are missing or broken (see Figure 4 below), and the ridge tiles are all tightly sealed with no gaps in which roosting bats could exploit, see Figure 4 below. The verges are sealed with no missing mortar (see Figure 5 on page 9), and the lead flashing around the chimney stacks is flat with no gaps in which roosting bats could utilise, see Figure 6 on page 9. The uPVC fascias and soffits are tight to the wall with no splits or gaps and offer no roosting opportunities for bats, see Figure 7 on page 10. On both the front and rear elevations are hanging tiles, all of which are tightly fitted with no gaps that could be exploited by crevice dwelling bat species, 8 on page 10.

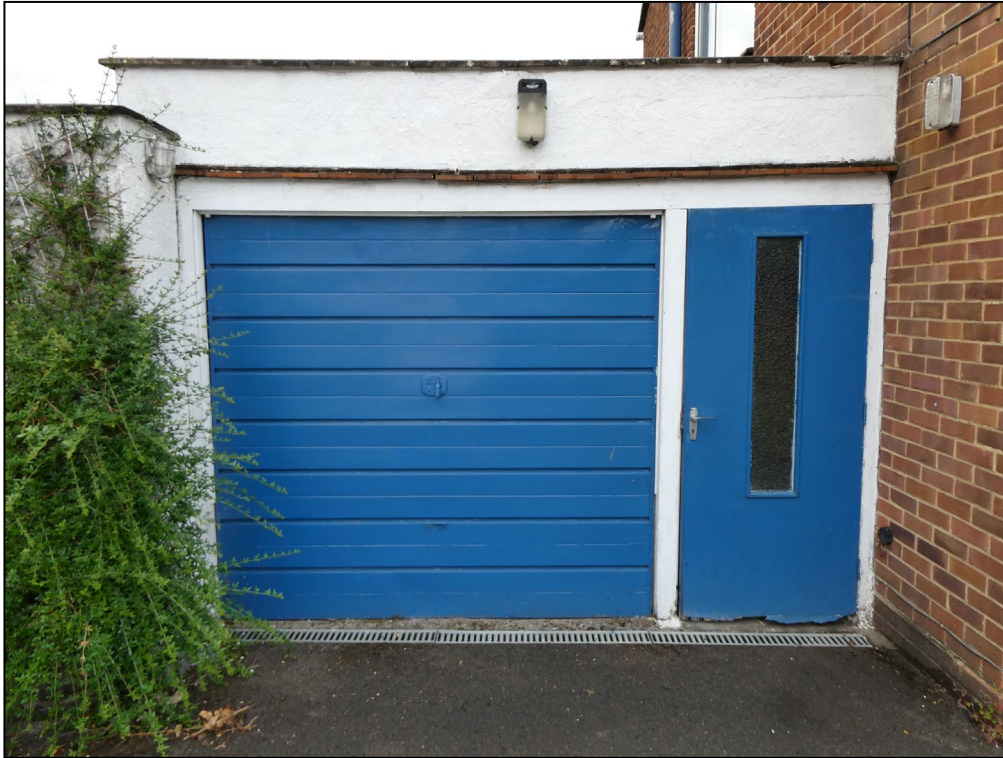
Figure 9. Garage. 33 Pitts Lane, Earley. 03.06.25

On the southwest elevation is the brick-built garage (see Figure 9 on page 11), the flat roof of which is covered in corrugated asbestos sheets, all of which are in a good condition with no holes, and they are firmly affixed to the main property, see Figure 10 on page 11. At the rear of the garage is a brick-built utility with large uPVC windows (see Figure 11 on page 12), the flat roof of which is covered in well fitted bitumen felt with no rips or tears, see Figure 12 on page 12. The uPVC fascias are tight to the wall with no gaps that roosting bats could exploit, see Figure 12 on page 12.

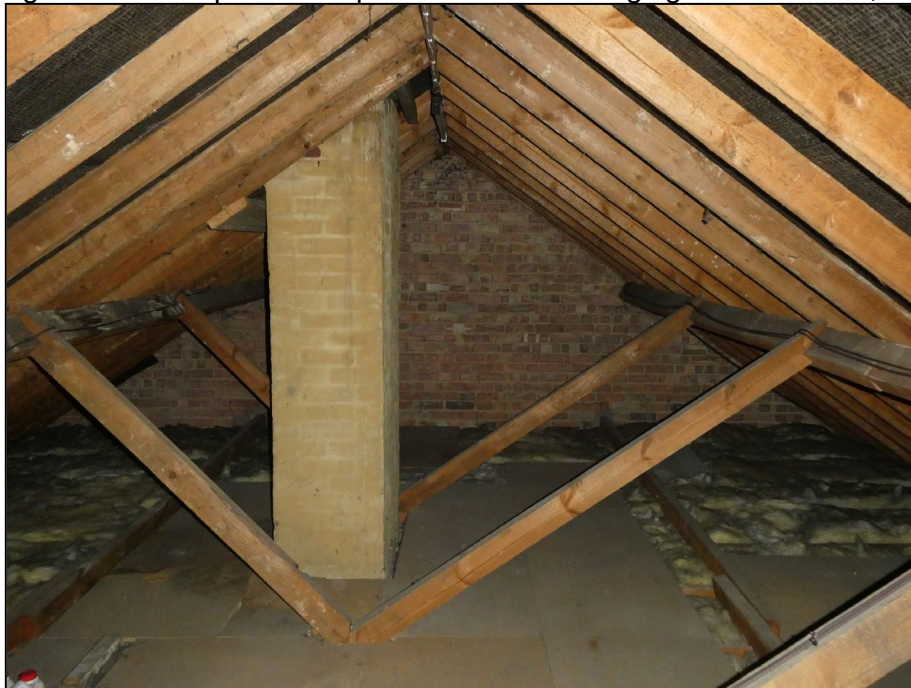
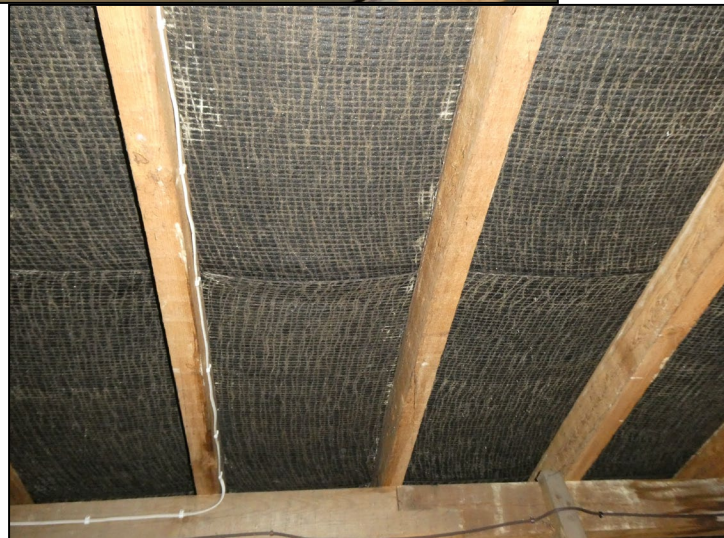
Figure 13. Example of loft space and bitumen lining. 33 Pitts Lane, Earley. 03.06.25

The loft of the property was accessed via a loft ladder and was in a good condition internally. The loft was not lit, partially boarded and insulated, see Figure 13 below. The roof tiles are lined with bitumen felt, all of which was in a good condition with no rips or tears, see Figure 13 below. The garage and summer room were also inspected internally. There is no loft space in either, internally the ceiling of the garage is corrugated with any holes filled with foam inserts, and the ceiling of the summer room is boarded and painted with no gaps or splits which could provide access into the building for bats, see Figure 15 on page 14.
