## Preliminary Roost Assessment

1, St Helier Close, Wokingham, Berkshire, RG412HA

This report is prepared to inform a planning application with Wokingham Borough Council. The proposal can be described as: 'A loft conversion.'

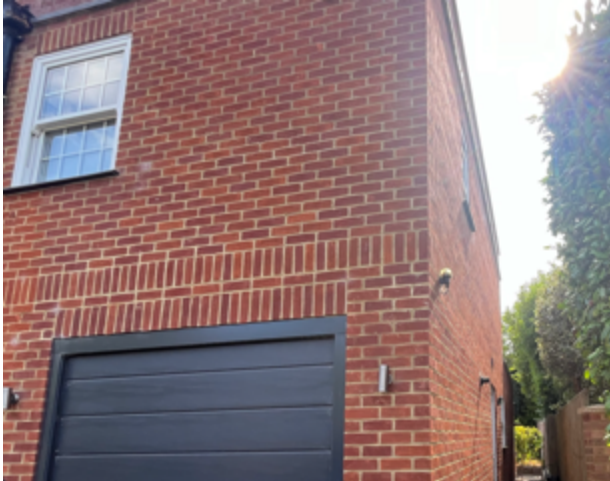
| Walls | Brick | <p><b>Condition/description</b></p> <p>All walls were seen to be in good condition, with no cracks, gaps or crevices within the brickwork or areas of missing mortar.</p> <p><b>Suitability/access/evidence of bats</b></p> <p>None.</p> | <p><i>B1 walls, northern elevation</i></p> |

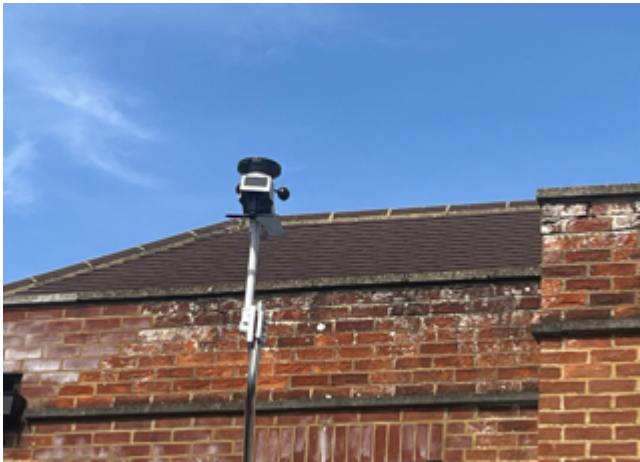
| Roof | Tiles | <p><b>Condition/description</b></p> <p>During the survey, multiple raised roof tiles were noted, particularly on the northern elevation. Tiles on the southern elevation were assessed to be in good condition with limited areas of lifting, though seven clear gaps were noted toward the east.</p> <p><b>Suitability/access/evidence of bats</b></p> <p>Crevice dwelling species of bats are known to use gaps under roof tiles to roost; where multiple raised roof tiles are present opportunities for larger roosts can be formed.</p> | <p><i>B1 roof, southern elevation, flush roof tiles</i></p> |

Two bat emergence/re-entry surveys are required on B1 during the active bat season (May – September) to confirm presence/likely-absence of bats roosting in or on the building.

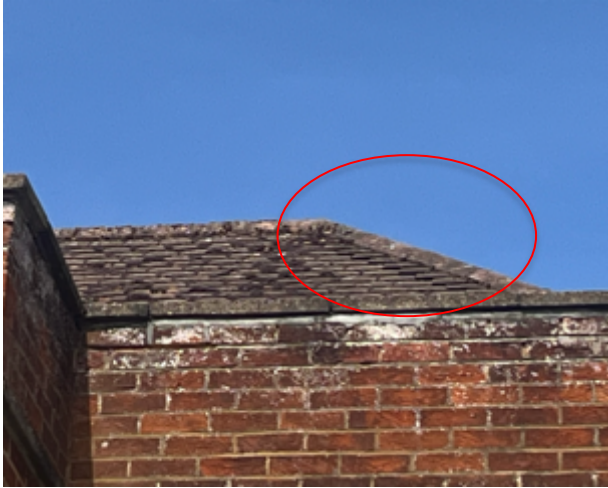
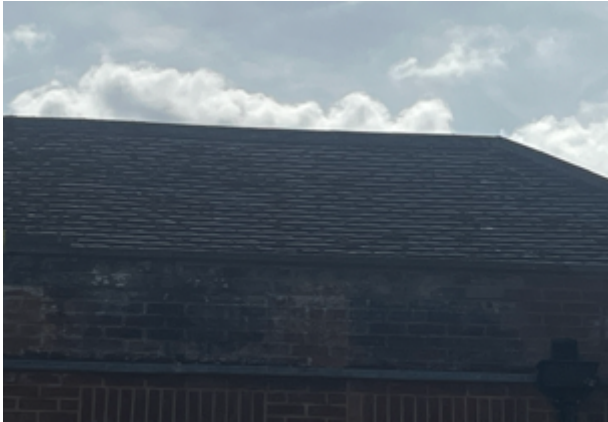
B1 is a residential dwelling with a hipped roof clad in tiles. The building features timber windows and door frames, which were found to be tightly fitted and in good condition, offering no roosting potential. During the survey, multiple lifted roof tiles, particularly on the northern elevation, and several large gaps on the southern elevation were seen to offer roosting opportunities for crevice-dwelling bats. Internally, the void featured timber beams, bitumen felt lining and mineral wool insulation. While no evidence of bats was found during the internal inspection, areas of ripped felt lining could offer suitable roosting crevices along with direct access into the void itself. B1 was assessed to have **moderate** habitat value. B1 will be subject to a loft conversion.

| | | | <p><i>B1 multiple gaps under rooftiles, southern elevation</i></p> <p><i>B1 multiple gaps under rooftiles, northern elevation</i></p> |

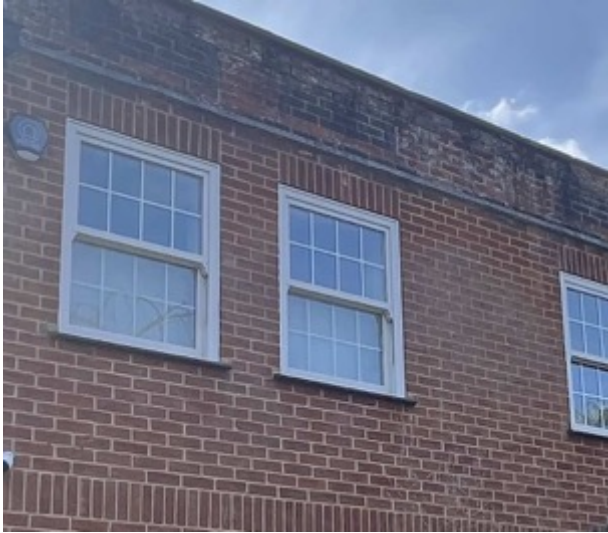
| Windows | Timber | <p><b>Condition/description</b></p> <p>The timber windows and doors were seen to be tightly-fitted and in good condition, with no areas of peeling paint or splitting wood within which bats could roost.</p> <p><b>Suitability/access/evidence of bats</b></p> <p>None.</p> | <p><i>B1 window / doors frames and lintels</i></p> |

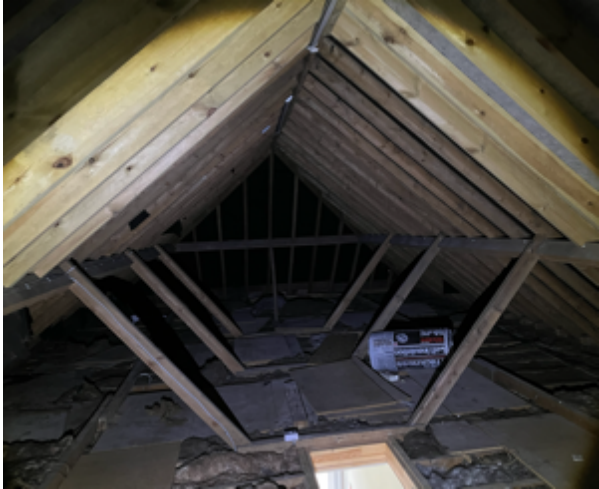
| Internal void 1 | Timber rafters. Mineral wool insulation. Plywood panels. Bitumen felt lining | <p><b>Condition/description</b></p> <p>The timber beams were seen to be in good condition, with no splitting of wood present which could provide roosting opportunities for bats.</p> <p>In some places, particularly on the northern elevation, areas of bitumen felt lining had ripped and peeled away to reveal the clay tiles.</p> <p><b>Suitability/access/evidence of bats</b></p> <p>While no points of light ingress were noted, and no evidence of bats or rodents was found internally, access into the void was deemed possible via the roof tiles and bitumen lining, which featured multiple rips and tears. Areas</p> | <p><i>B1 loft void, facing east</i></p> |

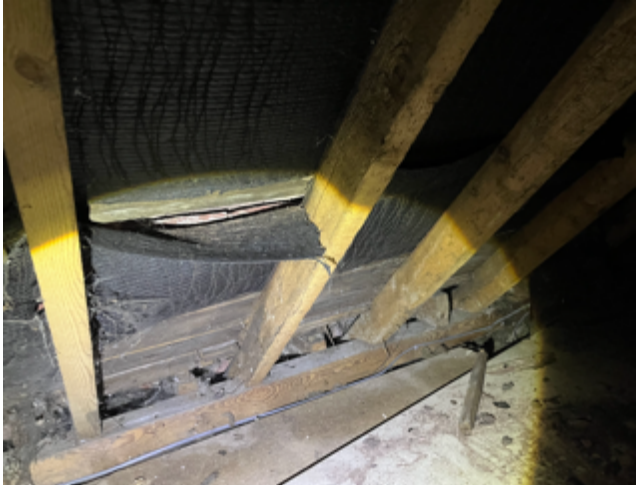
| | | <p>where bitumen felt lining has torn could offer suitable crevices within which bats could roost.</p> | <p><i>B1 loft void, ripped lining, northern elevation</i></p> |

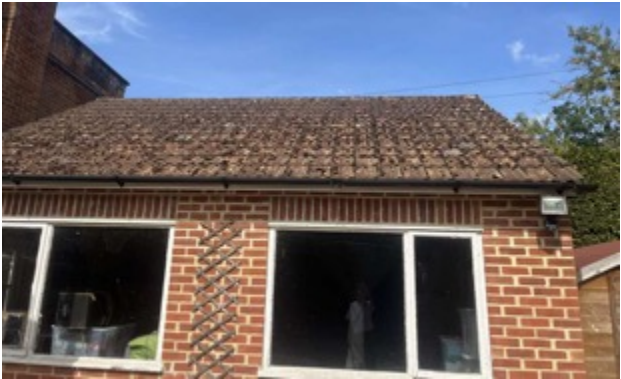
B2 is a garage located immediately to the south of B1. The building is brick built and features large windows to the south and two large metal garage doors to the north. The pitched roof is clad with interlocking tiles which are flush and do not feature any suitable gaps or crevices under which bats could roost. The building was deemed to be well-sealed with no points of access internally. B2 was assessed to have negligible suitability for bats owing to a lack of suitable features.

*Building B2, southern elevation*

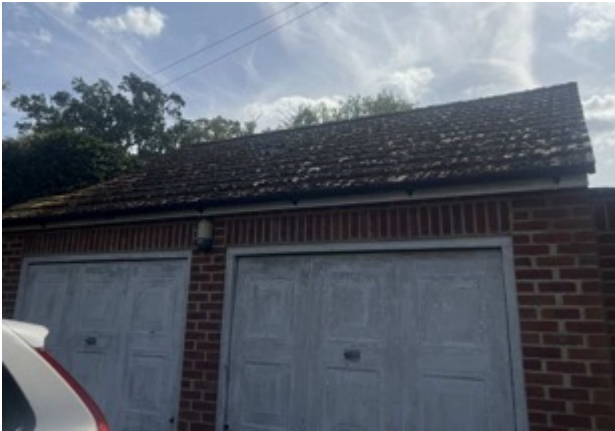
*Building B2, northern elevation*

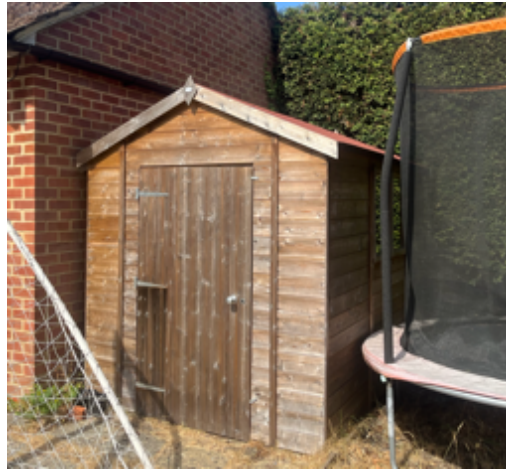
B3 is a pitched roofed timber shed located to the east of the site. This building lacks traditional features that would typically provide suitable roosting opportunities for bats and is likely to be subject to temperature fluctuations due to the nature of the construction materials, creating an unstable thermal environment that does not support bats roosting. No suitable gaps were observed during the survey. Therefore, assessed as having negligible value for roosting bats. B3 will be retained.

*Building B3, southern elevation*
