Measured Survey taken May 2025

11 HEADLEY ROAD  
WOODLEY  
BERKSHIRE  
BERKS

HICKS DEVELOPMENTS

WINDOWS A TO D  
EXISTING ELEVATIONS

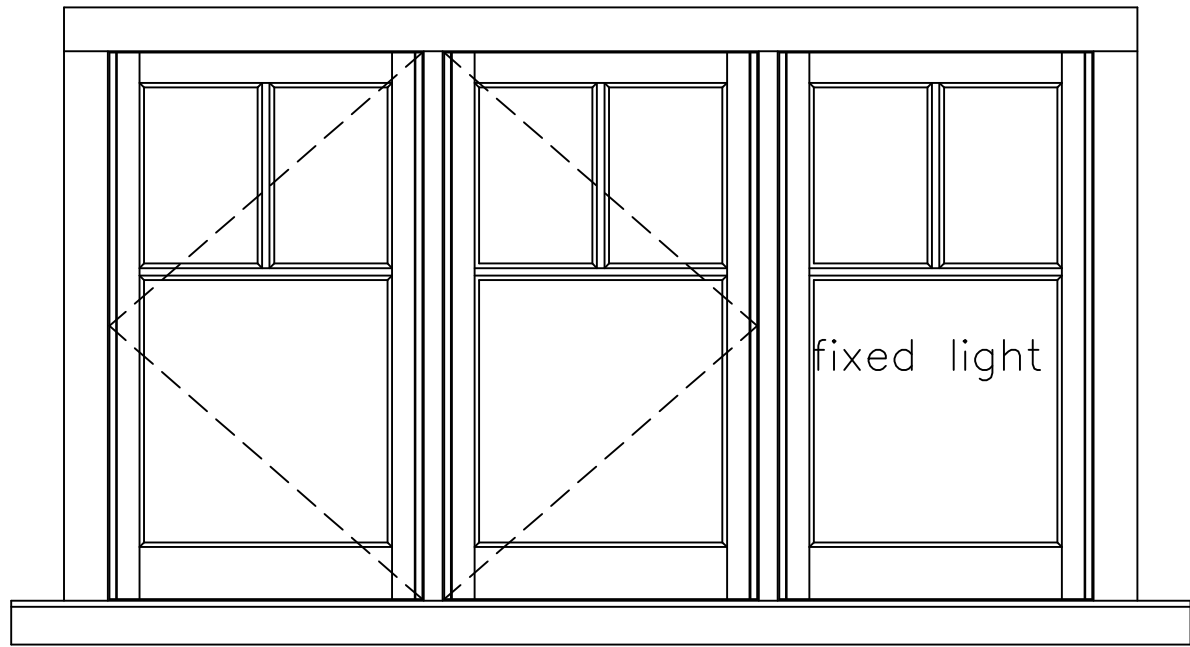
## Window A External

Frame set back 60mm  
into structural opening.  
Cill nose projects 30mm from brickwork.  
Cill is radiused and planted from previous  
repair

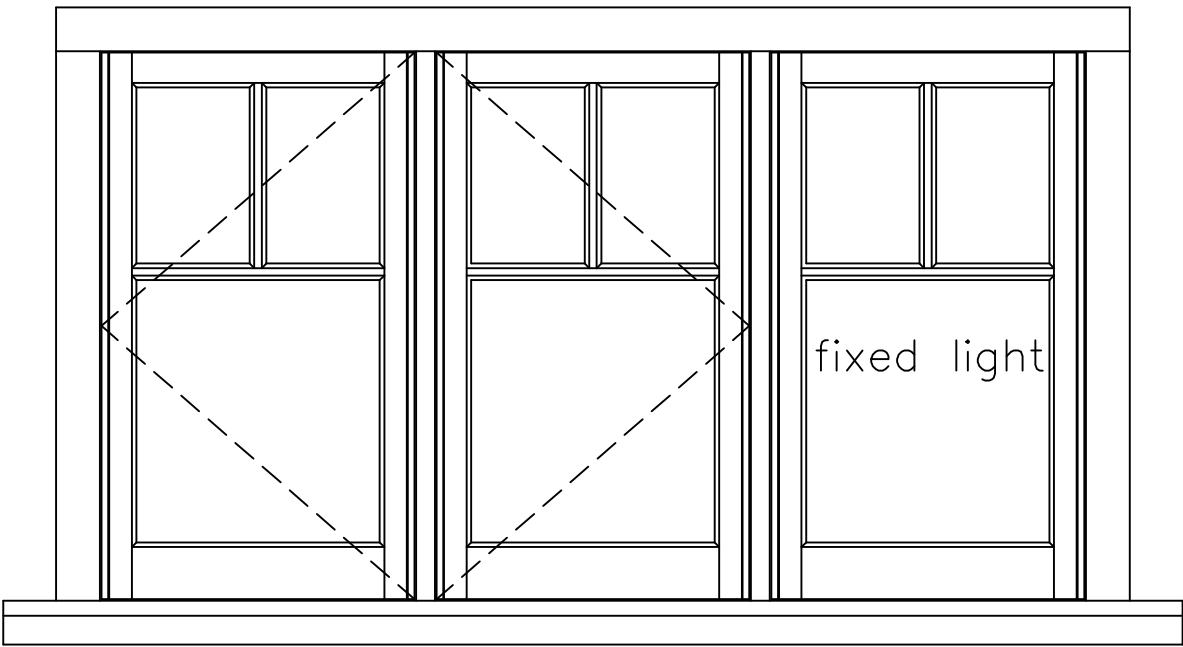
## Window B External

Frame set back 60mm  
into structural opening.  
Cill nose projects 30mm from brickwork.  
Cill is bull nosed and planted from  
previous repair.

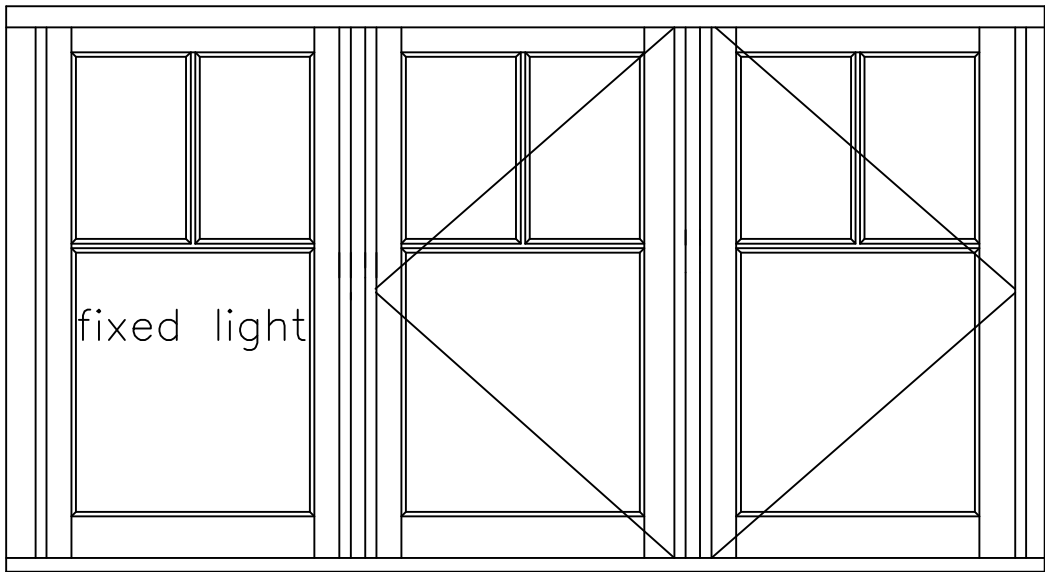
## Window A Internal

Existing iron pear drop casement stays  
and latch (with morticed keeps)  
Pair of 5 knuckle hinges per opening light

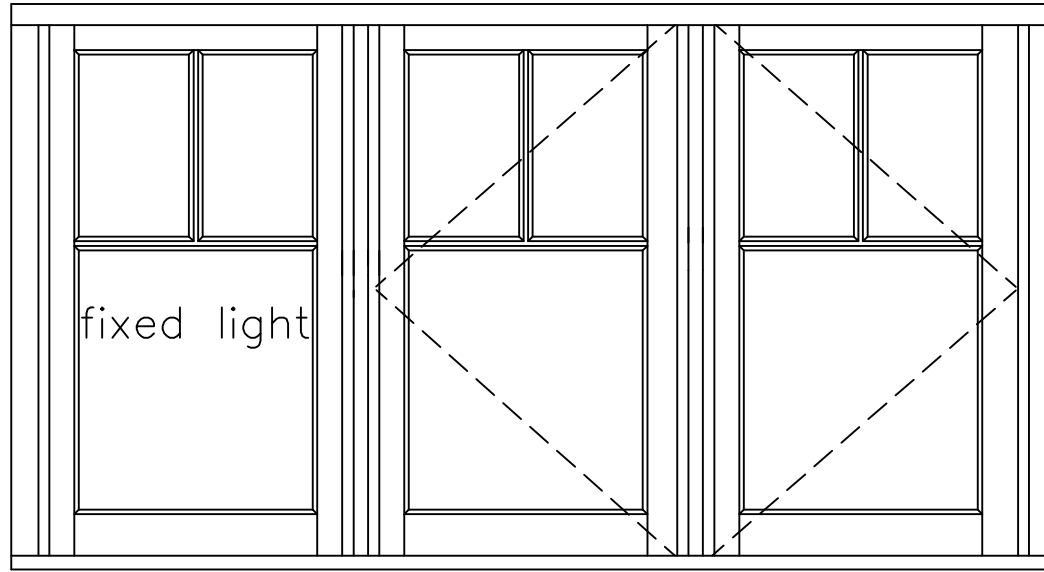
## Window B Internal

Existing iron pear drop casement stays  
and latch (with morticed keeps)  
Pair of 5 knuckle hinges per opening light

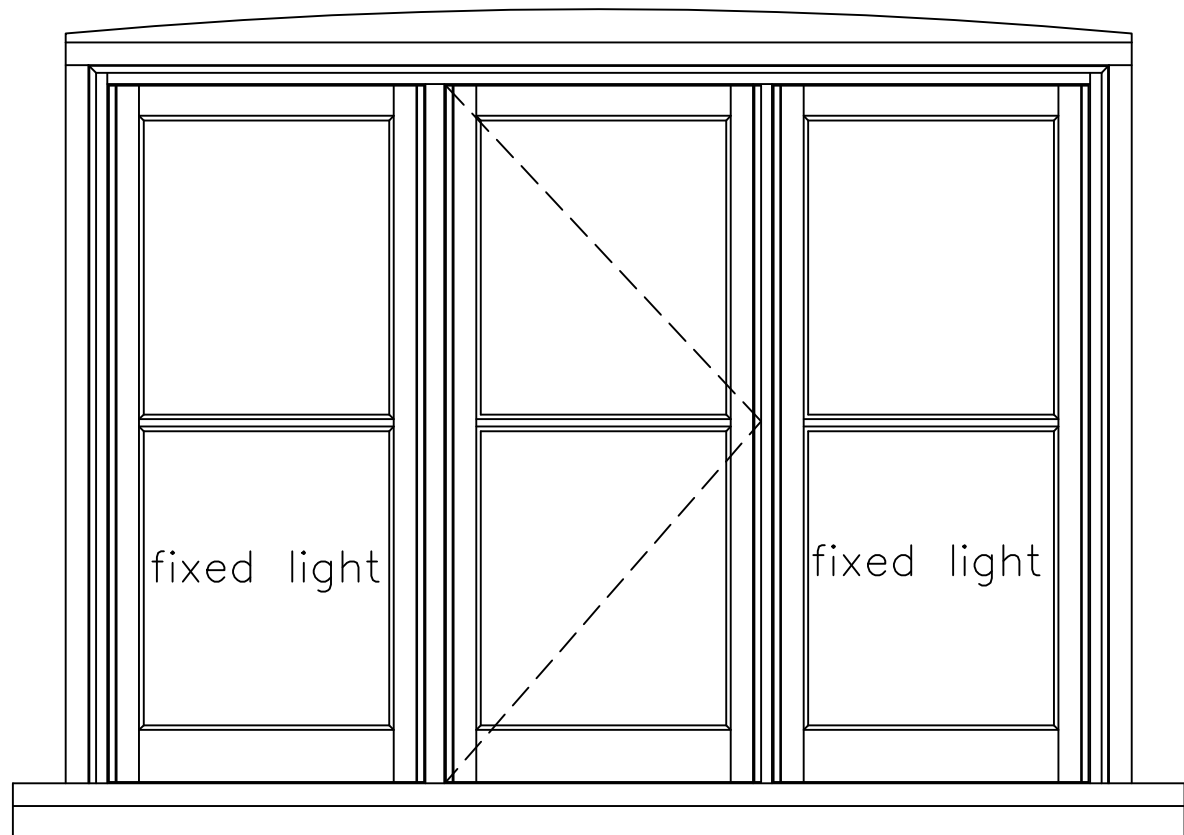
## Window C External

Frame set back 6–10mm  
into structural opening  
Cill nose projects 60mm from brickwork.  
Cill is bull nosed and planted from  
previous repair

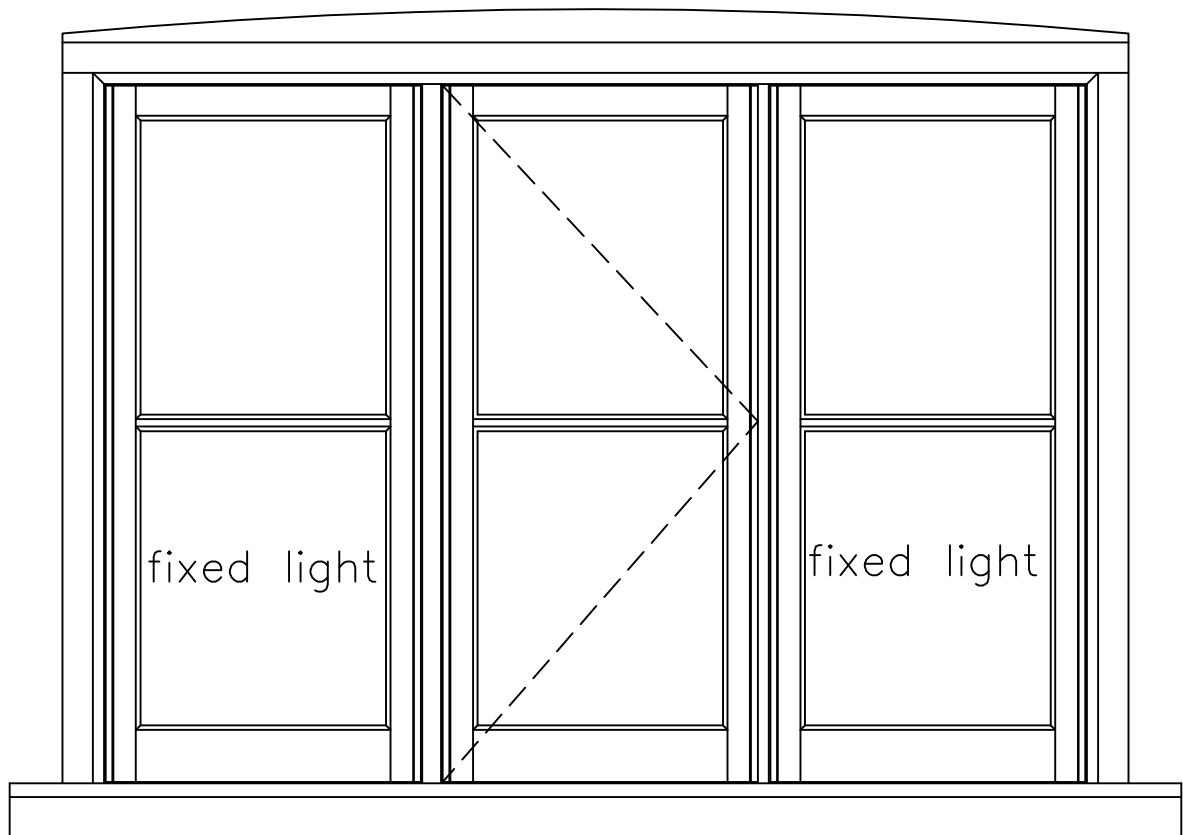
## Window D External

Frame set back 6–10mm  
into structural opening.  
Cill projects 70mm from brickwork.  
Cill is bull nosed and planted from  
previous repair

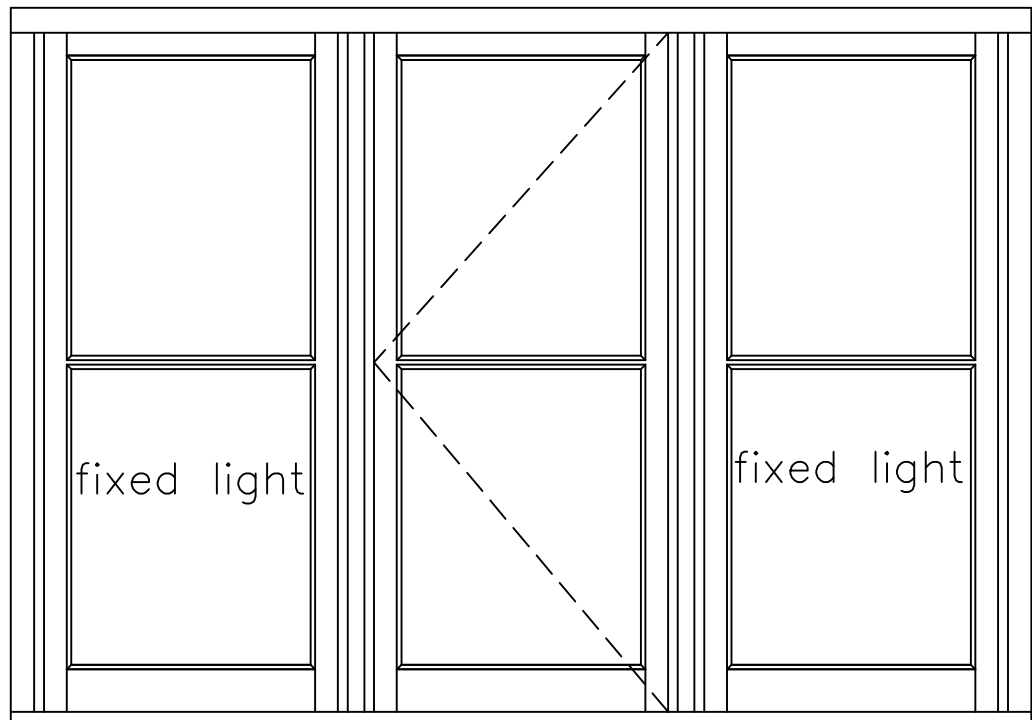
## Window C Internal

Existing iron monkey tail casement stay  
and latch (with morticed keeps)  
Pair of 5 knuckle hinges per opening light

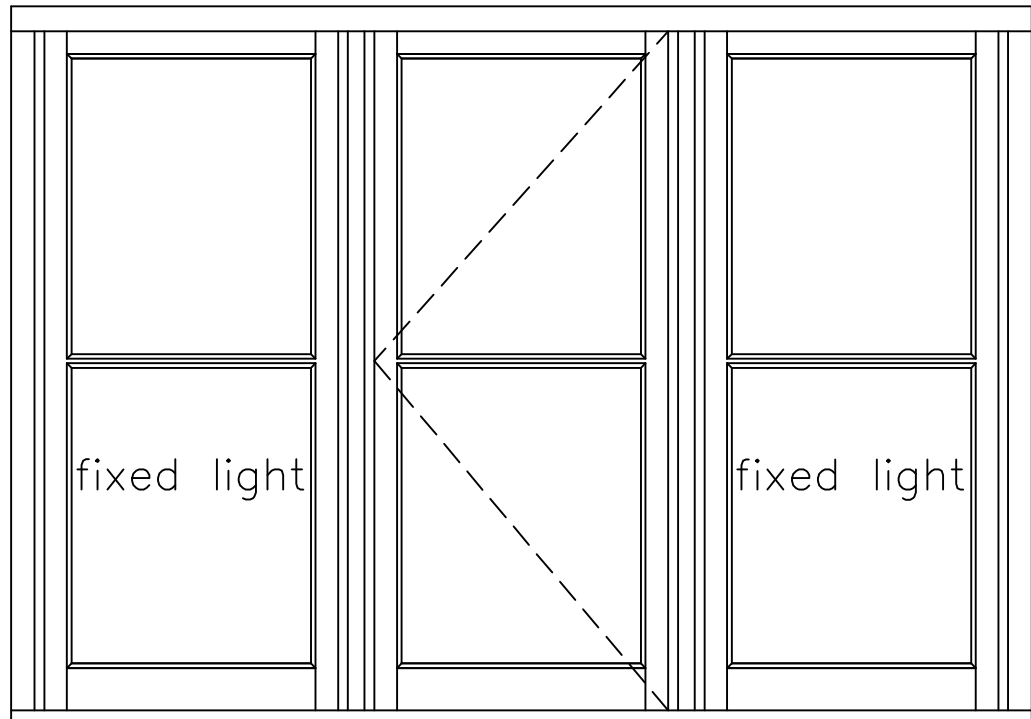
## Window D Internal

Existing iron monkey tail casement stays  
and latch (with morticed keeps)  
Pair of 5 knuckle hinges per opening light.
