# GLASSPOOL FARM

## DEMOLITION & REFURBISHMENT SURVEY

## **ASBESTOS SURVEY REPORT**

In line with the Control of Asbestos Regulations 2012 & Health & Safety guidelines, DL Surveying has carried out a survey to location identified within the survey to Glasspool Farm consisting for 3 barns buildings with a concrete portal farm.

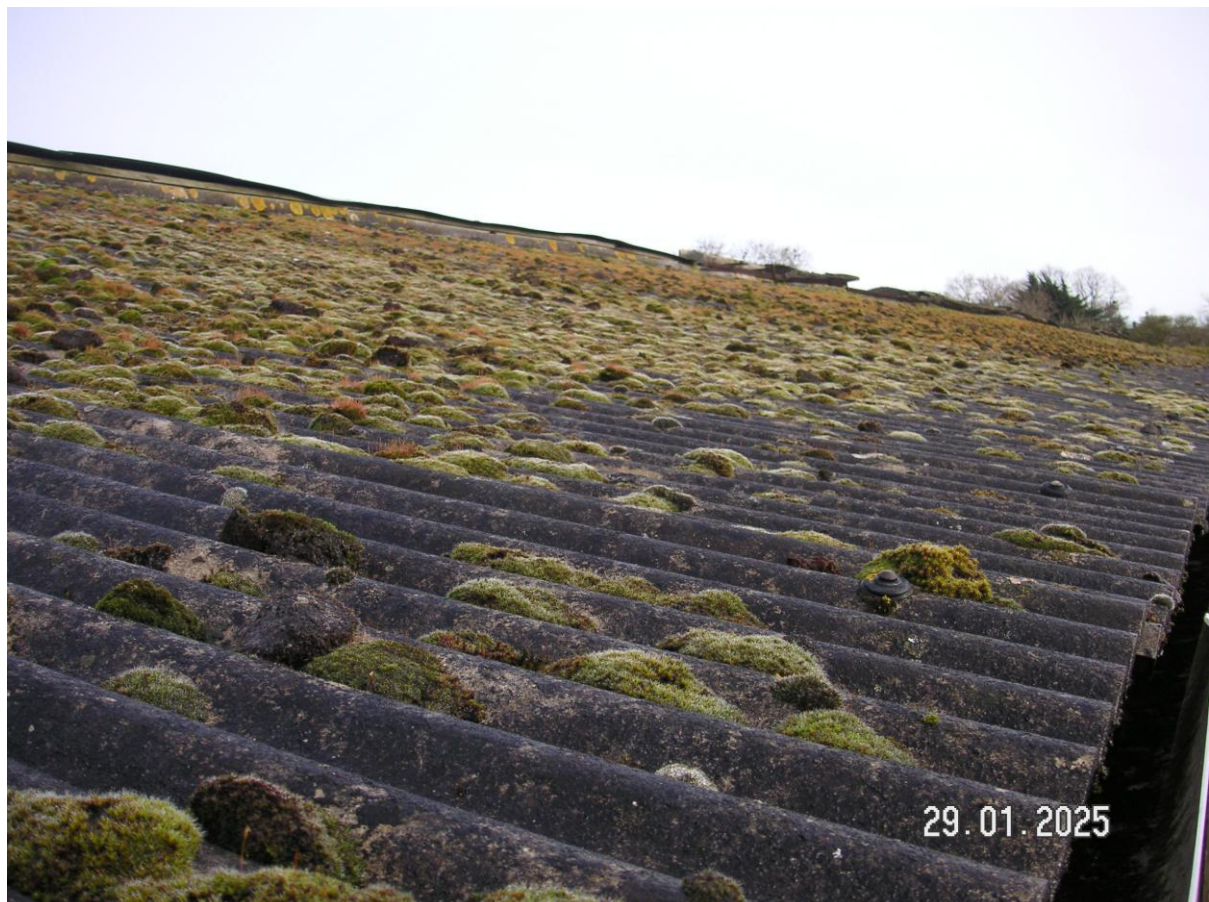
| Sample No | | GPF/2425/356/002 | | | |

| Room / Area | | Barn 1 | | | |
| Component | | Corrugated Profile Sheetting | | | |
| SURVEY RESULTS | | Approximate Area | 600m <sup>2</sup> | Asbestos Type | Chrysotile |
| Location | Roof | | | Product Type | Cement |

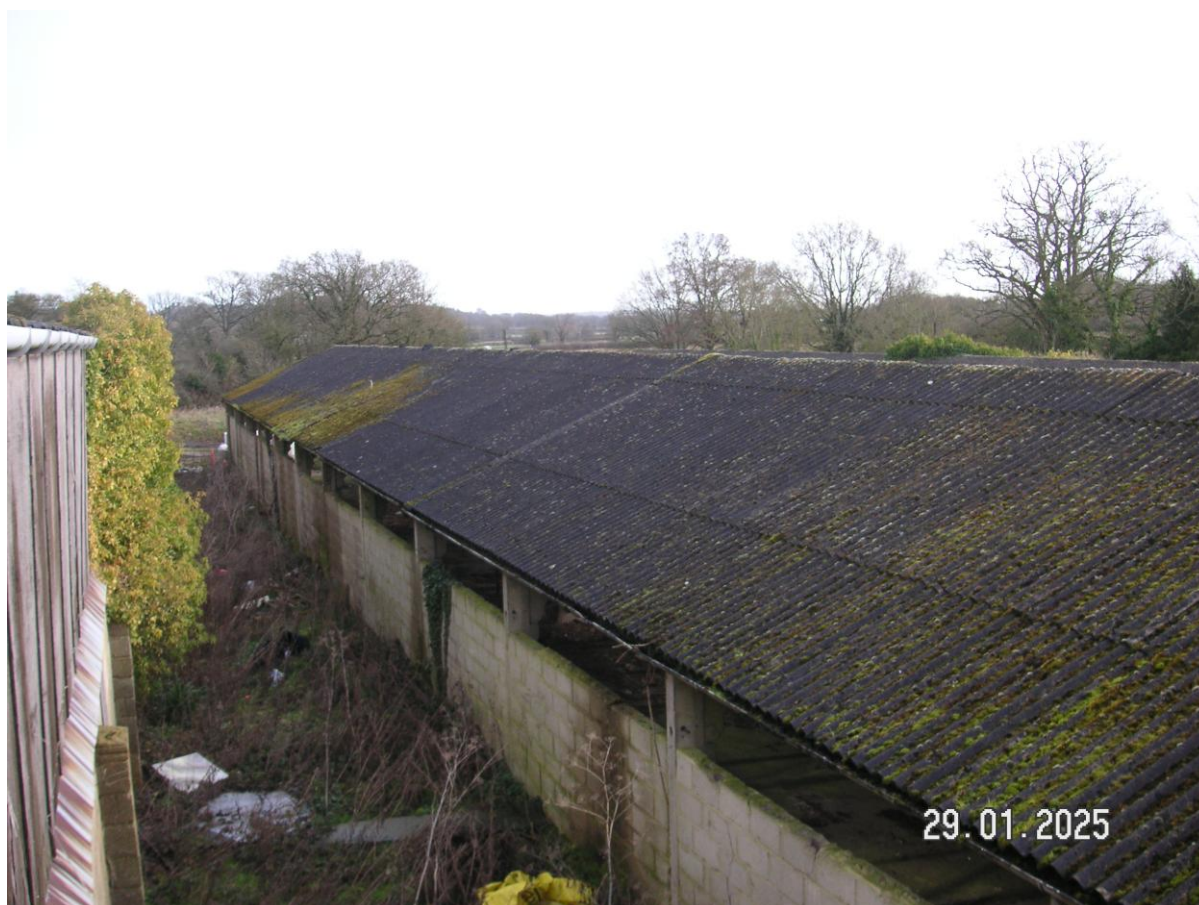
| THIS SAMPLE CONTAINS ASBESTOS | | | | | |
|---|---|---|---|---|---|
| Sample No | | GPF/2425/356/003 | | | |

| THIS SAMPLE CONTAINS ASBESTOS | | | | | |
|---|---|---|---|---|---|
| Room / Area | | Barn | | | |
| Component | | Corrugated Profile Sheetting | | | |
| SURVEY RESULTS | | Approximate Area | 480m <sup>2</sup> | Asbestos Type | Chrysotile |
| Location | Roof | | | Product Type | Cement |
