**PHASE II GEOENVIRONMENTAL
SITE INVESTIGATION**

RADSTOCK PRIMARY SCHOOL

PROJECT REF: R4319

Report Reference: R4319/25/GI

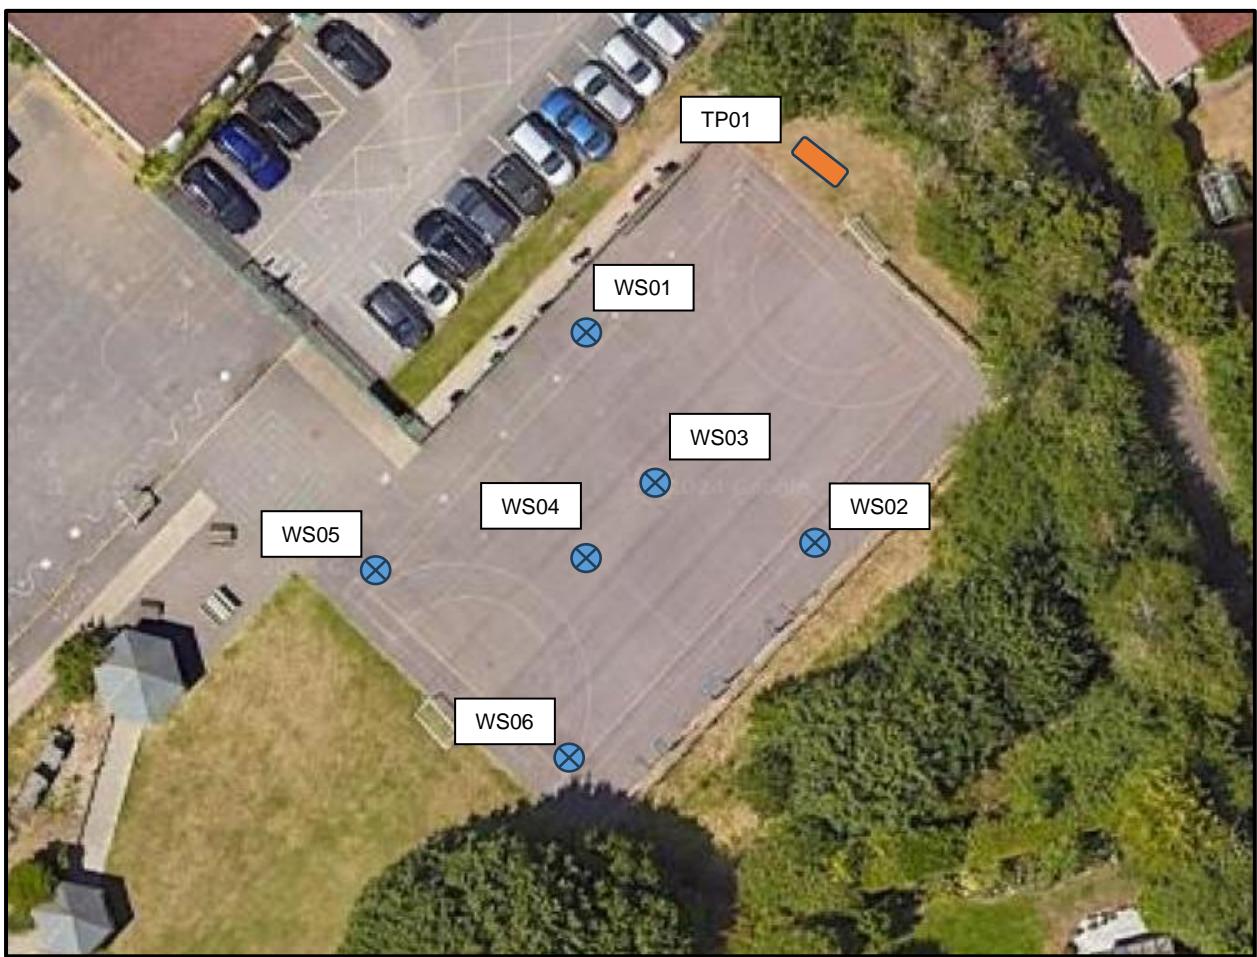
Figure 2: Exploratory Hole Location Plan

The exploratory hole locations were determined by EEGSL prior to the site works and considered site logistical constraints present at the time of investigation. The investigation locations completed are shown approximately on the Exploratory Hole Location Plan in Figure 2.

- 6 No. window sample boreholes (designated WS01-WS06) sunk to a maximum depth of 5.00m below existing ground level. Window sample boring is carried out with a small, track-mounted rig, which uses a chain driven trip hammer to drive sampling tubes or penetrometers into the ground. These tools are coupled to the anvil of the hammer by solid drill rods. Sampling tubes comprise “windowless samplers”, which are plain sampler tubes in which a continuous disturbed sample is recovered within a semi-rigid plastic liner. To reduce friction within the borehole, sampling tubes of progressively smaller diameter are used as the borehole depth increases. Sampler diameters generally range from between approximately 90mm to 50mm. Exploratory Hole logs are included in Appendix 1.

- 1 No. Machine dug Trial Pit (TP01) was dug to 1.7m below existing ground level and soakaway testing was undertaken in line with BRE 365 Guidance.

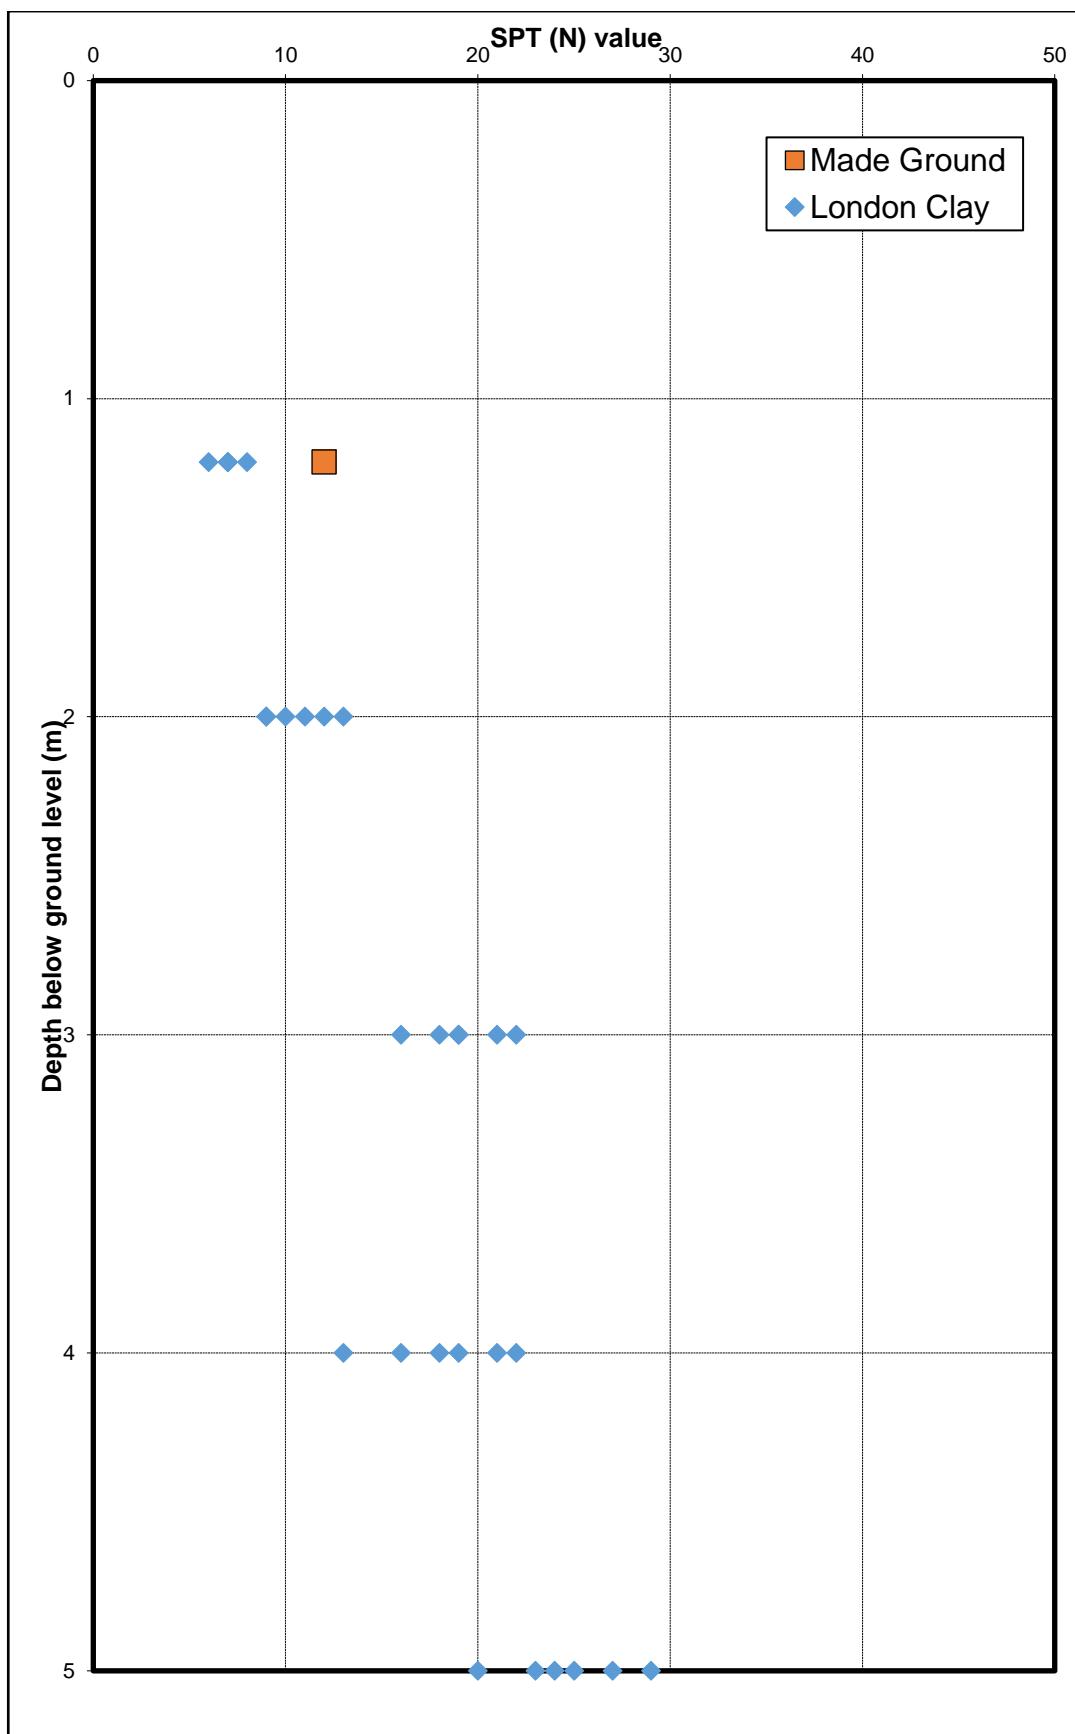
Figure 3: SPT N Vs Depth Graph

Soft becoming firm to stiff brownish grey slightly gravelly CLAY of the London Clay formation was found present at depths between 0.10mbgl and 5.00mbgl at the assessment site. During drilling 29 **SPT N** results were obtained at depths between 1.20mbgl and 5.00mbgl. The SPT N values would suggest the London Clay Formation is generally soft at 1.20mbgl becoming firm at 2.00mbgl and firm to stiff from 3.00mbgl to 5.00mbgl.

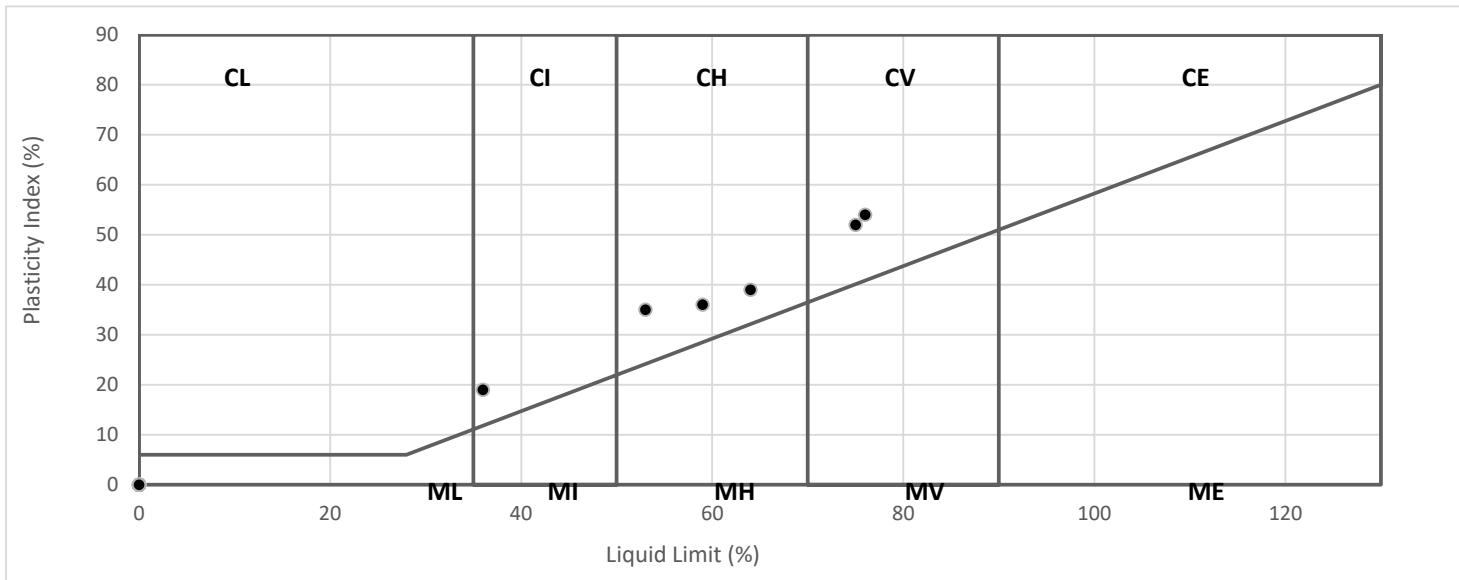
PLASTICITY CHART FOR CASAGRANDE CLASSIFICATION

Atterberg Limit tests were undertaken on six samples of the London Clay. Test results have given values for **liquid limit** ranging from 36-76%, values for **plastic limit** ranging from 17-25%, resulting in values of **plasticity index** ranging from 19-54%. These results suggest the samples tested are predominantly clay of Intermediate to high to very high plasticity. For design purposes, a value of plasticity index = 52% is recommended, based off an upper quartile average.

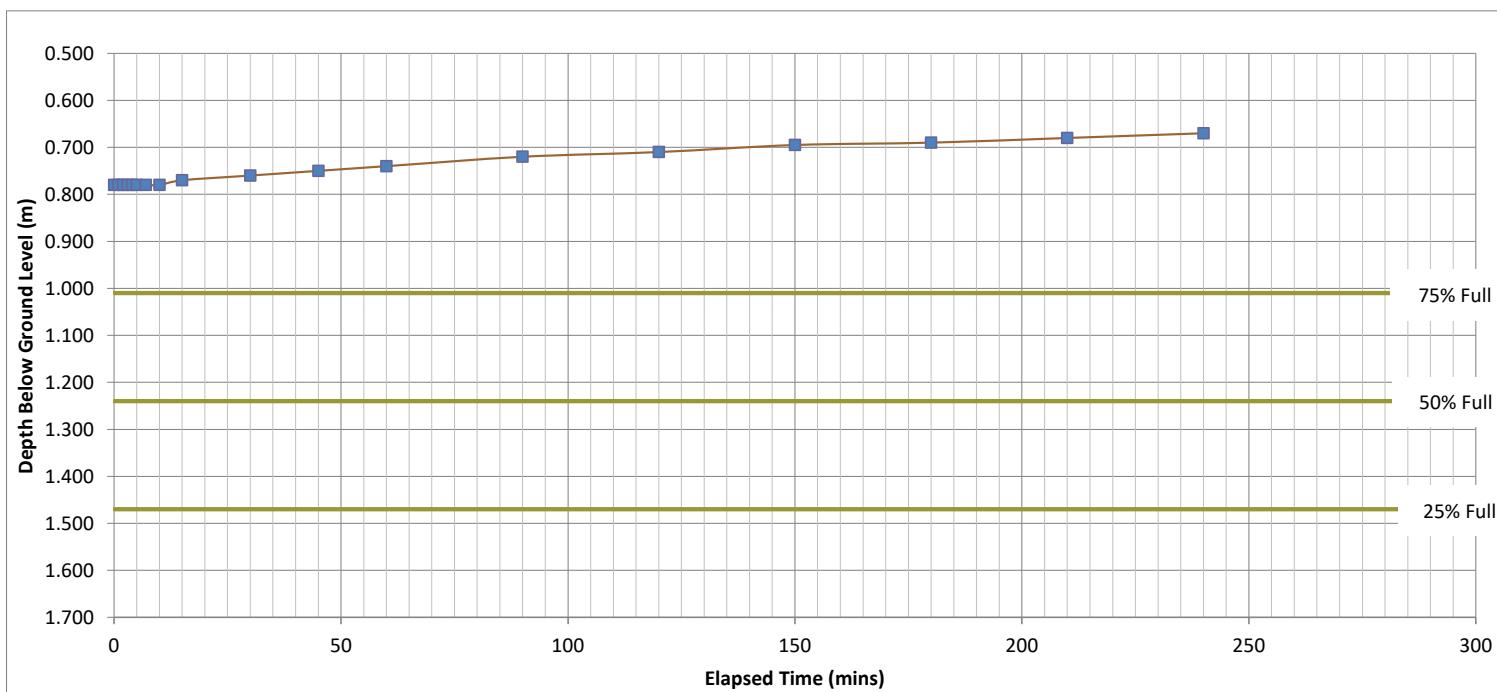
Testing was completed in line with BRE 365 Guidance, however testing at TP01 was abandoned after four hours due to the lack of infiltration.

TP01	Test 1
26/11/2024	
sl gravelly sl sandy CLAY	
1.70	m
0.92	m
0.50	m
2.70	m
0.78	m
-	m
0.69	m
1.01	m
0.46	m
1.24	m
0.23	m
1.47	m
0.46	m3
1.24	m3
-	mins
-	mins
-	secs
6.79	m2
-	m/s

Location	No. of Tests in Pit	Test Depth (m)	Strata	Soil Infiltration Rate (m/s)	Comments
TP01	1	1.70	London Clay	N/A	Soils are essentially impermeable showing no signs of infiltration after four hours. Test abandoned.
	2	-			Unable to complete
	3	-			Unable to complete
