HERITAGE STATEMENT IN SUPPORT OF LISTED BUILDING CONSENT APPLICATION OF PROPOSED STRUCTURAL REMEDIAL WORKS TO STAIRWELL AT THE REDDAM HOUSE, BEARWOOD ROAD, SINDLESHAM, WOKINGHAM, RG41 5BG

1.1 This heritage statement is produced to support the listed building consent application of structural support to the landings of the 'Back Staircase' in Reddam House.

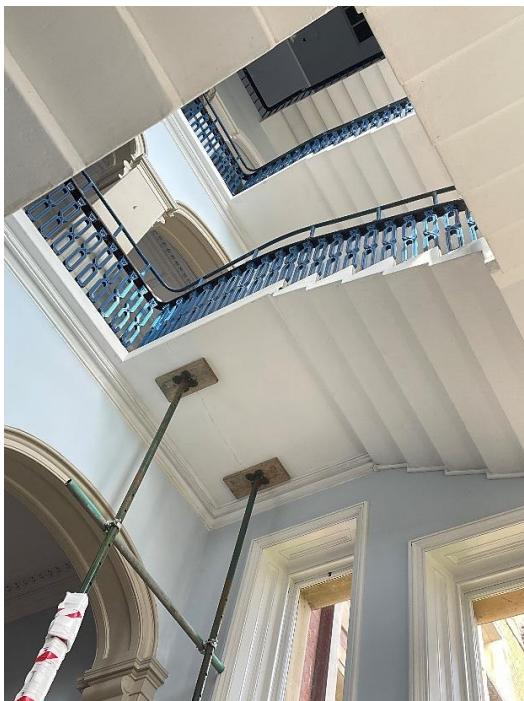
Figure 1. View of underside of feature arch over ground floor landing.

2.3 Currently the cracked staircase landing is secured by temporary Acrow propping support as shown in Figures 1, 2 and 3.

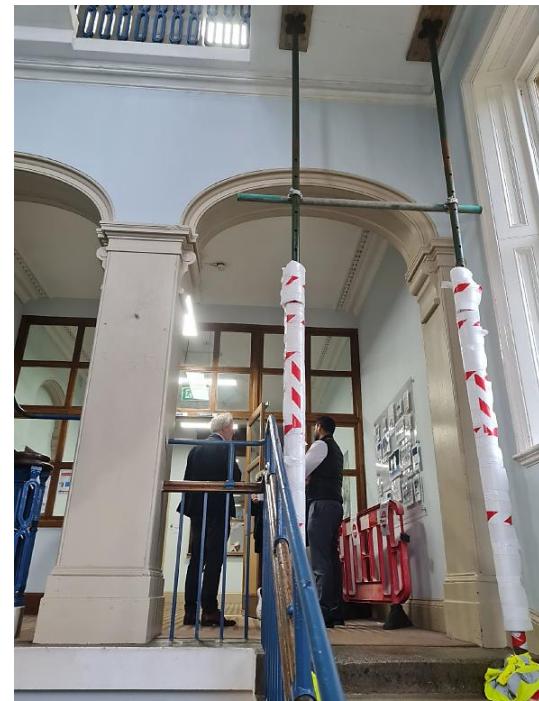
Figure 2. The ground floor landing to 'Back Staircase'.

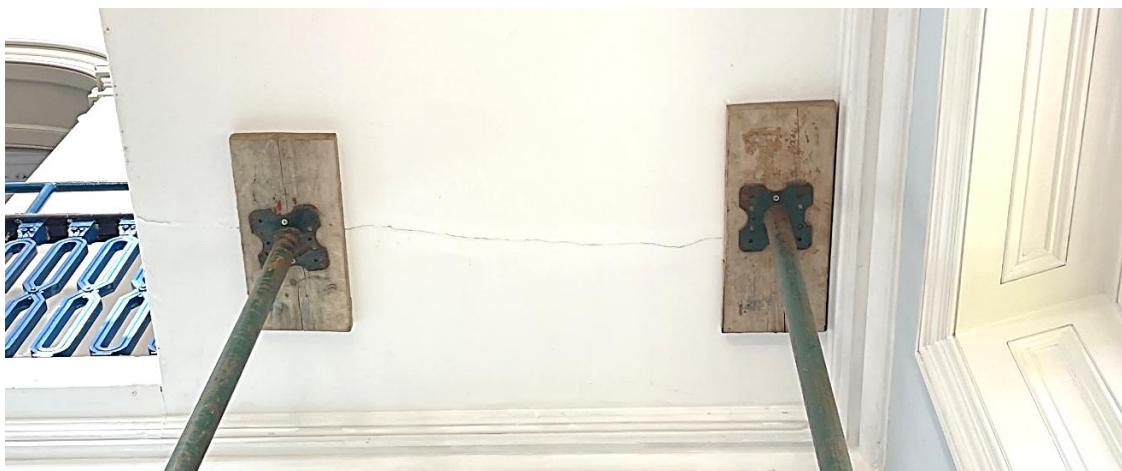
Figure 3. The cracking to the first floor landing – underside.

- 2.4 The proposed repairs include the installation of two sets of gallows brackets to the underside of the landing structure which have been designed by a structural engineer with experience of working on listed buildings.
- 2.5 Although the cracking has appeared only on the first-floor landing, it is proposed to replicate the same detail on each landing area (for all the flights) because of the

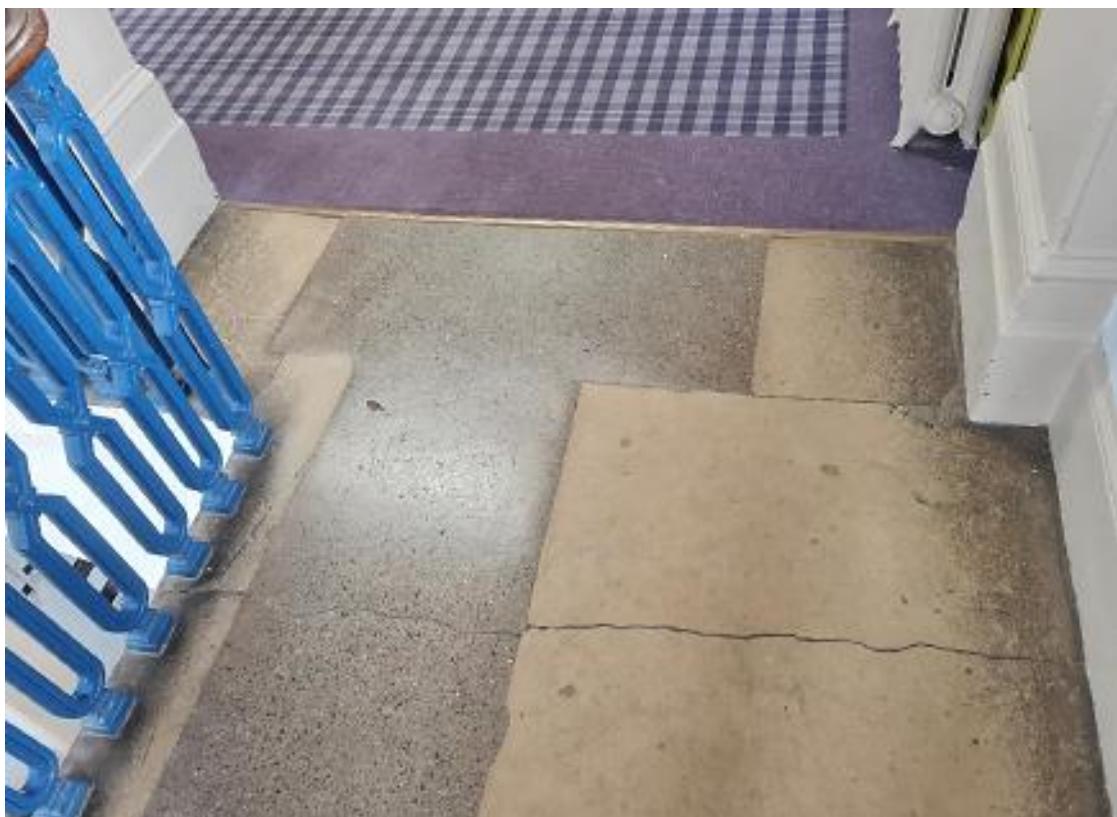
Figure 4. The cracking in the first floor landing.

inherently weak detailing and potential for cracking in the future. This is of safety concern given the current use of the building as a school.

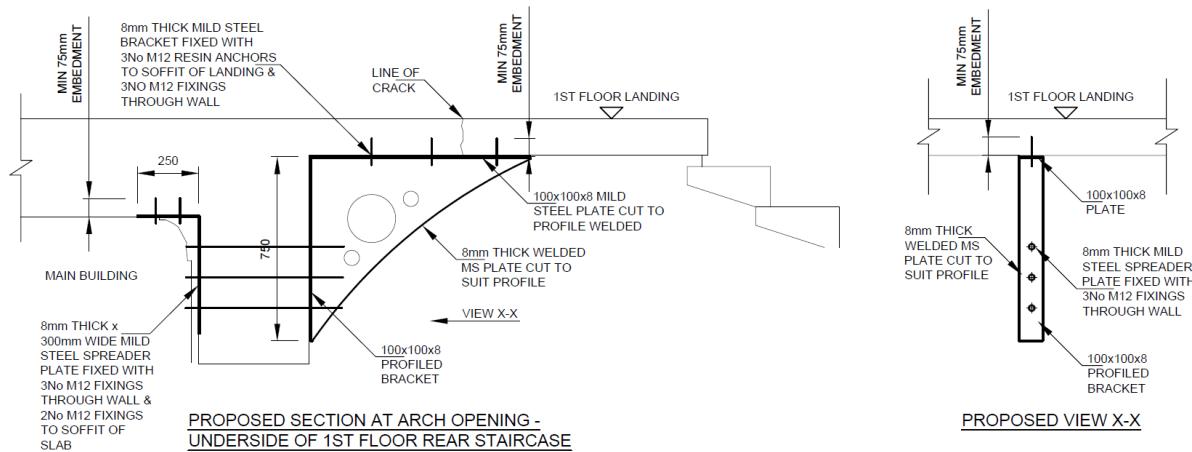
Figure 5. Proposed Section and View at Arch Opening – underside of the first floor 'Back Staircase'.

- 2.6 The suggested method of repairing would retain existing fabric as much as possible.
- 2.7 The intervention has been designed in such way that it cannot be misunderstood as original, and at the same time not removing more historic fabric than is necessary to complete the structural repair.
- 2.8 No other changes to the existing property or outbuildings are proposed within this application.
- 2.9 The Detailed Drawings and Outline Listing of Proposed Remedial Measures provided by Gawn Associates, structural engineers, are included as part of this application. The structural engineers' gallows brackets design is shown for reference in Figures 5-7.

- 5.1 The brackets will be installed using non-ferrous structural fixing resin, anchored into the existing structure as outlined in the structural report.
- 5.2 Access to the work areas will be provided via safe scaffolding. Scaffolding will allow the necessary structural repairs of each landing whilst enabling existing historic features to be protected and prevent damage during the works.
- 5.3 On completion, the scaffolding and protection will be removed and decorations made good on a like-for-like basis.

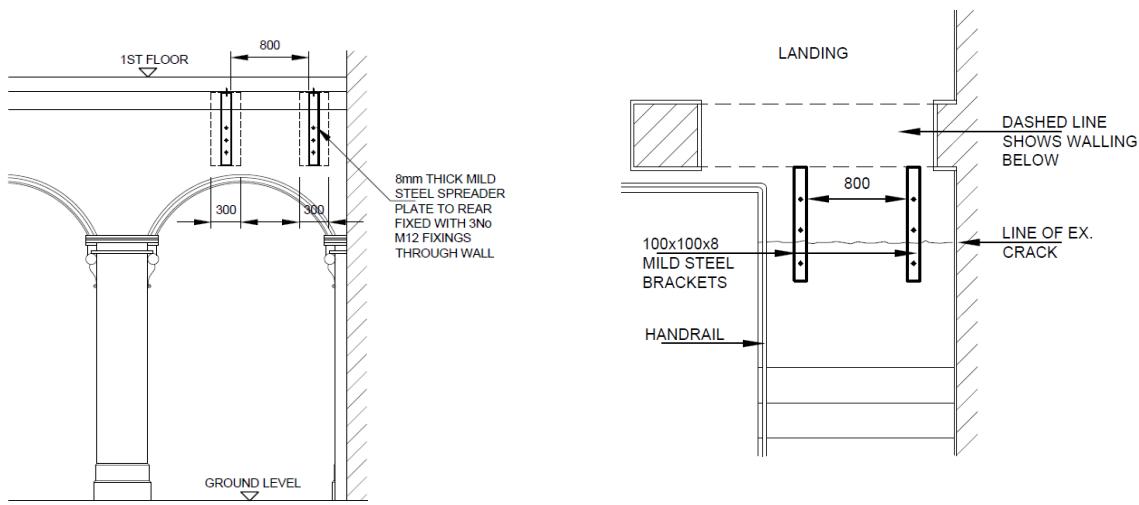
Figure 6. Proposed elevation on arched opening at the ground floor landing to the 'Back Staircase'.

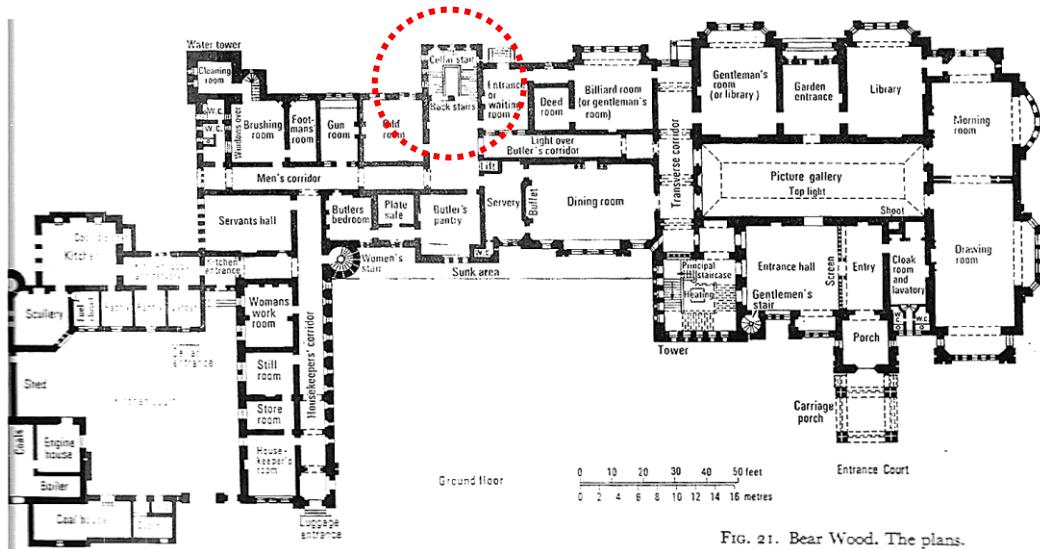
FIG. 21. Bear Wood. The plans.

Figure 14. Ground Floor – Historic plan. ‘Back Staircase’ marked in red.

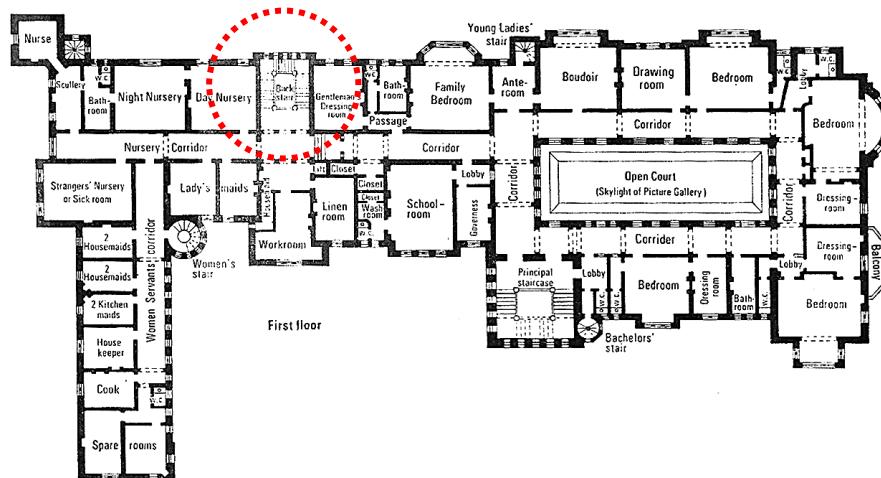
Figure 15. First Floor – Historic plan. ‘Back Staircase’ marked in red.

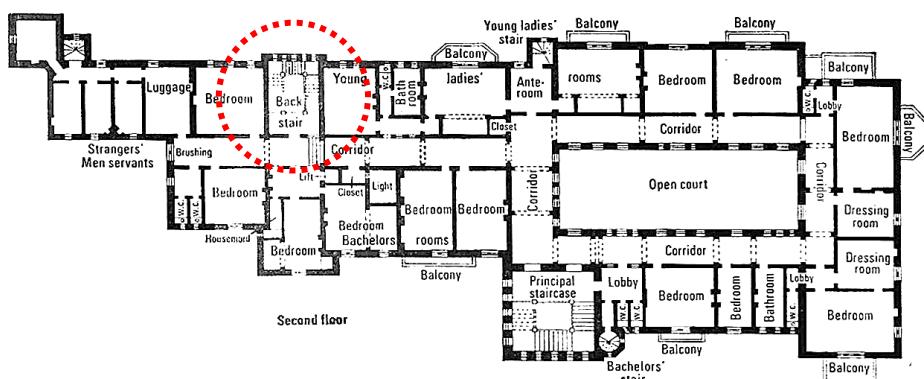
Figure 16. Second Floor – Historic plan. ‘Back Staircase’ marked in red.
