## **PRELIMINARY ECOLOGICAL APPRAISAL (DBW) AT COOMBE HILL BARKHAM**

**Prepared for:  
Mr L Smart  
Coombe Hill  
Hayes Lane  
Barkham  
RG41 4TA**

**12 May 2025**

**Ref: SPH/NP/PEA-25/29.04**

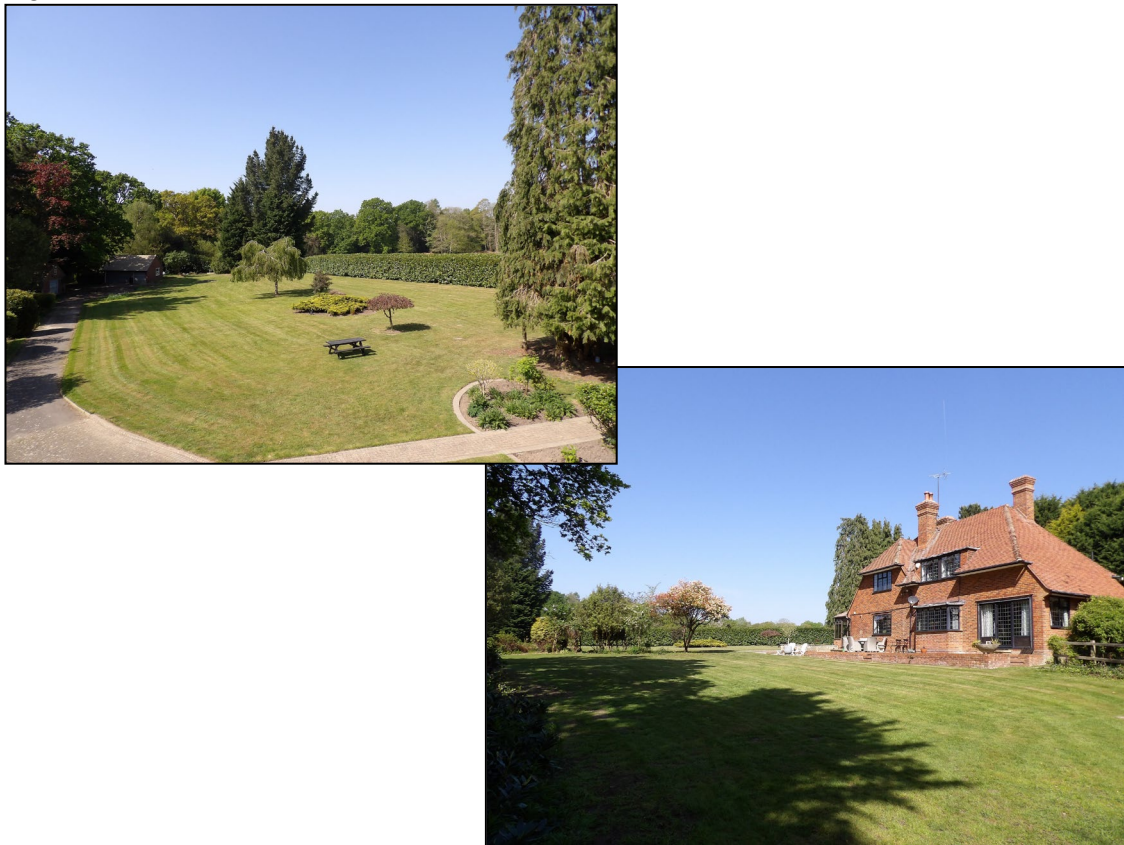
Figure 3. Gardens. Coombe Hill, Barkham. 29.04.25

The application site comprises a detached two-storey, brick-built property with side conservatory and various outbuildings all set within extensive grounds that are laid mainly to lawn with tarmacked driveway/parking area, see Figure 3 below. The site itself offers good foraging and commuting habitat for bats and there is direct ecological connectivity to the wider landscape that also provides good habitat for foraging and roosting bats.

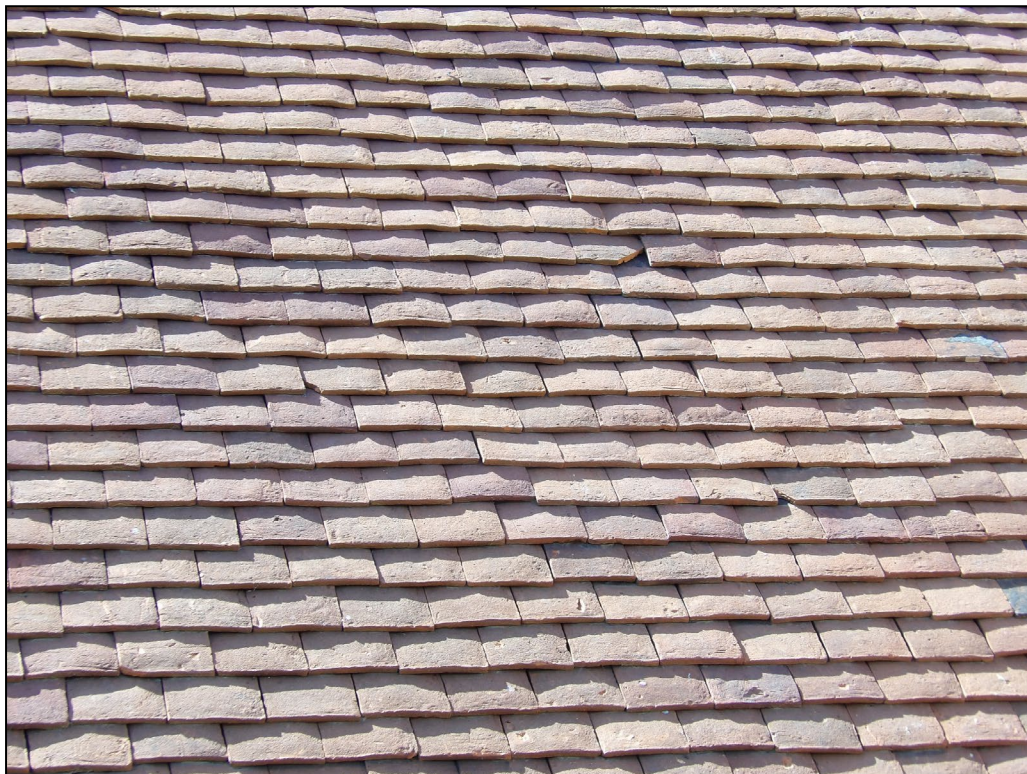
Figure 4. Examples roof tiles. Coombe Hill, Barkham. 29.04.25

The property is a detached, two-storey, brick-built building with single storey side conservatory. The multi pitched roof with catslide section is covered in tiles (see Figure 4 below), some of which, under the chimney stacks, have raised leaving gaps and provide roosting opportunities and could afford access into the loft for bats, see Figure 5 on page 9. There is cracked and missing mortar from some of the bonnet tiles (see Figure 9 on page 9), and there is missing mortar from a verge on the section of the roof to be affected by the proposed works, see Figure 7 on page 10. The soffits and fascias are tight to the wall with no gaps that could be exploited by crevice dwelling bat species, see Figure 8 on page 10. There are dormer windows on the front, rear and west elevations (see cover photo and Figure 9 on page 11), the rooves of which are covered in well fitted lead and the sides are covered in close fitted hanging tiles, there is no missing mortar from the verges, and they do not offer any roosting opportunities, see Figure 10 on page 11. On the west elevation is the conservatory (see Figure 11 on page 12), the roof of which is covered in close fitted composite tiles with no gaps for roosting, see Figure 12 on page 12.

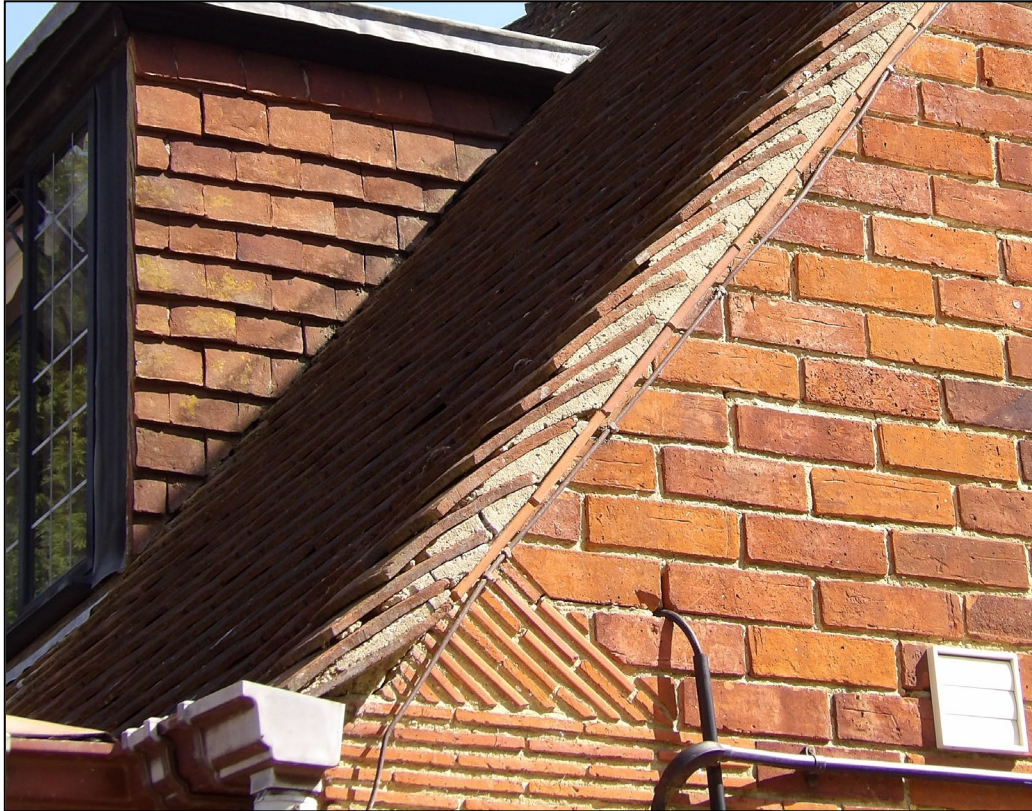
Figure 7. Example missing mortar in verge. Coombe Hill, Barkham. 29.04.25

The property is in a good condition internally and externally. The raised roof tiles and missing mortar in a verge provide crevice-like features suitable for bats to roost and may also provide access into the loft space and we are unable to determine the presence or absence of bats in the building without further survey effort. When the findings are combined with the desk top study the property was assessed as having a low potential to support roosting bats.

Based on the Bat Workers Manual and the Bat Surveys Good Practice Guidelines, one dusk emergence survey need to be undertaken on the property, between May and August, to establish the presence or absence of roosting bats and in order to inform appropriate mitigation for the proposed works if necessary. The features identified will require five survey positions, three equipped with bat detectors and all four with night vision cameras in order to cover the potential bat roosting features. If bats are recorded emerging from the building during the survey, two further activity surveys and an EPSL will be required in order for the development to proceed legally.

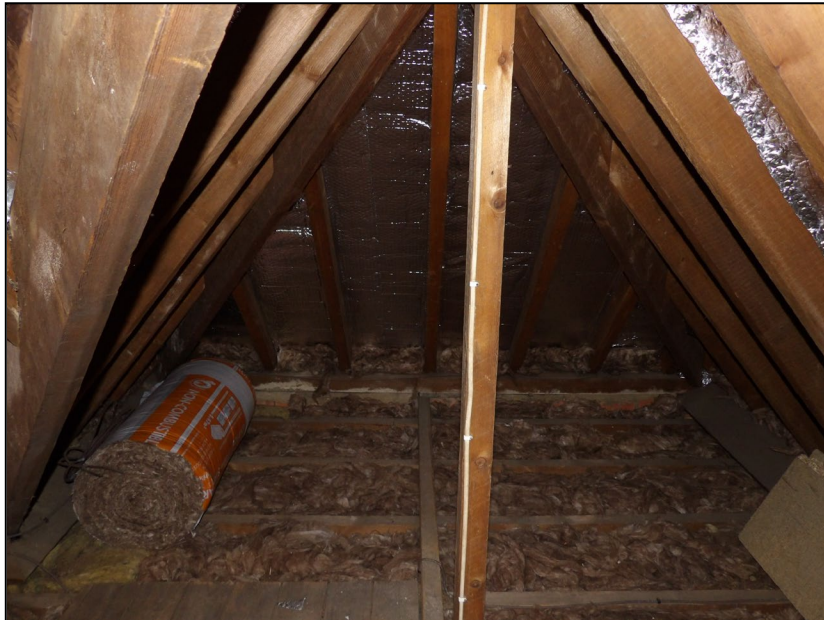
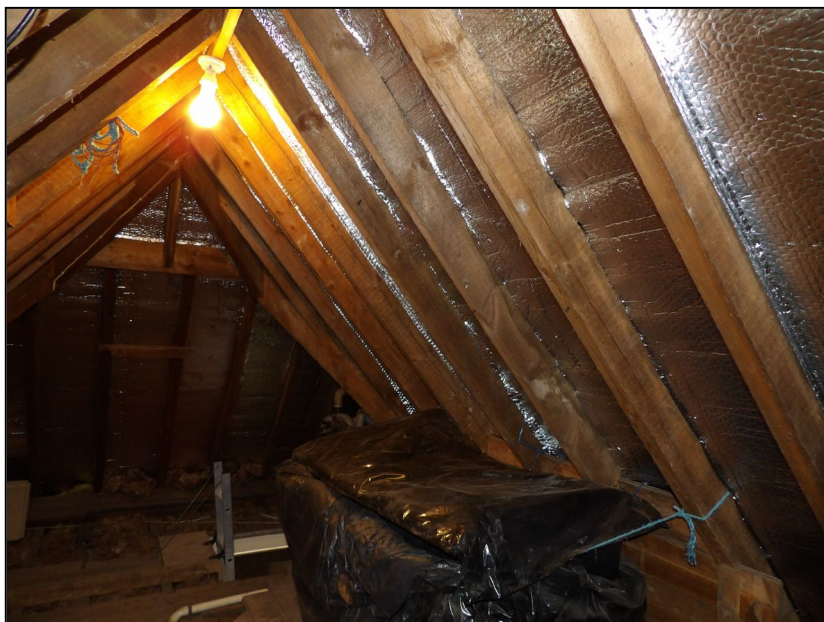
Figure 13. Example loft spaces. Coombe Hill, Barkham. 29.04.25

The loft space was accessed via a loft ladder and is in a good condition. The loft space is uncluttered, lit, partially boarded and insulated, see Figure 13 below. The roof tiles are lined with insulating foil, see Figure 13 below. There are also two eaves cupboards either side of the dormer window on the west elevation, these spaces are used for storage and are boarded, see Figure 14 on page 14. There is no loft space in the conservatory, the roof being boarded, plastered and painted, see Figure 15 on page 14.
