**13 Ellis Road**

Preliminary Roost Assessment

**13 Ellis Road**  
**Ecology 8714**  
**Version 01**

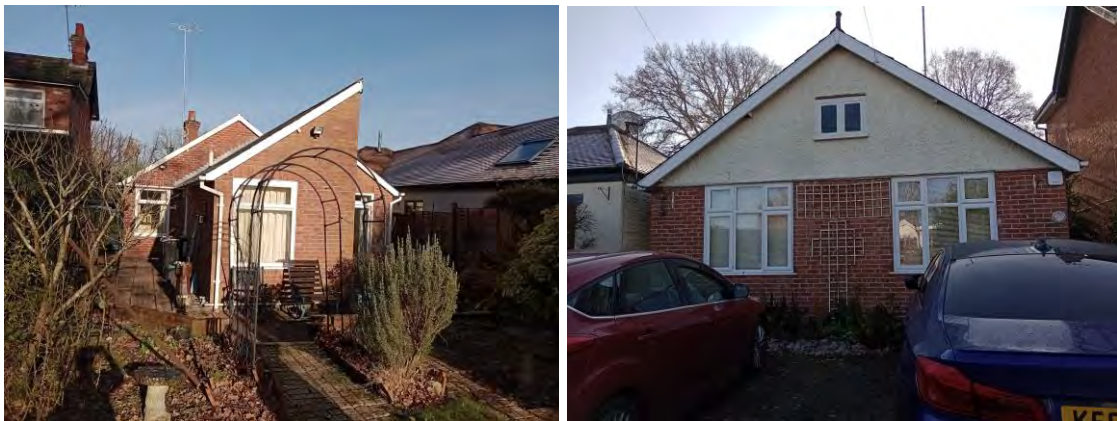
**Figure 1 and 2:** Front and rear elevation at 13 Ellis Road

- 4.4 The residential property at 13 Ellis Road is a detached bungalow comprising red brick walls which is partially rendered at the front of the property. The building includes a newer extension to the rear (**Figure 1**). The original section of the building has a pitched slate tile roof which is in good condition (**Figure 2**). The mortar along the ridge tiles was recently repaired across this section of the building.

- 4.5 The rear extension is lower than the original building and includes a half pitch section which extends to the south. Lead flashing is present along the join between the original building and the

extension, which is well-sealed. The building includes modern double glazed windows and uPVC fascia boards which are all in a good condition

- 4.6 The exterior of the building is in good condition. All the roof tiles appear to be well sealed, with no loose or missing tiles observed on any elevation. The fascia boards are well sealed against the wall, with no gaps present which bats could utilise.

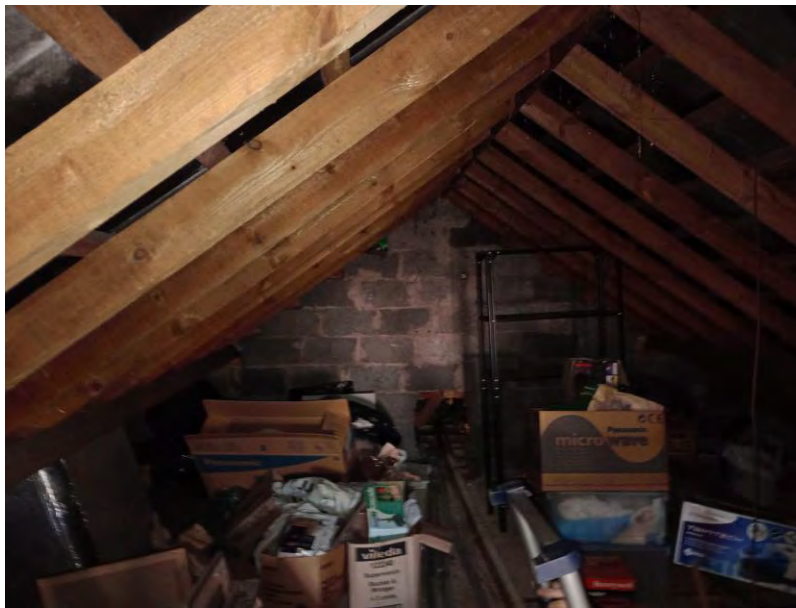
**Figure 3:** Void over the original building with hole leading to second void.

- 4.7 Two voids are present across the building, one over the original section of building and one over the more recent extension. The two sections of void are joined by a small hole through the breezeblock wall allowing access to both voids from the main void.
- 4.8 The void over the original section of building is approximately 2.5 metres high and extends over the entire building and is approximately 8 metres in width and length (**Figure 3**). The roof is unlined with wooden ridge beams. A small window is present on the northern elevation which allows light into the void. Dust was evident in the void from the recent repair works to the ridge. This section of void is boarded.

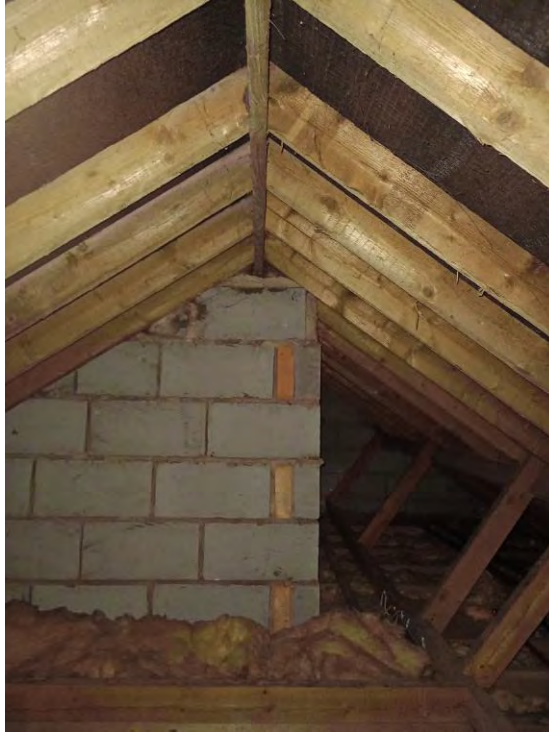
**Figure 4:** Void over the extension

- 4.9 The second void is slightly lower and 1.5 metres in height and 'L-shaped' where the southern end of the building comprises a half pitch (**Figure 4**). This void is approximately 8 metres long at its longest point and six metres wide.

- 4.10 The second void is lined with bitumen style roofing felt and has wooden beams and ridge. The void is unboarded with insulation material present across the void. The roof lining is in good condition and there were no gaps or visible light in the void.
- 4.11 No signs of bats, including droppings, feeding remains, urine stains, or bats themselves, were observed within the interior, or around the exterior of the building. There were no suitable access points identified on the building which is in good condition.
