354 Barkham Road  
Barkham  
Wokingham  
RG41 4DE

# Preliminary Roost Assessment

Report ref.: R2890\_PRA\_a

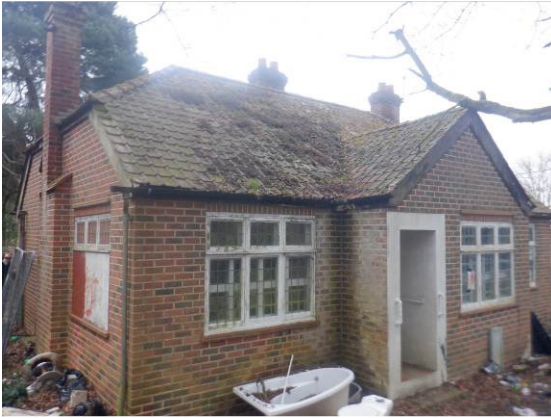
**5.2.2** The property was an empty bungalow with brick walls and a half-hipped roof (**Photographs 1 & 2**).

Photograph 1. Front of property viewed from north.

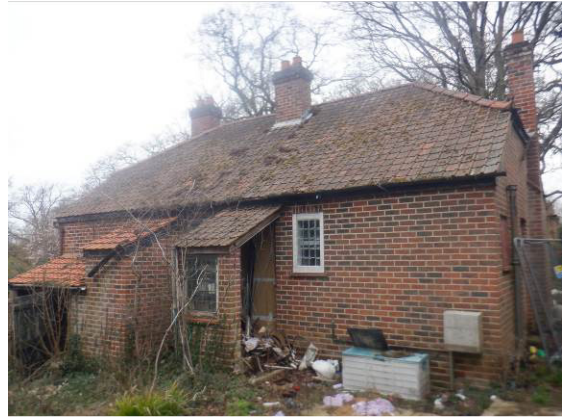
Photograph 2. Rear of property viewed from south.

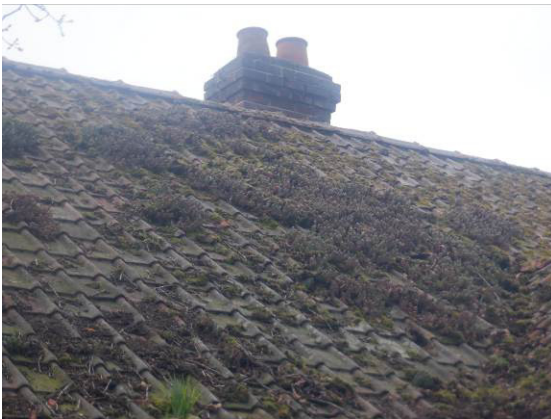
- 5.2.3** The roof was covered in interlocking clay tiles that were tightly fitted and intact, with substantial patches of moss and sedum (**Photograph 3**). Mortar beneath the ridge and hip tiles was recessed and had crumbled away in places, potentially enough to provide a few opportunistic roosting opportunities for small crevice-dwelling bats (**Photograph 4; Target note 1**).

Photograph 3. Interlocking clay tiles (front elevation).

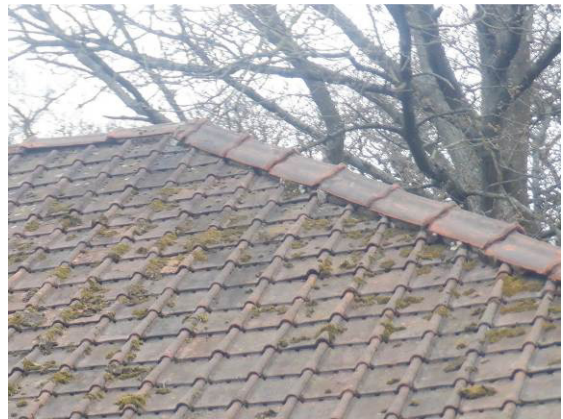
Photograph 4. Crumbling ridge and hip mortar (rear elevation).

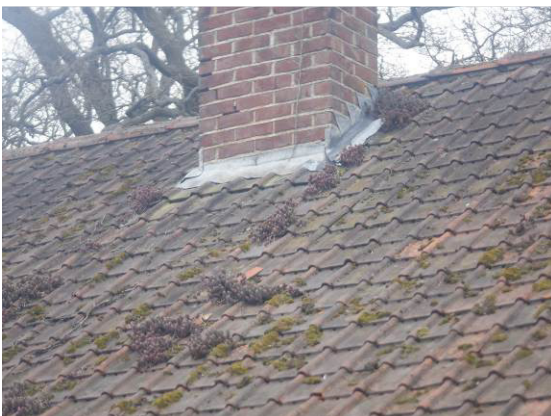
- 5.2.4** The lead flashing fitted around all three chimneys was flush against roof tiles (**Photographs 5 & 6**).

Photograph 5. Lead flashing flush around chimney (rear elevation).

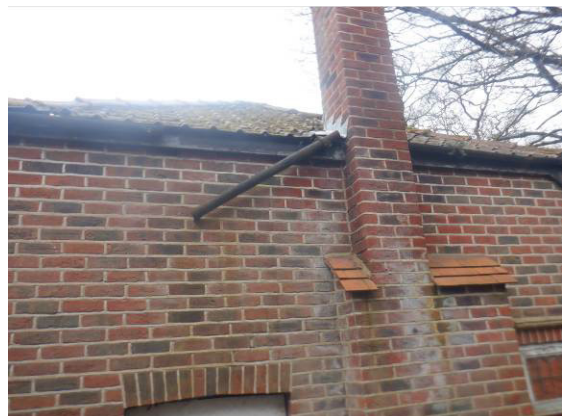
Photograph 6. Lead flashing flush around chimney (northeast elevation).

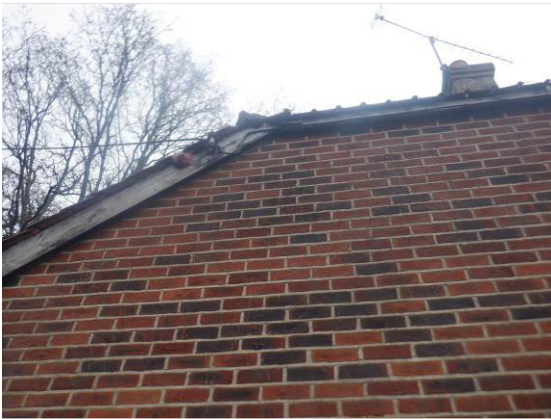
- 5.2.5** Occasional narrow gaps associated with timber barge boards at the half-hipped gables

and on the front gable could potentially offer opportunistic roosting opportunities to small crevice-dwelling bats (**Photographs 7 & 8; Target notes 2 & 3**).

*Photograph 7. Barge boards at half-hipped gables (southwest elevation).*

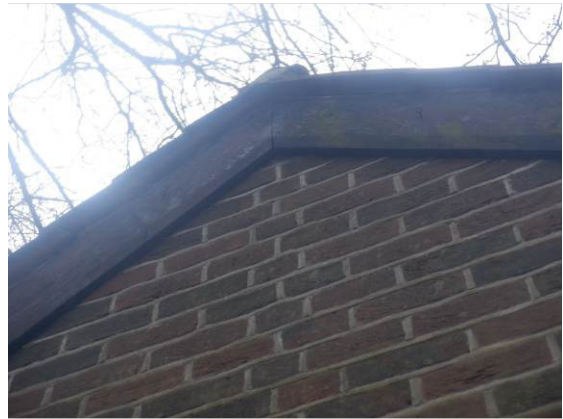
*Photograph 8. Barge boards at front gable (front elevation).*

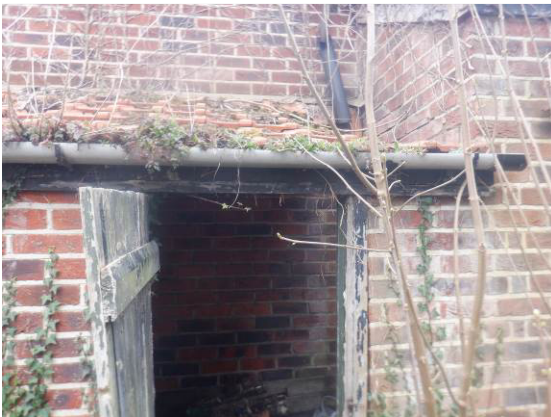
- 5.2.6** Brick sheds on the rear side of the bungalow and a dilapidated garage had collapsing roofs (**Photographs 9 & 10**).

*Photograph 9. Brick sheds (rear elevation).*

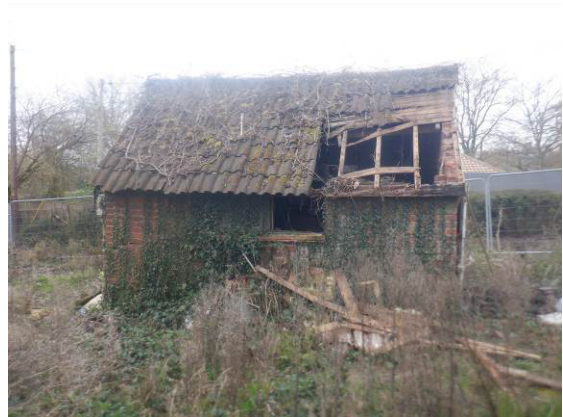
*Photograph 10. Dilapidated garage viewed from (east elevation).*

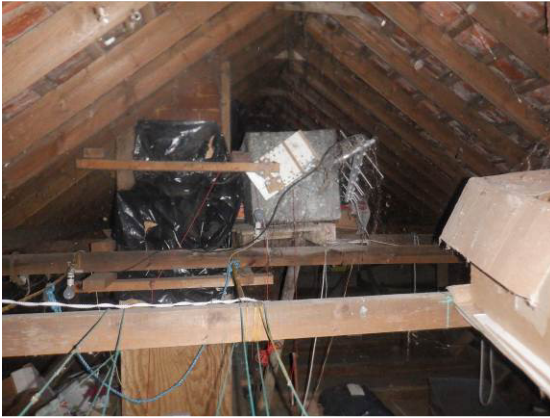
- 5.2.8** The roof void of the bungalow was accessible via a loft hatch. The void was over 2 metres in height and of 'cut and pitch' roof construction (**Photograph 11**). The roof was unlined and the space was heavily cobwebbed throughout, indicating an absence of void-dwelling bat activity (**Photograph 12**).

Photograph 11. Bungalow roof void.

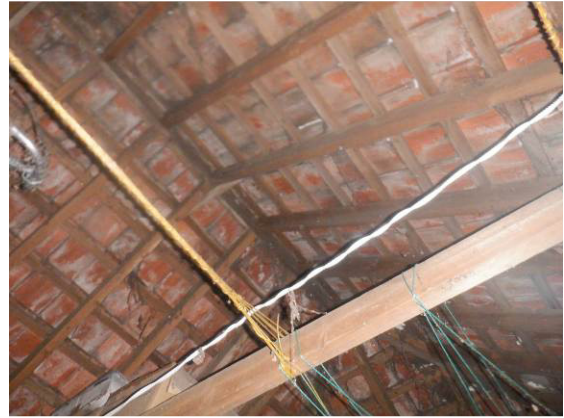
Photograph 12. Unlined roof (roof void).

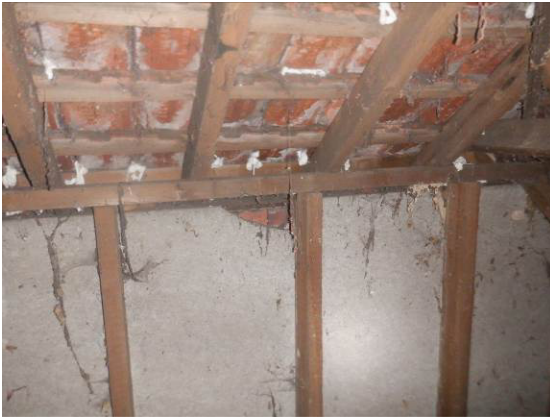
- 5.2.9** The half-hipped gables were boarded with asbestos and partially sealed with spray foam insulation (**Photograph 13**). There was no floor insulation and daylight was visible at the eaves (**Photograph 14**).

Photograph 13. Asbestos and spray foam at half-hipped gable (roof void).

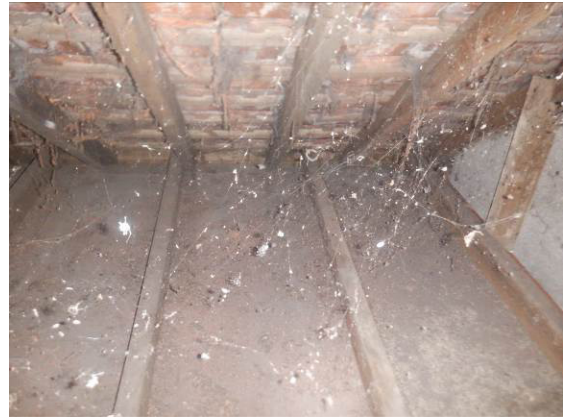
Photograph 14. No floor insulation (roof void).

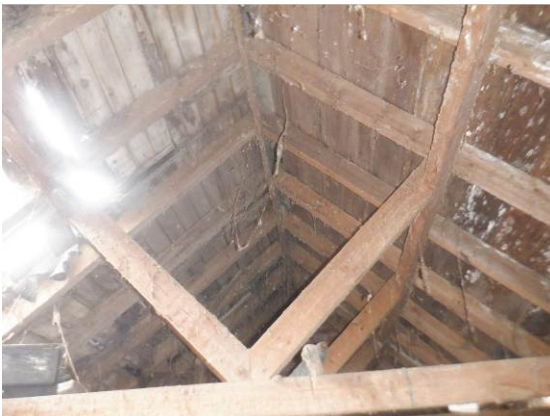
- 5.2.10** The garage interior was open to the roof, which was of 'cut and pitch' construction with crossbeams and timber sarking (**Photograph 15**).

Photograph 15. Garage interior.
