## **OMNIA GEOPHYSICAL SITE INVESTIGATION REPORT**

**Phase II  
Geo-Environmental Site Assessment**

**Land south of Nine Mile Ride, Finchampstead, Reading, RG40 3QD**

***Omnia ref: A12057/1.0***

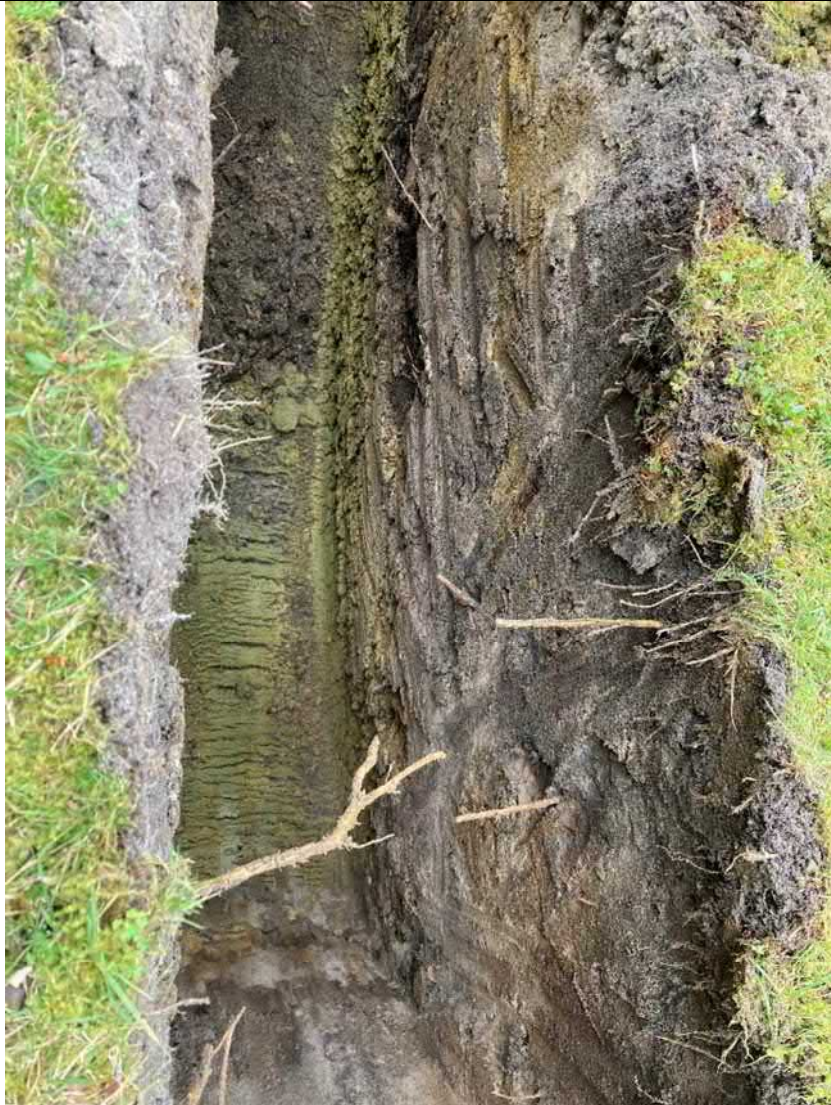
Photograph 4 – SA102 Trial pit, Windlesham Formation at the base.

For SA101, the required 25% effective storage depth intercept was not reached, and as such the test was considered to be unsuccessful and a soil infiltration rate could not be calculated.

For SA102, due to the proximity of the test reaching its 25% effective storage depth, the data was extrapolated using a line of best fit for the linear part of the graph to provide an indicative soil infiltration rate. Extrapolation indicates that the 25% depth intercept would have been reached within 8095 minutes (134 hours, 55minutes). The indicative soil infiltration rate calculated was  $2.54 \times 10^{-7}$  m/s.

By reference to published data (Carter and Bentley, 1981), the above results indicate low permeability with poor drainage conditions. Therefore, it is considered unlikely that soils in the vicinity of Locations SA101 and SA102 will prove suitable for traditional soakaway drainage without specialised design.

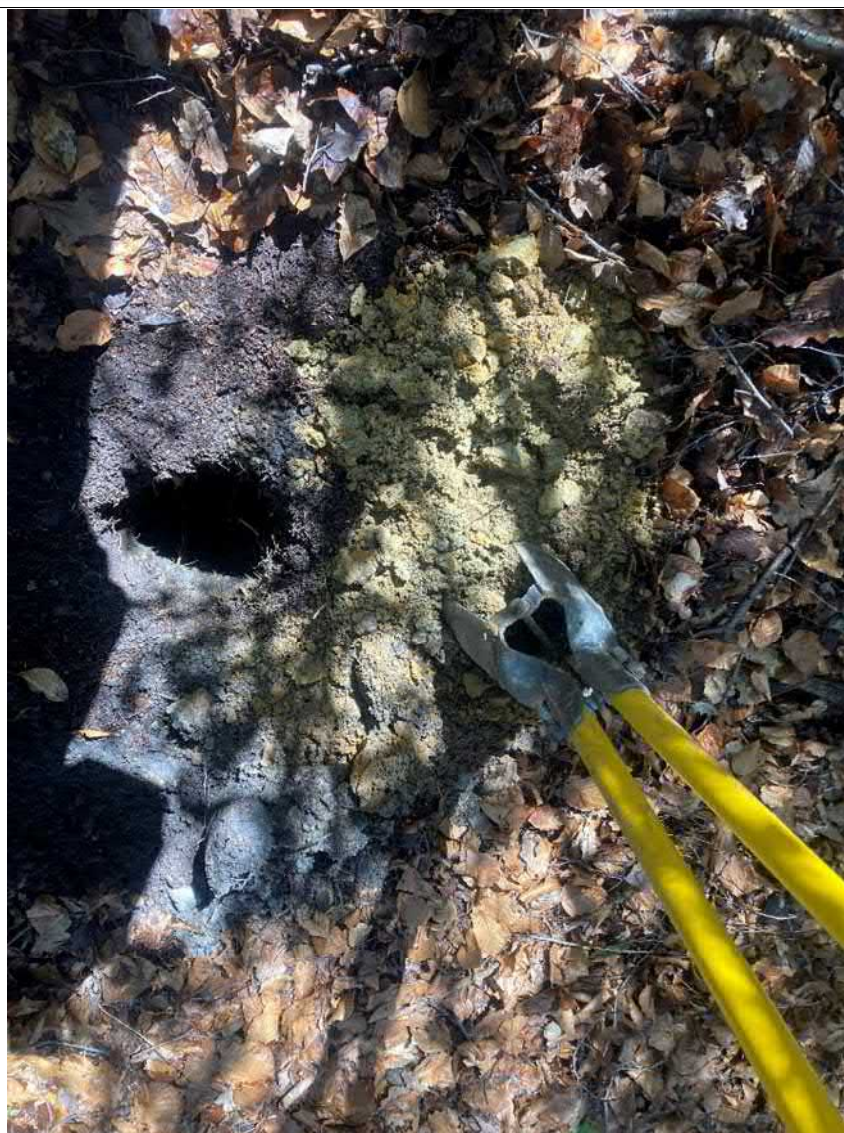
Photograph 5 – HP109 recovery, Topsoil left of hole and Camberley Sand Formation to the right of the Hand pit.
