# Arborfield Trunk Main – Ecological Note

<b>Site Name</b>	Arborfield Trunk Main
<b>Site Location (central grid reference)</b>	Central Grid Reference: Northeast road end SU 78354 68069 Southwest road end SU 76878 66436
<b>Date of Desk Study</b>	21 <sup>st</sup> January 2025,
<b>Date of Field Surveys</b>	7 <sup>th</sup> and 8 <sup>th</sup> January 2025
<b>Proposed Works</b>	<p>It is understood that Thames Water Utilities intend to install into service a new 355mm OD PE100 SDR17 pipe including associated hydrants, valves, chambers and structures to:</p> <ul style="list-style-type: none"><li>• Replace 1855m of the existing 9" trunk main along Bearwood Road and Barkham Road;</li><li>• Replace 230m of the existing 3" distribution main along Langley Common Road;</li><li>• Provide a new 395m section of trunk main along Langley Common Road.</li><li>• Create 10 connections from the new pipeline to the existing network</li><li>• Create eight new fire hydrants.</li></ul> <p>These are collectively hereafter referred to as the 'Proposed Works'</p> <p>AECOM understands that the Proposed Works will be confined to the highway with an open cut method of construction anticipated.</p> <p>The Propose

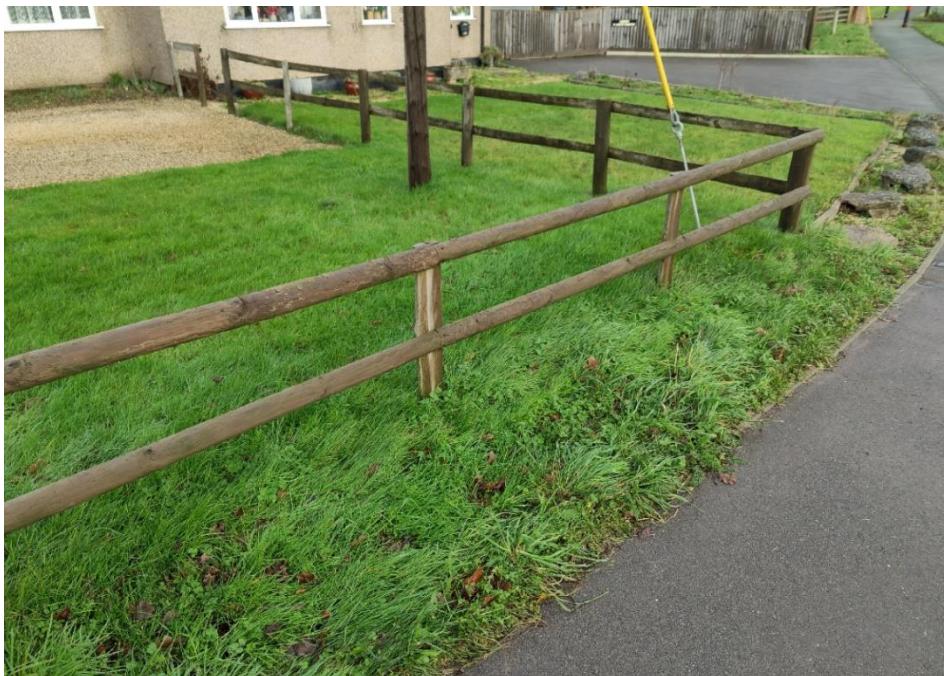
**Plate 5. Mown grassland gardens**

Ecological Features	Potential Ecological Constraints	Mitigation	Timing
g4, 32, 106 - Modified grassland (Scattered trees, Mown)	Some of the residential buildings within the Survey area had mown grassland gardens instead of hardstanding driveways (Plate 5).	.	
g3c, 81 - Other neutral grassland (Ruderal or ephemeral)	There were two areas of mown grassland used for recreation, located at SU 77556 66904 and SU 78111 67059 to the north of Barkham Road. These also supported scattered trees further away from the road, just beyond the Survey Area (Plate 6). Species within these areas consisted of; oak ( <i>Quercus robur</i> ), ash ( <i>Fraxinus excelsior</i> ), blackthorn ( <i>Prunus spinosa</i> ), holly ( <i>Ilex aquifolium</i> ) as well as perennial ryegrass, white clover, yarrow, ribwort plantain, bramble, spear thistle and common nettle.		
g1c - Bracken	There was one area of grassland towards the centre of the Survey Area at SU 78167 67094 that had not had recent or frequent management and as such, taller swards and ruderal species were present (Plate 7). Species within this area included cocksfoot ( <i>Dactylis glomerata</i> ), common thistle ( <i>Cirsium vulgare</i> ), common dock ( <i>Rumex obtusifolius</i> ), annual meadow grass ( <i>Poa annua</i> ), white clover, bramble, perennial ryegrass, yarrow and common nettle.

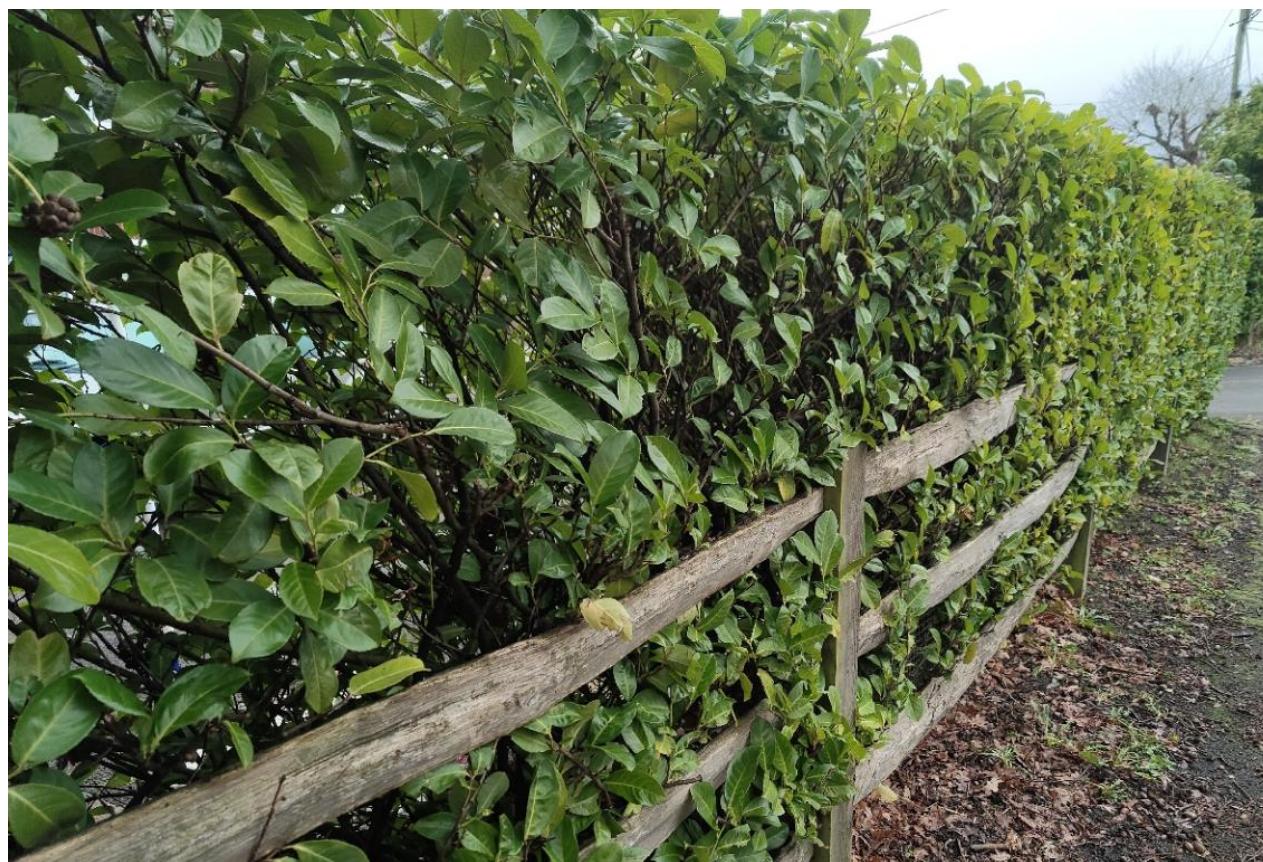
Plate 12. Non-native cherry laurel hedgerow

There were 20 non-native ornamental hedgerows that formed residential garden or driveway borders, with many of them being located along the more urban Bearwood Road (Plate 12). The majority of these hedgerows comprised cherry laurel ( <i>Prunus laurocerasus</i> ) with some containing species such as Lawson cypress ( <i>Chamaecyparis lawsoniana</i> ), rhododendron ( <i>Rhododendron spp.</i> ) (TN4), and other ornamental species. No other ornamental species were invasive non-native species.	If this changes, it is recommended that an invasive species mitigation plan is put in place to allow for removal of invasive species without spreading to other areas. If more signs of invasive non-native species are discovered during the works, an ecologist should be contacted for advice.	
Woodland		Broadleaved woodland is a priority habitat and no woodland or individual trees are scheduled to be lost within the Proposed Works. Many woodlands have a natural hedgerow or fencing buffer already in place between the woodland and the road itself.	Prior to works

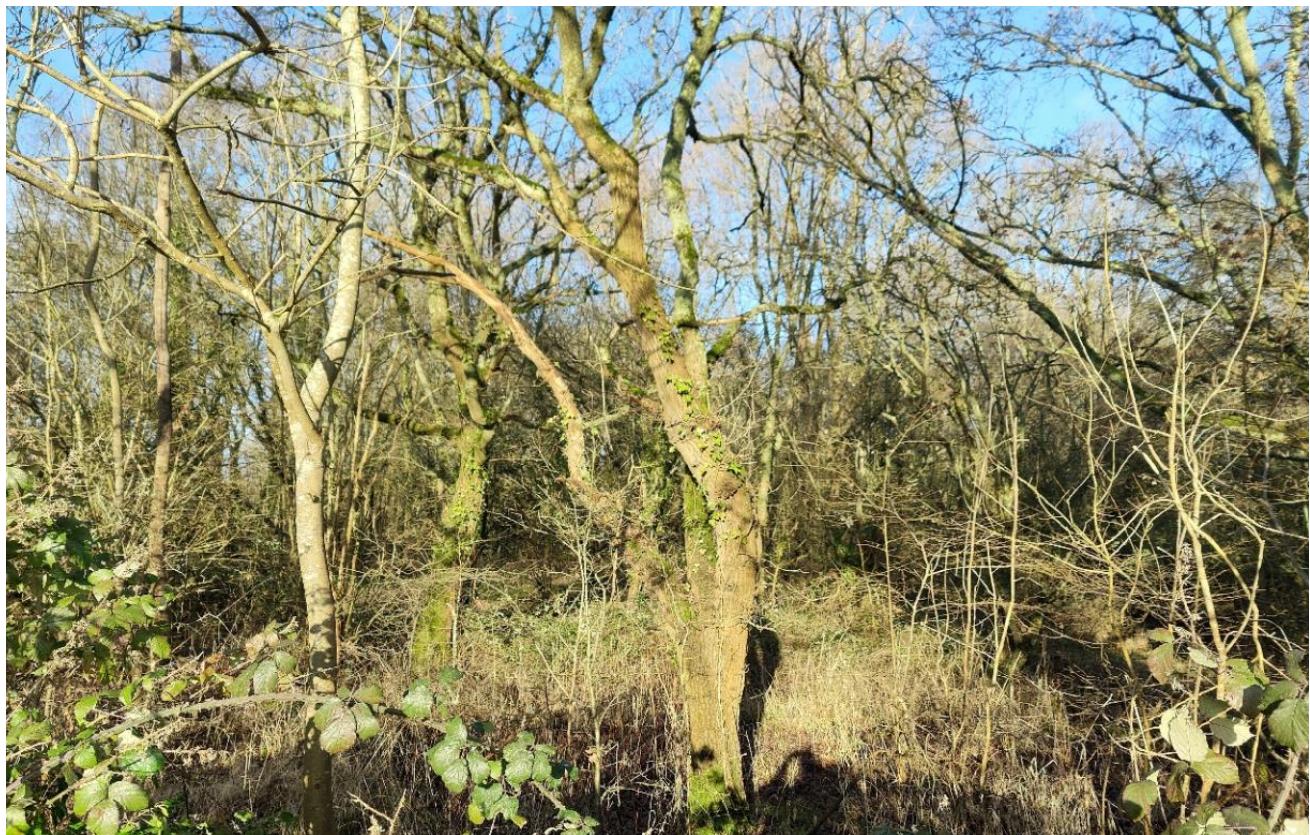
**Plate 13. Mixed deciduous woodland block in centre of Survey area**

w1f7 – Other lowland mixed deciduous woodland	There were eight areas of mixed deciduous woodland within the Survey Area (Plate 13). Many of these were blocks of a similar composition containing species such as oak, ash, hawthorn, blackthorn, holly, bramble, common nettle, ground ivy ( <i>Glechoma hederacea</i> ), silver birch ( <i>Betula pendula</i> ), beech ( <i>Fagus sylvatica</i> ), gorse ( <i>Ulex europaeus</i> ) and willow ( <i>Salix spp.</i> )	Pollution impacts on retained habitats will be avoided through use of standard construction measures in the CEMP, outlined above. There must be no lighting of trees or woodlands.	During work including CEMP
	There were also a total of 50 large individual trees located along the length of the Site (Plate 14). The majority of these trees were large mature oak trees, but other species included Scots pine ( <i>Pinus sylvestris</i> ) particularly in the	Currently no areas of woodland, lines of trees or individual trees are due to be removed during the Proposed Works

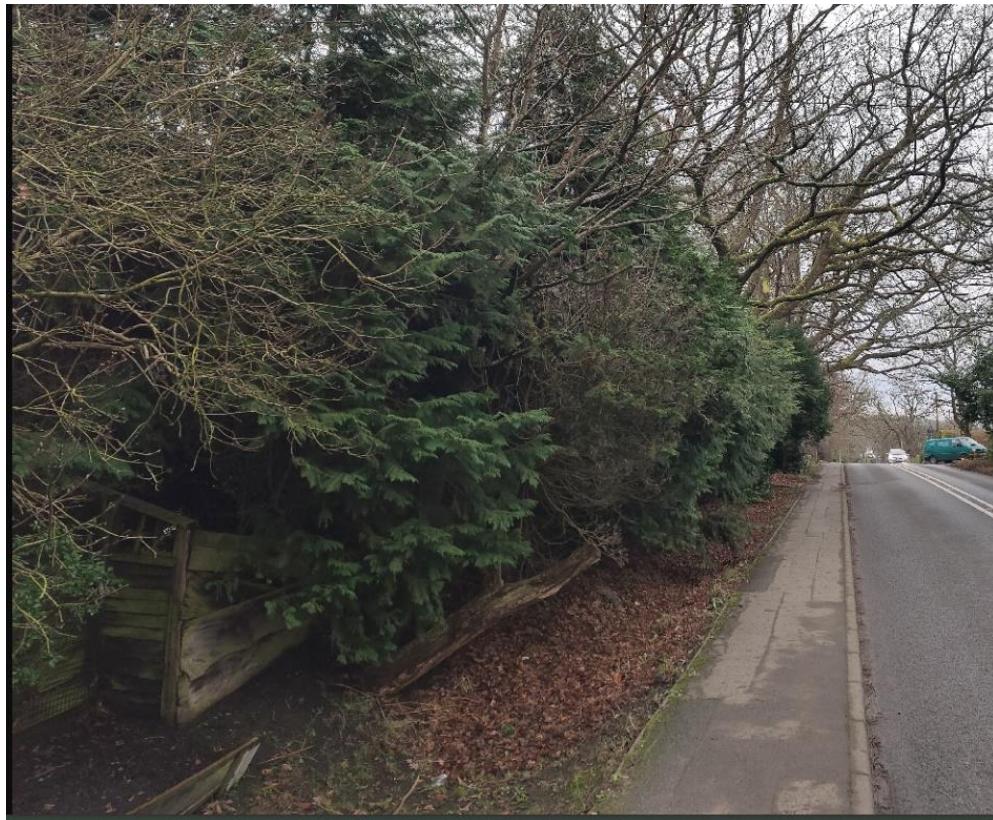
**Plate 15. Example of line of trees**

Ecological Features	Potential Ecological Constraints	Mitigation	Timing
w1h, 33 - Other woodland mixed (Line of trees)	<p>northern end of the Site, hornbeam (<i>Carpinus betulus</i>) and ash were present.</p> <p>Running parallel to the roads were some instances of lines of trees (Plate 15). The majority of these were lines of Lawson cypress with some comprising native species such as oak, ash, blackthorn and hawthorn.</p>	<p>If changes to the works areas mean works would impact woodland within the Survey Area, additional consultation with an ecologist is required.</p>	
Rivers and Lakes  r1g, 40 – Other standing water (Priority habitat)	<p>Pond 1 (TN1) was a small 240m<sup>2</sup> pond located at SU 76909 66446 8m to the far southwest of the Site (Plate 16). The pond is located within a woodland positioned adjacent to the hardstanding pavement and road. The previous Mott MacDonald report from 2021 recorded this pond as having a Habitat Suitability Index (HSI) of 0.38 - poor quality</p>	<p>Due to the lack of habitat removal, it is unlikely that Pond 1 or Pond 2 would be directly ecologically affected.</p>	N/A

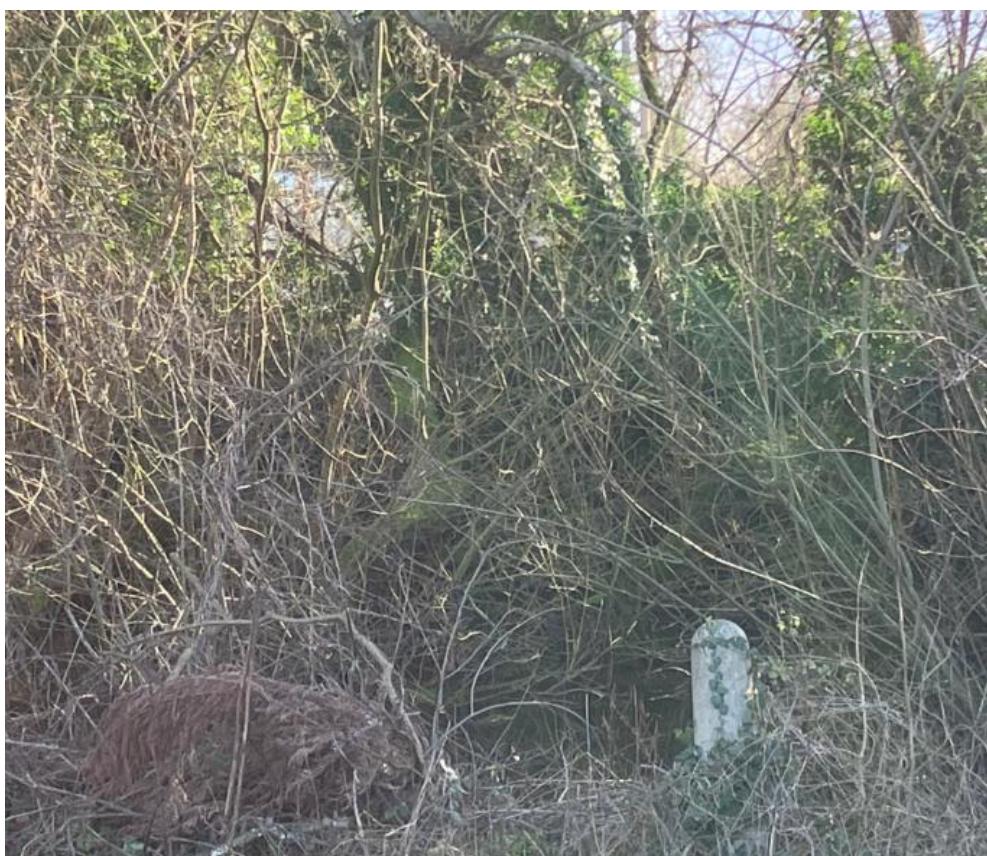
**Plate 16. Pond 1 within woodland**

Great crested newts ( <i>Triturus cristatus</i> ) and amphibians	<p>There were two suitable water bodies within the Survey Area being Pond 1, 8m from the Site, and Pond 2 9m from the Site. Pond 2 was inaccessible for a Habitat Suitability Index (HSI) assessment; however, Pond 1 was assessed to have a score HSI score of 0.65 Average.</p> <p>Within 250m of the Proposed Works were an additional two ponds located at SU 78019 67230 and SU 77267 66794. These ponds are likely suitable for great crested newts; however, these ponds have not been surveyed due to having no access as well as having limited connectivity with the Site.</p>	<p>Due to the lack of suitable aquatic or terrestrial habitats being removed or disturbed, with the Proposed Works limited to within the hardstanding highway, great crested newts and other common amphibian species are considered unlikely to be killed or disturbed by the Proposed Works.</p> <p>With more suitable terrestrial habitat of woodland and scrub being situated further south in the opposite direction of the Proposed Works, it is more likely that these areas are used by great crested newts and other amphibians, decreasing the likelihood of these species being present within the Proposed Works areas.</p>	N/A

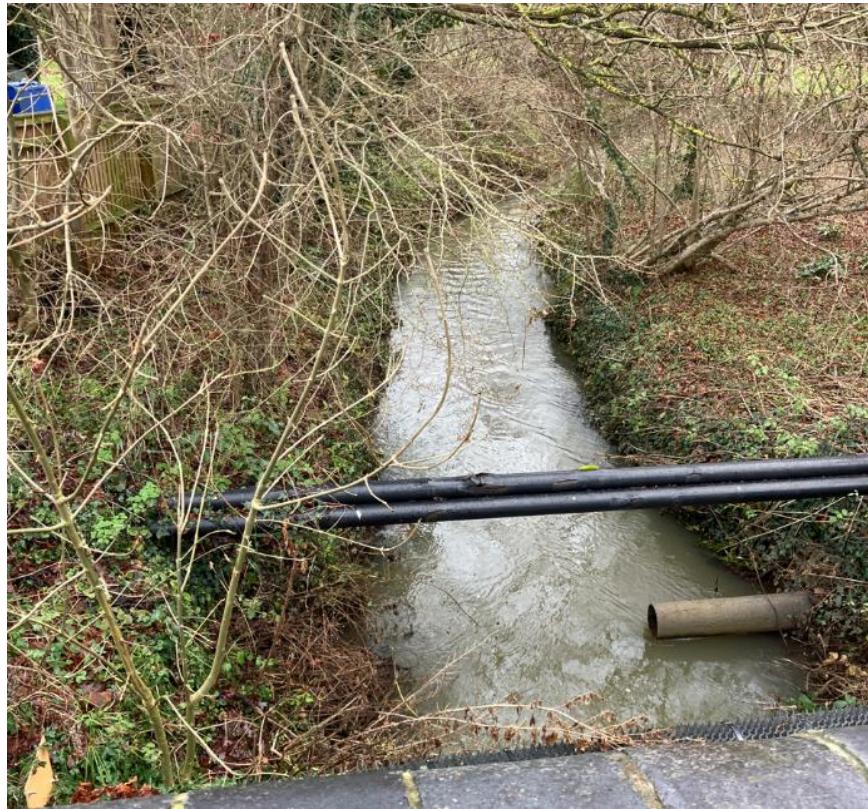
**Plate 17. River 1 outside of Survey Area**

R2a – Rivers (Priority habitat)	<p>Pond 2 (TN3) was a small 77m<sup>2</sup> garden pond located at SU 78110 67021 9m south of the Site in the centre of the Survey Area. This pond had no access as it was located within a private garden behind a hedgerow.</p> <p>Although the river Loddon (TN2) located at SU 77672 66928 is outside of the 30m boundary for both the southwest section and the northeast section of works, there remains a low potential for pollution events to impact the river (Plate 17).</p>	<p>Pond 1 and Pond 2 are priority habitat and are not scheduled to be within the Proposed Works area. If changes to the works areas mean works would impact Pond 1 or Pond 2, additional consultation with an ecologist is required.</p> <p>Pollution impacts on the ponds and river will be avoided through use of standard construction measures in the CEMP, outlined above.</p> <p>With the lack of habitat removal, the implementation of the CEMP above, and with no works within 40m of the river Loddon, there are set to be no ecological impacts to the river.</p>

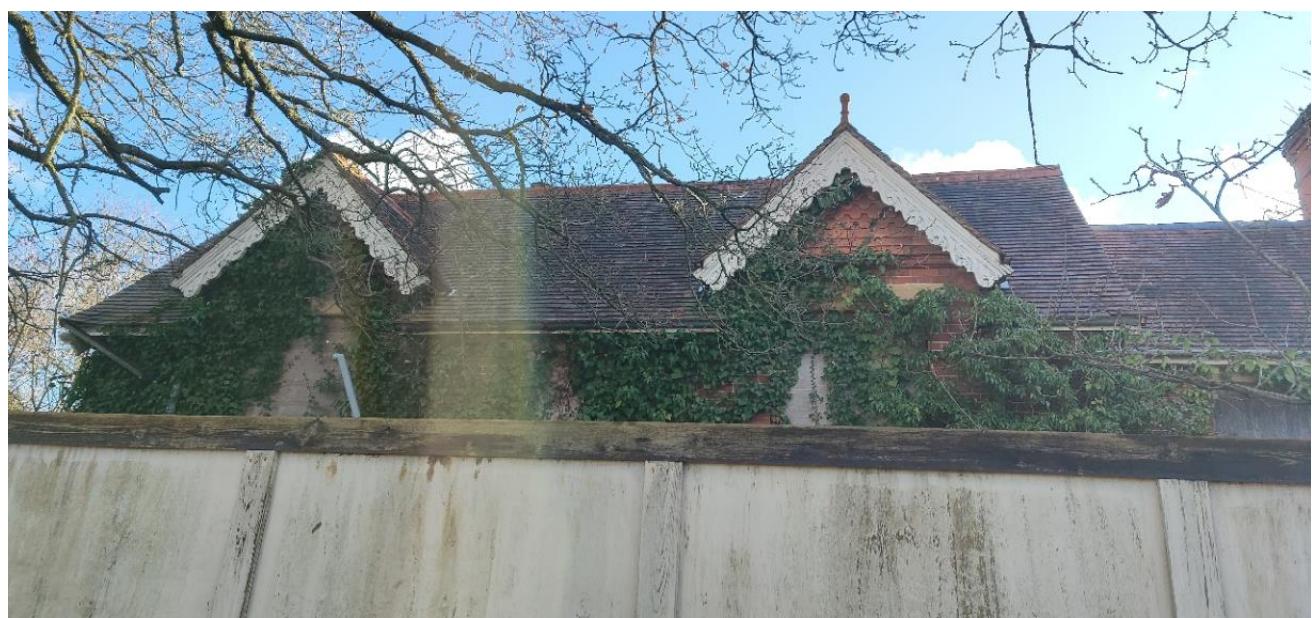
**Plate 18. Building 1 in the far southwest of the Survey Area**

Bats	<p>Both suitable buildings and trees were recorded within 10m of the Proposed Works. Both trees and buildings within the survey area were not fully surveyed for roosting bats but any potential roost features identified from accessible areas are included below.</p> <p>Building 1 was a derelict house located 8m from Site at the southwestern end of the Site at SU 76943 66470. This building had multiple entryways into the building with only boarded up windows and open holes in the brickwork making this building have potential for roosting bats (Plate 18).</p>	<p>Clearance of vegetation or works on buildings suitable for roosting bats is not anticipated to facilitate the Proposed Works. If works to or removal of trees and buildings is required, additional consultation with an ecologist must be completed.</p> <p>Implementation of measures within the CEMP outlined above for designated sites will reduce the risk of noise disturbance to roosting bats. In addition, all buildings and trees with bat roost suitability within 10m of the Proposed Works are also within 10m of either Barkham Road or Bearwood Road, both busy roads used by large vehicles in urban environments. Therefore, the temporary Proposed Works would not likely significantly increase the disturbance levels generally seen in these locations.</p> <p>However, it is recommended that where possible works within 10m of trees with bat roost suitability are conducted during the</p>	<p>Works should be programmed to avoid working at night. If this cannot be avoided, mitigation is required.</p> <p>No tree removal or building work is required. If this changes additional mitigation is required.</p> <p>Recommended that where possible works</p>

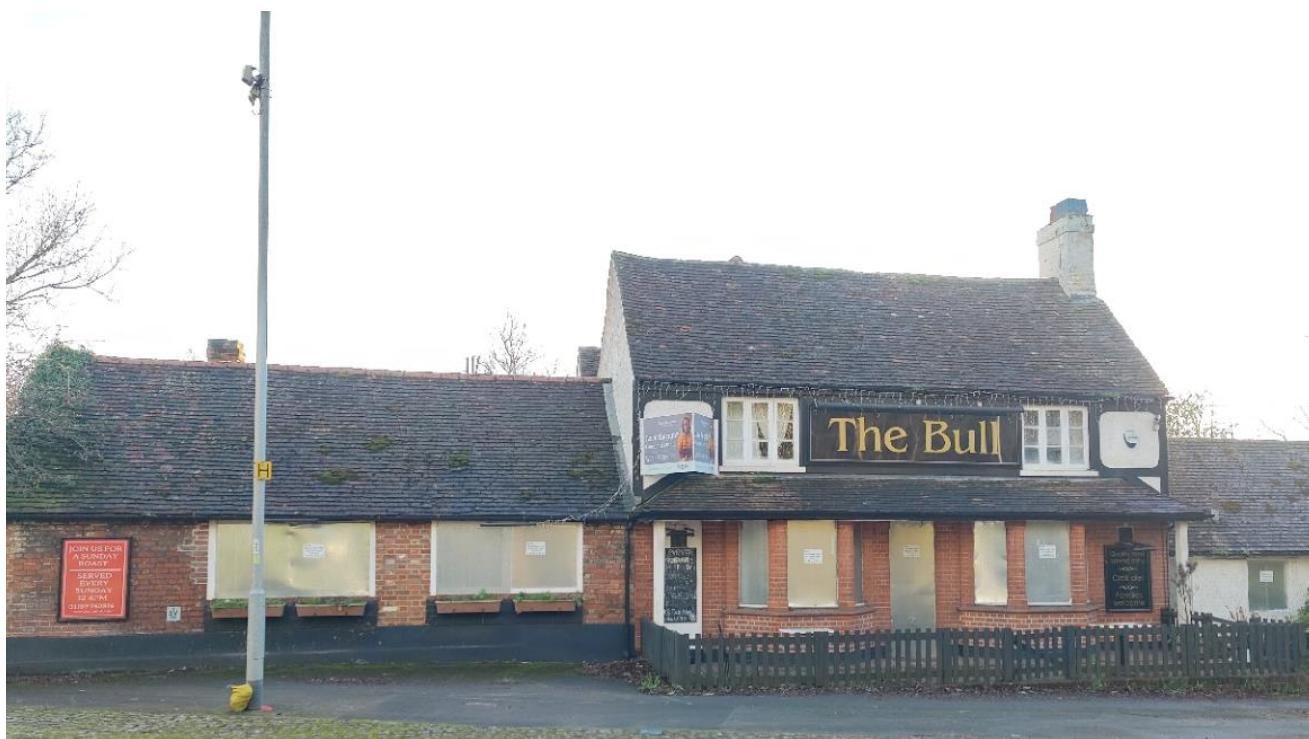
**Plate 19. Building 2 in the southern centre of the Survey area**

Ecological Features	Potential Ecological Constraints	Mitigation	Timing
	<p>Building 2 was a pub that was not in use located 7m from Site towards the centre of the Site at SU 77965 66925, and had similar features of the derelict house of Building 1, with broken boarded windows and missing and gaps in the roofing tiles resulting in a potential for roosting bats (Plate 19).</p> <p>No trees are to be removed within 10m of the proposed Site works; however, trees within 10m of the Site support features suitable for roosting bats.</p> <p>The roads within the Proposed Works in combination with adjacent hedgerows and trees form a linear feature which may be suitable for foraging and commuting bats.</p> <p>The desk study returned records of twelve species of bat within 1km of the Proposed Works; brown long-eared bat (<i>Plecotus auritus</i>), common pipistrelle (<i>Pipistrellus pipistrellus</i>), Daubenton's bat (<i>Myotis daubentonii</i>), Leisler's bat (<i>Nyctalus leisleri</i>), <i>Myotis</i> bat species (<i>Myotis</i> sp.), Nathusius' pipistrelle (<i>Pipistrellus nathusii</i>), Natterer's bat (<i>Myotis nattereri</i>), noctule (<i>Nyctalus noctula</i>), serotine (<i>Eptesicus setotinus</i>), soprano pipistrelle (<i>Pipistrellus pygmaeus</i>), barbastelle (<i>Barbastella barbastellus</i>) and Whiskered bat (<i>Myotis mystacinus</i>).</p> <p>The closest of these records were common pipistrelle, noctule and soprano pipistrelle all recorded approximately 0.01km east from the Proposed Works in 2022.</p>	<p>time of year bats are less likely to be present. Based on the features present, where possible works should be conducted during the period late October to March inclusive.</p> <p>To avoid disturbance of, foraging and commuting bats, all works should be conducted during the day where possible, to avoid the requirement for construction lighting. Where this is not possible, lighting should be designed with ecological input to ensure a sensitive lighting design with regards to bats and must avoid light spill into the adjacent woodlands.</p>	<p>should be conducted during the period late October to March inclusive.</p>
