## Preliminary Roost Assessment

4 Westview Drive,  
Twyford,  
RG10 9BP

**Site Name:** 4 Westview Drive  
**Site Location:** 4 Westview Drive, Twyford, RG10 9BP  
**Reference Number:** Eco26-37  
**Report Version:** 002  
**Status:** Final

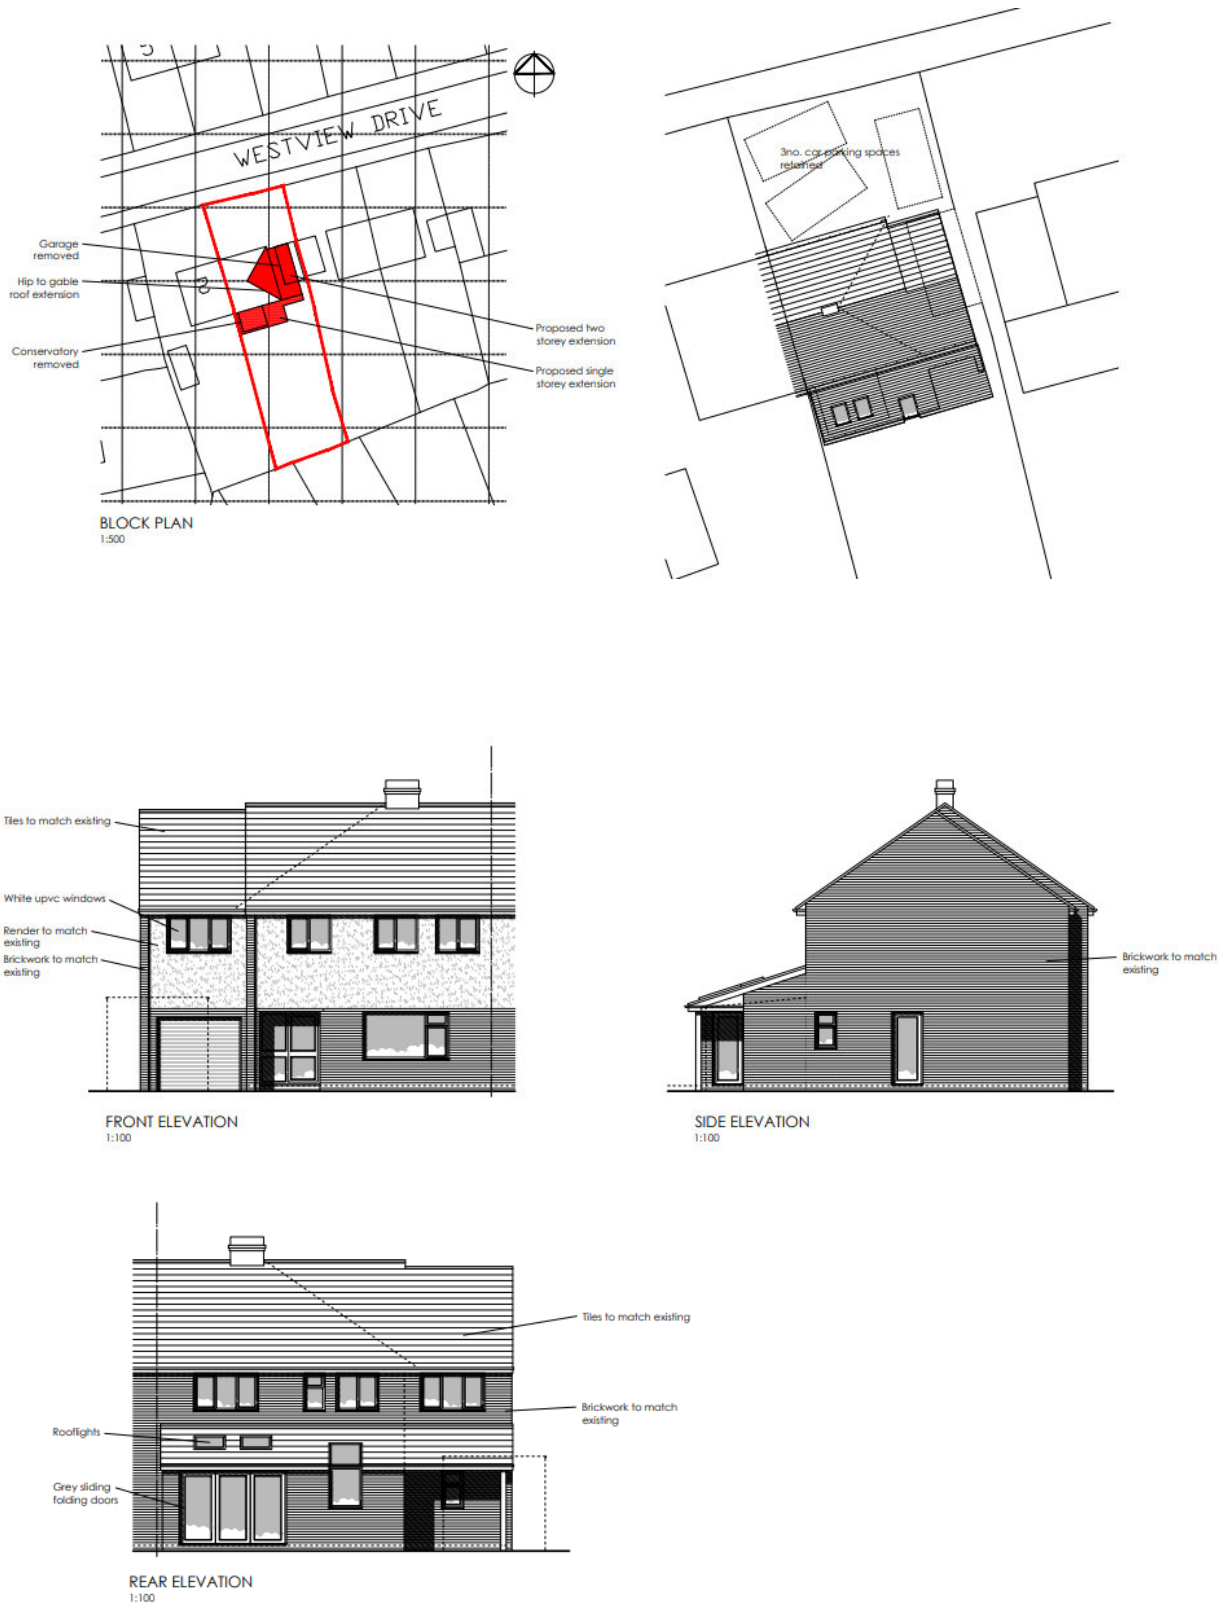
### 6.1 Site Plans

The proposed works comprise a two-storey side and single-storey rear extension, facilitated by the removal of B2.
