# ROAVR | GROUP

**Project:** 25\_PRA\_06\_69  
**Site:** L'ortolan, Church Lane, Shinfield, Reading, RG2 9BY  
**Client:** [REDACTED] Hussain

| Report Type: | Preliminary Roost Assessment Report [PRA]<br>Daytime Bat Walkover (DBW) |

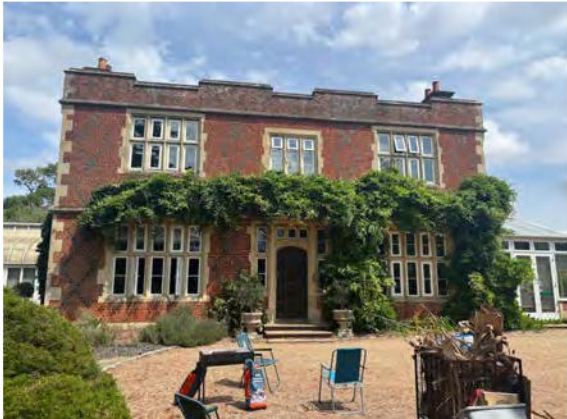
| Detail | Photograph |
|---|---|
| <p><i>Plate 1 - Front elevation of B1.</i></p> | |

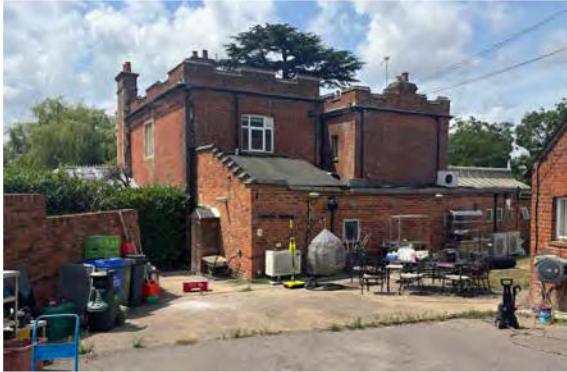
| Detail | Photograph |
|---|---|
| <p><i>Plate 2 - Rear elevation of B1.</i></p> | |

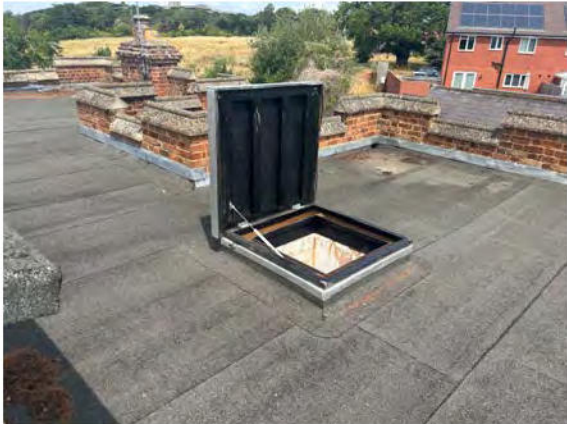
| Detail | Photograph |
|---|---|
| <p><i>Plate 3 - Entrance onto flat roof of B1.</i></p> | |

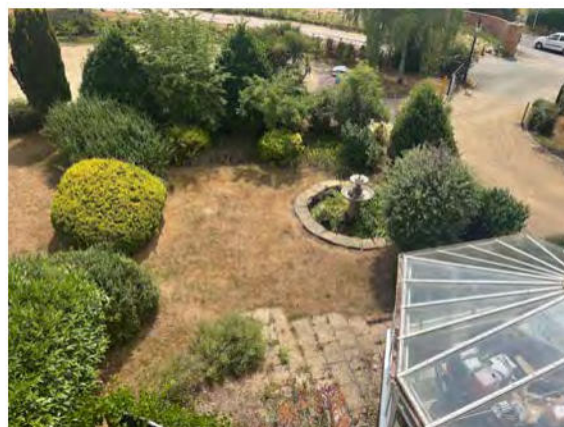
*Plate 4 - View from B1 roof showing front garden and small oriental pond (TN1).*

TN1: Located to the south of Building B1 within the vegetated garden, this small ornamental pond is heavily shaded and overgrown with marginal vegetation. The waterbody contains minimal open water and appears subject to seasonal drying. The pond has steep, hard edges that limit accessibility for amphibians and lacks surrounding wetland habitat or gradual shelving, both important for breeding suitability. Based on current condition and structural features, the pond is assessed as having negligible suitability for amphibians.

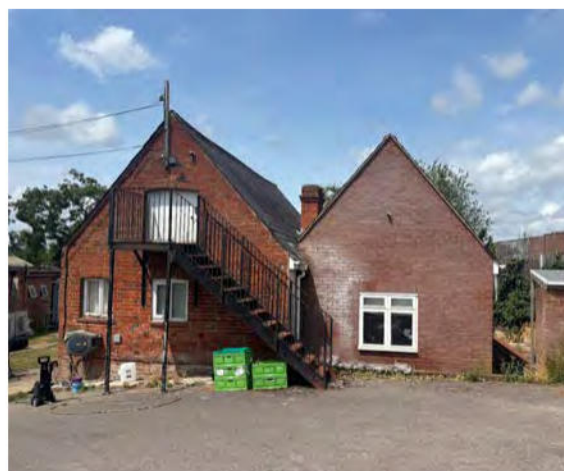
The northern elevation of Building B2 is constructed from red brick and contains traditional slate roof tiles forming part of a pitched roof design. The ridge line and roof covering showed signs of weathering, and there are sections where slates appear lifted or slipped, particularly near the eaves, creating small voids that may offer potential access points for roosting bats. Missing cladding beneath the eaves was also noted, further enhancing the suitability of this elevation for crevice-dwelling bat species. Given the proximity of surrounding vegetated gardens and mature trees, this elevation presents moderate bat roost potential with a viable ecological pathway for commuting and foraging bats.

The roof of B2 consists of two traditional pitched roofs clad in slate tiles with a central ridge. The surface shows typical ageing, with slipped and lifted tiles observed, creating several areas with potential for crevice-roosting bats. The presence of missing cladding around the eaves and possible gaps at the ridge line further increases the likelihood of bat access. In combination with its proximity to mature trees, linear vegetative features, and limited disturbance levels, the roof of B2 has moderate suitability for roosting bats.

*Plate 5 - Building B2. This was assessed as having moderate potential for roosting bats.*

- 7.4 It is recommended that two presence/absence surveys be carried out on B2. The surveys should be carried out between May and September (with September considered to be sub-optimal). However, **please refer to paragraph 7.6 for the clients preferred course of mitigation.**

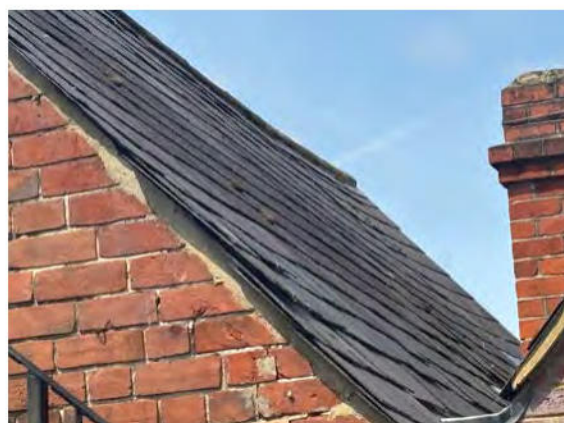
- 5.3 The lifted tiles, missing cladding around the eaves and possible gaps at the ridge line provide roosting potential for crevice dwelling bats species such as common pipistrelle which are known to be present in the local area. Therefore, based on this information and the guidance outlined by the Bat Conservation Trust, building B2 has been assessed as having moderate suitability for roosting bats.

*Plate 6 - PRFs on B2 in the form of lifted and slipped tiles.*

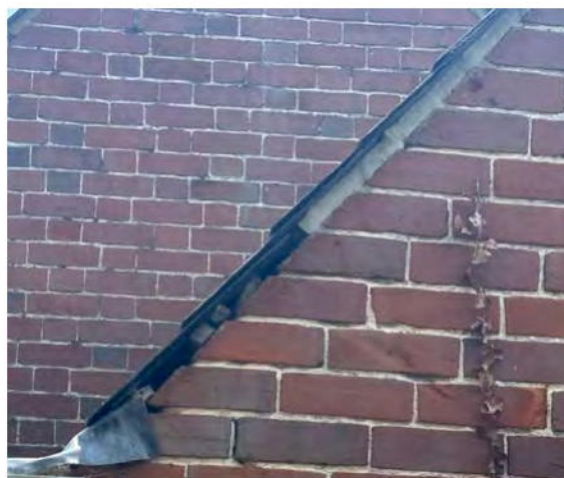
*Plate 7 - PRFs on B2 in the form of gaps under tiles due to missing mortar.*

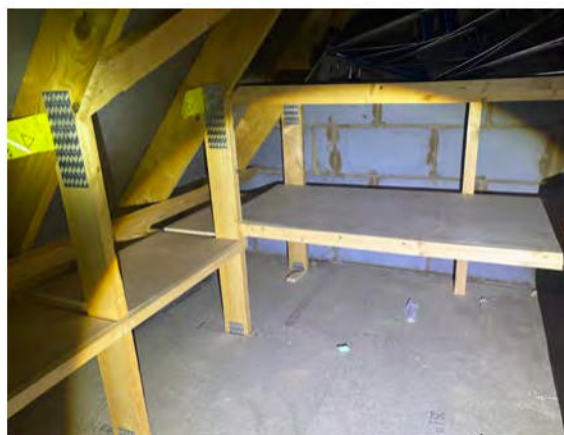
No evidence of bats was identified during the internal inspection. Specifically, no bat droppings, urine staining, feeding remains, or characteristic odours associated with roosting colonies were observed on floors, sills, or beneath potential entry points such as loft hatches, window frames, or rafters. Finishes and furnishings across the interiors do not suggest any history of bat occupation. Given the lack of

*Plate 9 - No evidence of bats was found within the void space.*

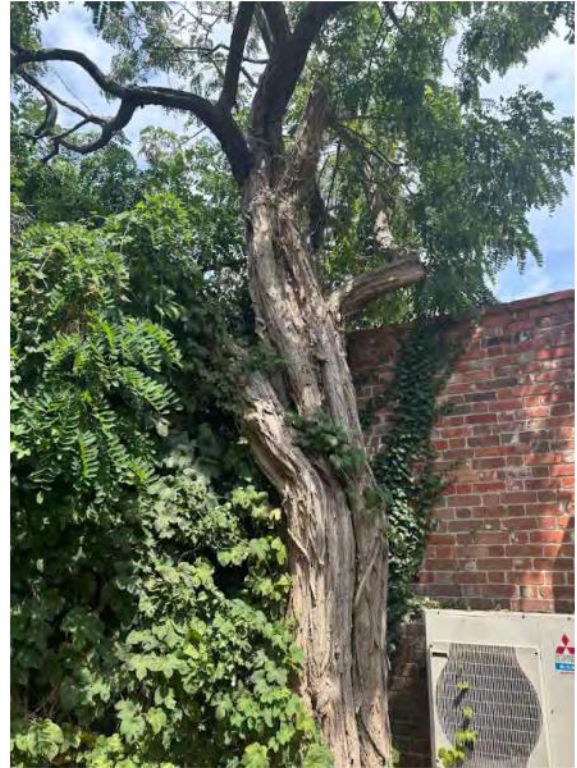
*Plate 10 - Five trees were identified as having PRFs on site.*

The site supports a number of mature and early veteran trees that hold potential roosting features (PRFs) suitable for bats. Five trees within or adjacent to the vegetated garden area were subject to closer assessment due to their structure, age, or visible features consistent with bat use.

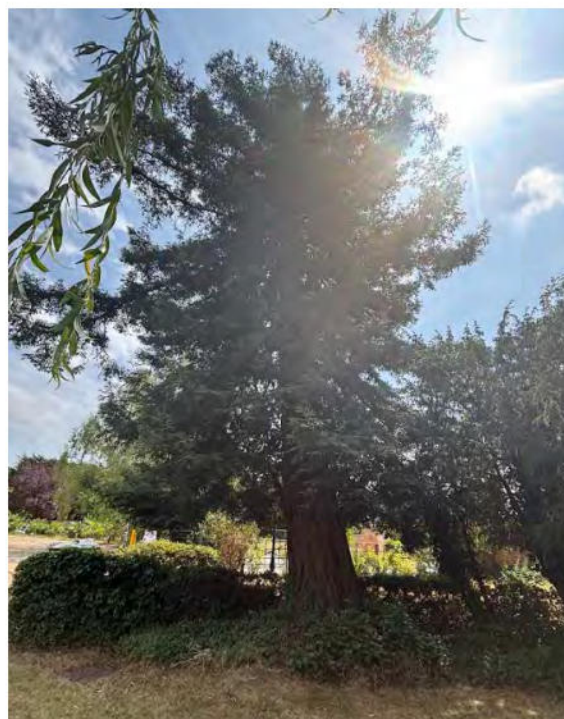
Plate 12 - A very large coast redwood (*Sequoia sempervirens*), is in good condition and supports PRF type I in the form of peeling bark, providing small sheltered crevices which could be used by crevice-dwelling bats.

T1, a very large coast redwood (*Sequoia sempervirens*), is in good condition and supports PRF type I in the form of peeling bark, providing small sheltered crevices which could be used by crevice-dwelling bats. T2, a large weeping willow (*Salix babylonica*), also in good health, has a prominent pruning wound identified as PRF type I. This wound may extend into the sapwood, offering a stable and sheltered opportunity for bats to roost. T3, a very large Cyprus cedar (*Cedrus*
