## Bat Emergence Surveys (BERS)

47 Simons Lane, Wokingham, Berkshire, RG41 3HG

The construction of a two-storey side and rear extension

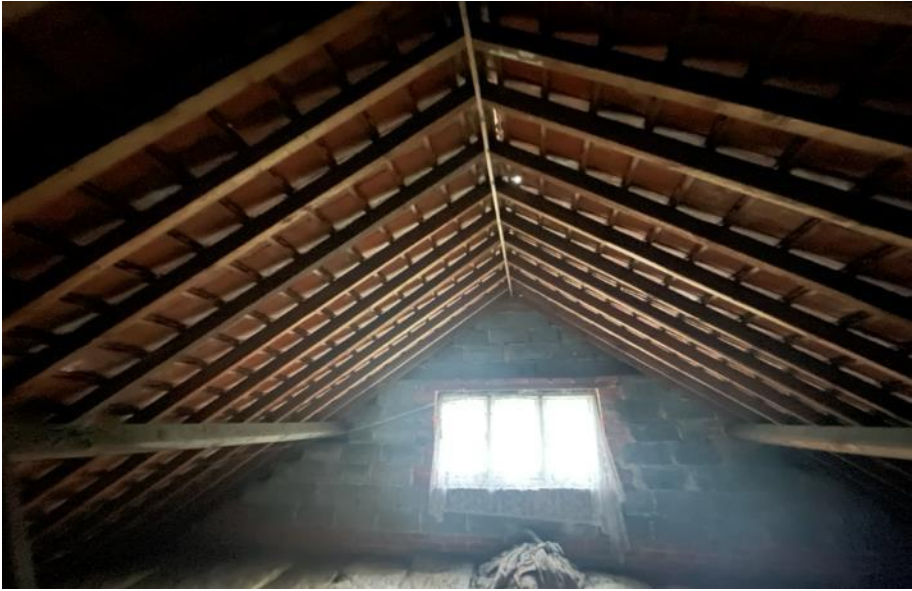
| Field Survey | |
|---|---|
| Inspection of the building | <p>The building was inspected internally and externally before the survey began. There is one loft space within the main roof void of B1. The roof structure is built from modern timber beams including the ridge beam. The roof is unlined and the backs of the clay tiles can be observed. The floor of the loft space is lined with mineral wool insulation and there are timber boards in places. There are cobwebs around the ridge beam and roof to floor cobwebs. Daylight enters the loft through a window on the western elevation, allowing high levels of light internally. No evidence of roosting bats was observed internally during the building inspection.</p> <p><i>Figure 1: the loft space within B1.</i></p> <p>Externally, the building is in the same condition as when the previous PRA (John Wenman Ecological Consultancy, April 2024) was undertaken. This included gaps under the ridge tiles, gaps under the lead flashing around the chimneys and gaps between the barge boards and walls on the eastern gable end.</p> |

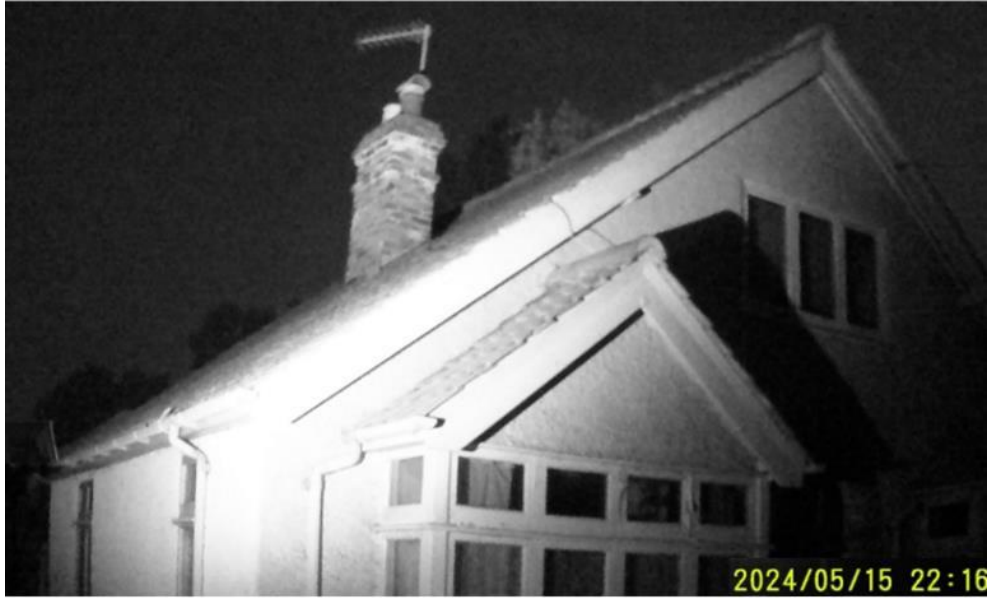
| Date of survey | Sunset Start and end time | Species and numbers | Roost type | Structure reference | Roost location | Access points | Dimensions and explanation of roost location |
|---|---|---|---|---|---|---|---|
| <i>Surveyor 1</i> | | <b>No emergences.</b><br><br>The first activity was from three common pipistrelles passing along the western boundary of the site at 21:13. A common pipistrelle was observed passing east to west along the boundary line at 21:15, 21:16 and 21:22. A soprano pipistrelle was heard but not seen at 21:38. | | | | N/A | |

| <i>IR position</i> | The footage reflected the view of surveyor 1. | |

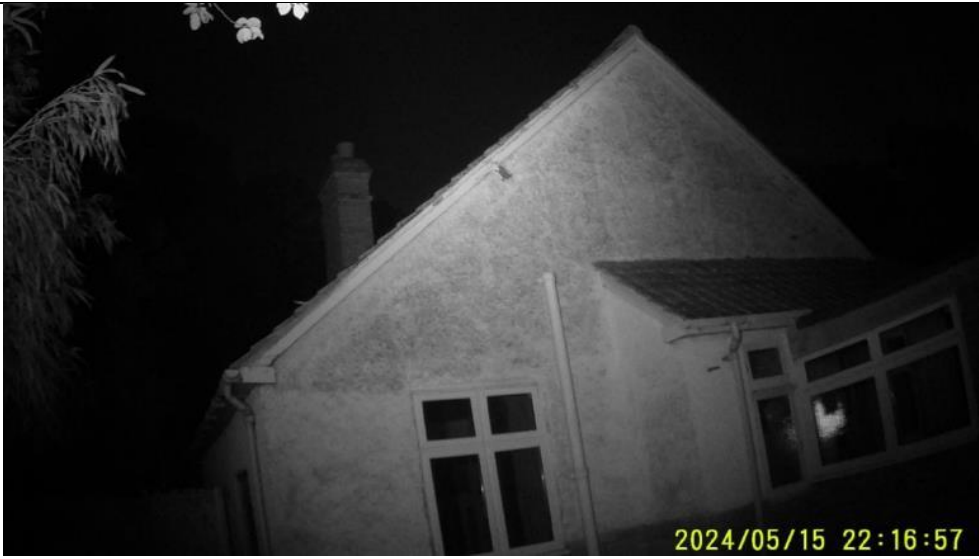
| <i>Surveyor 2</i> | <p><b>No emergences.</b></p> <p>The first activity was from three common pipistrelles passing along the western boundary of the site, flying west between 21:11 and 21:13. A common pipistrelle was observed passing east to west along the boundary line at 21:20. A soprano pipistrelle was heard but not seen at 21:38. A noctule was heard but not seen at 22:11.</p> | N/A |

| <i>IR position</i> | The footage reflected the view of surveyor 1. | |

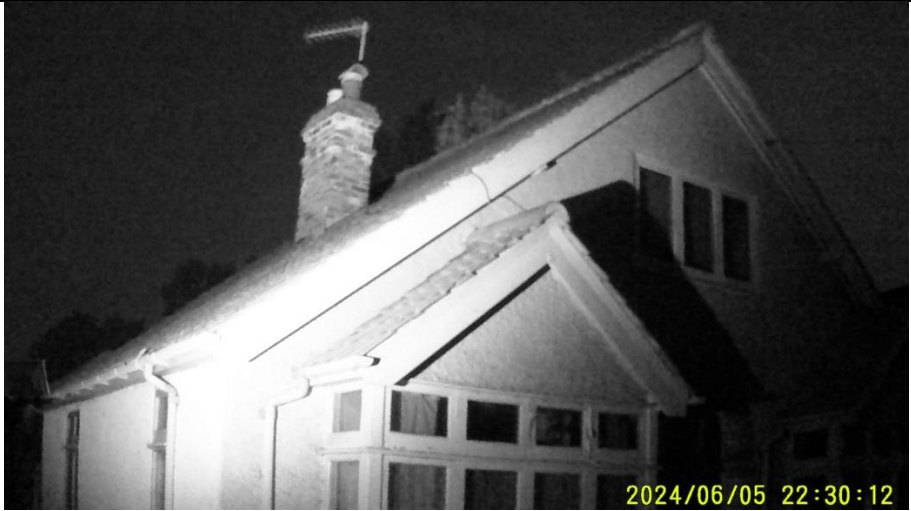
| <i>Surveyor 1</i> | | <b>No emergences.</b> First bat was seen was a common pipistrelle at 21:26 flying south to west along the south west elevation. From 21:27 to 21:41 there was constant common pipistrelles commuting south to west and back again along the hedgerow on the right side of the | | | | N/A | |

| <i>IR position</i> | The footage reflected the view of surveyor 1. | |

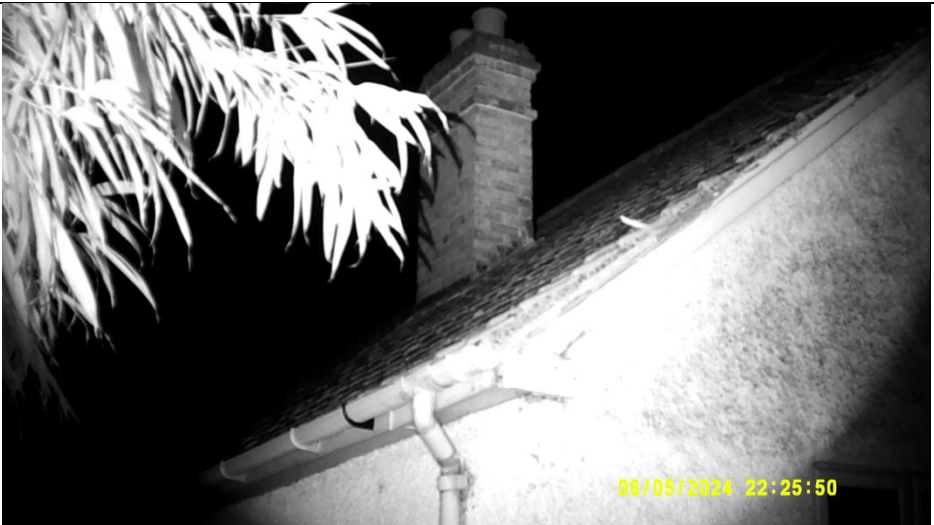
| <i>Surveyor 2</i> | <b>No emergencies.</b> First bat activity at 21:27, common pipistrelle was observed passing north-east to west. Numerous common pipistrelles throughout the duration of the survey, all commuting and foraging along the treeline to the west of the building. Last bat activity was an unseen common pipistrelle at 22:35. | N/A |

| <i>IR position</i> | The footage reflected the view of surveyor 2. | An infrared night vision photograph showing a close-up of a building's exterior. A textured wall is on the right, and a roofline with a brick chimney is visible in the background. A white downspout runs vertically. In the upper left, there are dark, leafy branches. A yellow timestamp '06/05/2024 22:25:50' is in the bottom right corner. |
