**PHASE 2
GEOTECHNICAL AND GEO-ENVIRONMENTAL
SITE INVESTIGATION**

**LAND PARCEL 9
HOGWOOD FARM
(FINCHWOOD PARK DEVELOPMENT)**

**CALA HOMES THAMES AND
LEGAL & GENERAL HOMES LIMITED**

41623-020

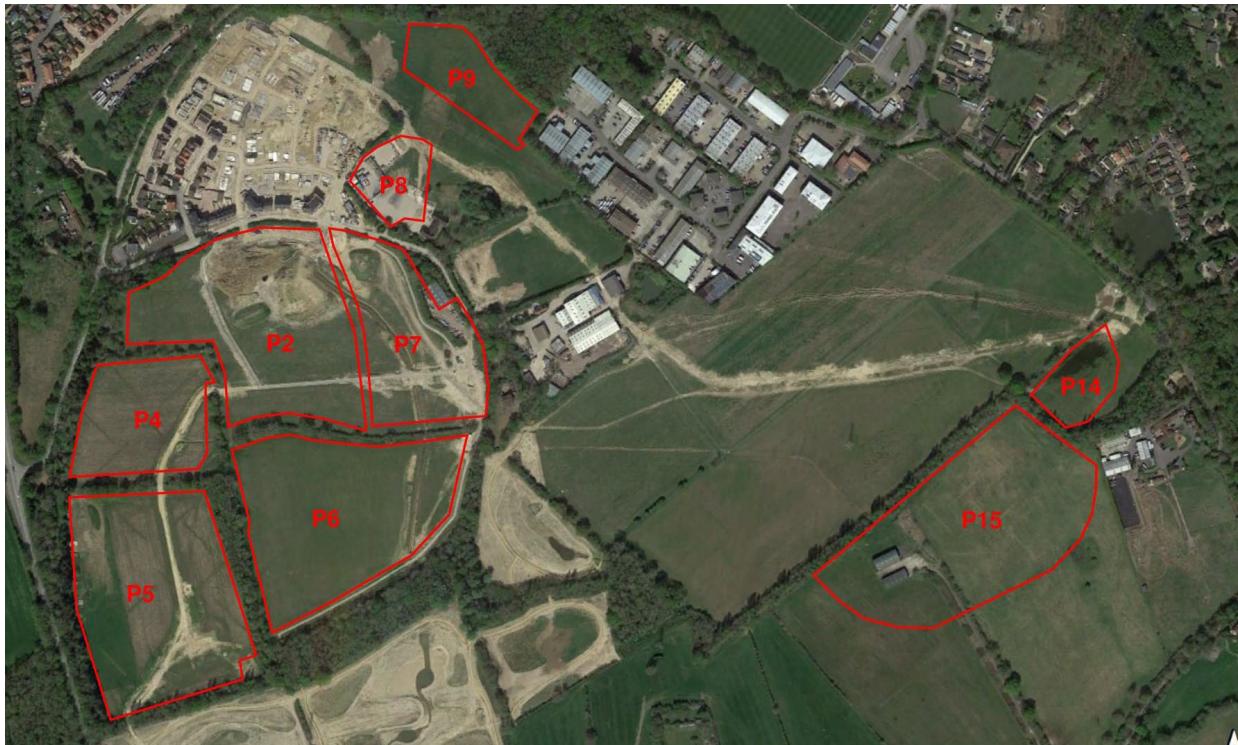
The plan below shows parcel 9 in relation to other land parcels that form part of the Finchwood Park development.

Land parcel 9 is an approximately 1.2 hectare area of open, former agricultural land consisting of grass and scrub vegetation and is part of the wider Finchwood Park development. Aborfield Garrison lies 1 km to the north and the partially constructed phase 1 development area is 100 m to the west.
