## EXTENDED PHASE 1 ECOLOGICAL ASSESSMENT

BIRD PLACE, HENLEY BRIDGE, HENLEY-ON-THAMES, BERKSHIRE, RG9 2LN

FINAL REPORT

June 2025

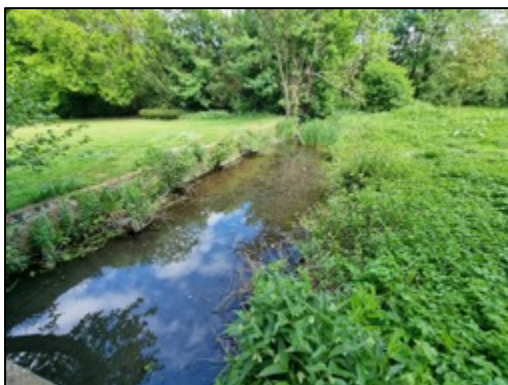
**Figure 15** – Stream south of the lawn onsite.

A man-made stream enters the site from a culvert along the eastern site boundary, extending westwards to the south of the lawn, through the woodland and into the River Thames (Figures 15 and 16). At the time of the survey the water level was low inside the waterway with no observable flow.

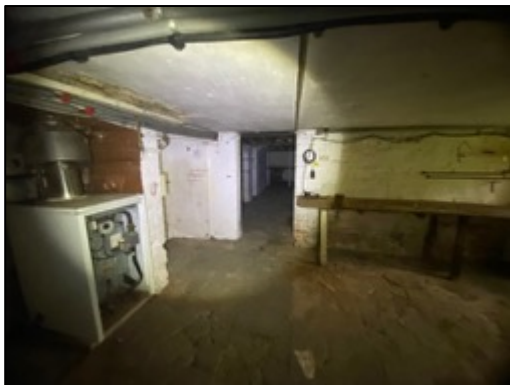
**Figure 19** – Basement under the main house.

The basement area is  $\frac{3}{4}$  height with multiple rooms and light cobwebbing throughout (Figure 19). At the time of the survey the door from the house to the basement was left open allowing continuous access to the buildings interior.

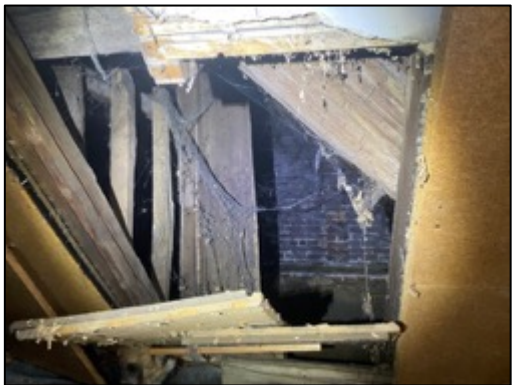
**Figure 23** – Roof void 4 inside south-western roof pitch.

Void 4 extends along the south-western roof pitch. The roof is bitumen felt lined with fibreglass insulation on the floor. The space is heavily cobwebbed throughout (Figure 23).

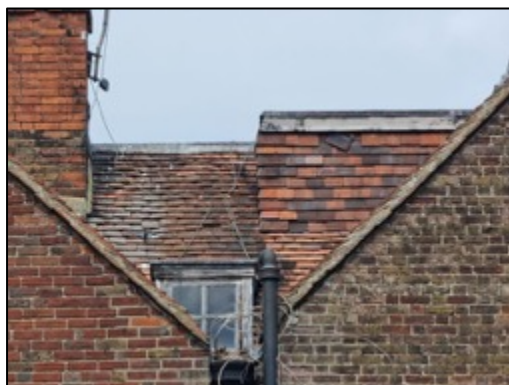
**Figure 24** – lifted roof tiles on the southern roof face and slipped hanging tiles.

| | <i>Suitability</i> | <i>Evidence</i> |
|---|---|---|
| | <p>are either lifted or have slipped away on rear roof faces (Figure 24).</p> <ul style="list-style-type: none"> <li>- Gaps are located under the hanging tiles on the flat roof extensions on the roof of the house (Figure 24).</li> <li>- Crevices in the brickwork of the building where cracks have formed (Figures 25 and 26).</li> <li>- Crevices around window frames where mortar has fallen away (Figure 27).</li> <li>- Missing mortar under stone copping (Figure 28).</li> </ul> | |

The preliminary roost assessment has confirmed that the house and attached cottage support high suitability for roosting bats. Therefore, further survey effort is recommended to confirm the presence/absence of roosts, characterise any bat roost/s, assess the extent bats may be affected by the proposed alteration and construction works and devise an appropriate mitigation strategy to support the proposed works and address any breaches in the legislation. In accordance with Natural England standing advice and BCT Good Practice Guidelines, three presence/absence surveys for the house and cottage should be undertaken between May and September. No further survey work is required for the conservatory outbuilding.

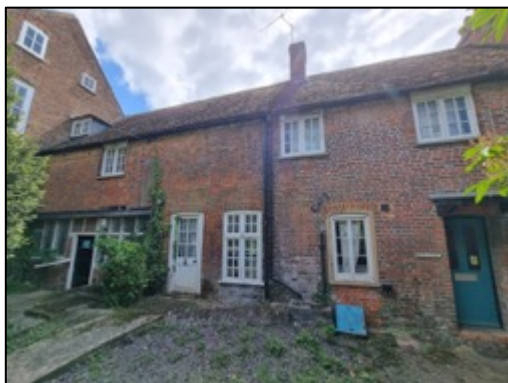
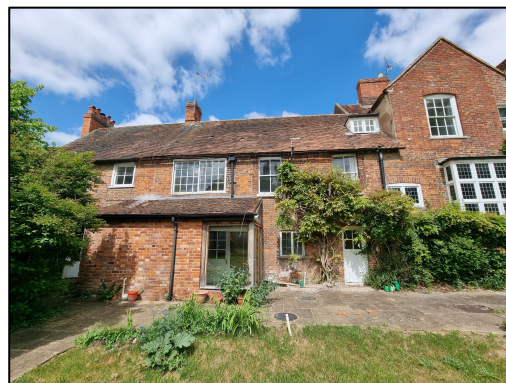
The cottage consists of a two-storey extension which protrudes westwards from the eastern elevation of the main house (Figures 29 and 30). The extension rises to a pitched roof clad with clay roof and ridge tiles. The cottage is oriented north to south. A single-storey lean-to extension protrudes from the southern elevation of the cottage clad with clay roof tiles and lead flashing at the joins. A single dormer window is located on both the northern and southern roof faces. A brick-built chimney is located along the central ridge of the roof with lead flashing at the base. The eaves remain open but are infilled with brick between them. All windows and doors are set in wooden frames.

**Figure 29** – Northern elevation of Rose Cottage.

**Figure 30** – Northern elevation of Rose Cottage.

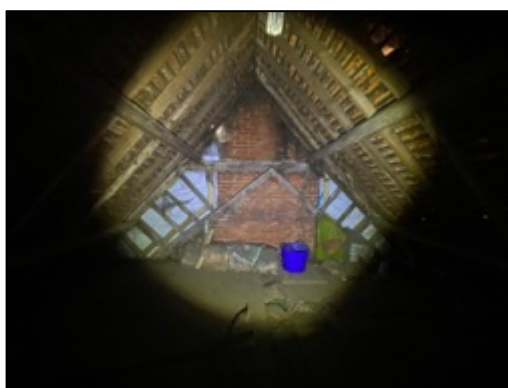
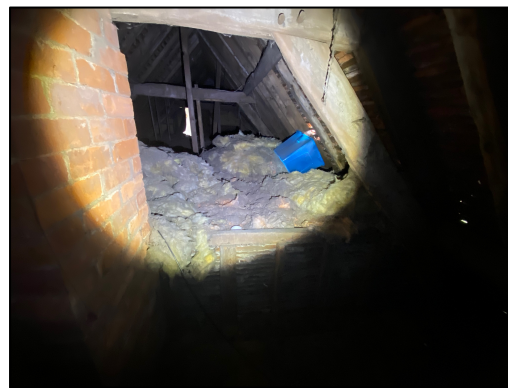
A single roof void extends along the entire roof pitch of the building (Figures 31 and 32). The roof remains unlined with the underside of the clay tiles exposed. The floor is insulated with fibreglass and partially boarded. Cobwebbing is present around the joists and under the tiles.

**Figure 31** – Interior roof void of the cottage looking west.

**Figure 32** – Interior roof void of the cottage looking east.

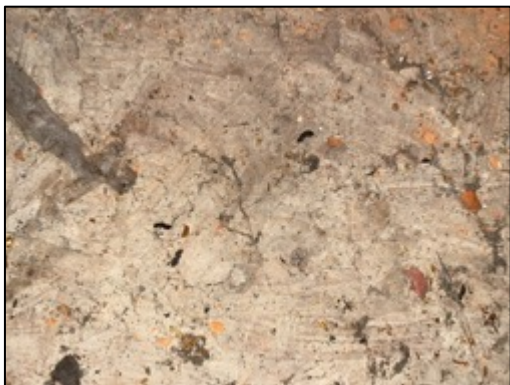
**Figure 35** – Scattered long-eared bat droppings in the roof void.

| | <i>Suitability</i> | <i>Evidence</i> |
|---|---|---|
| <i>Interior</i> | <p>The following suitable access/egress and roosting features were recorded internally during the survey.</p> <p>N/A</p> | <p>The following evidence of roosting activity was recorded internally during the survey.</p> <ul style="list-style-type: none"><li>- Approximately 50 long-eared bat type droppings were recorded scattered around the roof void inside Rose Cottage (Figure 35).</li></ul> |

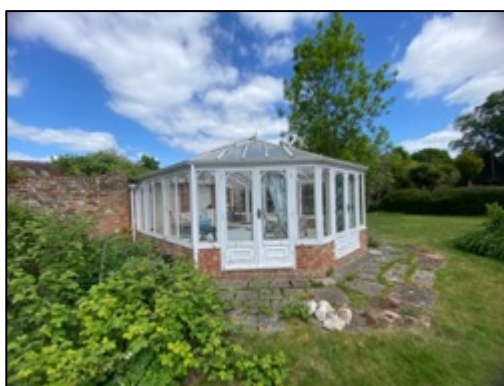
**Figure 36** – Conservatory outbuilding.

The building is built on a brick plinth with shallow brick walls and a wooden framed structure rising to a hipped and pitched glass roof (Figure 36). The windows and doors are set in wooden frames and uPVC guttering extends around the roof.

Internally, there are no roof voids.
