## SUMMARY and OVERVIEW 28/08/2025

### 2.2 The Catchment

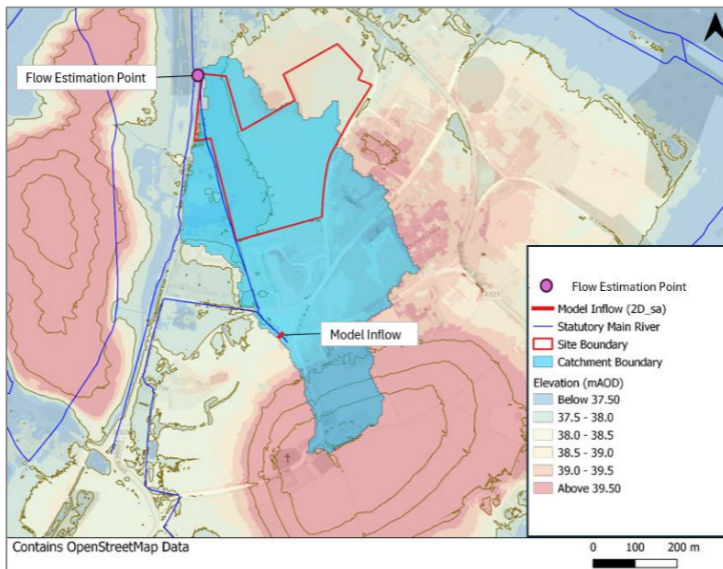
Figure 2-3 Location Plan Showing Statutory Main Rivers, Subject Catchment Area, Model Inflow Location and Site Boundary

This core data dilemma is graphically indicated on the Appellant's Figure 2-3 showing the man-made drainage-obstructing Hurst Landfill hills immediately west of the site, now superimposed over virtual reality EA Main Rivers that no longer exist - the two features cannot exist together.

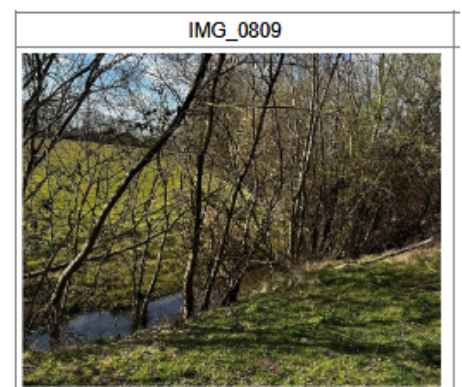
The leachate-contamination segregation ditch pictured in the Appellant's “Walkover survey site photos” (right) is located on Summerleaze's private land, part of the waste landfill, and drains south to Lea Farm leachate treatment plant and gas flare compound. The same Rev06 FRA Site Location Plan Figure 1-1, shows no rivers or ditches west of Lodge Road but does show the Appellant's on-site truncated and blocked section of Hatchgate Ditch (now swale) which no longer flows anywhere.

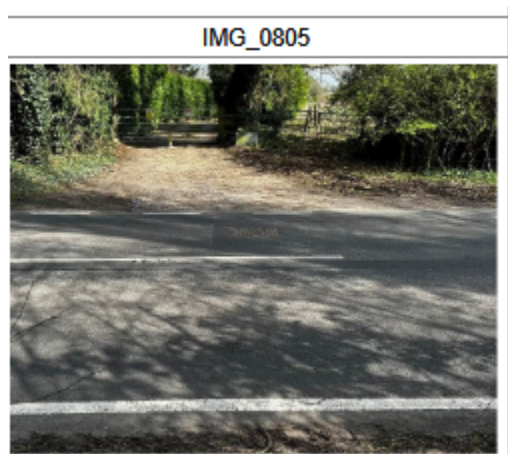
This history is relevant because it indicates a general position and layout of on-site culverts and open ditch in 1967 under the joint access drive with “The Paddocks” (on the right of IMG\_0805 screenshot left). Other photos show Hatchgate Ditch immediately roadside west of Lodge Road is now defunct and completely filled-in, the present Landfill segregation ditch now running roughly 40m west of what was the roadside Hatchgate Ditch. Below left IMG\_0803, a similar view east towards Thames Water Manhole 2801 from “Howard’s Way” footpath including the “vented” Summerlease landfill bio-solids

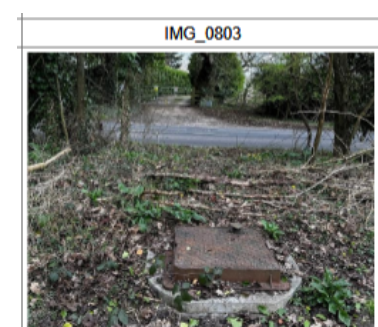
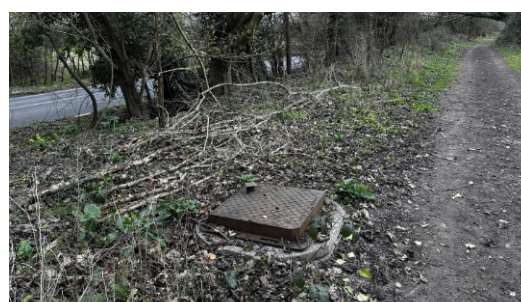
Photograph 10: Manhole in a northeastern direction from site

leachate pipe discharge manhole - giving access to the (pink) discharge isolation valve. The appellant’s own photos, immediately west of the site by Lodge Road, including in the view south in wrongly labelled Photograph 10, show the absence of any west roadside Hatchgate Ditch. The much-photographed Summerlease discharge Manhole in IMG\_0801 is nothing to do with site drainage.

“[APP - C3 - Appendix D Photomontage2 appendix C](#)” - includes Photo 10 of Summerleaze Leachate Discharge Valve Manhole northwest of site

If correct, the Summerleaze leachate discharge valve (Photograph 10) will appear on the CCTV footage at some stage which should also reveal whether the culvert is concrete, plastic, or just simply short and blocked.

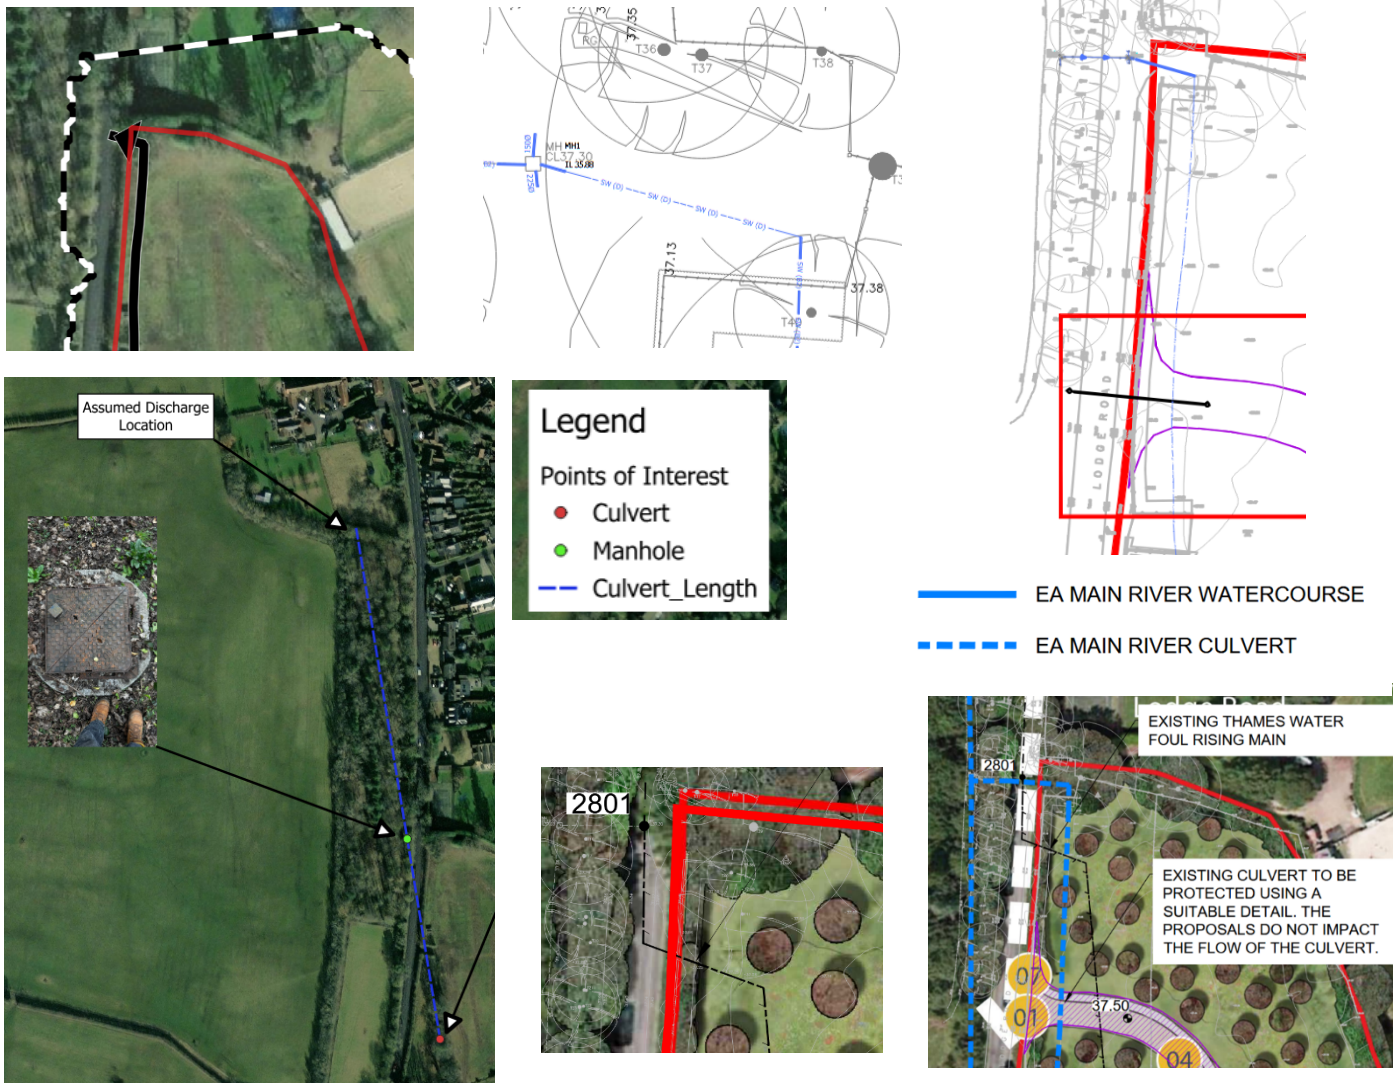
We are provided with options showing a foolhardy (blue) direct connection to Thames Water Manhole 2801 in Lodge Road southbound – the manhole where the Summerleaze pumped leachate and Sawpit pumped rising foul main join Hurst's sewer system under pressure. Such a connection – resulting in sewage and leachate discharging on site – would never be allowed. Another option annotated with blue broken lines (EA MAIN RIVER CULVERT) crosses near Manhole 2801 and joins a north/south culvert in a random position on the opposite side of Lodge Road. Another option - the hydraulic modelling boundary, and probably the most realistic option, shows a thick black line stopping and blocked at the site boundary.

A clear statement is needed from the Appellant confirming which of the alleged culvert routes is correct and make the CCTV survey available for a competent LLFA representative to review – or a retraction of the statement previously made that the culvert crosses Lodge Road.

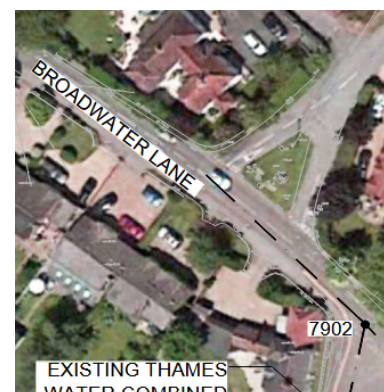
already since taken-up spare sewer capacity. A new sewer search should be requested including the surcharging Hogmoor Lane Manhole connection close to site - within 100m north of the junction island (near A321 Manhole 7902, 37.77m AOD and on a similar level).

Surcharging here directly links the

site to S-19 flooding of white Rose Cottage beyond. This extra sewer information is needed to assess the risks of sewer connectivity flooding which the appellant has not addressed at all – in central Hurst it is not distance that matters but level! Whether it’s pumped sewage and leachate, or just floodwater, the trapped water will find its own level.

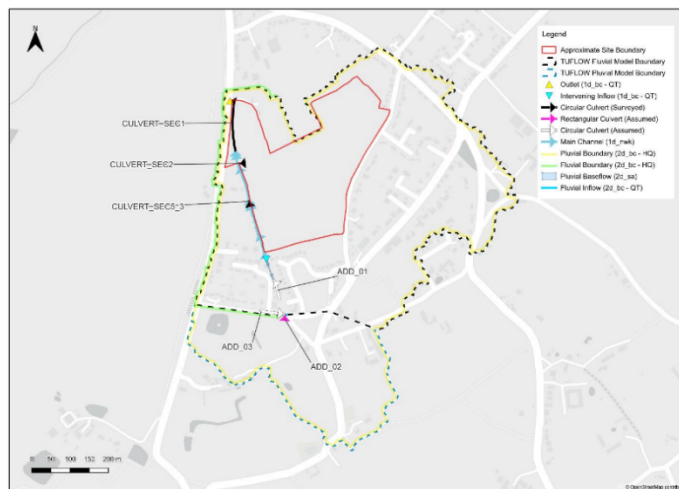
Figure 2-1: 1D/2D Hydraulic Model Extent and Features

The west boundary of the model stops just short of the Summerleaze landfill segregation ditch, stops just short of the surcharging Hogmoor Lane Manhole, only includes a little bit of Church Hill, and no inflow from the impervious landfill hills, etc.

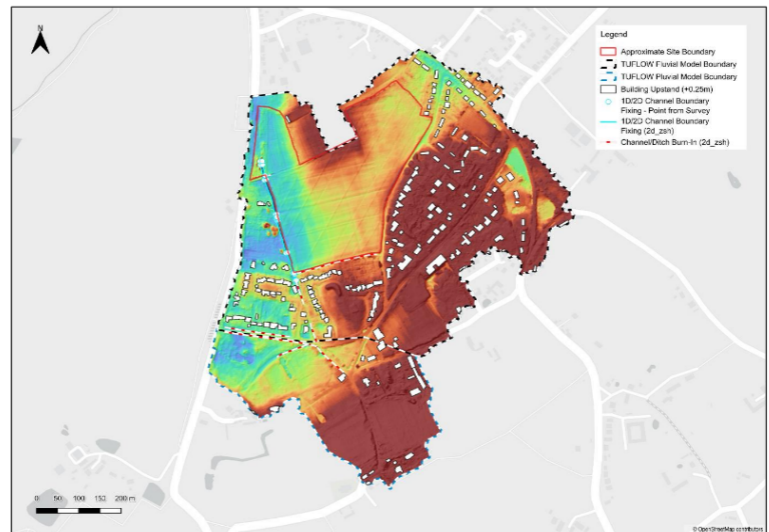
Figure 2-2: Hydraulic Model Topography Changes

(5.3.1) Item 22 of the “Not agreed Conditions 19/08/2025” states “*proposed finished ground levels and finished floor levels across the site to be set at a minimum level of 38.13mAOD*” – note the word minimum above the present near 37.5mAOD seasonally waterlogged site. The Appellant’s “access-only” indicative drawings show the surface of the on-site “retention pond” at 38.0m AOD – the new pond raised more than 0.5m above the level of existing seasonal ponding on-site and relative to neighbours. A common-sense statement (or perhaps responsibility shifting disclaimer?) is made at the end of FRA para. 7.4.3 affirming Archimedes’ principle and most Hurst residents’ understanding of what will happen: “*7.4.3 Exception Test – Fluvial Flooding: Therefore, provided there is no land raising within design flood envelope without suitable compensation elsewhere, the proposed development would not increase the flood risk elsewhere by virtue of the reduction in floodplain storage or the obstruction of flood flows.*” The unanswered question is – “By how much is the near 37.5mAOD 10.68ha site to be raised – and to meet the condition, where is the 50,000+ cubic metres of suitable flood compensation elsewhere provided?” The indicative 38.0mAOD high retention pond at less than 2000 cubic metres would have negligible effect - being less than 4% of the required volume needed of flood compensation ditches, swales and ponds below 37.5mAOD – which in winter and spring, in Hurst, will be full of water anyway.

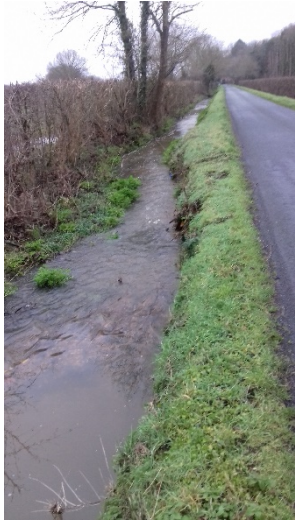
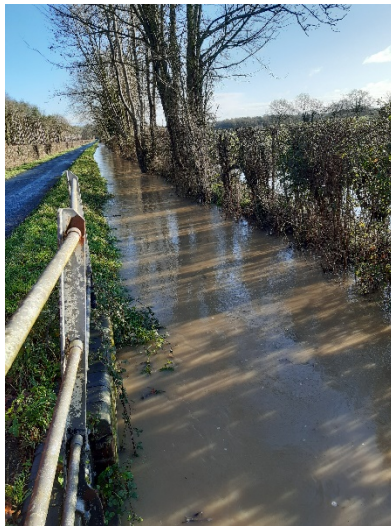
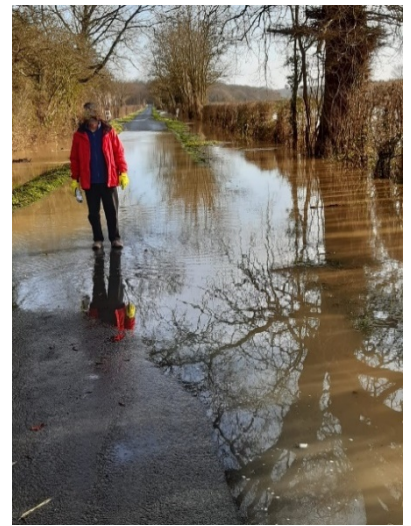
Pictured (left) as a normal babbling brook flowing west into the model, from the road bridge (centre) looking east, partially flooded, and (right) flooded, also looking east and not safely passable with the road bridge in the background with higher containment land beyond – at present, this EA Main River is not shown alongside Broadcommon Lane on OS 1 ¼” Maps (or Phillip’s Street Atlas) and the bridge road crossing not annotated as such on OS 6 ¼” Maps.

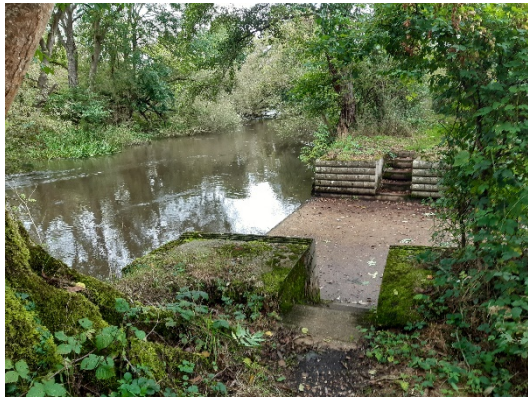
A significant boundary condition will be the deliberate River Loddon fluvial flooding model inflow resulting from the old weir in the east Hurst bank of the Loddon just north of Heron's

water – a heinous or perhaps inexcusable omission from WBC's "*WSP Sandford Lane Flood Investigation Report January 2016 Flood Event FIGURE 01/02*" (it is quite hard to find and hazardous to access during flooding). Pictured (left) this weir is marked on OS Maps and preferentially floods Sandford Lane in Hurst (rather than Woodley), also Sandford lake and Lavell's Lake nature reserve etc. More seriously this flooding is towards leachate treatment facilities at Lea Farm and affects the Zone 3 landfill segregation ditch just west of

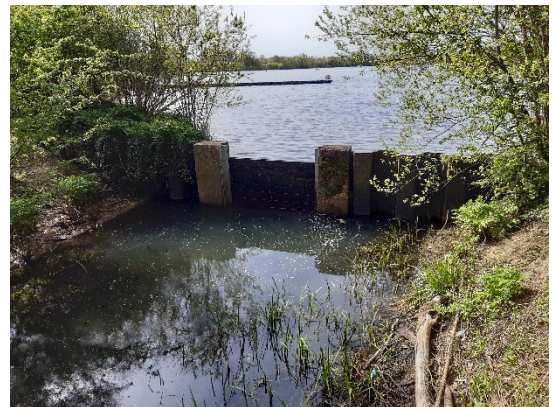
Risk of flooding from black Swan Lake reservoir - which the Appellant has failed to address at all in FRA Rev06 – is another possible boundary condition to consider for inflow at both the Sandford gap, but more so for inflow at the Whistley Green gap at the north of the Trapment Triangle. Pictured (right) with high "wet day" flood risk river levels this wood slat weir  $\frac{3}{4}$  mile from site – not shown on OS Maps – is holding back around 300,000 cubic metres of water and the risk of failure or vandalism, albeit probably very low, should be addressed. WBC core data gives the weir height as up to 2m and the reservoir volume as 200,000 m<sup>3</sup> – but with the water held over 1m higher than river level as photographed, and a lake area approaching 300,000m<sup>3</sup>, it might be prudent to review the core data being used for EA Reservoir Flood Maps for Black Swan Lake.

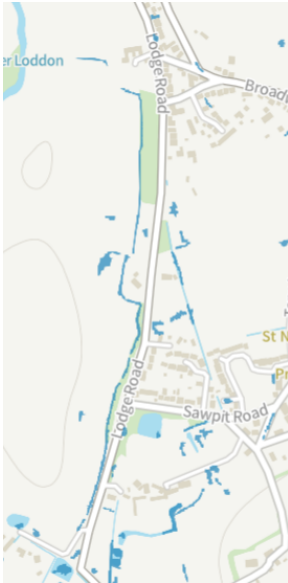
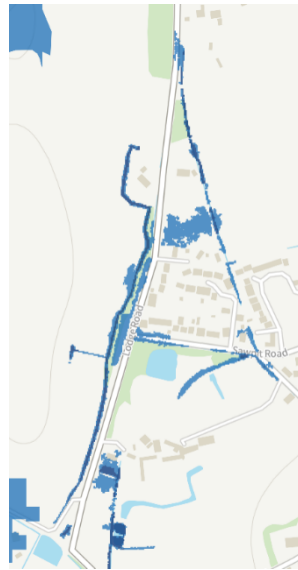
The flood map for surface water flooding (above left) on the other hand indicates the ditch continuing to run northwards beyond the Summerleaze access to its start near Whistley Farm. The reasons for these differences may be that two different LiDAR databases are being used – perhaps one data set scanned when trees were full leaf – the other in winter. But whatever the reasons for the differences, this ditch -not shown on OS and EA data – very much exists and must be included in any modelling.

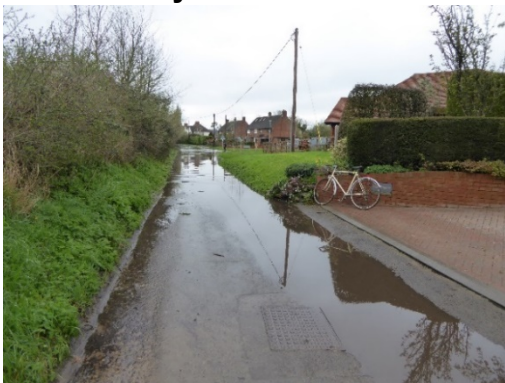
The 1/04/2023 photo (left) of Tape Lane looking north immediately adjacent to the site’s east boundary on the left - shows deep flood water (over one foot) badly affecting the entrance to Barker Court and extending towards Broadwater Lane A321 and junction with Hogmoor Lane. Pictured the day after the major flooding - this deep flooding covers several manholes, like the one in the foreground, and manholes can leak.

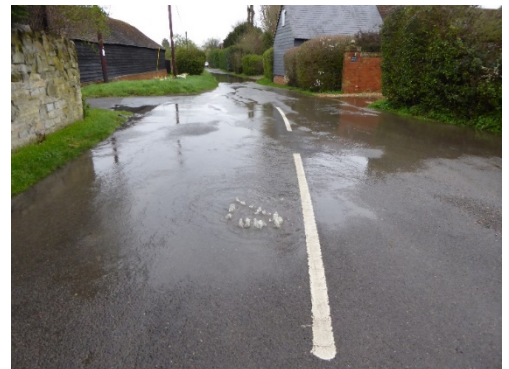
Looking in the same direction on the same day (right) , but just a little further north across A321 in Hogmoor Lane 0.1km from site, sewage/floodwater/leachate from this surcharging manhole is draining to, and adding to the subsiding flooding at S-19’s White Rose Cottage – a further 0.37km down Hogmoor Lane. This sewer flooding connectivity is also pictured in WBC’s S-19 Report – titled “Thames Water Pumping Station Ineffective”.

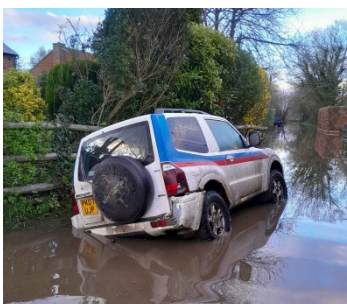
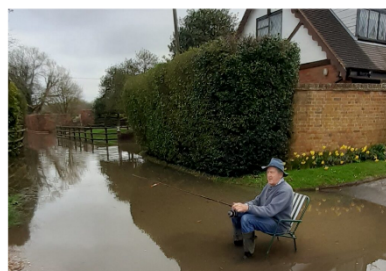
Wokingham Today press photos (left) taken the day before, looking along the same section of Hogmoor lane a little further on, perhaps demonstrate why sewer flooding is not always obvious – because the surcharging fountains are flooded and hidden from sight! As are Hurst’s ditches!

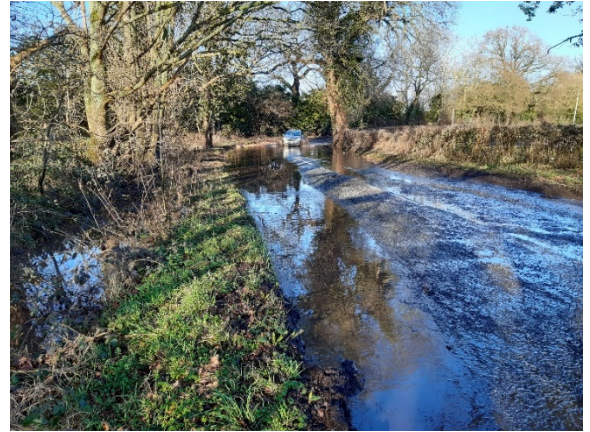
**(6.2.2) Drainage that previously drained northwest in the defunct Lodge Road north Hatchgate Ditch now begins its tortuous route south anti-clockwise around Church Hill. The photo right taken earlier this year, the driest spring for 69 years, shows a vehicle ploughing through the flooding near the increasingly soggy junction with Lodge Road/Davis Street and Lines Road. The day after this photo was taken Church Hill was closed to traffic.**

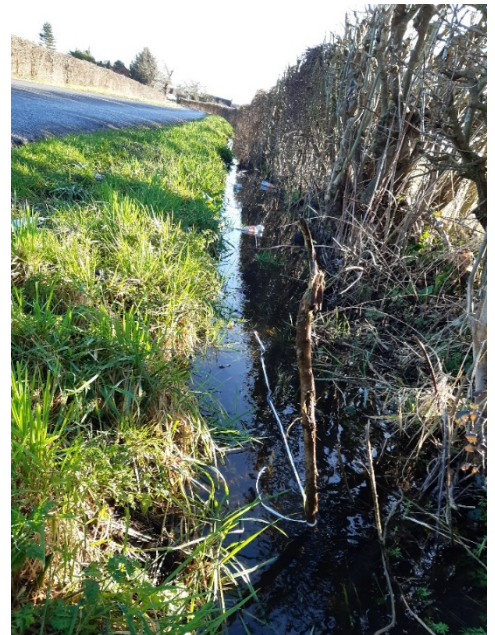
**(6.2.3) Pictured (right) flowing earlier this year is what could be all that is left of a functioning Hatchgate Ditch that is no longer simply a swale. Looking south towards Hatch Gate Farm entrance, this traffic-damaged roadside ditch is not marked on OS Maps but is designated EA Main River. Once perhaps the start of The Hatchgate Ditches system, the “stick and ribbon” ditch flow indicator shows flow in this remaining section of ditch is now strongly south – not north as wrongly indicated by arrows on some maps.**

*Hatch gate Farm entrance in the distance is where planning permission has been approved for new dwellings on yet another near 37mAOD site, and where there is no Thames Water sewer nearby. Any disruption of this “reversed” now essential drainage will have upstream consequences.*

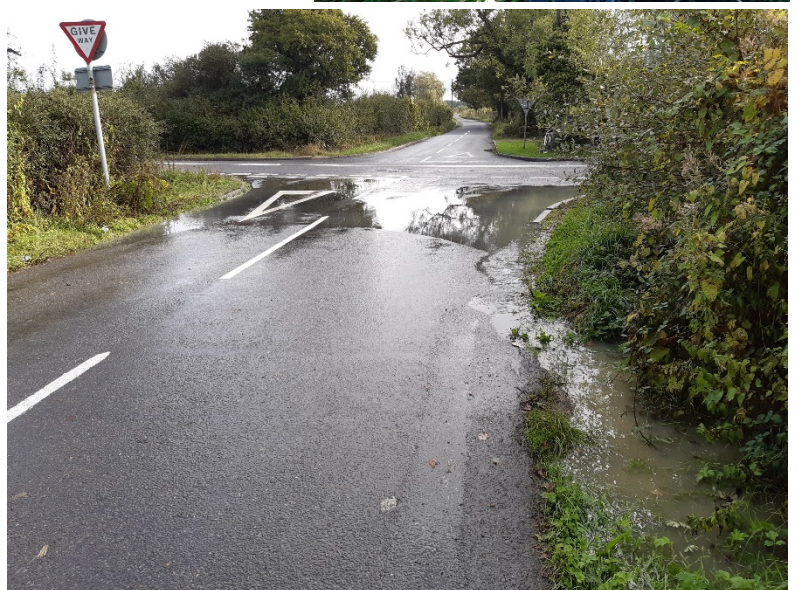
**(6.2.4) looking northeast, at the opposite east end of Lines Road, at its junction with A321, with Pound Lane opposite – the turbulent flow from the ditch on the south side of Lines road crosses the road north to drain into the A321 roadside ditch towards Keyers Bridge and towards regularly flooded Islandstone Lane.**

**This very active roadside waterway near and opposite “The Mount Farm” - is not shown on OS 6 ¼” Mapping, and is not shown on GOV.UK/EA/OS MAIN River Maps but is clearly another**

**unexpected “reverse flow” contributing directly to increased “S-19” flooding at Keyers Bridge House. – adding to flows from the original ditch system already converging on Keyers Bridge. It is these changed drainage flows that need to be properly understood as a result of the historic destruction of floodplain and raising of land to the west of Hurst. The**
