# **FINCHWOOD PARK**

## **Arboricultural Impact Assessment**

JSL5287\_770  
Arboricultural Impact  
Assessment  
P01  
11 March 2025

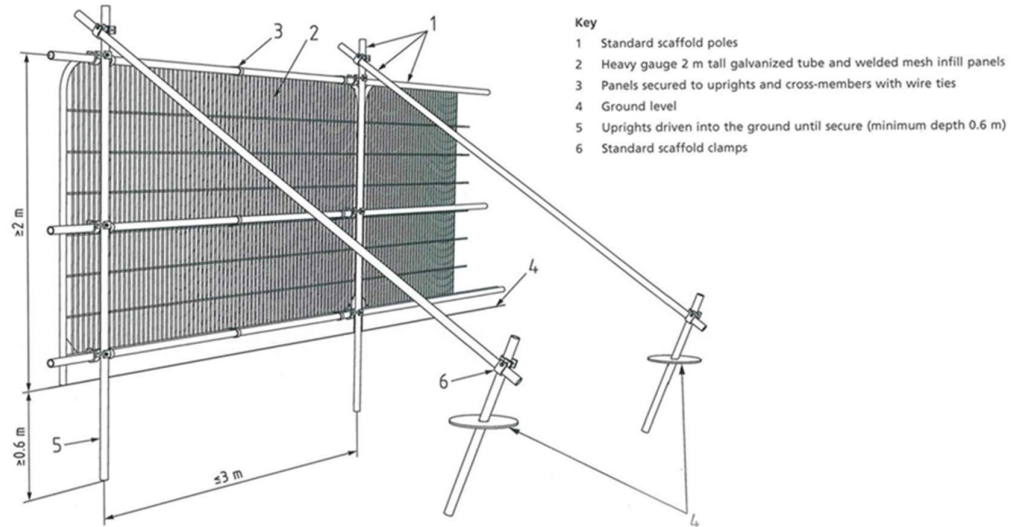
Figure 2 Default specification for protective barrier

### Example Tree Protection Barriers (BS5837:2012 Fig 2 & 3)
