# Preliminary Ecological Appraisal & Roost Assessment

Grove Cottages, Sandford Lane, Hurst, Reading, Wokingham, Berkshire RG10 0SX

This report is prepared to inform a planning application with Wokingham Borough Council. The creation of a single-storey rear extension to the rear of the main dwelling.

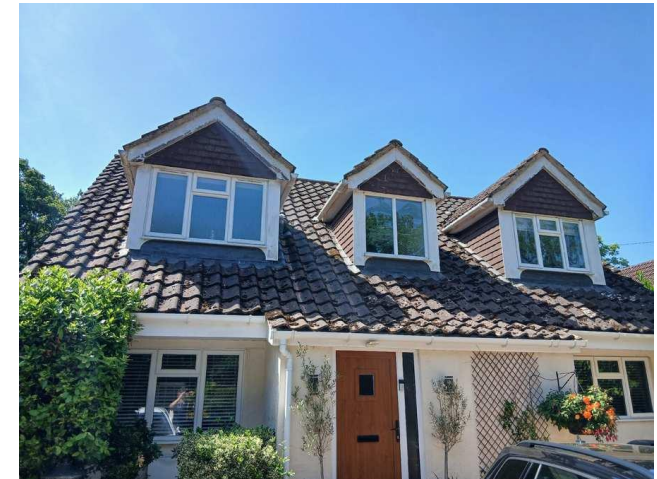
B1 is a two-storey residential dwelling with a gabled roof constructed of interlocking clay tiles. The roof tiles are tight-fitting, presenting no obvious roosting features or access points. Three dormer windows are located on the northern and southern elevation. The uPVC soffit boxes are also in good condition with no gaps. Internally, an insulated loft void was noted to be in good condition with no light spill and no identified access points. No bat roosting features or access points, or evidence was identified throughout the structure.

In line with Good Practice Guidelines (Collins, J (Ed) 2023), B1 is assessed to have **negligible** habitat value for roosting bats.

*The northern elevation of B1.*

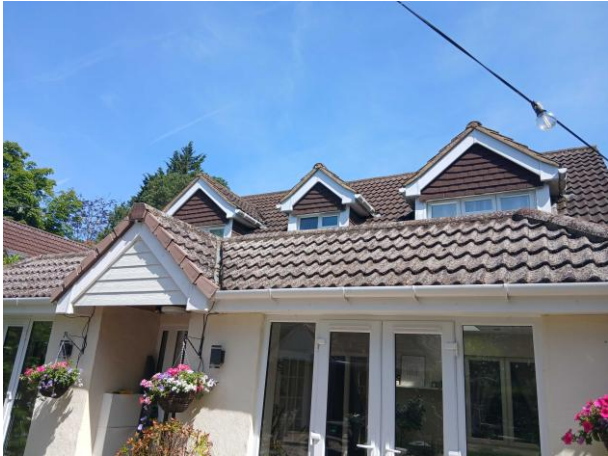
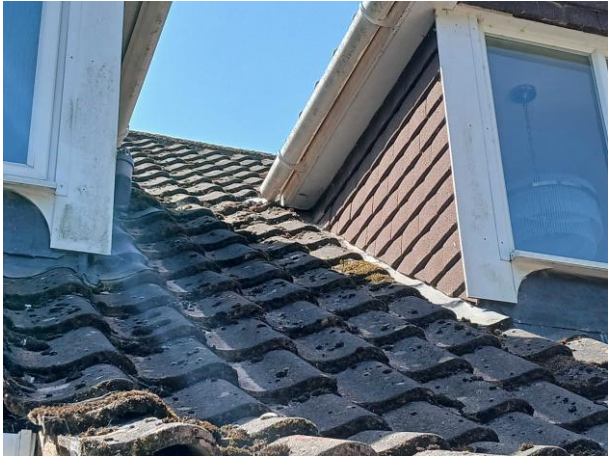
| Feature | Materials/Details | Condition / description / suitability | Photograph |
|---|---|---|---|
| Roof | Interlocking clay tiles | <p><b>Condition/description</b></p> <p>The main roof tiles, ridge tiles and roof verges are tight-fitting.</p> <p><b>Suitability/access/evidence of bats</b></p> <p>No bat roosting features or access points were identified.</p> | <div><p>Southern elevation roof of B1.</p><p>A section of the northern elevation roof of B1.</p></div> |

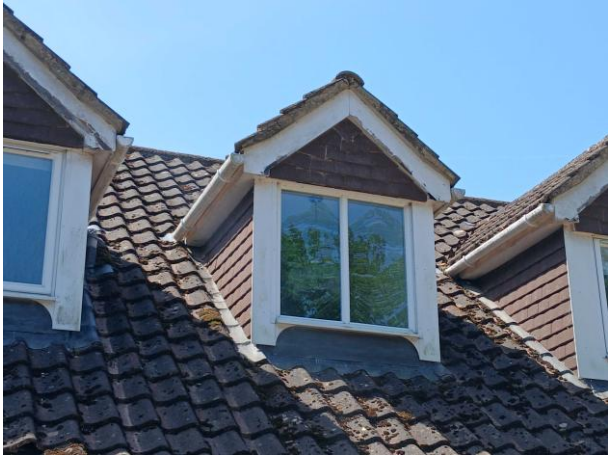
| Dormer windows | Hanging tiles | <p><b>Condition/description</b></p> <p>The hanging tiles on the dormer windows of B1 are in good condition with no gaps or cracks.</p> <p><b>Suitability/access/evidence of bats</b></p> <p>No bat roosting features or access points were identified.</p> | <p><i>The hanging tiles in good condition on the northern elevation of B1.</i></p> |

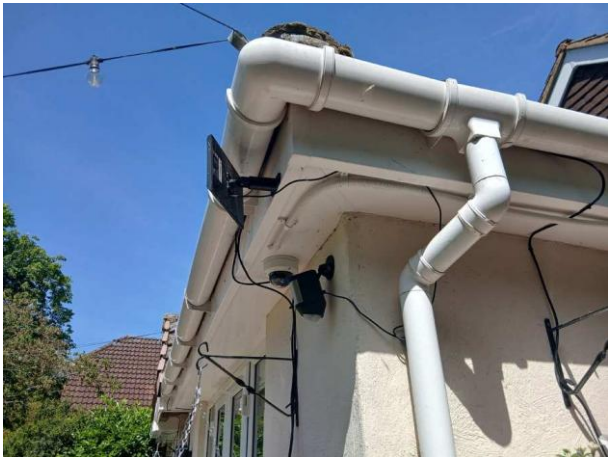
| Soffit boxes | uPVC | <p><b>Condition/description</b></p> <p>The uPVC soffit boxes of B1 are in good condition with no gaps.</p> <p><b>Suitability/access/evidence of bats</b></p> <p>No bat roosting features or access points were identified.</p> | <p><i>Soffit boxes on the southern elevation of B1.</i></p> |

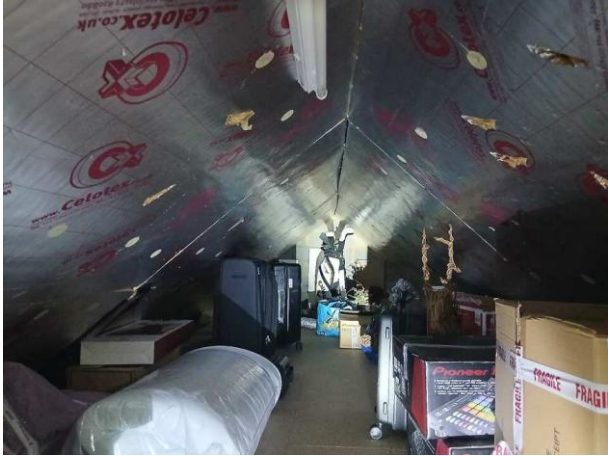
| Internal void | Blanket insulation | <p>The internal void is 10m long, 1.5m tall and 1.5m wide. It is lined with blanket insulation which is in good condition. No rips or tears were identified in the lining, and no light spill was observed, indicating an absence of access points into the internal void.</p> <p>The flooring of the loft void is covered in plywood allowing access to all areas.</p> <p>No rodent droppings were identified within the loft void.</p> <p>No evidence of roosting bats was identified within this void.</p> | <p><i>Internal void, facing east.</i></p> |

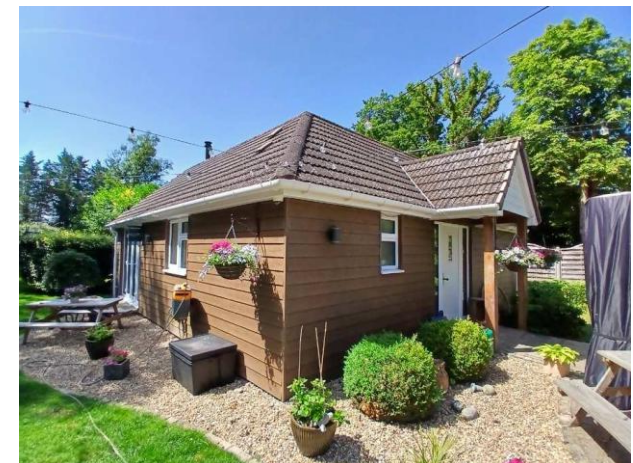
B2 is a one-storey annex with a hipped roof constructed of interlocking clay tiles. The roof tiles are tight-fitting, presenting no obvious roosting features or access points. The uPVC soffit boxes are also in good condition with no gaps. Internally, a roofing felt lined loft void was noted to be in good condition with no light spill and no identified access points. No bat roosting features or access points, or evidence was identified throughout the structure.

In line with Good Practice Guidelines (Collins, J (Ed) 2023), B2 is assessed to have **negligible** habitat value for roosting bats.

*Northeastern elevation of B2.*

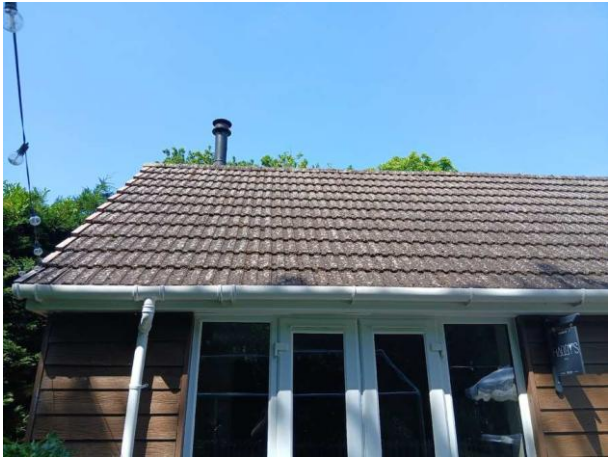
| Feature | Materials/Details | Condition / description / suitability | Photograph |
|---|---|---|---|
| Roof | Interlocking clay tiles | <p><b>Condition/description</b><br/>The main roof tiles, ridge tiles and roof verges are tight-fitting.</p> <p><b>Suitability/access/evidence of bats</b><br/>No bat roosting features or access points were identified.</p> | <p><i>Eastern elevation roof of B2.</i></p> |

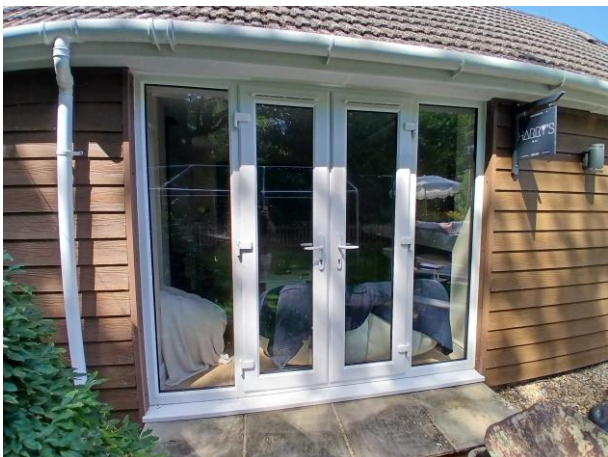
| Feature | Materials/Details | Condition / description / suitability | Photograph |
|---|---|---|---|
| Doors, windows and soffit boxes | uPVC | <p><b>Condition/description</b><br/>The uPVC soffit boxes of B2 are in good condition with no gaps.</p> <p><b>Suitability/access/evidence of bats</b><br/>No bat roosting features or access points were identified.</p> | <p><i>The doors and soffits on the eastern elevation of B2.</i></p> |

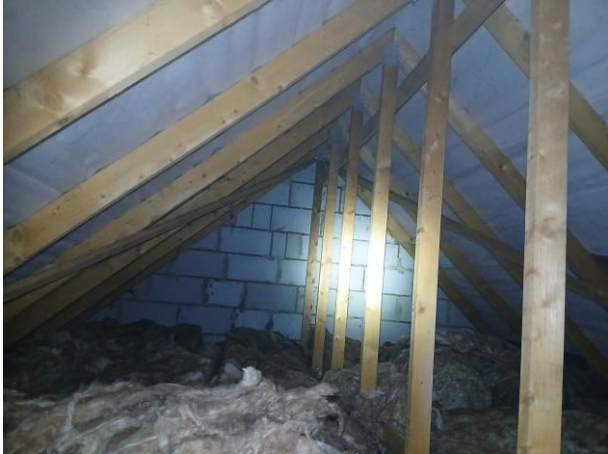
| Internal void | Timber rafters.<br>Bitumen felt lining | <p>The internal void is in an L-shape. It is lined with roofing felt which is in good condition. No rips or tears were identified in the lining, and no light spill was observed, indicating an absence of access points into the internal void.</p> <p>The flooring of the loft void is partially covered in plywood allowing access to all areas.</p> <p>No rodent droppings were identified within the loft void.</p> <p>No evidence of roosting bats was identified within this void.</p> | <p><i>Internal void, facing west.</i></p> |

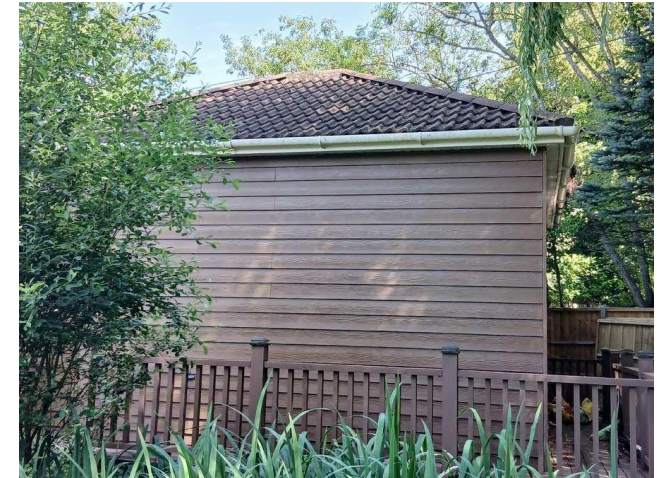
B3 is a one-storey garage with a hipped roof constructed of interlocking clay tiles. Internally, a roofing felt lined internal space was noted to be in good condition with no light spill and no identified access points. No bat roosting features or access points, or evidence was identified throughout the structure.

In line with Good Practice Guidelines (Collins, J (Ed) 2023), B3 is assessed to have **negligible** habitat value for roosting bats.

*Southern elevation of B3.*

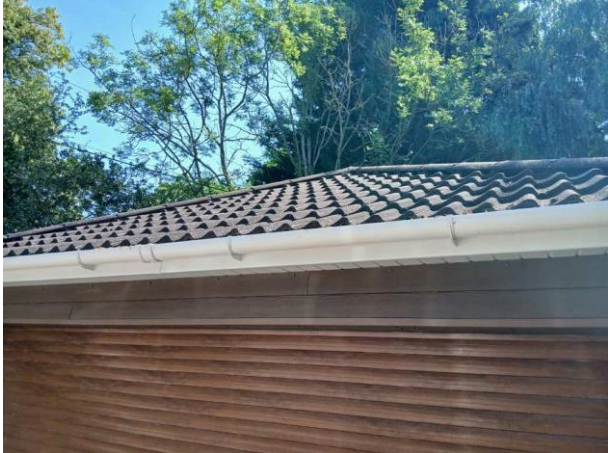
| Feature | Materials/Details | Condition / description / suitability | Photograph |
|---|---|---|---|
| Roof | Interlocking clay tiles | <p><b>Condition/description</b></p> <p>The main roof tiles are tightly fitted with no significant gaps identified.</p> <p>A continuous gap was present between the ridge tiles and the roof tiles along the entirety of the ridgelines. This feature was fully visible and inspected from ground level and was found to be shallow, measuring approximately 100mm in width and 100mm in depth. Due to its large dimensions and exposed nature, the</p> | <p><i>Western elevation roof of B3.</i></p> |

| | | <p>feature does not provide the confined, sheltered and thermally stable conditions typically preferred by roosting bats and is therefore considered unlikely to support a bat roost.</p> <p><b>Suitability/access/evidence of bats</b></p> <p>No bat roosting features or access points were identified.</p> | <p><i>Southern elevation roof of B3.</i></p> |

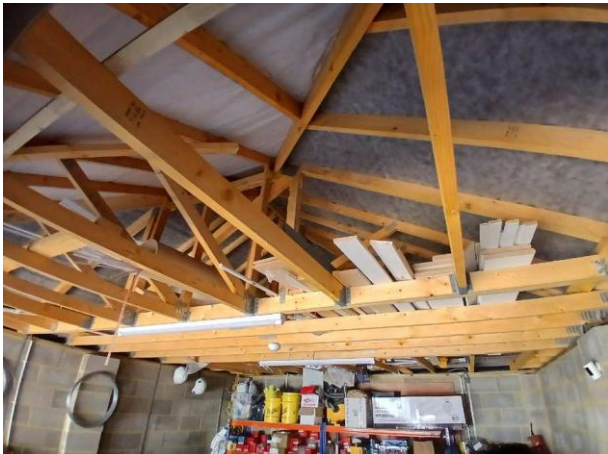
| Internal space | <p>Timber rafters.</p> <p>Bitumen felt lining</p> | <p>The ceiling within B3 is vaulted and as a result the internal aspect of the roof is well lit when the garage is in use. The roof is lined with bitumen felt in good condition with no gaps or tears.</p> <p>No roosting features, access points, light spill or evidence of bats were noted within the garage.</p> | <p><i>Internal space of B3, facing east.</i></p> |

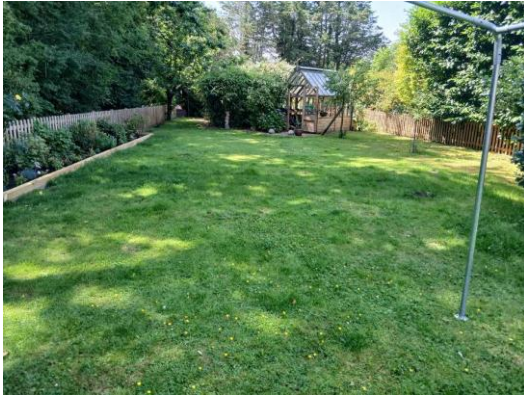
An amenity lawn is present to the west of site. This grassland is actively managed via regular mowing, resulting in a short sward of ~5cm. No signs of compaction or damage are present, resulting in areas of bare ground totalling <10% of the site. Some areas of the site are planted with ornamental garden species including shrubs, saplings, and flowerbeds.

*Vegetated garden, facing south.*

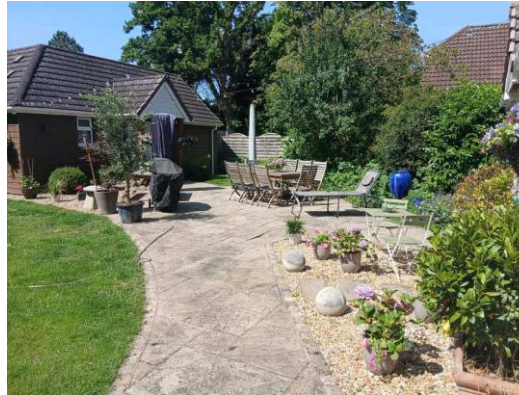
To the south of B1 is an area of hardstanding comprising a patio and associated footpath, providing access around the property and connecting the building to the surrounding garden.

*Patio and footpath to the south of B1, facing west.*

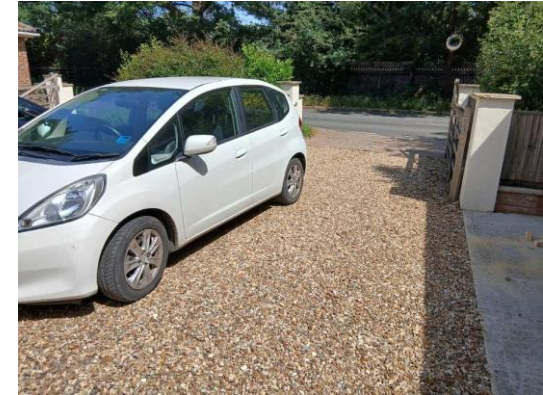
To the north of B1 is a shingle driveway, which provides vehicle access to the property and is of negligible ecological value due to its regularly disturbed and unvegetated nature.

*Artificial unvegetated, unsealed surface, facing north.*

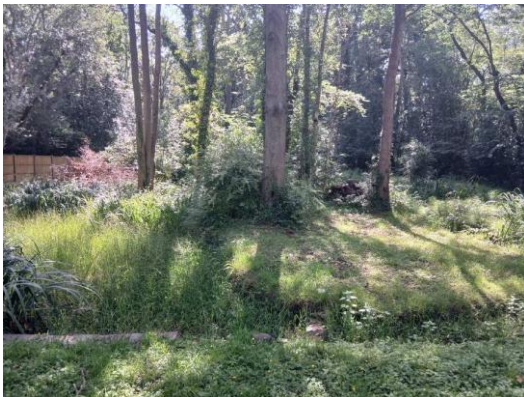
The eastern portion of the site comprises a parcel of lowland mixed deciduous woodland that extends beyond the site boundaries to the south and east, forming part of a larger and well-connected woodland block within the local landscape. The woodland canopy is dominated by mature oak *Quercus spp.*, ash *Fraxinus excelsior*, sweet chestnut *Castanea sativa* and occasional Lawson cypress *Chamaecyparis lawsoniana*.

*Lowland mixed deciduous woodland to the east of the site.*

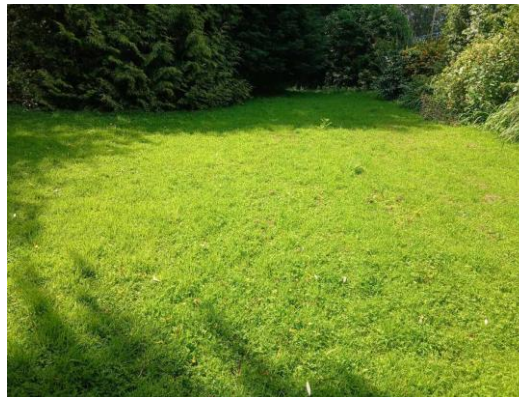
The site is covered with grassland comprised of a low variety of common grassland species. This grassland is actively managed via regular mowing, resulting in a short sward of ~5cm. No signs of compaction or damage are present, resulting in areas of bare ground totalling <10% of the site. The species composition is good, with 6-8 vascular plant species present per m<sup>2</sup>.

*Modified grassland in the centre of site, facing south.*

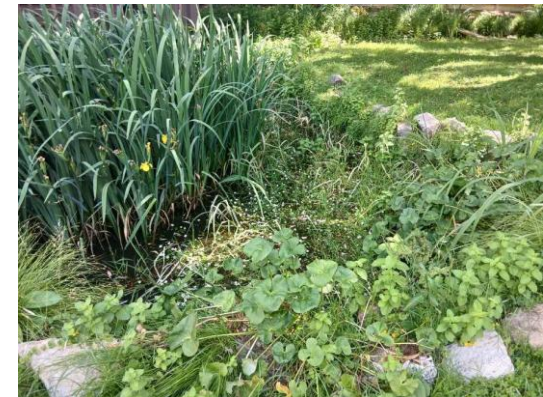
A pond is located on the eastern section of the site. A description and Habitat Suitability Index (HSI) assessment of the pond can be found within the Fauna section of this report.

*Pond P1, facing north.*
