# Phase II Site Investigation Report

at Bridge Farm, Bridge Farm  
Road, Twyford, Berkshire,  
RH10 9PP

for Croudace Homes Ltd

Report Reference: LP3302

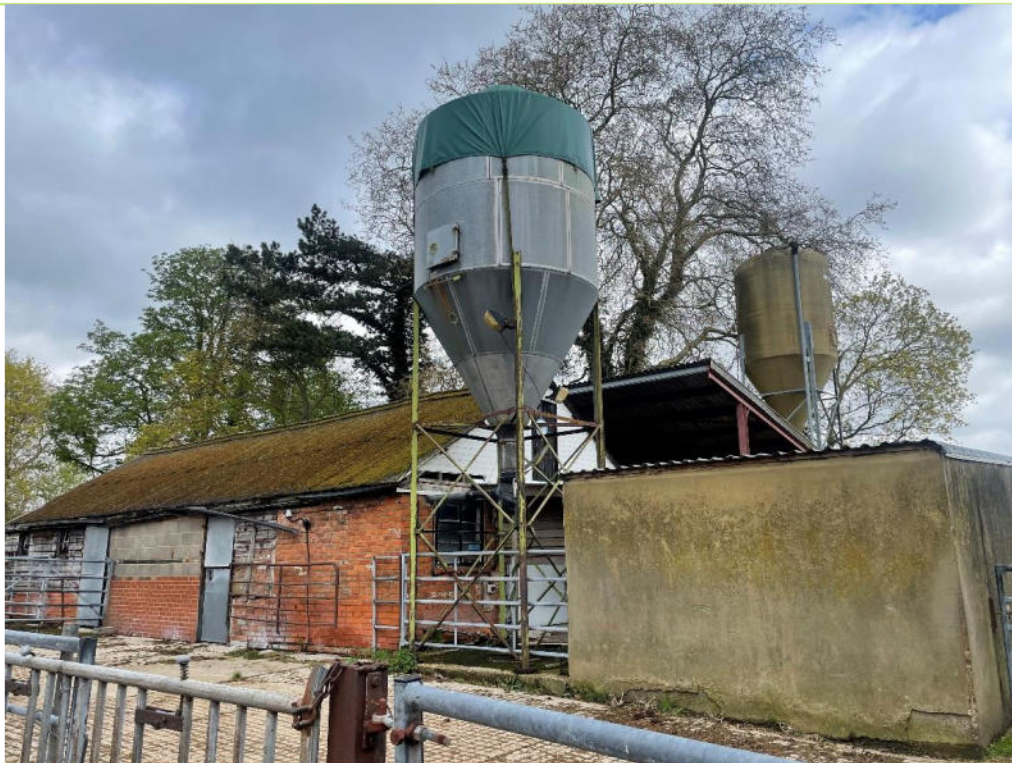
Plate 2 – View of overhead storage tanks near farm entrance.

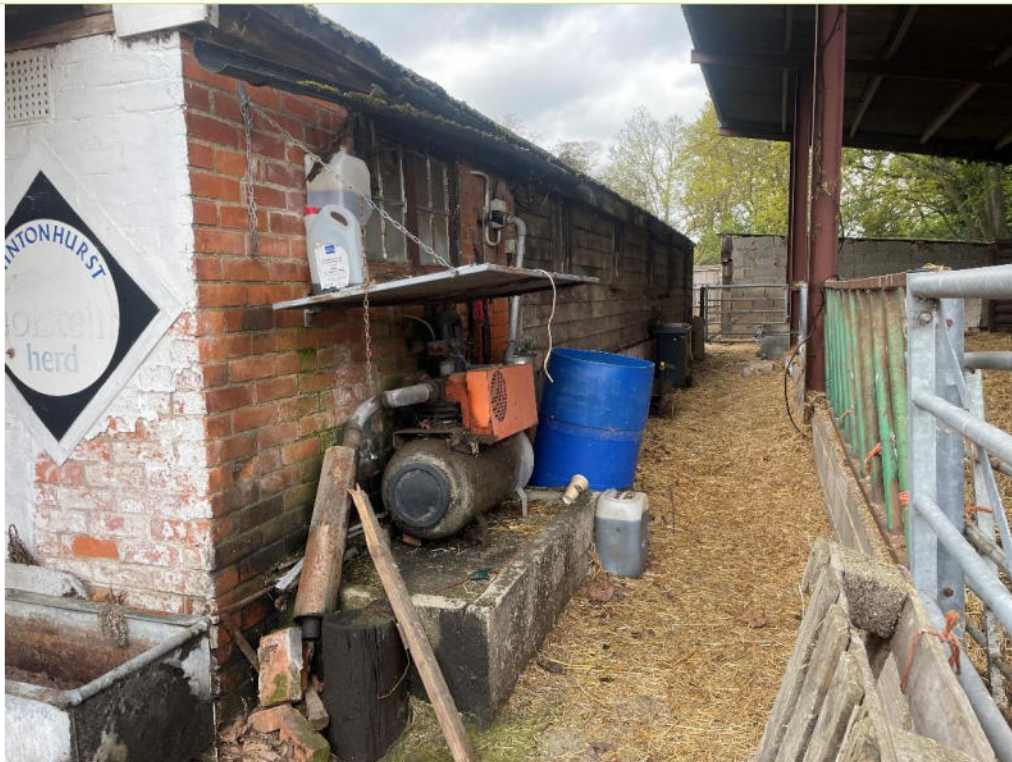
Plate 3 – View of small oil powered generator.

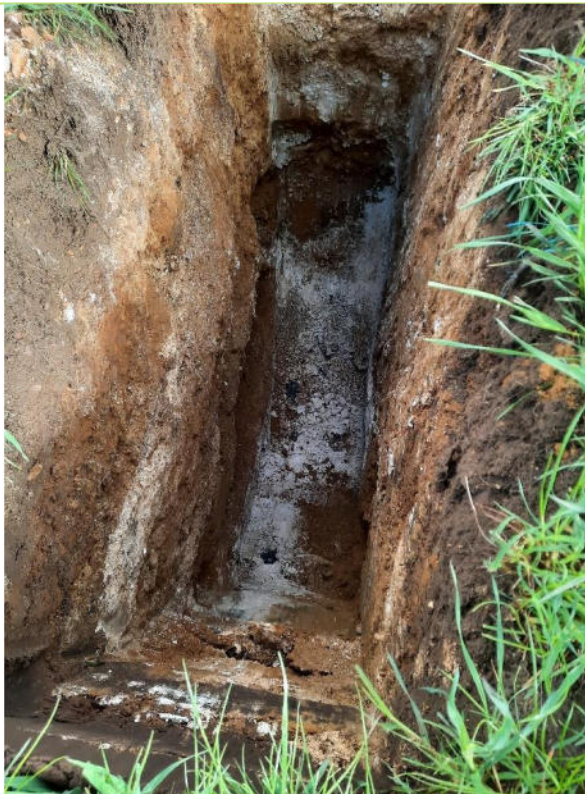
Plate 11 – View of trial pit from above.

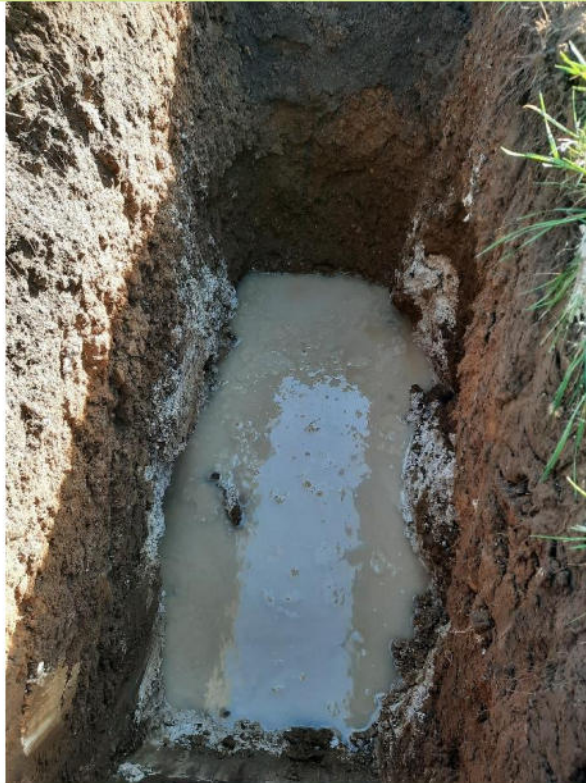
Plate 13 – View of water seepage infilling a trial pit.

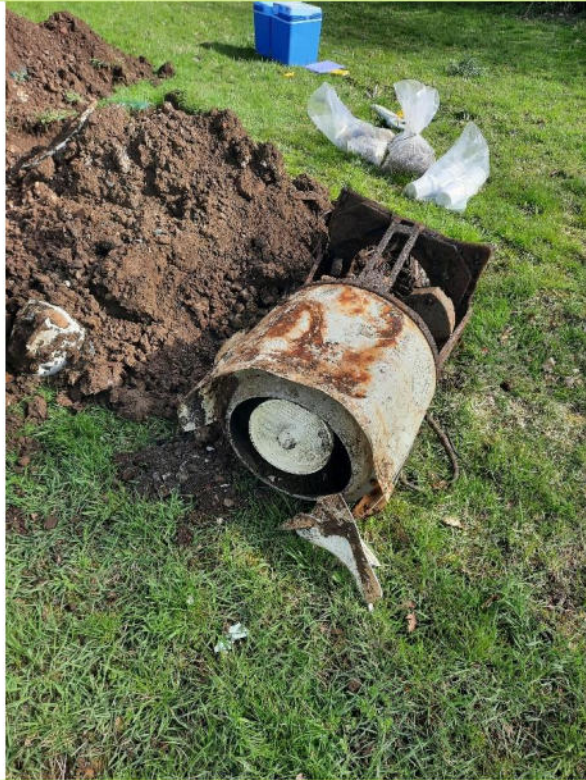
Plate 17 – View of metal debris removed from trial pit.

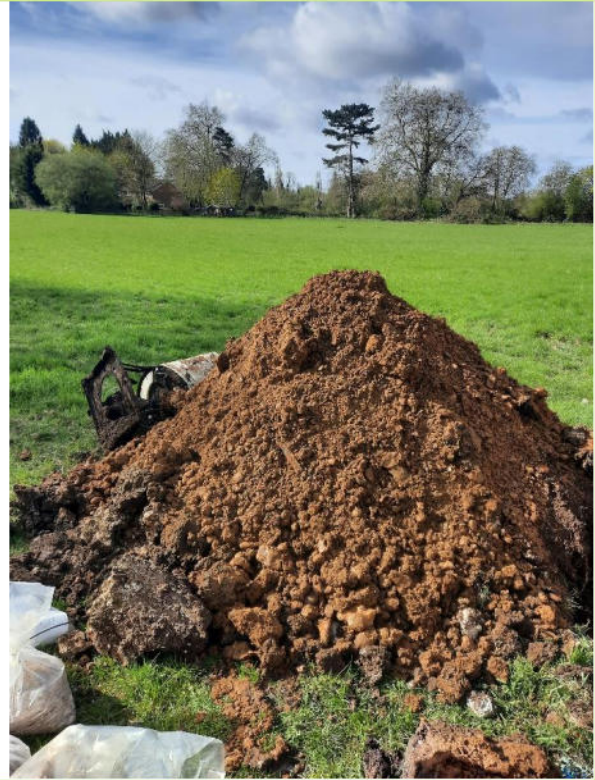
Plate 18 – Second view of arisings and metal debris removed from trial pit.

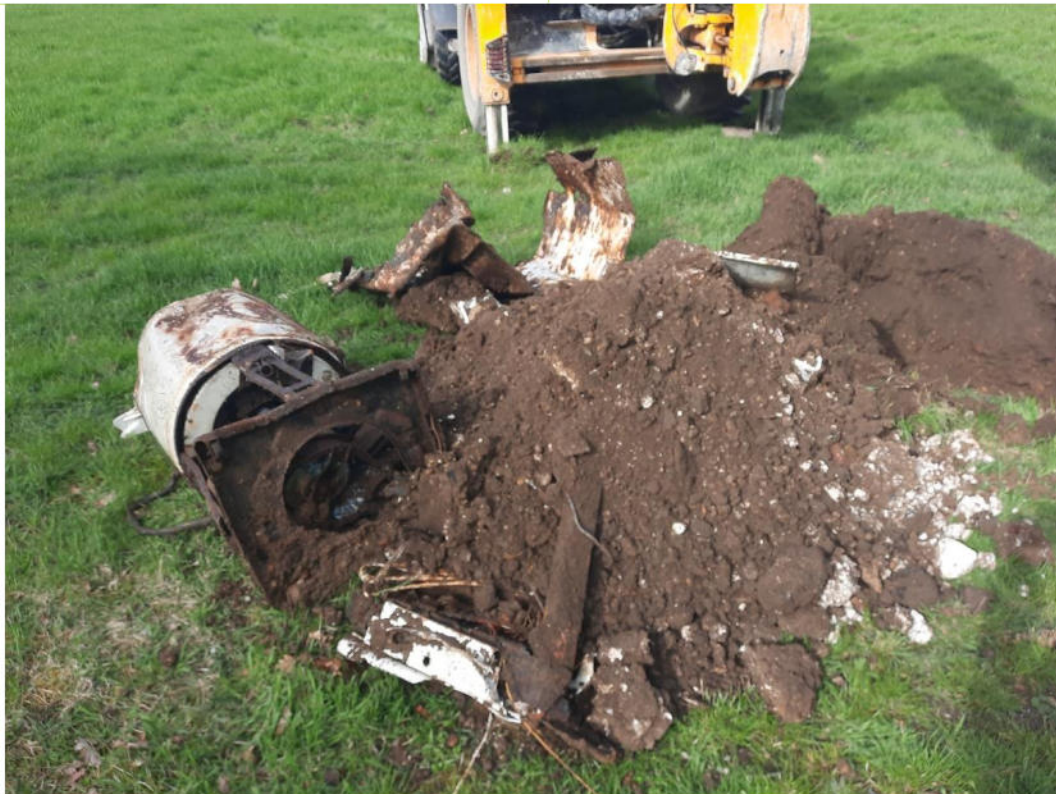
Plate 19 – Overview of metal debris and arisings removed from trial pit.
