## PRELIMINARY ECOLOGICAL APPRAISAL (DBW) AT 23 STARMEAD DRIVE WOKINGHAM

Prepared for:  
Mr D Simpson  
23 Starmead Drive  
Wokingham  
RG40 2JA

30 June 2025

Ref: SPH/NP/PEA-25/17.06

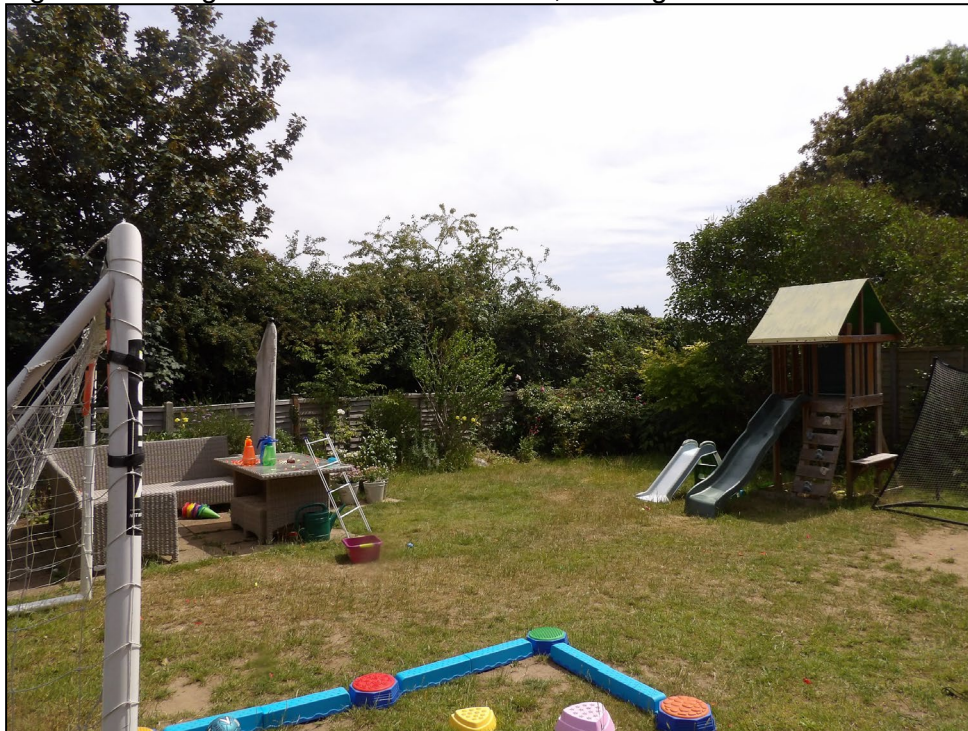
Figure 3. Rear garden. 23 Starmead Drive, Wokingham. 17.06.25

The application site comprises a detached, brick-built property with part integrated garage. The remainder of the site comprises a small front garden with lawn, shrubs and a driveway/parking area, the rear garden that is laid mainly to lawn with seating area and mature trees and shrubs on the boundaries, see Figure 3 below. The site itself offers some foraging and commuting habitat for bats and there is good ecological connectivity to the wider landscape.

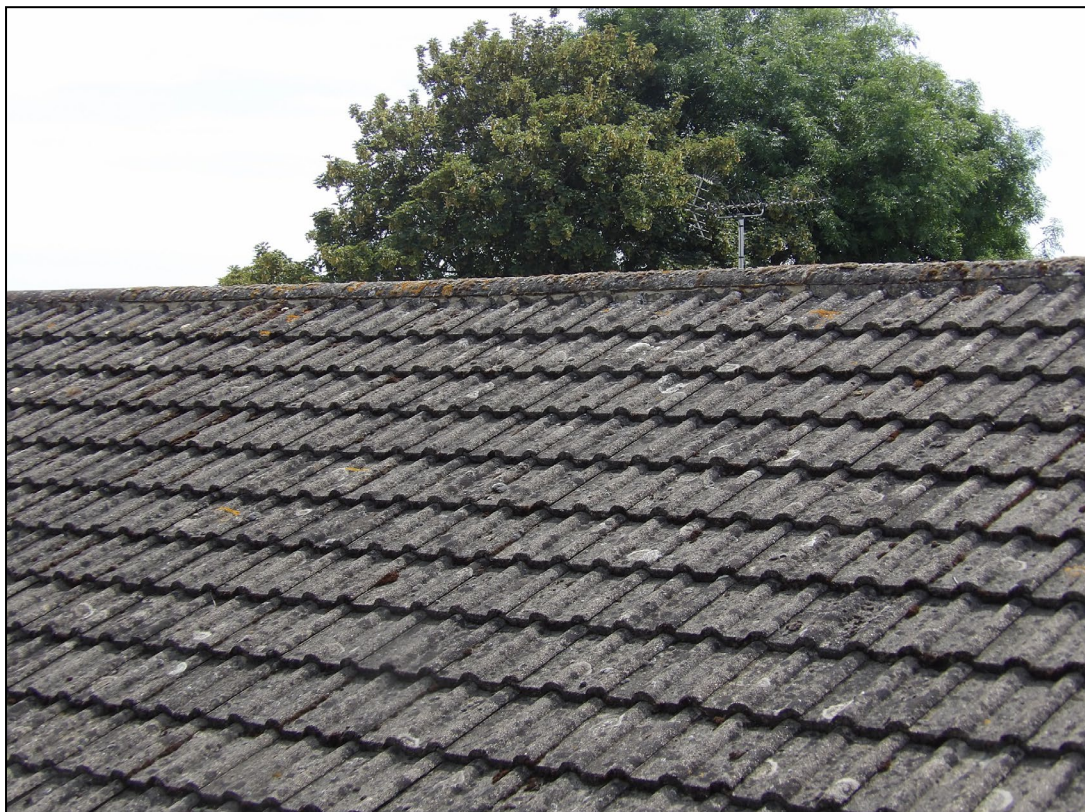
Figure 4. Example of roof and ridge tiles. 23 Starmead Drive, Wokingham. 17.06.25

The property is brick-built, two storey building that is in a good condition externally. The main, pitched roof section is covered in close fitting composite tiles, none of which are missing or broken (see Figure 4 below), and the ridge tiles and verges were all tightly fitted with no gaps or missing mortar in which bats could roost (see Figure 5 on page 9) however, on the front single pitched section over the part integral garage (see Figure 6 on page 9), some tiles near the ridge have moved leaving gaps, see Figure 7 on page 10. The soffits and fascias are all tightly fitted to the walls and have no cracks or splits in which roosting bats could exploit, see Figure 8 on page 10. On the front elevation are hanging tiles and a section of wooden cladding, all of which are tightly fitted with no gaps, see Figure 9 on page 11. On the northern elevation is a dormer window, the rear section of which forms part of the rear wall of the property (see Figure 10 on page 11), the side and front sections are covered in wooden cladding which, on the front elevation has broken/slipped leaving gaps that could be exploited by crevice dwelling bat species, see Figure 11 on page 12. The flat roof of the dormer is covered in well fitted bitumen felt with no rips or tears that roosting bats could exploit, see Figure 12 on page 12.

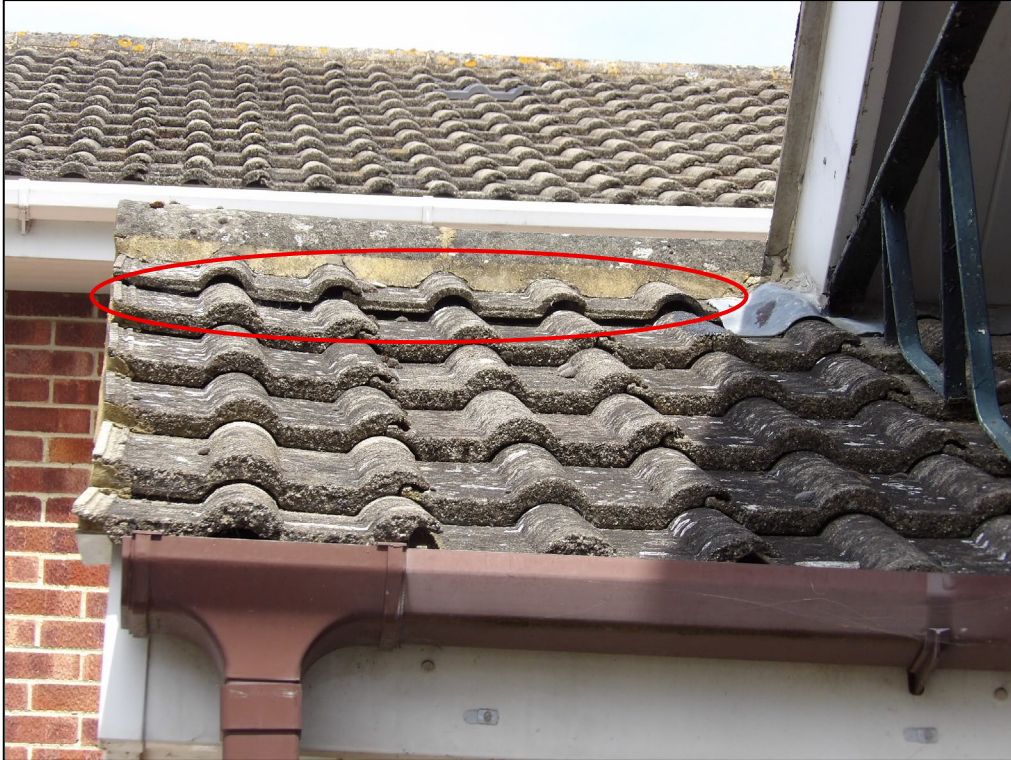
Figure 7. Example gaps in tiles on single storey front pitched roof. 23 Starmead Drive, Wokingham. 17.06.25

The broken/slipped timber boarding on the front elevation of the dormer window and the raised roof tiles on the section of the roof over the garage provide potential roosting opportunities for crevice dwelling bats and the presence or absence of bats could not be determined. When combined, the crevice-like features and surrounding habitat that is suitable for foraging, commuting and roosting bats result in the property being classified as having a low potential to support roosting bats.

However, surveying the front section of the dormer window is not possible due to the presence of the neighbouring property and design of the property (protruding front section of the integral garage) therefore a watching brief must be undertaken during works to the dormer and roof, conditioned in any planning consent.

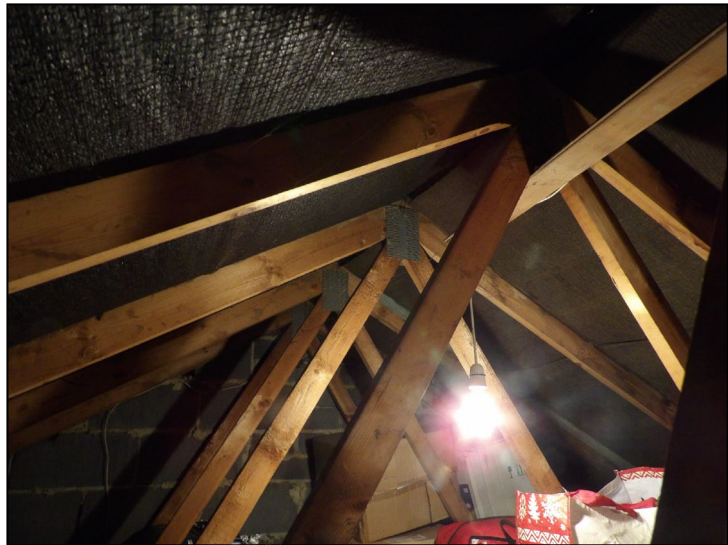
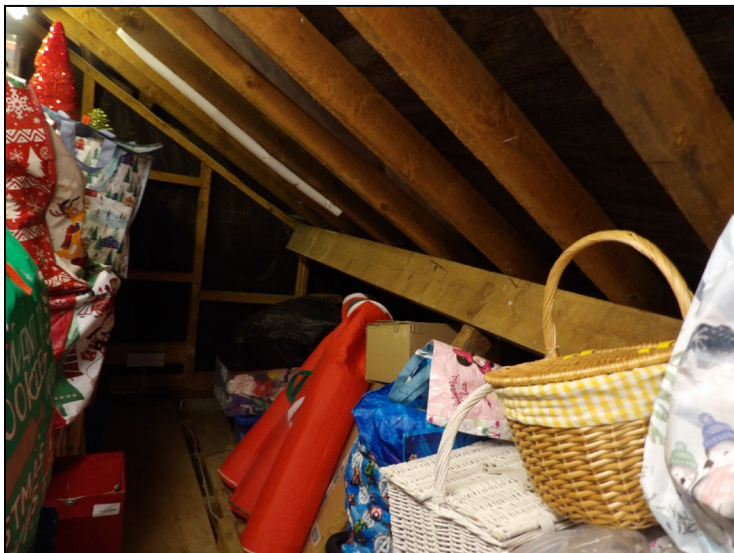
Figure 13. Example main loft space. 23 Starmead Drive, Wokingham. 17.06.25

The main loft of the property was accessed via a loft ladder and was in a good condition internally. The loft is used for personal storage and was cluttered, but this did not hinder the inspection. The loft was lit, partially boarded and insulated, see Figure 13 below. The roof tiles are lined with bitumen felt, all of which appears to be in a good condition with no rips or tears which could be utilised by roosting bats, see Figure 13 below.
