**40 Paddock Heights  
Twyford  
Reading  
Berkshire  
RG10 0AR**

# **Preliminary Roost Assessment**

Report ref.: S3092\_PRA\_a

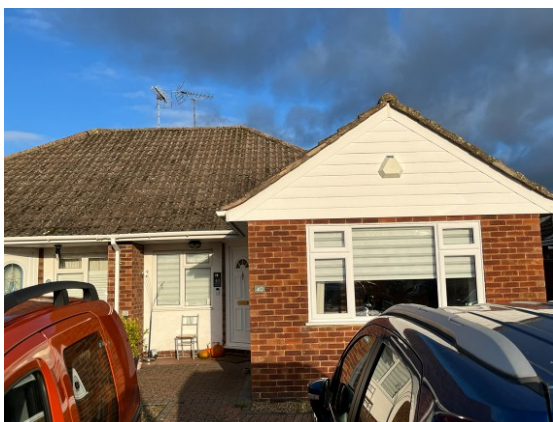
a conservatory attached to rear eastern side. The hipped roof had a front gable and a garage with a sloped roof and brick walls was situated at the rear (**Photographs 1 & 2**).

*Photograph 1. Front elevation viewed from the southwest.*

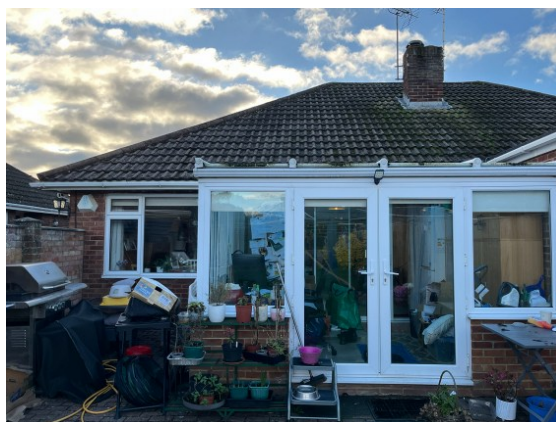
*Photograph 2. Rear elevation of bungalow viewed from the northeast.*

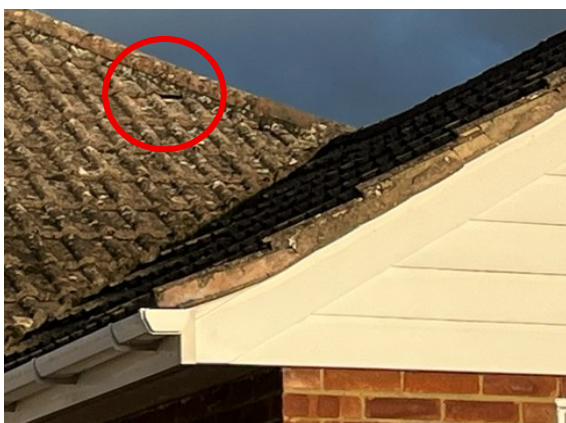
- 5.2.3** The hipped roof was covered by interlocking concrete tiles that were mostly sealed and intact, other than a lifted tile on the front elevation and behind the chimney on the south eastern elevation (**Photographs 3 & 4; Target notes 1 & 2**). The lifted tiles at the chimney were closely inspected with an endoscope, which confirmed the feature to be of a suitable size and condition for roosting bats, but no evidence was observed (**Photographs 5 & 6**).

*Photograph 3. Sealed interlocking roof tiles (rear elevation).*

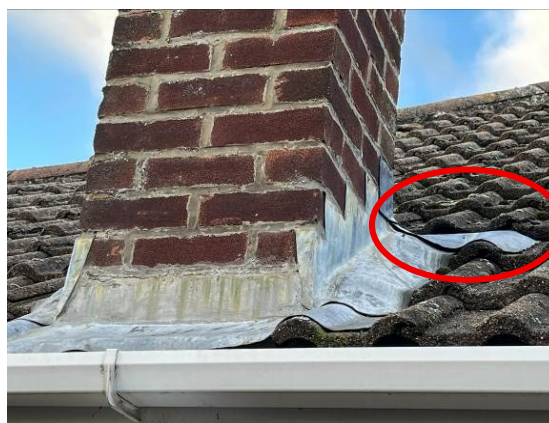
*Photograph 4. Lifted interlocking roof tiles by chimney (southeast elevation).*

- 7.2.1** The proposals are unlikely to affect bats or their roosts based on these findings; however, the tiles around the chimney stack, which were features of low bat roost potential, which showed no signs of roosting bats currently, could be used in the future and therefore a precautionary pre-commencement survey is recommended (refer to Recommendations in **Section 8**).

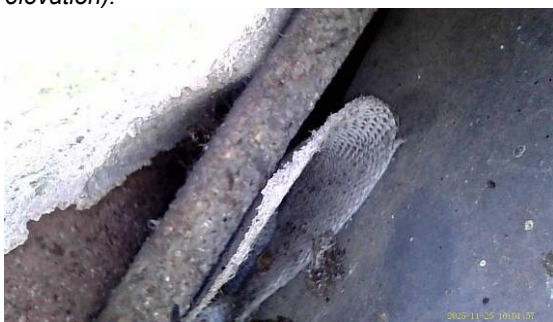
*Photograph 5. Gap under tiles behind the chimney.*

- Lifted interlocking concrete roof tiles on the front and southeastern elevations (**Photographs 5 & 6; Target notes 1 & 2**);
- Crumbling ridge mortar (**Photograph 9; Target note 4**);
- Gaps within the party wall with direct access to the neighbouring roof void (**Photograph 17; Target note 6**); and
- Gaps along the edge of the party wall (**Photograph 18; Target note 7**).

**8.1.2** A soft strip approach to the roof works, i.e. careful removal of the roof tiles around the chimney by gloved hands and handheld tools, will be adopted by the contractors and carried out under the direct supervision of a suitably licensed ecologist. In the unlikely event that a bat roost is found during the soft strip, by either uncovering bat droppings or encountering a bat, the work must stop immediately and must not continue until further written advice has been received. At this stage, a European Protected Species (EPS) mitigation licence may be required to permit the works to recommence lawfully.

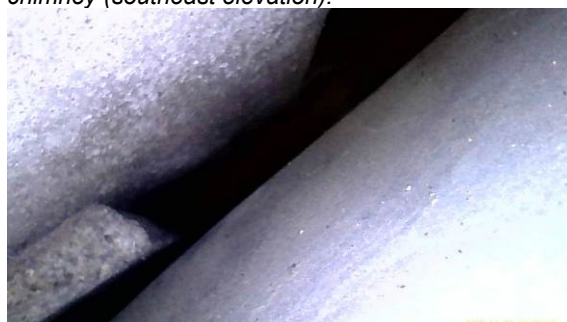
*Photograph 6. Gap under tiles behind the chimney.*

linings/insulation. Whilst the endoscopic check of the lifted tiles across the southeastern elevation showed no evidence of the presence of roosting bats; the feature is of a suitable size and condition for roosting bats and so may be utilised in the future.

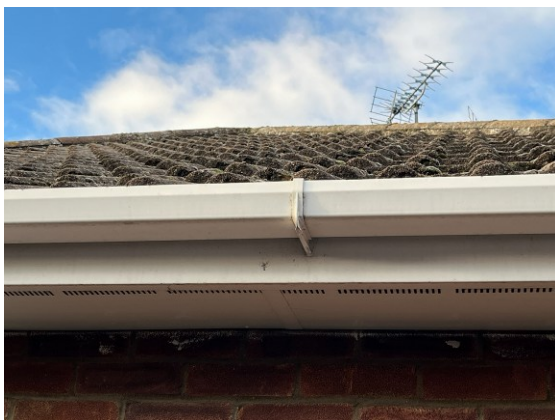
- 5.2.4** The hip mortar was fully intact and whilst the verge mortar across the front gable was intact, a slight gap was situated between the mortar and under cloaking, however, close inspection with a high-powered torch confirmed the feature to be superficial (**Photographs 7 & 8; Target note 3**). Whilst mostly intact, the ridge mortar was partially crumbling along the front gable with direct internal access to the roof void (**Photograph 9; Target note 4**).

*Photograph 7. Fully intact hip mortar (southeastern elevation).*

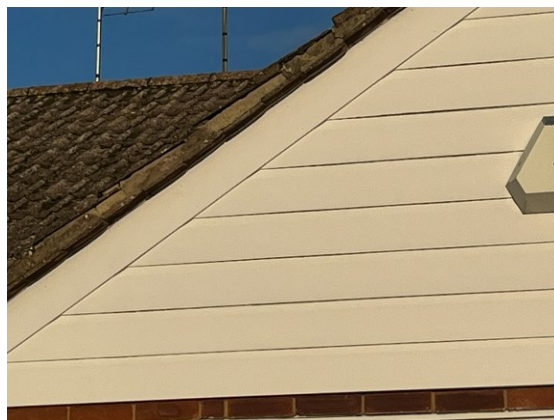
*Photograph 8. Superficial crevice between mortar and under cloaking (front elevation).*

6.1.3 Whilst a slight gap was situated between the under cloaking and verge mortar across the front gable, close inspection with a high-powered torch confirmed this feature to be superficial with no suitable crevice (**Photograph 8; Target note 3**).

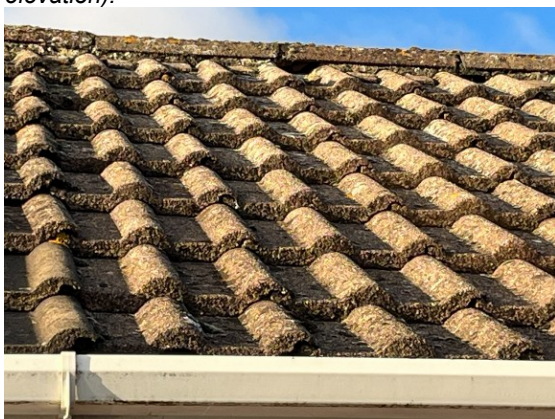
*Photograph 9. Crumbling ridge mortar (southeastern elevation).*

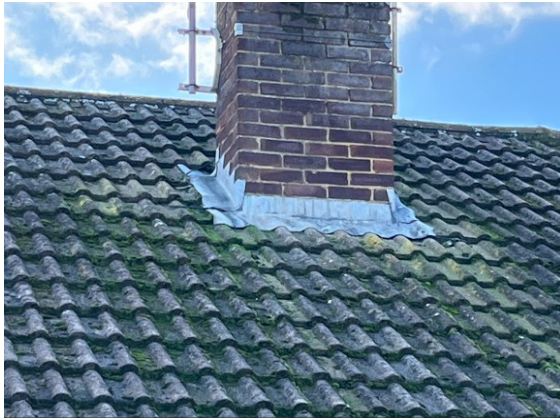
- 5.2.5** The lead flashing at the base of the brickwork chimneys was mostly sealed to the concrete roof tiles and brickwork (**Photographs 10 & 11**). The vented uPVC soffit was sealed to the brickwork walls across all elevations (**Photograph 12**).

*Photograph 10. Lead flashing sealed to chimney and roof tiles (rear elevation).*

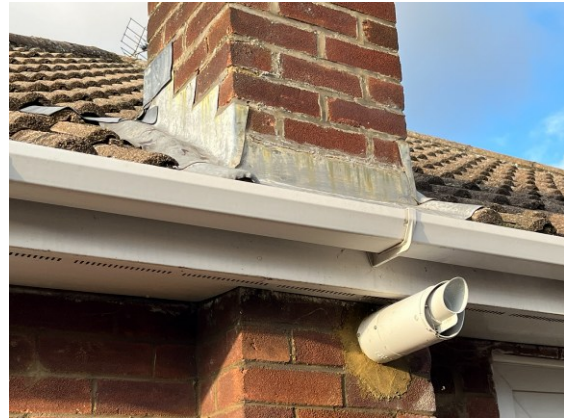
*Photograph 11. Lead flashing sealed to chimney and roof tiles (southeast elevation).*

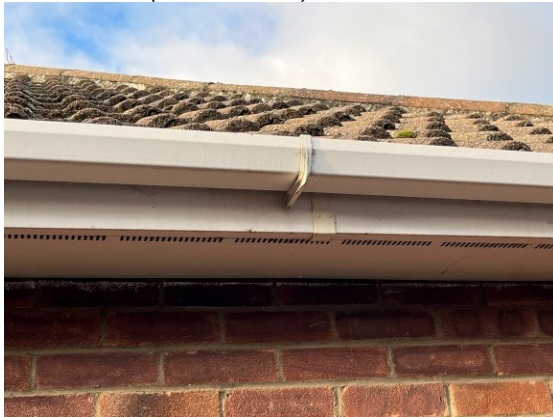
*Photograph 12. Vented uPVC soffit sealed to the brickwork (southeast elevations).*

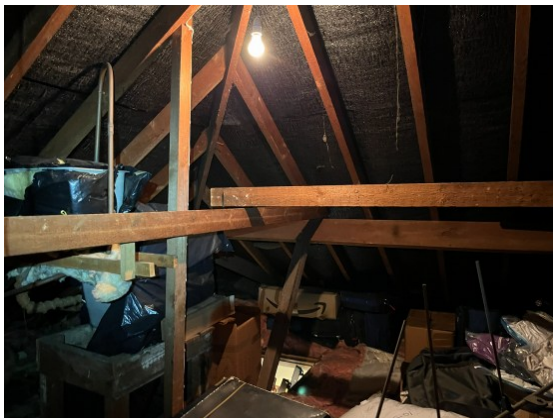
- 5.2.6** The property had one roof void that covered its footprint. The void was accessible via a ground floor loft hatch, was of 'cut and pitch' construction, cobwebbed throughout, and had an approximate floor-to-ridge height of 2 metres (**Photograph 13**).

*Photograph 13. Roof void.*

6.1.4 The lifted tiles and crumbling ridge mortar may lead into the roof void, which had sufficient space for internal flight and suitable conditions for regular use by individual or small non-breeding groups of void-dwelling bats, such as the locally recorded brown long-eared bat (*Plecotus auritus*). However, no droppings were observed within the roof void and so it is unlikely to support principally void dwelling species, such as the locally recorded brown long-eared (*Plecotus auritus*).

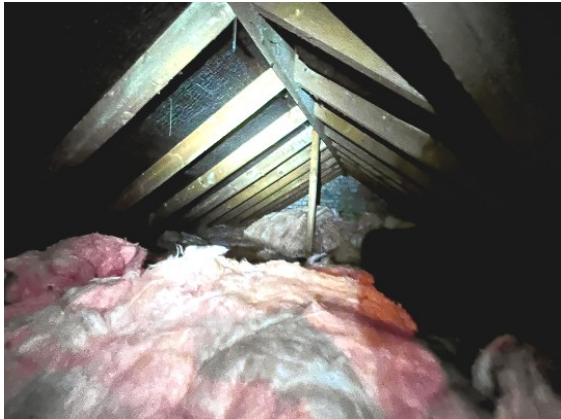
- 5.2.7** The roof was lined by hessian reinforced bitumen felt that was fully intact throughout (**Photograph 14**). The timbers around the chimney were also sealed to the brickwork and bitumen felt (**Photograph 15**). The chimney was cobwebbed.

*Photograph 14. Fully intact bitumen felt roof lining.*

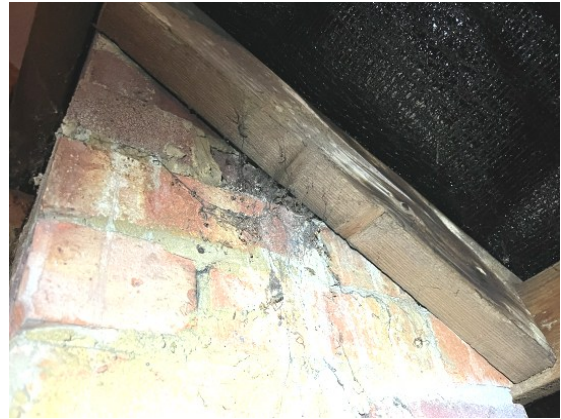
*Photograph 15. Timbers sealed to the brickwork chimney.*

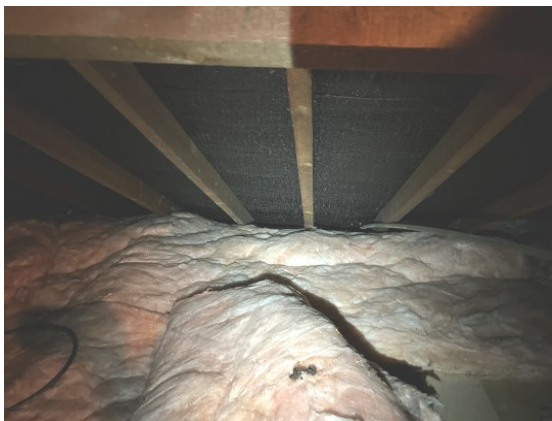
**5.2.8** The floor was partially boarded over fibreglass insulation that did not fill all the eaves, allowing access to sections of the vented uPVC soffit where daylight was visible (**Photograph 16; Target note 5**). The party wall had large gaps within it, providing direct access to the neighbouring void (**Photograph 17; Target note 6**). Furthermore, gaps were situated along the edge of the party wall (**Photograph 18; Target note 7**).

*Photograph 16. Open eaves with access to the vented uPVC soffit.*

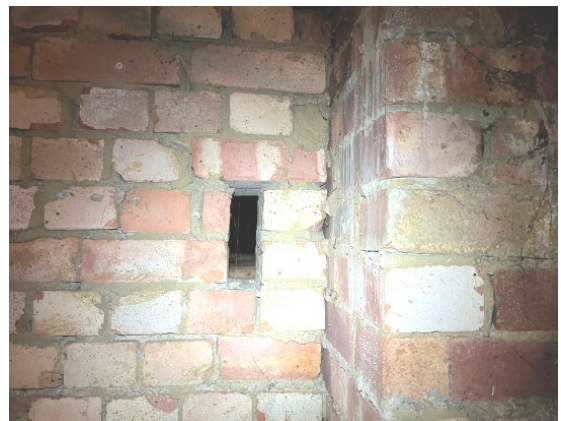
*Photograph 17. Gap within party wall.*
